**NEW MEXICO
ENVIRONMENT DEPARTMENT**

**Re: Mora National Fish Hatchery and Technology Center; Minor Non-Municipal, SIC 0921;
NPDES Compliance Evaluation Inspection; NPDES Permit No. NM0030031; September 5,
2013**

NPDES Compliance Inspection Report

Compliance Evaluation Inspection
Mora National Fish Hatchery and Technology Center
NPDES Permit No. NM0030031
September 5, 2013
Page 1 of 5

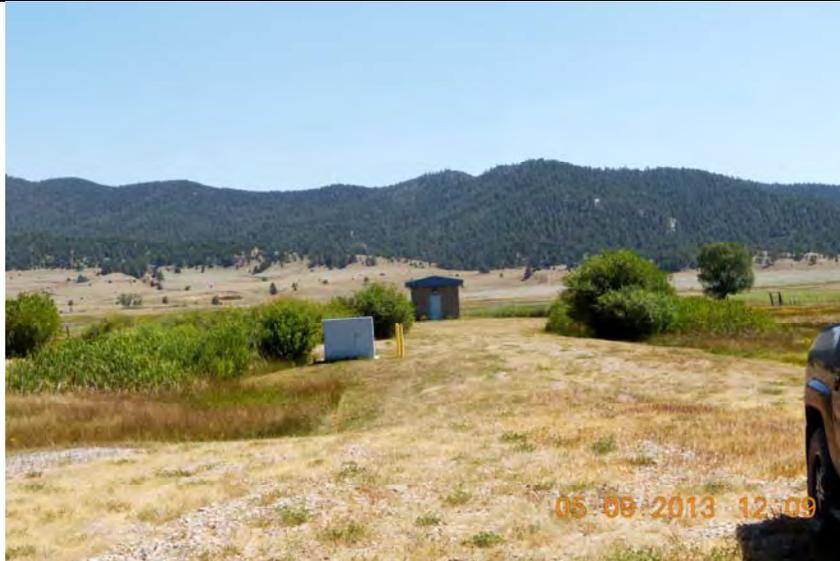
NMED/SWQB
Official Photograph Log
Photo #1

Subject: One of four well and pump houses for source water. The well water is pumped to an above ground storage tank/reservoir.

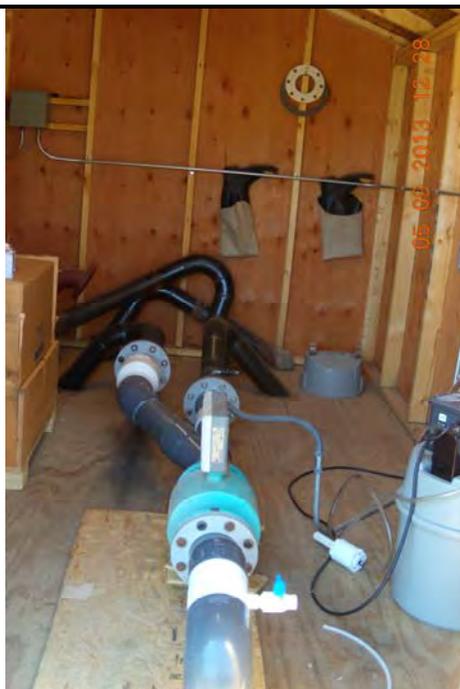
NMED/SWQB
Official Photograph Log
Photo #2

Subject: Effluent Pipes have been reconfigured so there is only one discharge point, the purge water from the wells now is mixed with the regular effluent before discharge. This is in response to finding in the CEI report March 30, 2011. Note in the picture: an inline effluent flow meter and a composite sampling unit.

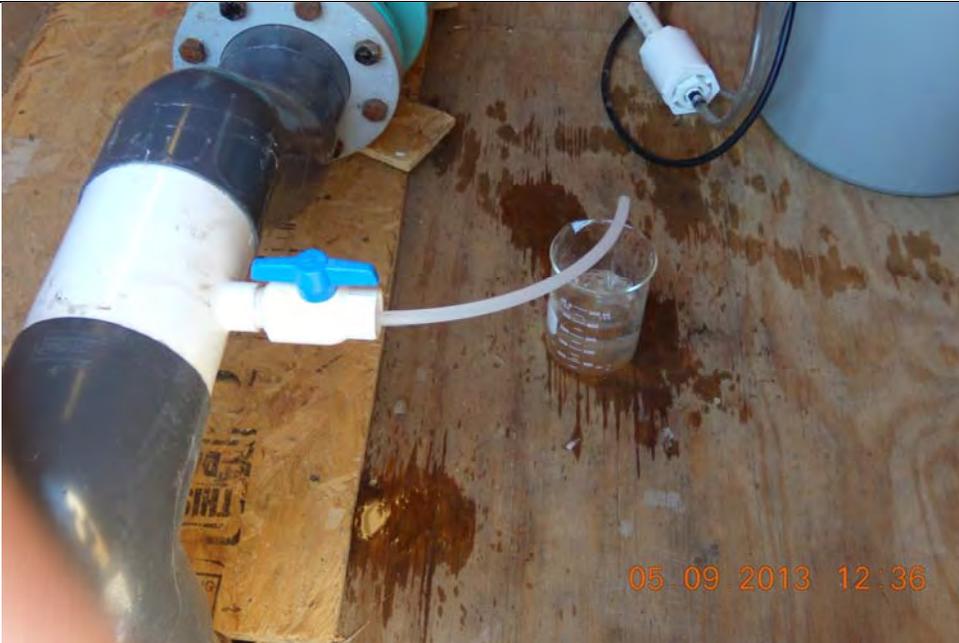
NMED/SWQB
Official Photograph Log
Photo # 3

Subject: Effluent Sampling Location

a) SAMPLES REFRIGERATED DURING COMPOSITING. Need to add ice to the compartment in the ISCO composite sampler Y N NA

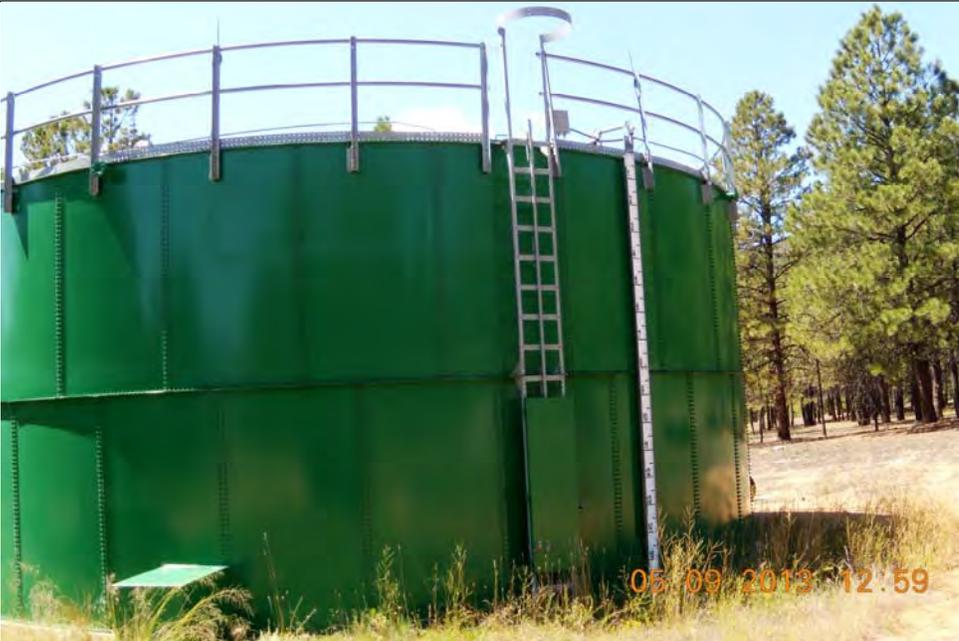
NMED/SWQB
Official Photograph Log
Photo # 4

Subject: Holding tank – reservoir holds 150,000 gallons

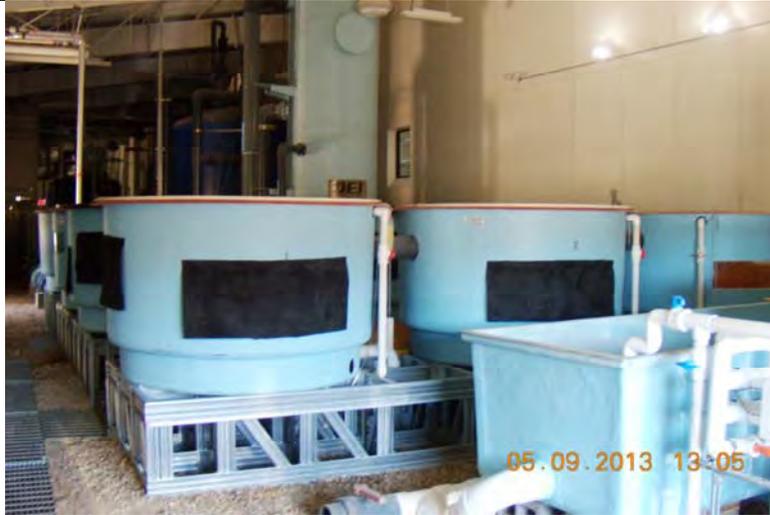
**NMED/SWQB
Official Photograph Log
Photo # 5**

Subject: These are the quarantine tanks where freshly caught fish are kept.

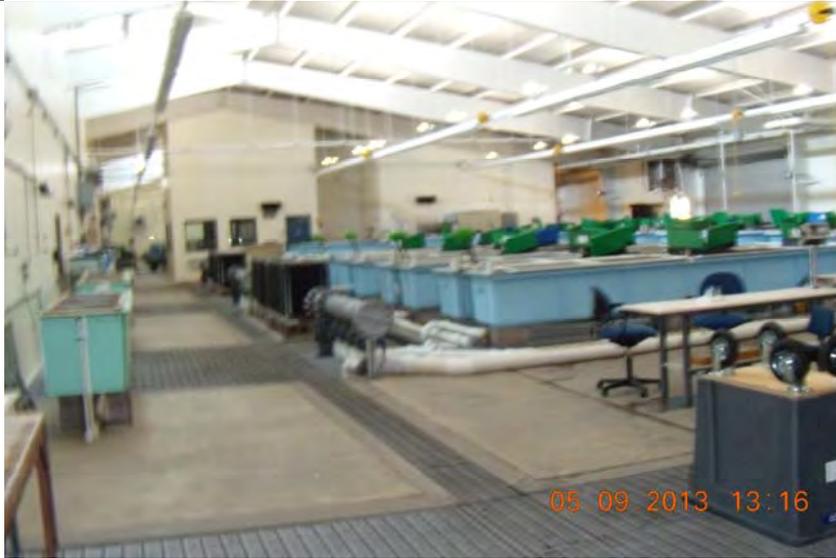
**NMED/SWQB
Official Photograph Log
Photo # 7**

Subject: Raceways

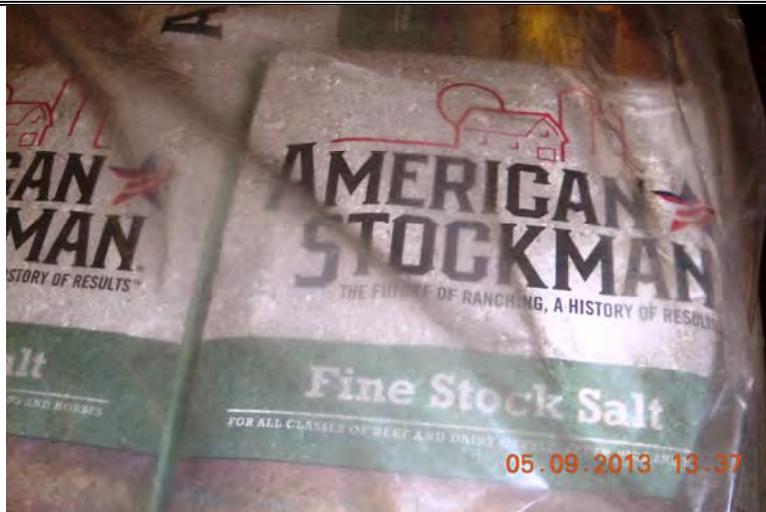
**MED/SWQB
Official Photograph Log
Photo # 9**

Subject: Salt used during the transport of fish – helps with regulation and homeostasis of the fish metabolism.

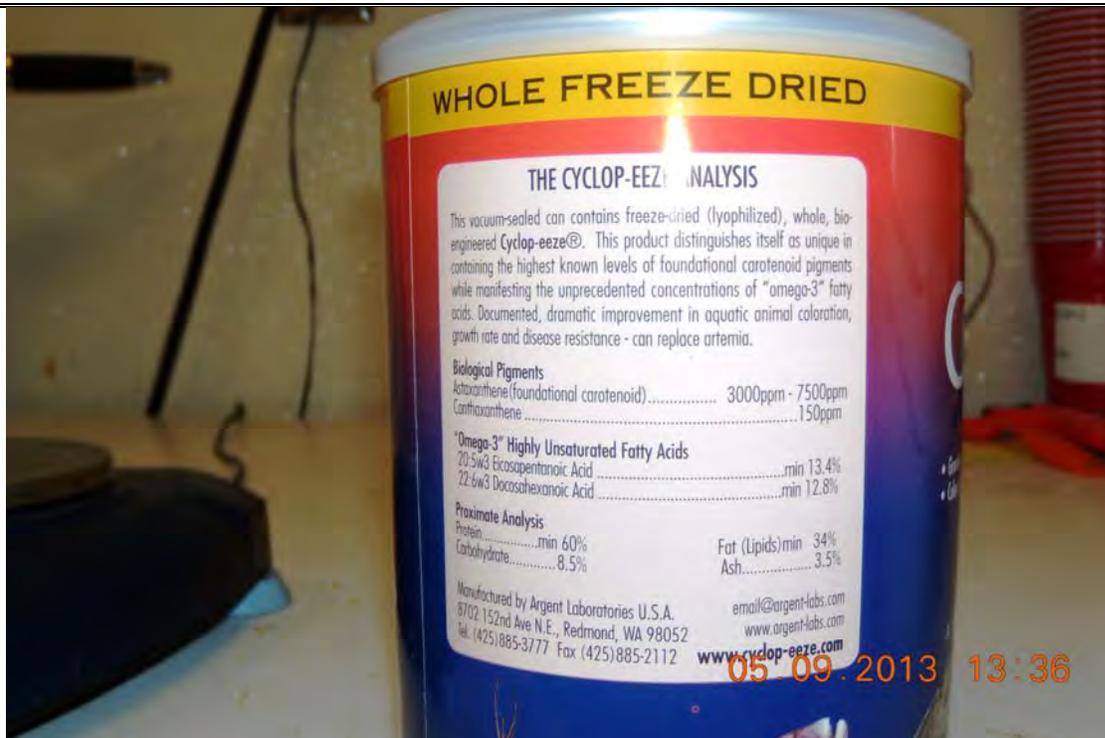
**NMED/SWQB
Official Photograph Log
Photo # 10**

Subject: Feed Ingredients

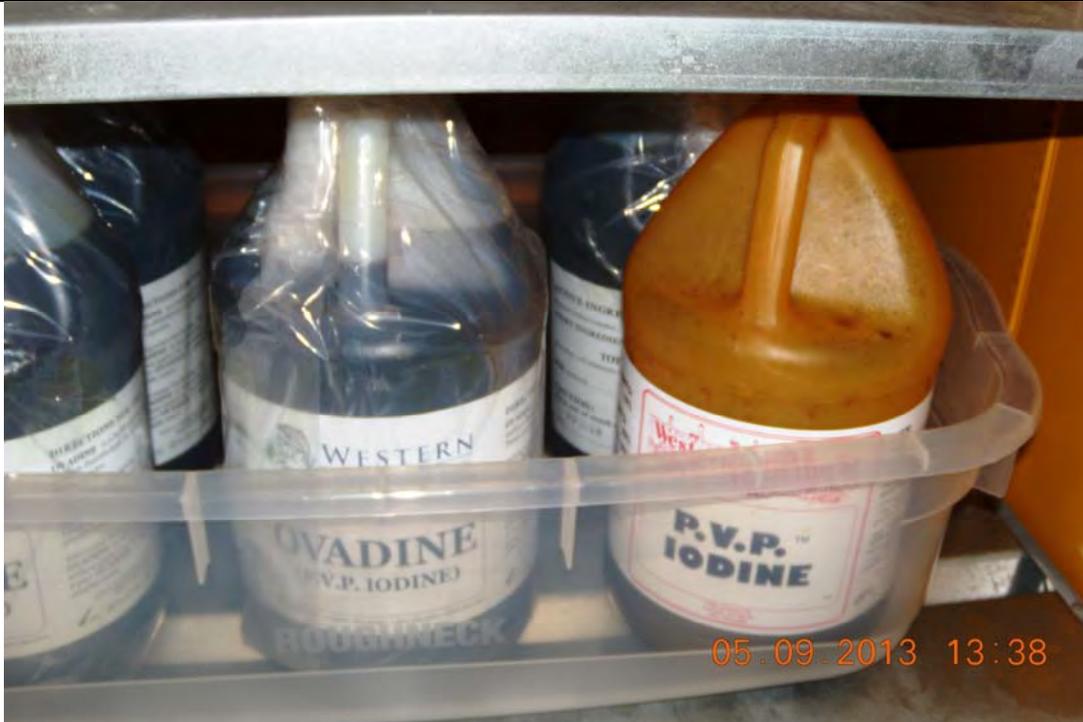
NMED/SWQB
Official Photograph Log
Photo # 13

Subject: Treatments Used Onsite

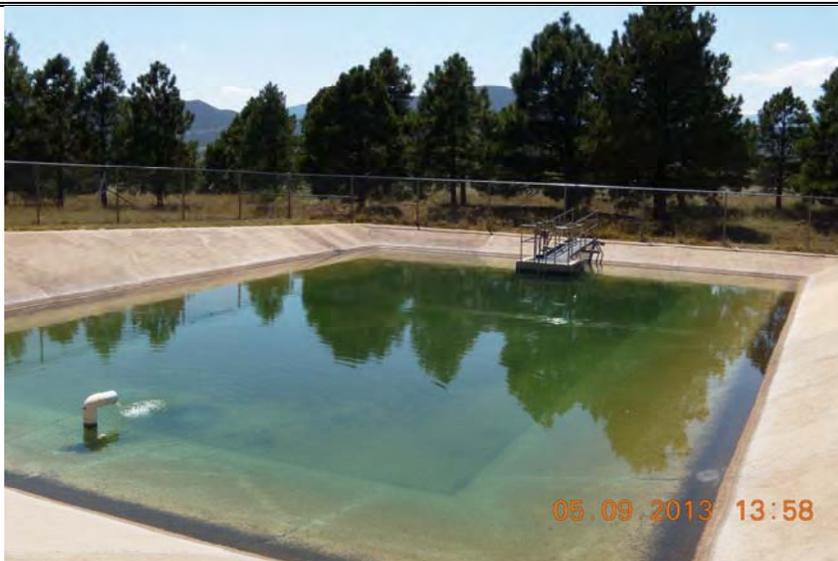
NMED/SWQB
Official Photograph Log
Photo # 14

Subject: Cement Lined Holding Pond – Discharge Goes To Final Polishing Pond

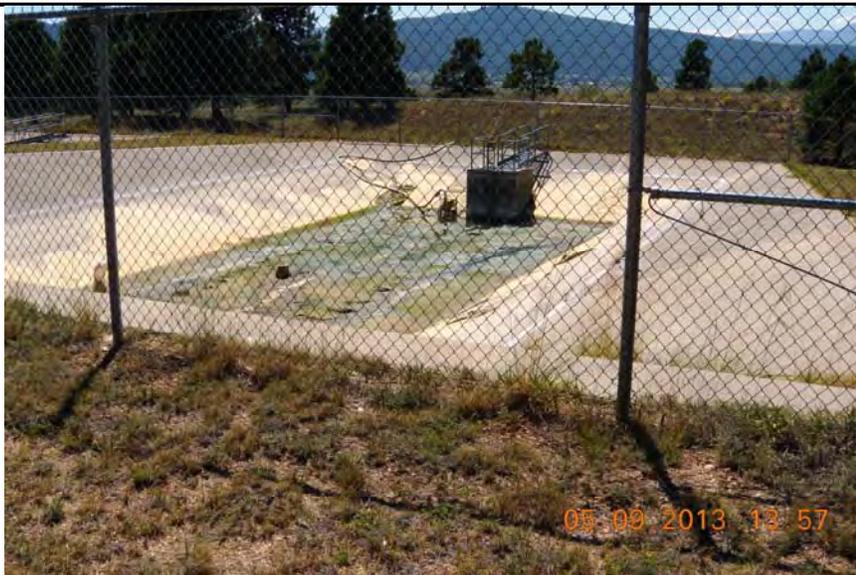
NMED/SWQB
Official Photograph Log
Photo # 15

The only operational step being taken to reduce total phosphorous is to clean the algae and solids from the cement lined settling ponds on a regular schedule and to dispose of it on site. There are no other additional controls being implemented for this pollutant.

Subject: Cement Lined Holding Pond In the Process Of Being Cleaned – Discharge Goes To Final Polishing Pond – The Remaining Algae Is Removed And Disposed Of Onsite.

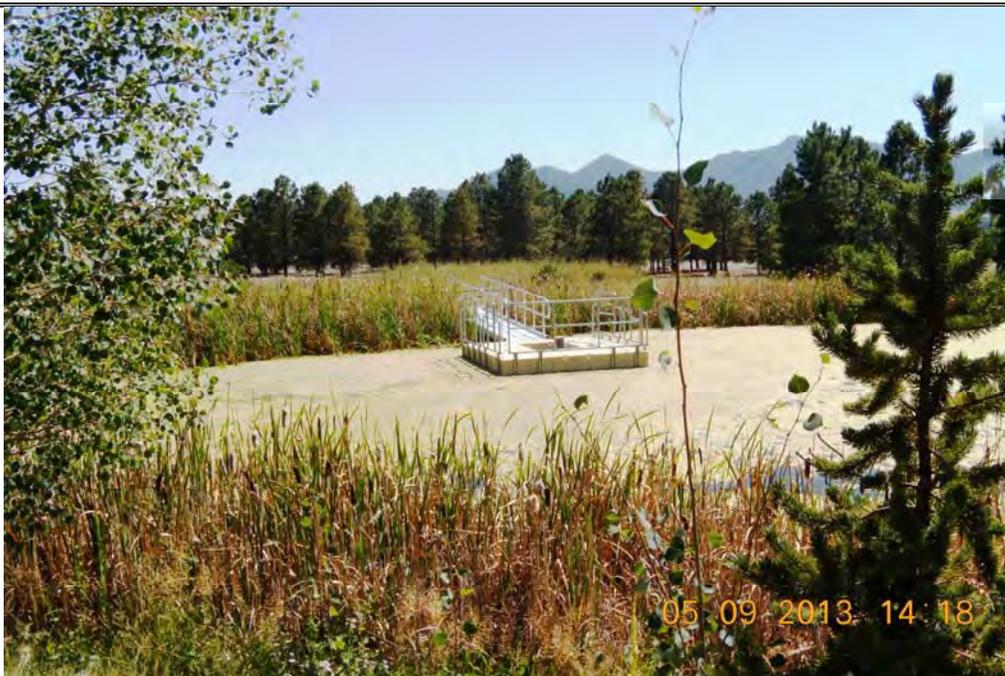
NMED/SWQB
Official Photograph Log
Photo # 16

The permittee was required to meet effluent limits for Total Nitrogen and Total Phosphorous beginning January 1, 2012. The Facility has exceeded effluent limits for Total Nitrogen and Total Phosphorous several times since that date. This is the reason for the “Unsatisfactory” rating for this section.

Subject: Final Polishing Pond – Overgrown Algae

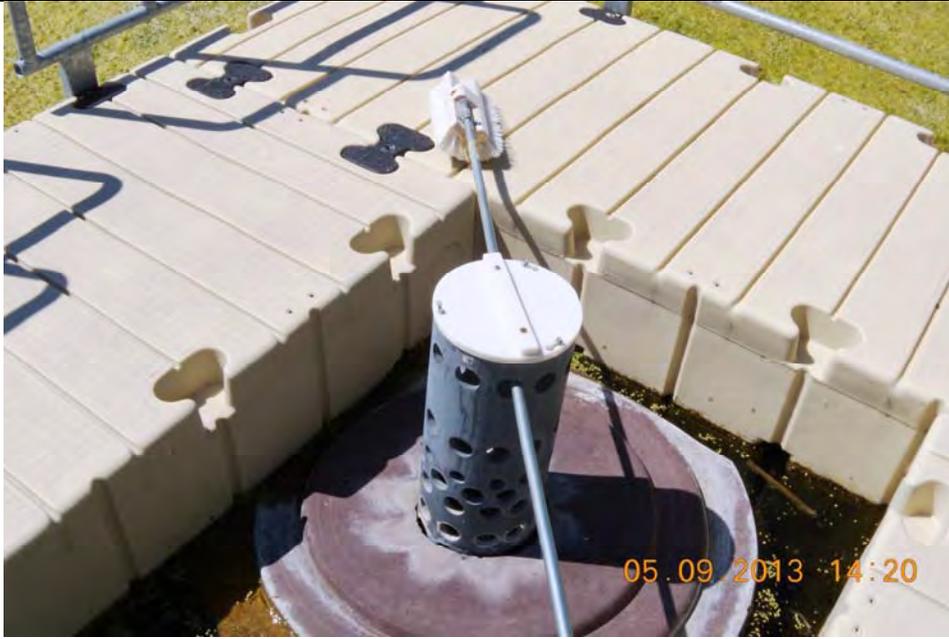
NMED/SWQB
Official Photograph Log
Photo # 17

Subject: Final Polishing Pond – Overgrown Algae – The Floating Book Keeps Much Of The Algae From Being Discharged Through The Effluent Pipe.

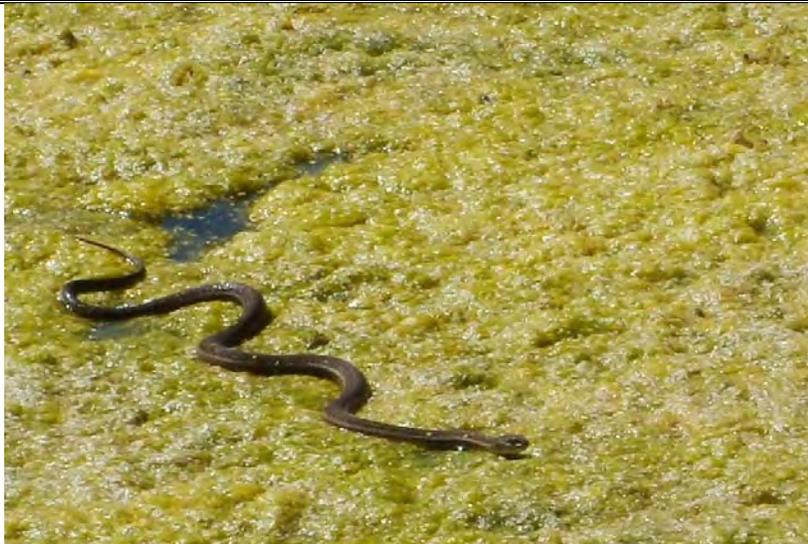
NMED/SWQB
Official Photograph Log
Photo # 18

Subject: The polishing pond surface algae bloom was thick enough to support the weight of a four foot long snake. This indicates the presence of nutrients in the water.
Note: Picture cropped to zoom in. The original photo is available upon request.

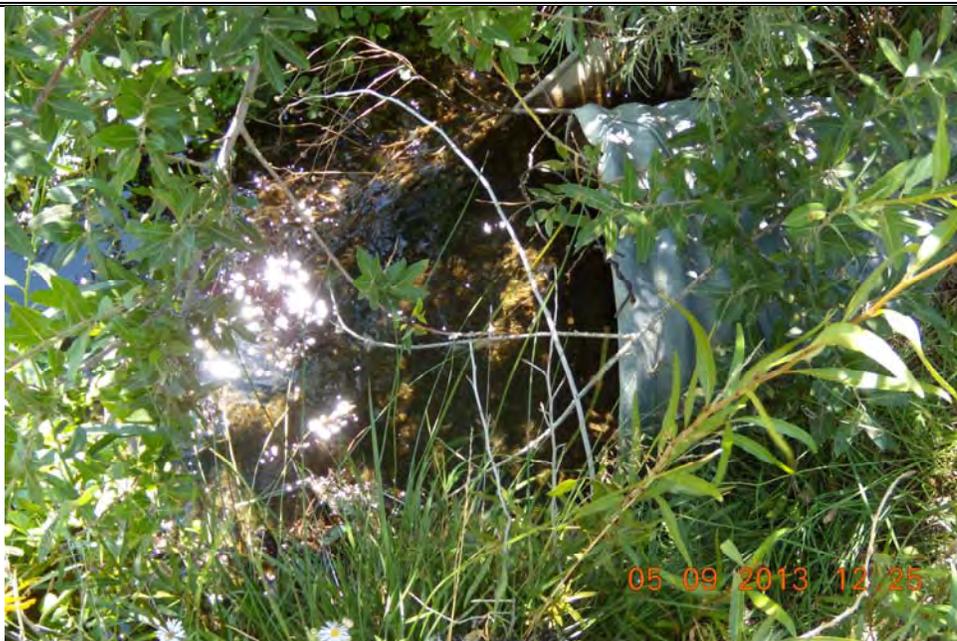
NMED/SWQB
Official Photograph Log
Photo # 19

Subject: Effluent to the Irrigation Ditch. – Large mats of Duck Weed Were Growing Over The Ditch.

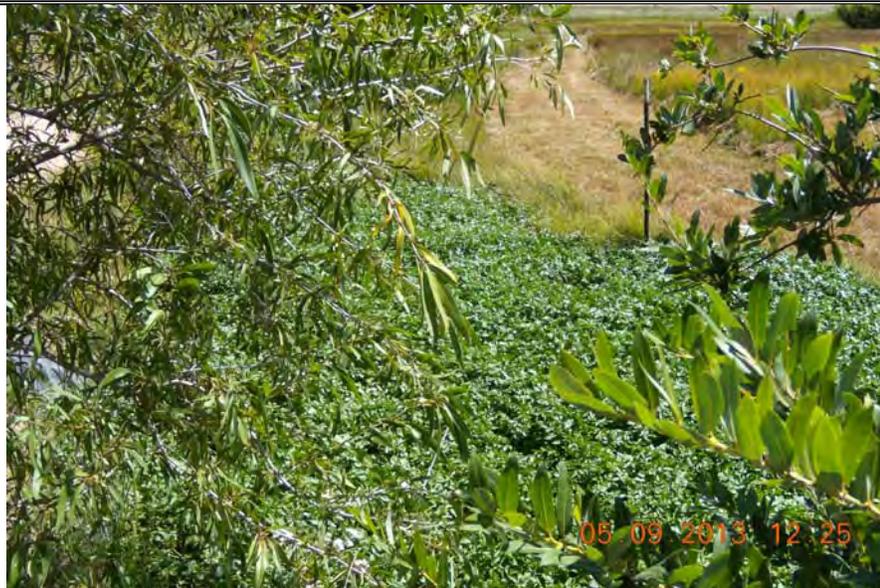
NMED/SWQB
Official Photograph Log
Photo # 20

Subject: Irrigation Ditch Where Hatchery Effluent Is Discharged Is Overgrown With Vegetation. The Ditch Above The Outfall Does Not Have The Same Level Of Growth.
