Re: **Minor-Non-Municipal; SIC 0921; NPDES Compliance Evaluation; Los Ojos State Fish Hatchery; NM0030139; 20 April 2012**

NPDES Compliance Inspection Report

Compliance Evaluation Inspection
New Mexico Department of Game & Fish, Los Ojos State Fish Hatchery
NPDES Permit NM0030139
20 April 2012
Page 1 of 7

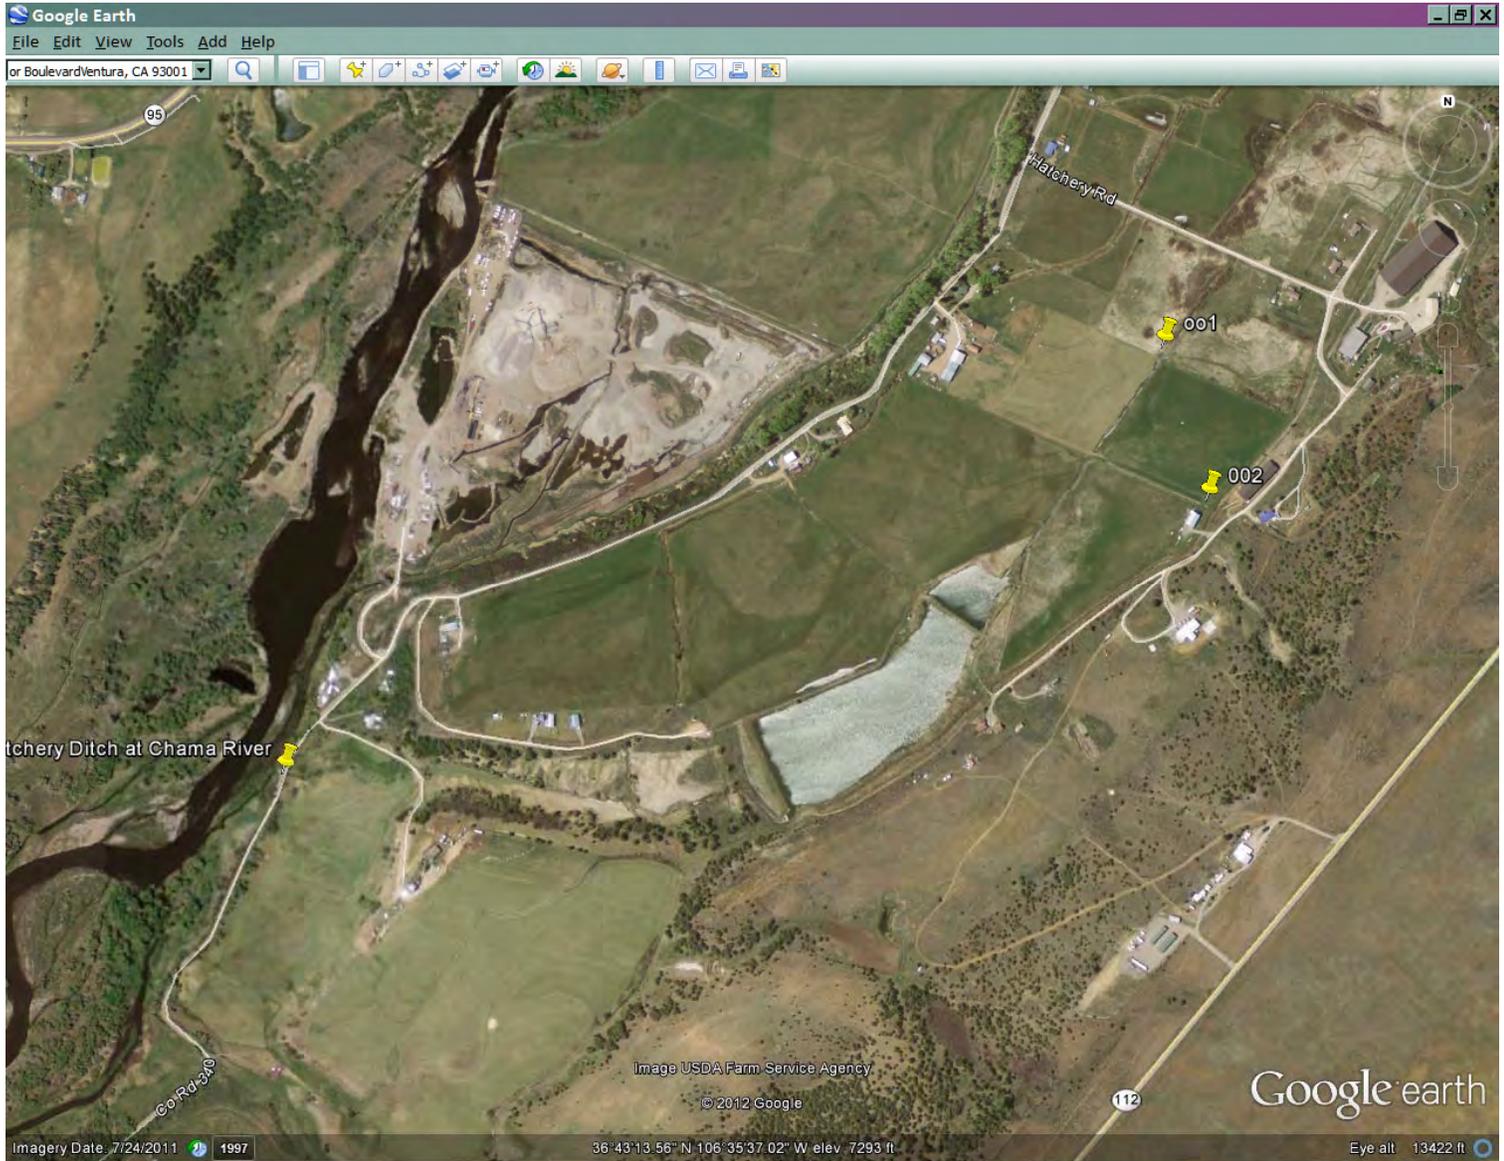
Subject: Yellow Pins on image show: Outfall Locations 001 - 002 and where the irrigation ditch reaches the Chama River

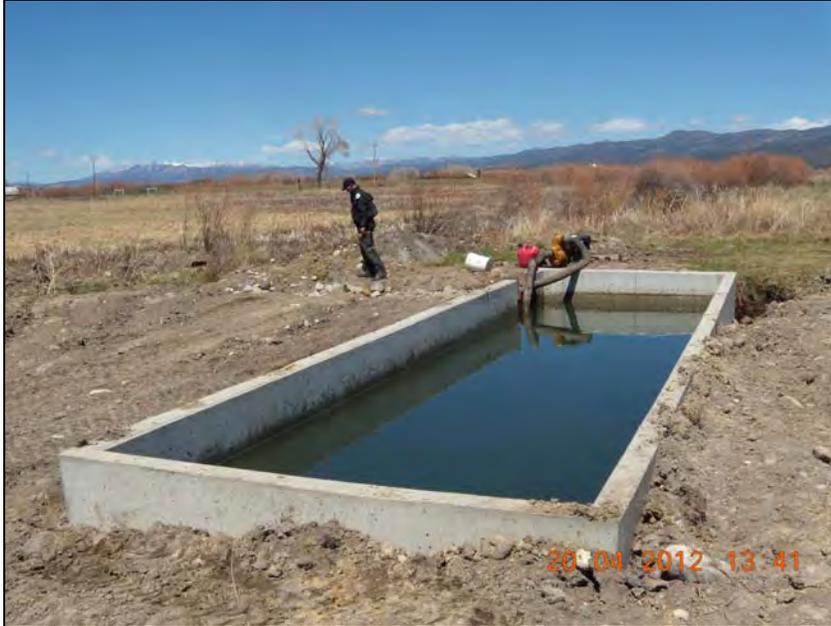
NMED/SWQB
Official Photograph Log
Photo # 2

Subject: Outfall 001 newly installed basin

2. At the outfalls 001 and 002, new cement basins (approximate size 32'Long x10'Wide x10'Deep). Facility representative indicated the basins at Outfalls 001 and 002 are intended to act as solids settling basins. Due to the high volume of the effluent being discharged at these outfalls, the basin design appear to act more as mixing units rather than as settling units. The water flowing into the short basins is at such a velocity as to cause a degree of turbulence that does not allow for settling to occur. There is no mechanism in place for solids removal and disposal from these basins.

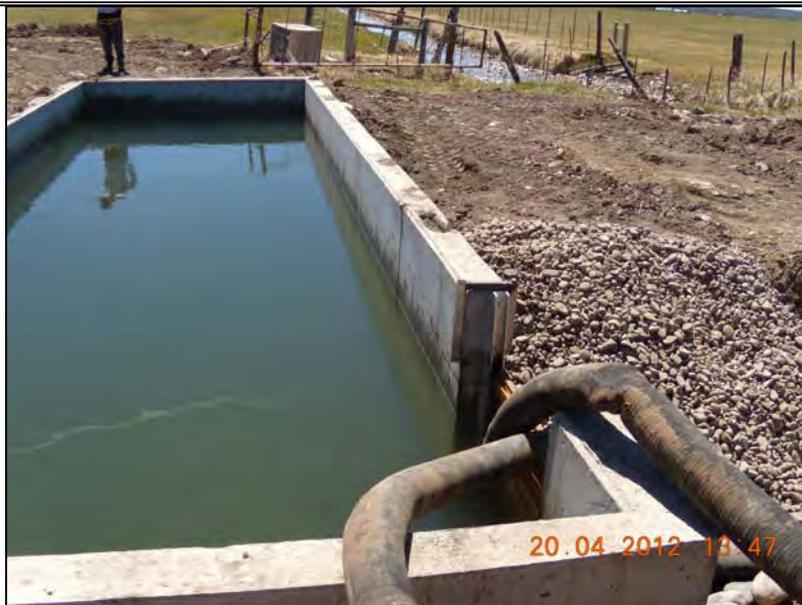
NMED/SWQB
Official Photograph Log
Photo #3

Subject: Outfall 001 - staff gauge and sampling location.

Outfall 001 - the effluent measurement is over a rectangular weir that is approximately 3 feet wide. The weir has a fixed metal ruler that measures to tenths of an inch. This measurement is converted to Gallons Per Minute (GPM) then to Million Gallons Per Day (MGD). At the time of the inspection, the main flow was being diverted to Outfall 002 and a portable sump pump was operating at the 001. Operators were emptying the unit to work on it. Flow measurements

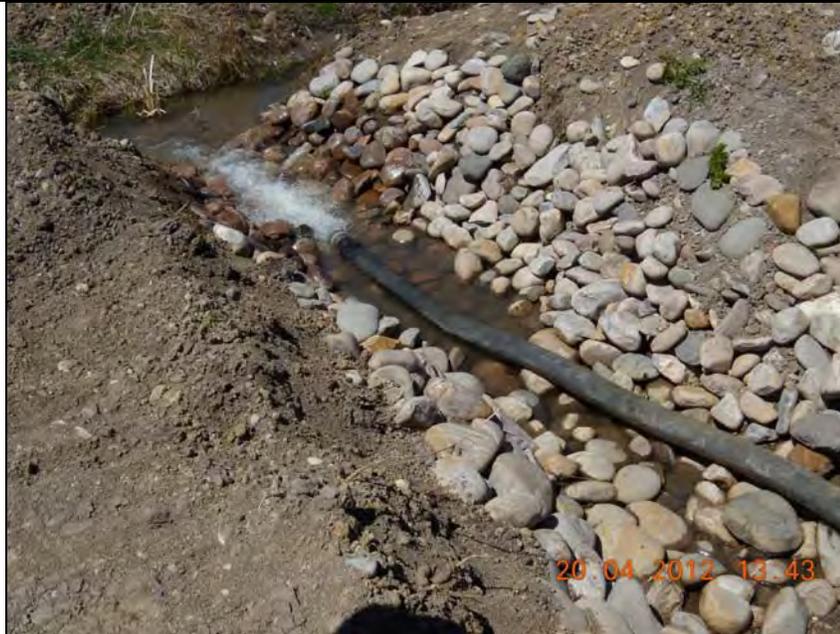
NMED/SWQB
Official Photograph Log
Photo #4

Subject: Discharge from Outfall 001 - sump pump to irrigation ditch.

were not being recorded at the time. The flow from the sump pump was being estimated. There is no back up flow measurement device in place.

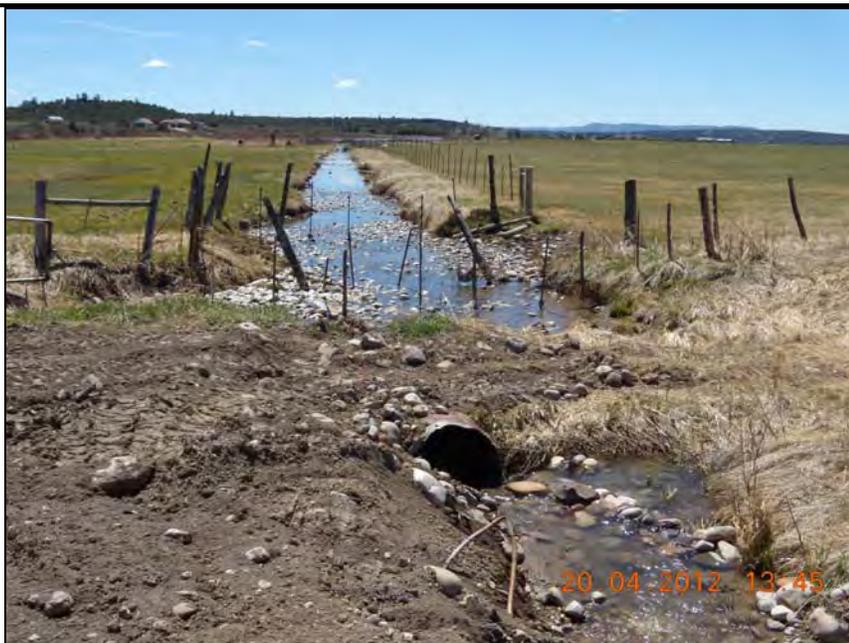
NMED/SWQB
Official Photograph Log
Photo # 5

Subject: Unnamed irrigation ditch at Outfall 001 from this ditch agricultural fields are irrigated before it reaches Burns Lake.

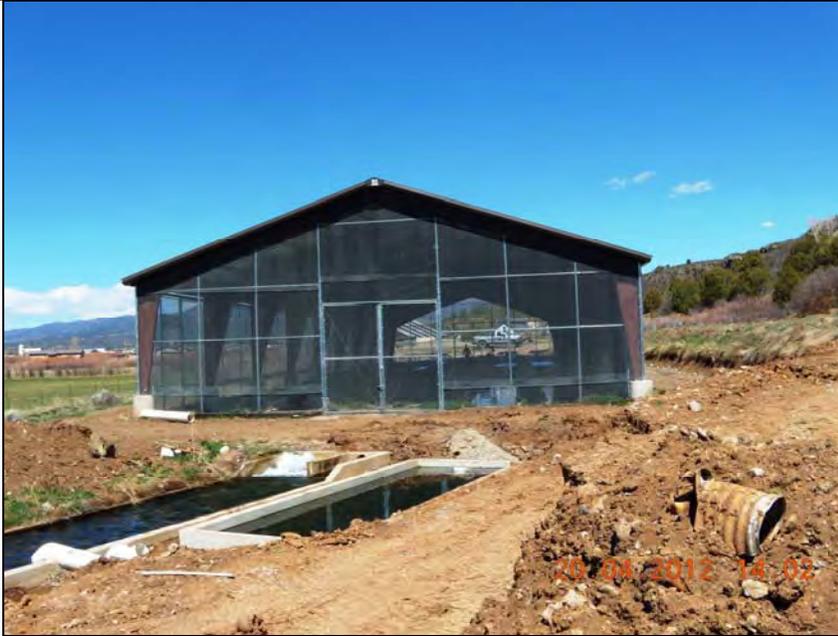
NMED/SWQB
Official Photograph Log
Photo # 6

Subject: Outfall 002 - Water is from J Battery raceways.

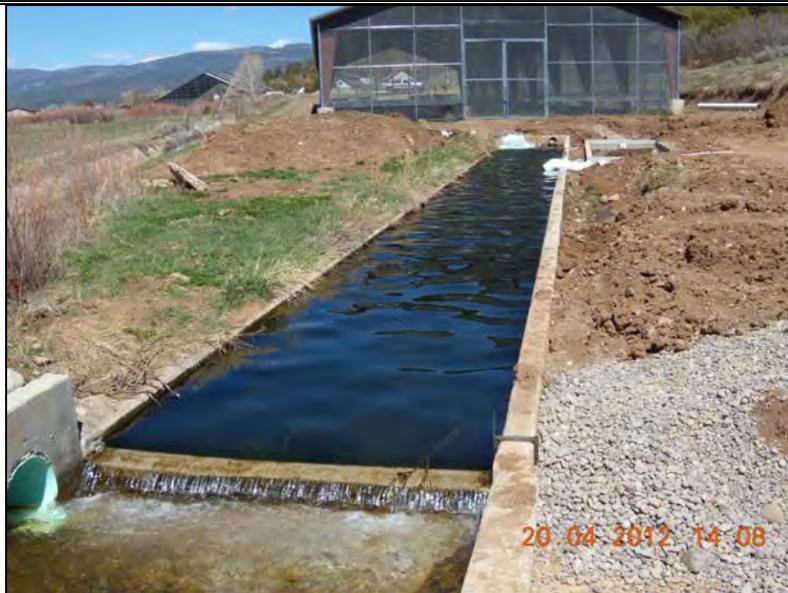
NMED/SWQB
Official Photograph Log
Photo # 7

Subject: Outfall 002 - to Parkview Irrigation Ditch

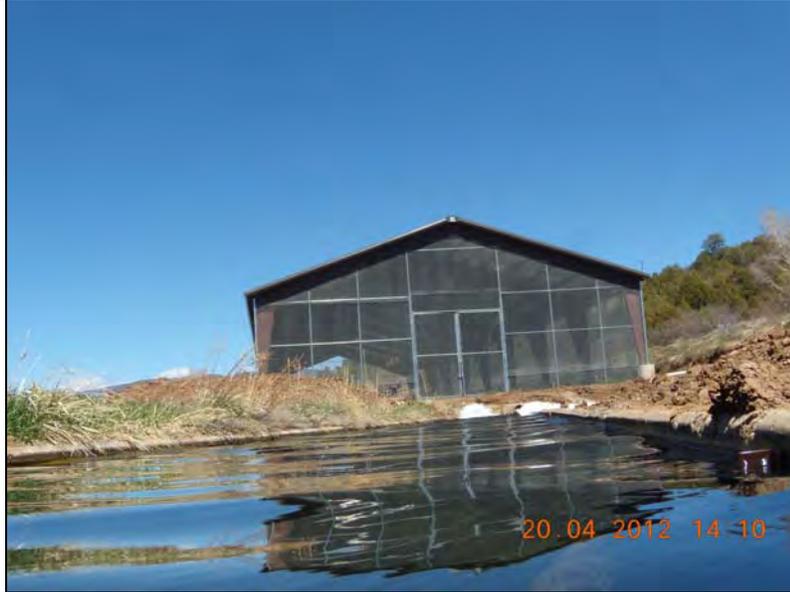
NMED/SWQB
Official Photograph Log
Photo # 8

1. PRIMARY FLOW MEASUREMENT DEVICE PROPERLY INSTALLED AND MAINTAINED. Outfall 002 there is turbulence and may cause inaccurate reading Y N NA
 TYPE OF DEVICE
2. FLOW MEASURED AT EACH OUTFALL AS REQUIRED. Y N NA
3. SECONDARY INSTRUMENTS (TOTALIZERS, RECORDERS, ETC.) PROPERLY OPERATED AND MAINTAINED. Y N NA
4. CALIBRATION FREQUENCY ADEQUATE. (DATE OF LAST CALIBRATION _____)
 RECORDS MAINTAINED OF CALIBRATION PROCEDURES. Y N NA
 CALIBRATION CHECKS DONE TO ASSURE CONTINUED COMPLIANCE. Y N NA
5. FLOW ENTERING DEVICE WELL DISTRIBUTED ACROSS THE CHANNEL AND FREE OF TURBULENCE. Y N NA
6. HEAD MEASURED AT PROPER LOCATION. Y N NA
7. FLOW MEASUREMENT EQUIPMENT ADEQUATE TO HANDLE EXPECTED RANGE OF FLOW RATES. Y N NA

Subject: Outfall 002 waves make it difficult to take an accurate flow measurement.

Outfall 002 - the effluent is measured over the rectangular weir that is approximately 8 feet wide. The weir has a fixed metal ruler that measures to tenths of an inch. This measurement is converted to Gallons Per Minute (GPM) then to Million Gallons Per Day (MGD). Leading to the weir is an approximately 200 foot long rectangular channel. The water flowing in the channel is at a high volume and considerable wave action was occurring. Due to the waves, it would be difficult to take a very precise flow measurement. There are also no back up flow measurement devices in place.

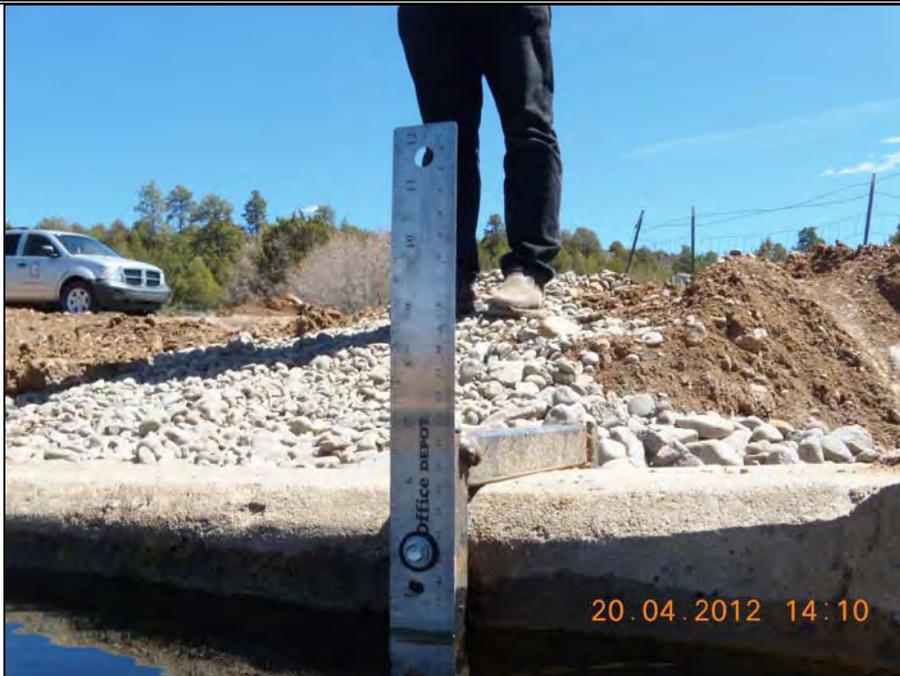
NMED/SWQB
Official Photograph Log
Photo # 9

Subject: Outfall 002 Staff gauge - metal ruler that measure in 1/10 ".

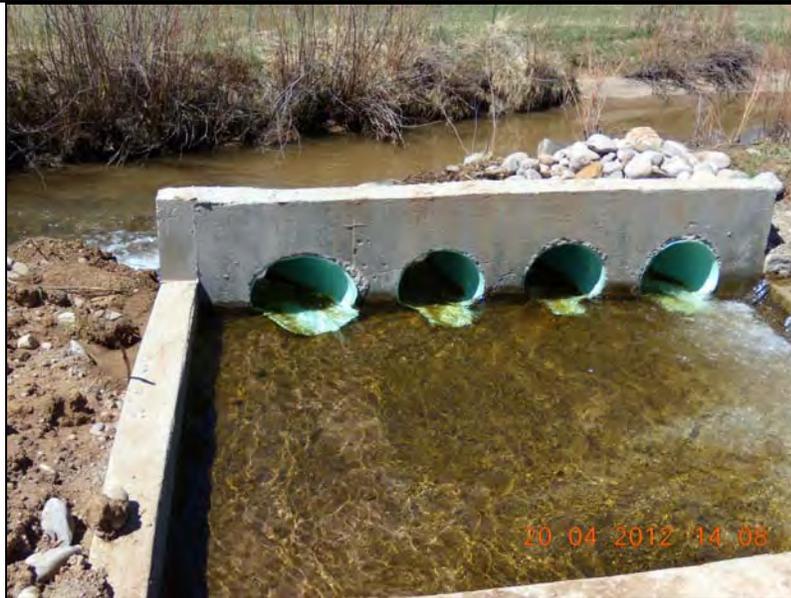
NMED/SWQB
Official Photograph Log
Photo # 10

Subject: Outfall 002 to Park View Irrigation Ditch.

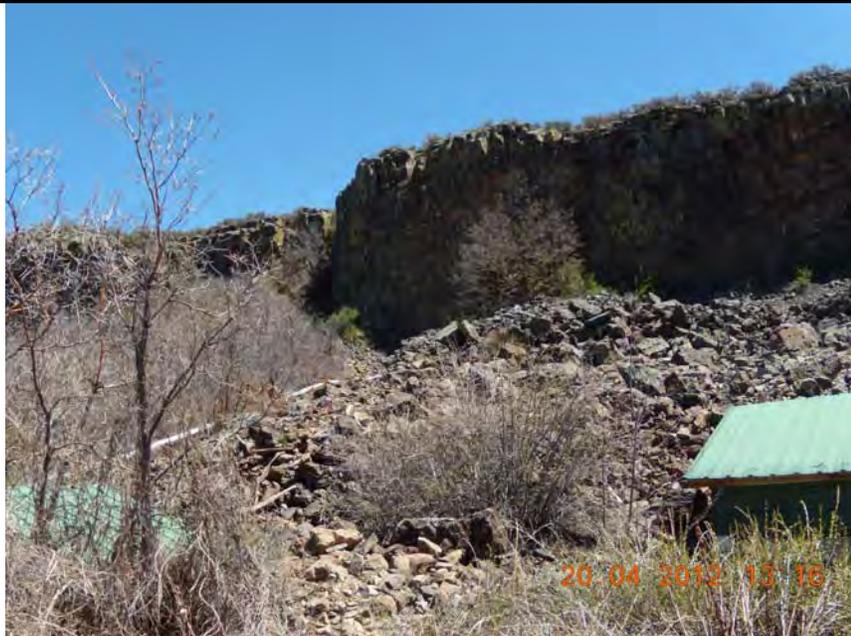
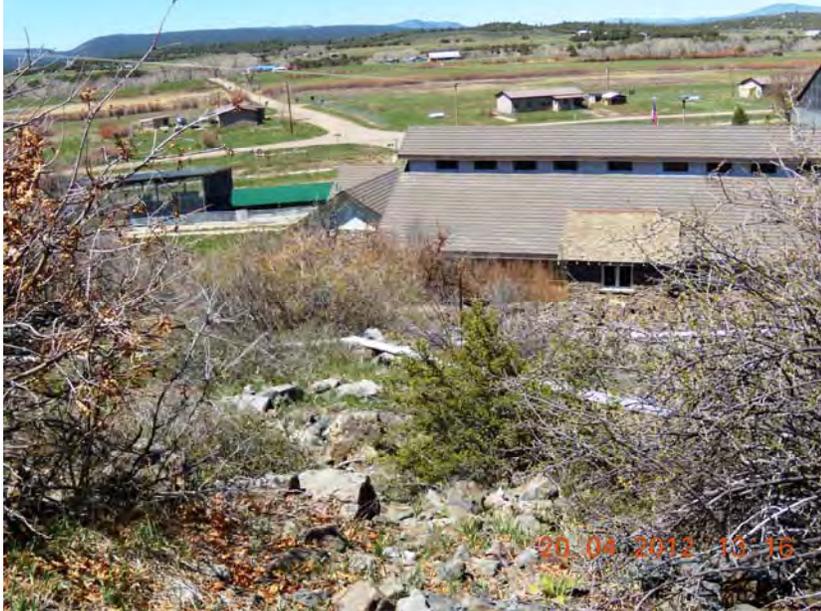
Subject: Source Water from several springs above the hatchery. White PVC piping transports the water to the aeration tower before entering the raceways.

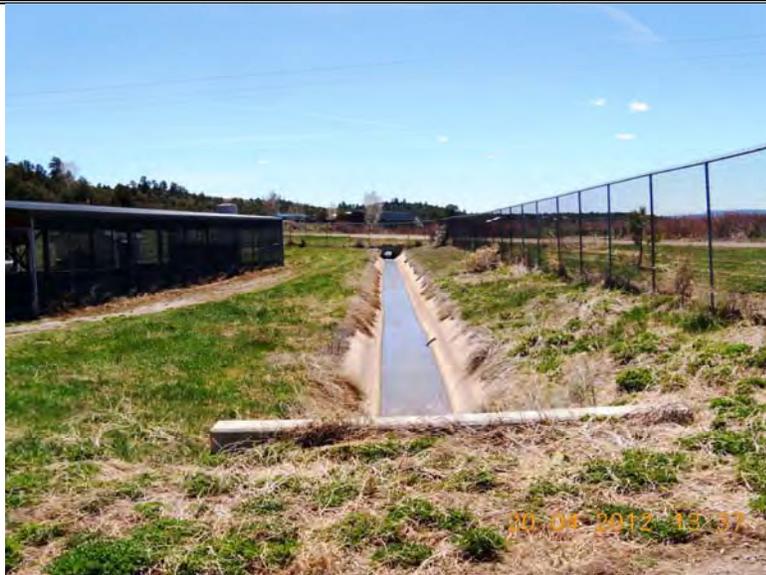
NMED/SWQB
Official Photograph Log
Photo # 17

Subject: Cement lined Park View Ditch above the Outfall OO2 discharge location

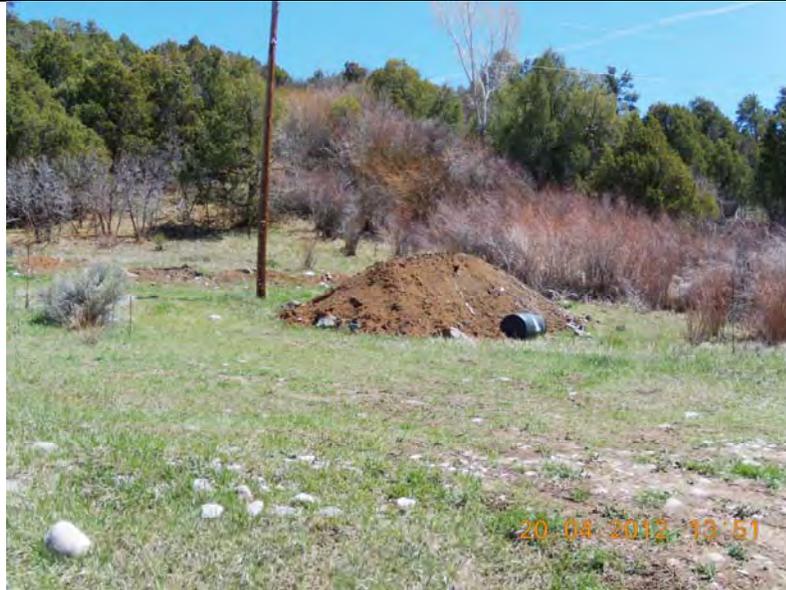
NMED/SWQB
Official Photograph Log
Photo # 18

Subject: Mortality Pits for disposal of dead fish are on a slope above the Raceways and adjacent to wetland vegetation. It is likely the Mortality pits are also in a location where ground water is present at the depth of the pits.

The mortality fish are removed from the raceways and are buried in pits on site. These pits are uphill of the final raceway, J Battery. The unlined pits are located in an area where willows are growing indicating high natural water availability. It is possible during high spring season runoff; these pits are very near the ground water table. There is no actual solids removal of fish waste and/or uneaten fish food in the raceways. The raceways are periodically scrubbed and the scrubbed material is flushed through the system to the outfalls without being removed from the system. The settled solids in the raceways become mobilized and mixed throughout the water column as it is discharged.

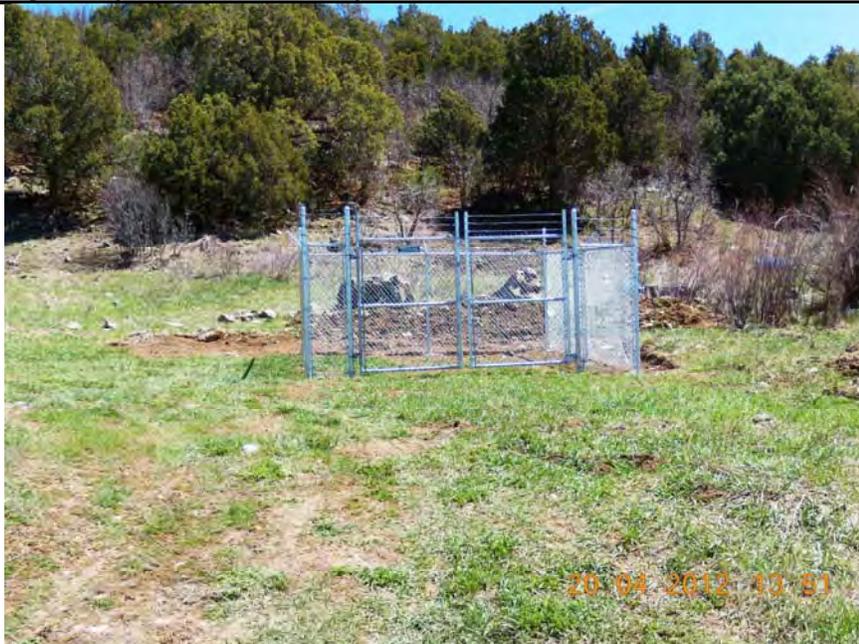
NMED/SWQB
Official Photograph Log
Photo # 19

Subject: Planned location for compost mixing of dead fish and shredded vegetative material.

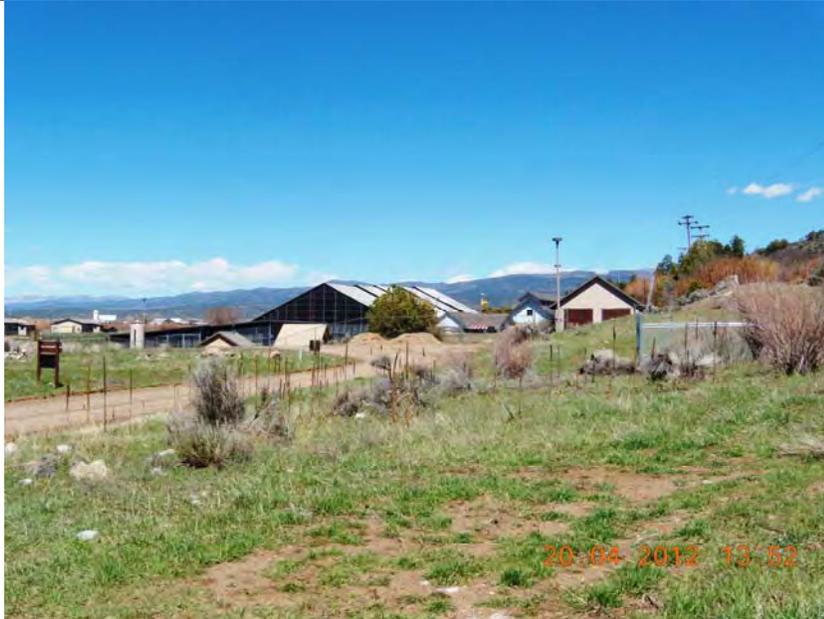
NMED/SWQB
Official Photograph Log
Photo # 20

Subject: From Mortality pits looking back at Raceways A,B,C enclosure. Mortality pit is up-gradient of Park View Ditch.

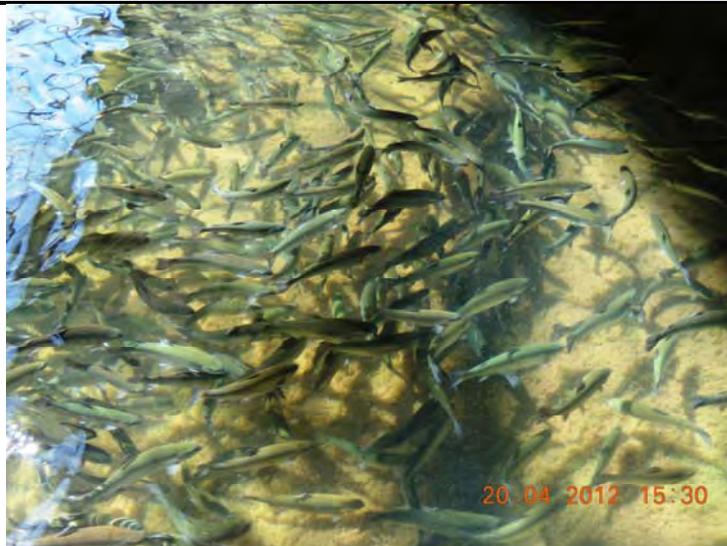
NMED/SWQB
Official Photograph Log
Photo # 23

Subject: Raceways - note : there is a considerable mass of solids on the bottom of the channel. According to facility representatives, cleaning was one week prior to the photo date.

The raceways are periodically scrubbed and cleaned of solids and debris. There is no mechanism for the removal of the solids and debris from the water stream, it is simply allowed to flow through, primarily to Outfall 001 for discharge.

This comment is also found in the section of this report above, " Sludge". There is no actual solids removal of fish waste and/or uneaten fish food in the raceways. The raceways are periodically scrubbed and the scrubbed material is flushed through the system to the outfalls without being removed from the system. The settled solids in the raceways become mobilized and mixed throughout the water column as it is discharged.

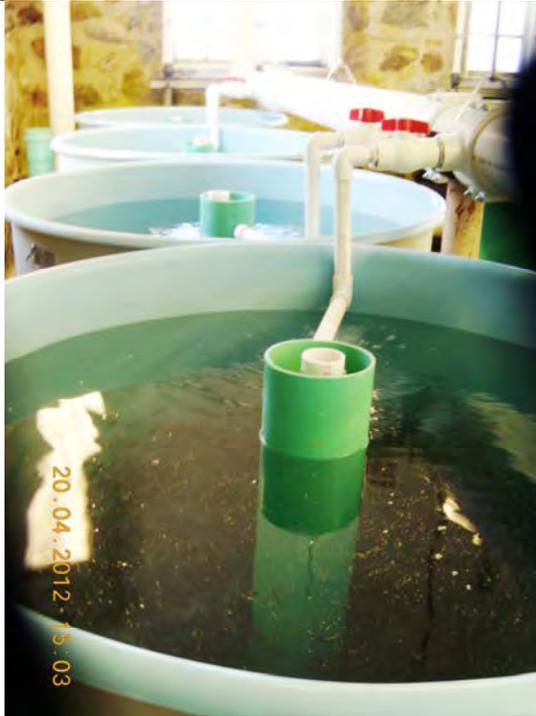
NMED/SWQB
Official Photograph Log
Photo # 24

Subject: Round Rearing Basins - make removal of solids easier for operators.

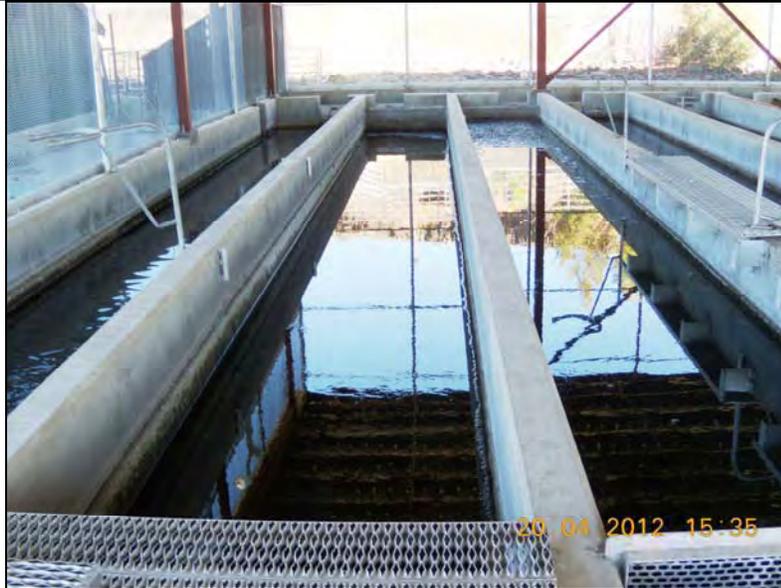
NMED/SWQB
Official Photograph Log
Photo # 26

Subject: Lower Raceways have been off line - these discharge to Outfall 002.

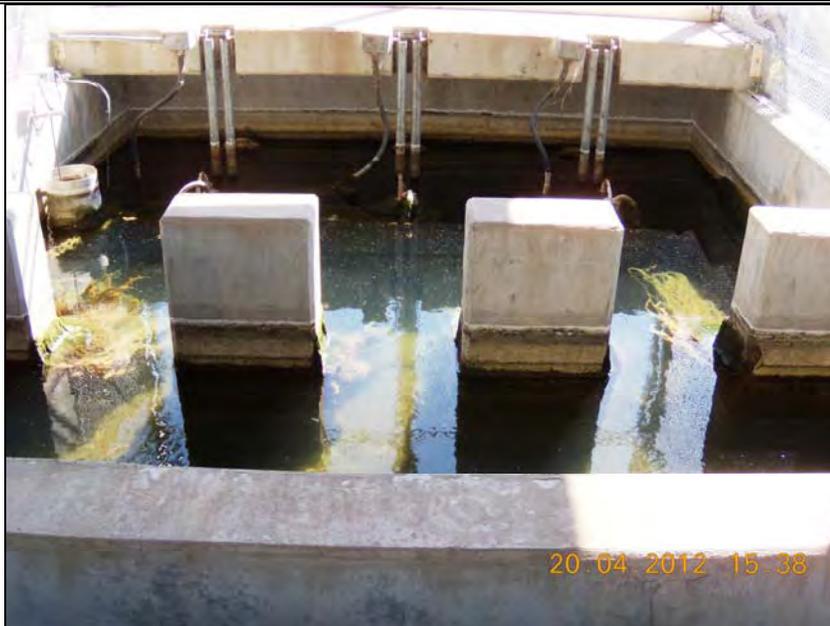
NMED/SWQB
Official Photograph Log
Photo # 27

Subject: Solids build up and algae before being lifted with submersible pumps to tower.

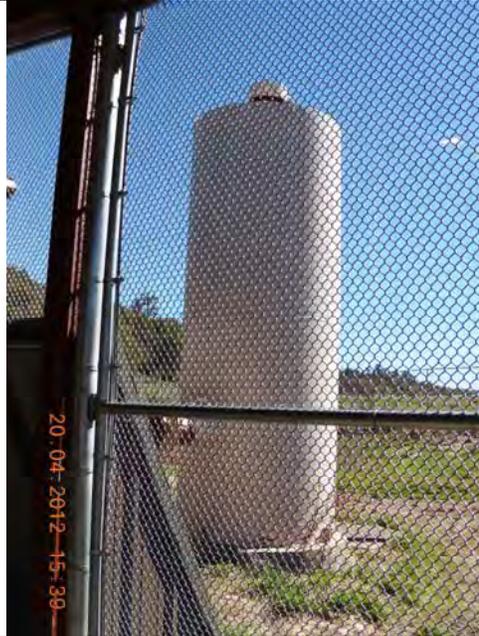
NMED/SWQB
Official Photograph Log
Photo # 28

Subject: Tower - flow from here is via gravity to J Battery of Raceways.

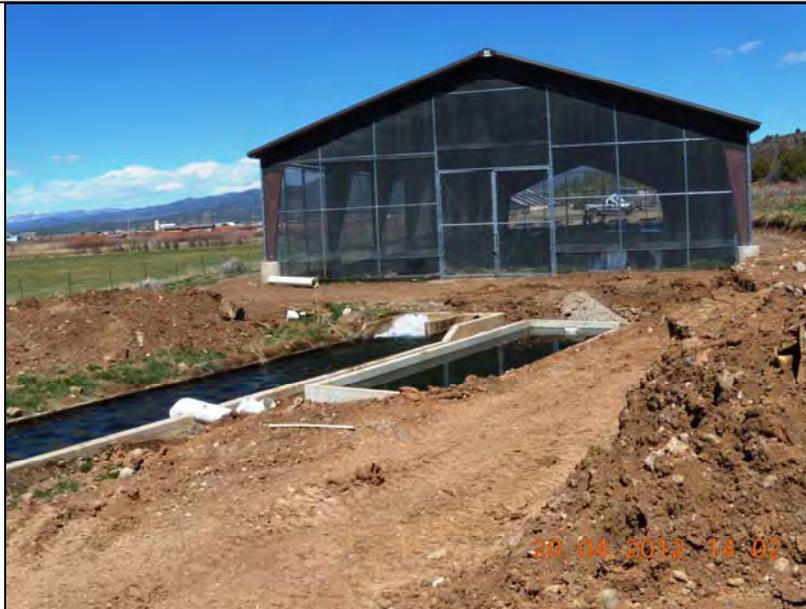
NMED/SWQB
Official Photograph Log
Photo # 29

Subject: J Battery - Raceways and newly installed basin - for solids containment - then to the outfall channel.

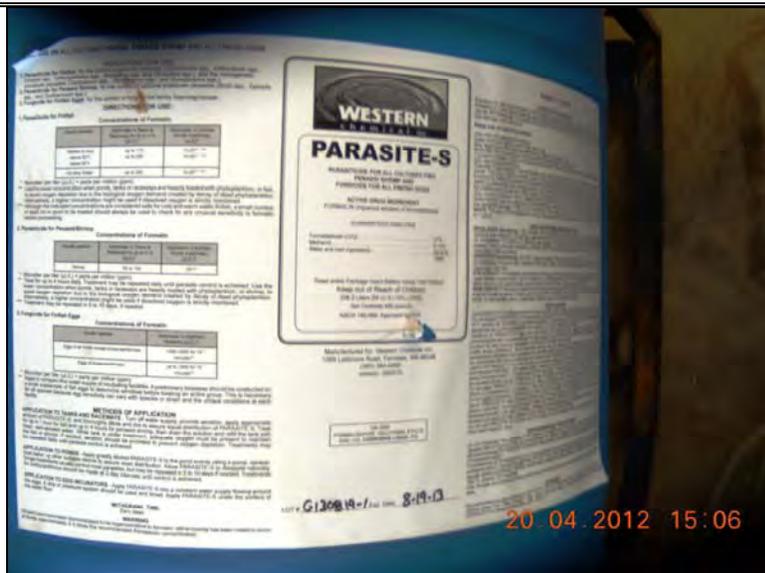
**NMED/SWQB
Official Photograph Log
Photo # 31**

Subject: DMC chemicals on site.
