NEW MEXICO
ENVIRONMENT DEPARTMENT
Surface Water Quality Bureau

RE: Minor Non-Municipal, SIC 0921, NPDES Compliance Evaluation Inspection, New Mexico Department of Game & Fish / Red River State Trout Hatchery, NM0030147, July 9, 2012

NPDES Compliance Inspection Report

New Mexico Department of Game & Fish / Red River State Trout Hatchery
NPDES Permit No NM0030147
Compliance Evaluation Inspection
July 9, 2012

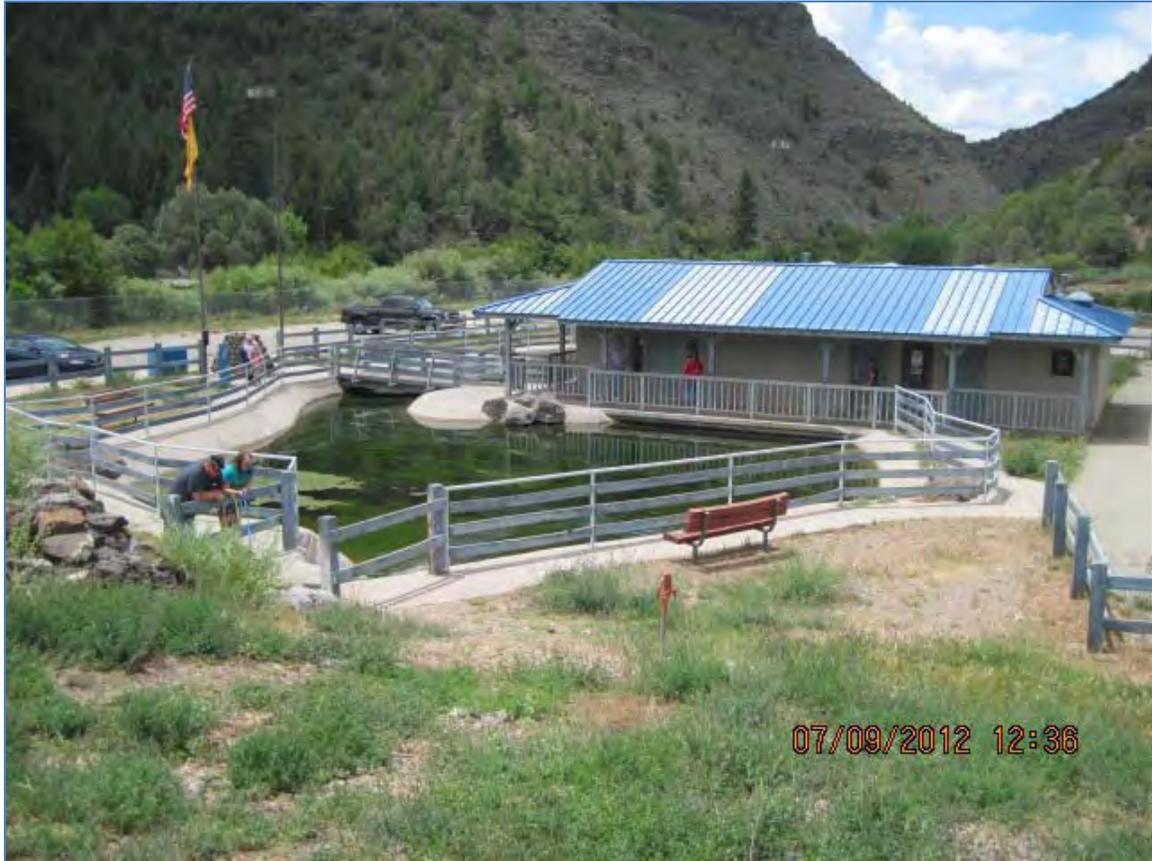
NMED/SWQB
Official Photograph Log
Photo # 1

Photographer: Erin S. Trujillo	Date: 07/09/212	Time: 1236 hours
City/County: Near Questa / Taos County	State: New Mexico	
Location: NMDG&F / Red River State Trout Hatchery / NM0030147		
Subject: "Show Pond" with algal growth. Algal growth can be an indicator of increased nutrients.

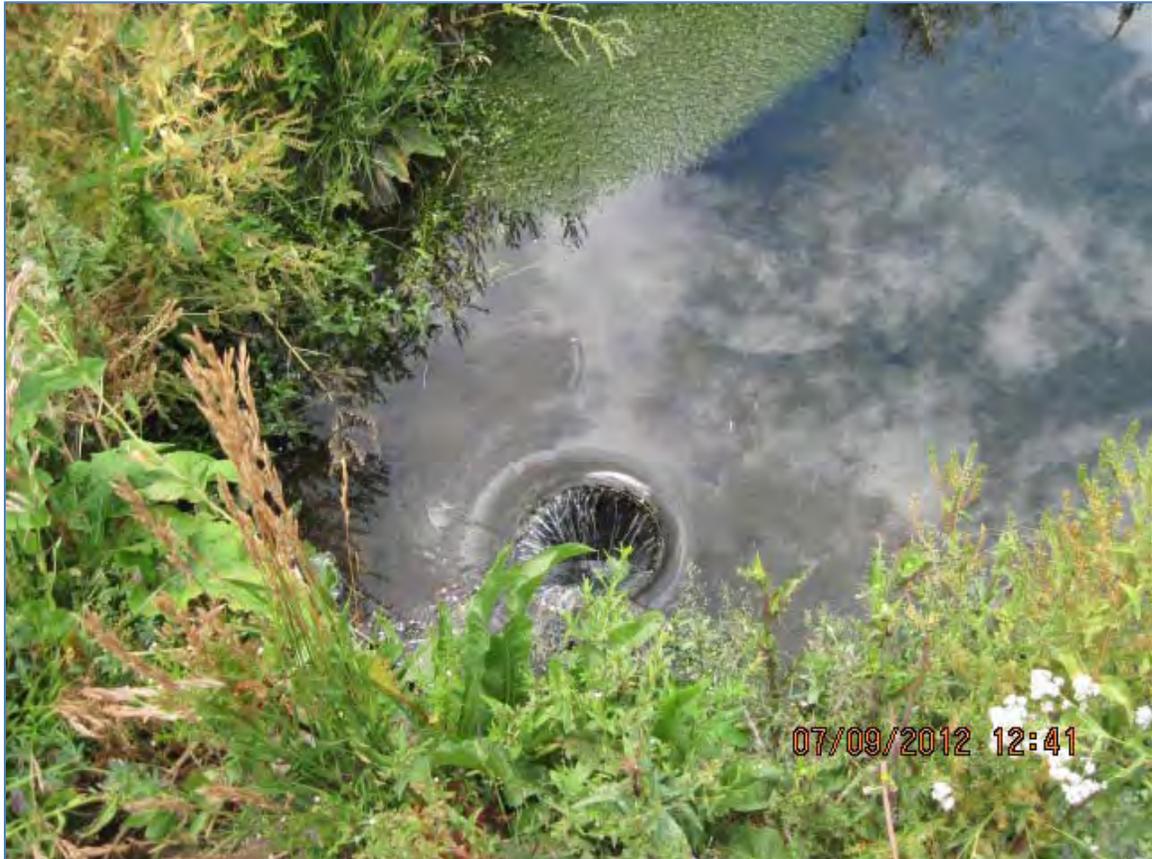
**NMED/SWQB
Official Photograph Log
Photo # 2**

Photographer: Erin S. Trujillo	Date: 07/09/212	Time: 1241 hours
City/County: Near Questa / Taos County	State: New Mexico	
Location: NMDG&F / Red River State Trout Hatchery / NM0030147		
Subject: Flow from upper settling pond entering open inlet to lower settling pond. No raceway cleaning was conducted on the day of this inspection.

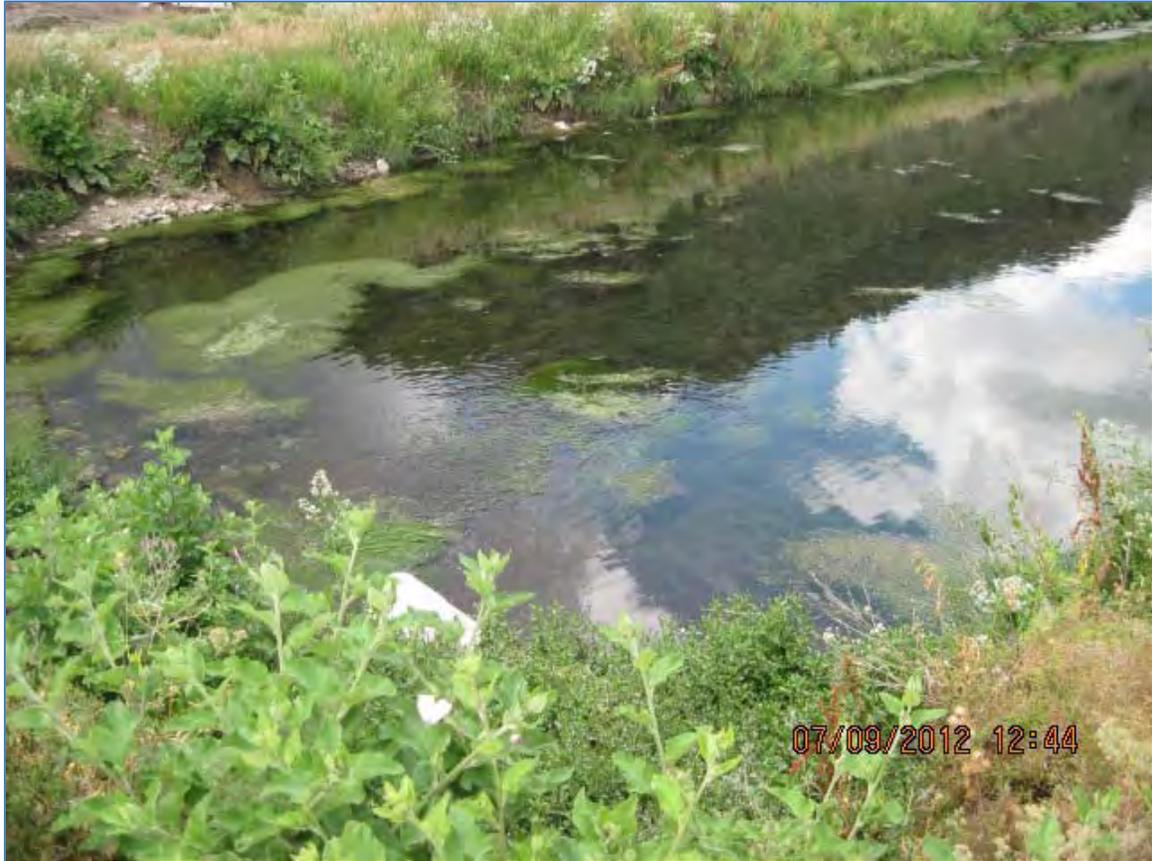
NMED/SWQB
Official Photograph Log
Photo # 3

Treatment units, in this case both the upper and lower settling ponds that discharge at Outfall 003, were shallow with accumulated solids on the day of this inspection. Vegetation, algae growth and solids were observed entering the riser pipes in the ponds. Some foam and solids were observed in the effluent at

Photographer: Erin S. Trujillo	Date: 07/09/212	Time: 1244 hours
City/County: Near Questa / Taos County	State: New Mexico	
Location: NMDG&F / Red River State Trout Hatchery / NM0030147		
Subject: Shallow water, accumulated sediments, algal growth in lower settling pond.

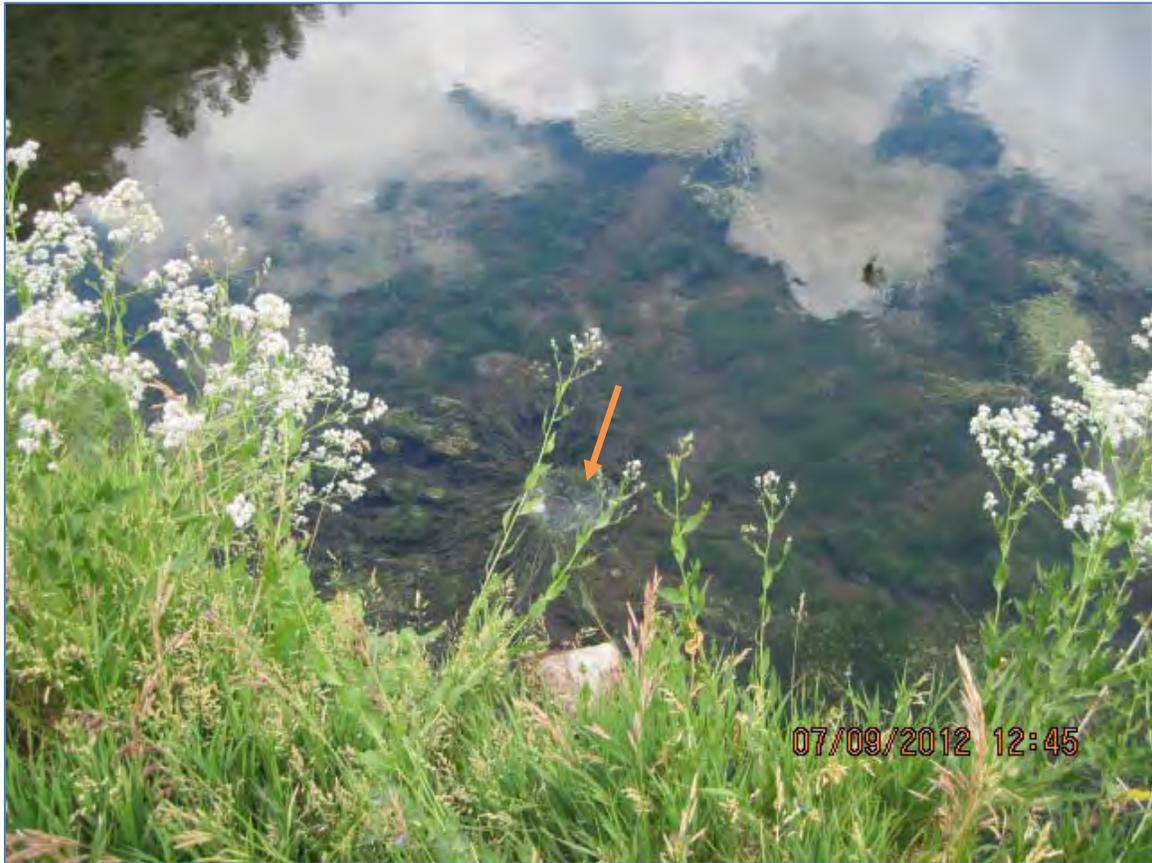
NMED/SWQB
Official Photograph Log
Photo # 4

Photographer: Erin S. Trujillo	Date: 07/09/212	Time: 1245 hours
City/County: Near Questa / Taos County	State: New Mexico	
Location: NMDG&F / Red River State Trout Hatchery / NM0030147		
Subject: Arrow points to flow in lower settling pond entering open inlet to Outfall 003. Vegetation and solids in the shallow pond was observed to enter inlet on day of this inspection.

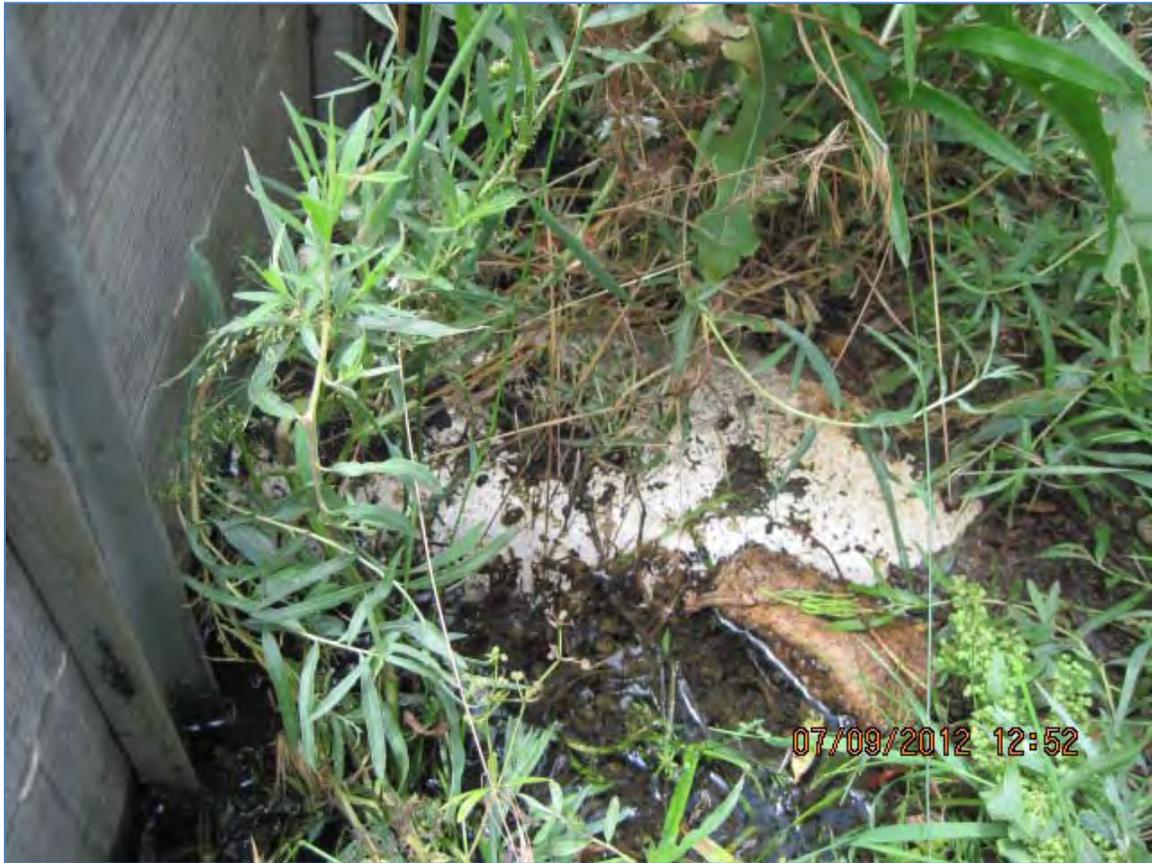
NMED/SWQB
Official Photograph Log
Photo # 5

The drain line pipe from the upper and lower ponds was leaking where it entered the constructed channel at Outfall 003 on the day of this inspection. A portion of the flow did not enter the weir to be measured. The flow around the constructed channel could affect the integrity of the bank at the base of the constructed box and cause settling.

Photographer: Erin S. Trujillo	Date: 07/09/212	Time: 1252 hours
City/County: Near Questa / Taos County	State: New Mexico	
Location: NMDG&F / Red River State Trout Hatchery / NM0030147		
Subject: Flow at leak where drain line pipe from settling ponds enters constructed channel box at Outfall 003. Flow that does not enter box would not measured by weir device.

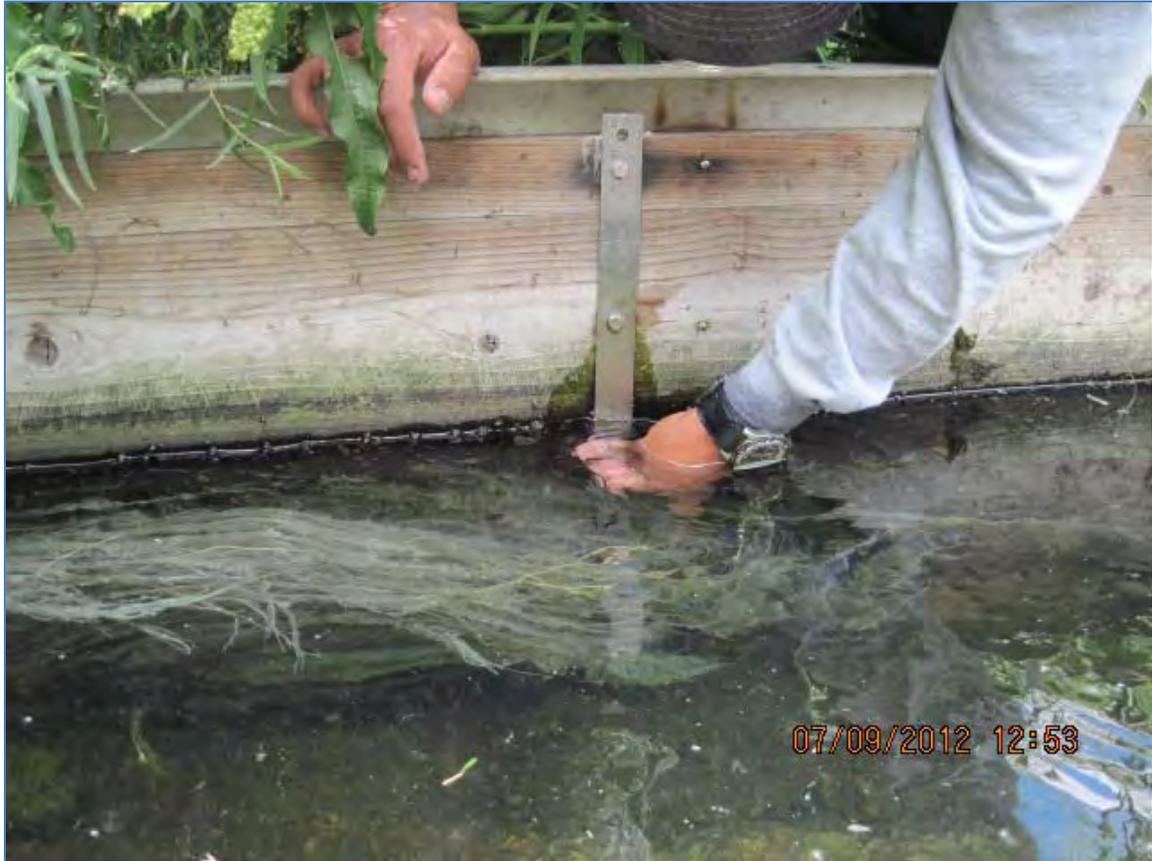
NMED/SWQB
Official Photograph Log
Photo # 6

Algal growth was observed on weir crests; and algal growth, vegetation and roots were observed in the constructed open channel box above the weirs on the day of this inspection. Cleaning appeared needed to help ensure smooth water flow.

Photographer: Erin S. Trujillo	Date: 07/09/212	Time: 1253 hours
City/County: Near Questa / Taos County	State: New Mexico	
Location: NMDG&F / Red River State Trout Hatchery / NM0030147		
Subject: Roots, algal growth and floating solids in constructed channel box ahead of weir at Outfall 003.

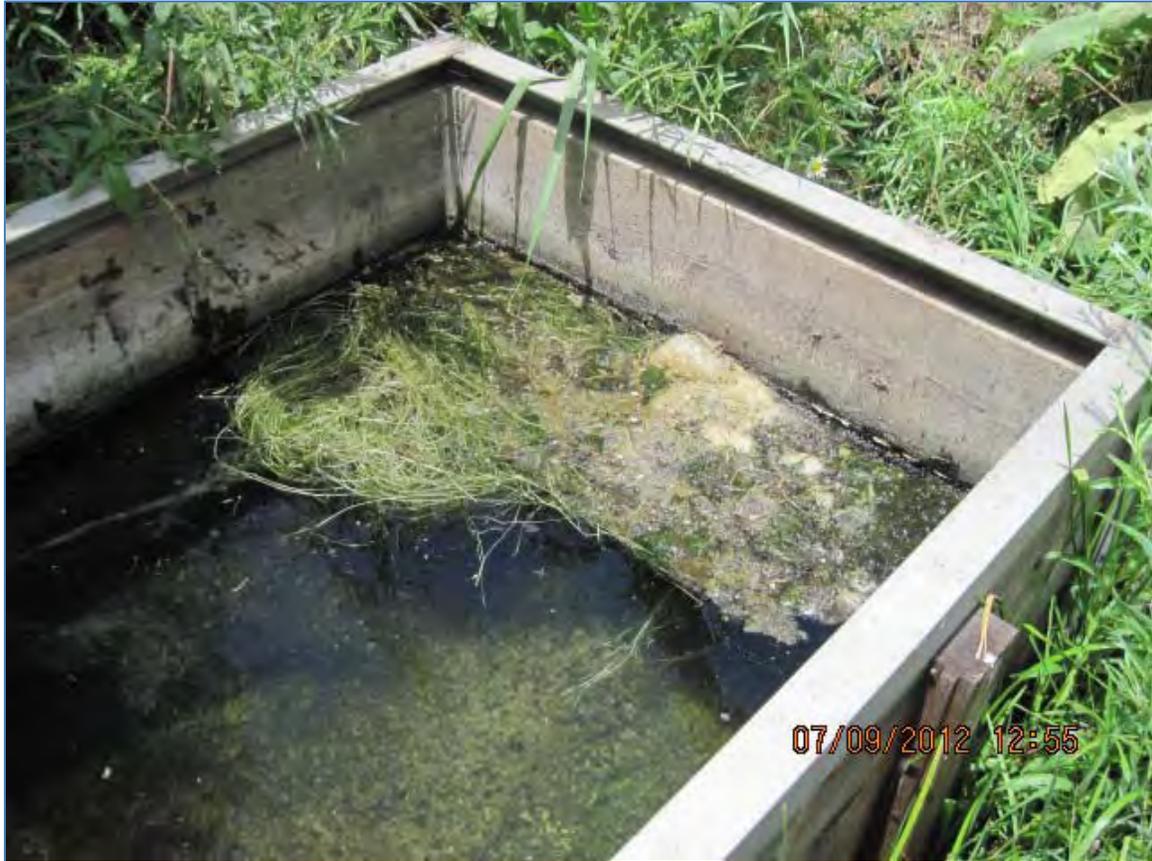
NMED/SWQB
Official Photograph Log
Photo # 7

Photographer: Erin S. Trujillo	Date: 07/09/212	Time: 1255hours
City/County: Near Questa / Taos County	State: New Mexico	
Location: NMDG&F / Red River State Trout Hatchery / NM0030147		
Subject: Algal growth and foam in channel box at Outfall 003.

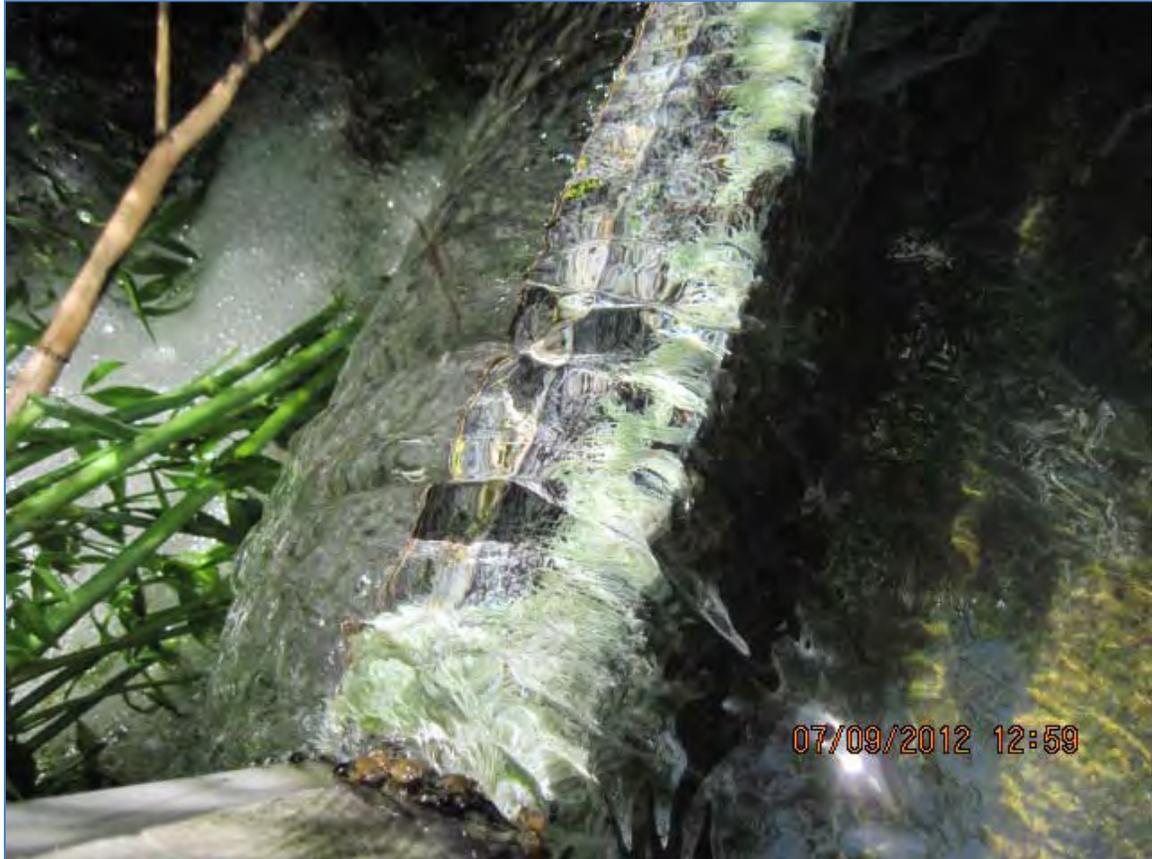
NMED/SWQB
Official Photograph Log
Photo # 8

Photographer: Erin S. Trujillo	Date: 07/09/2012	Time: 1259 hours
City/County: Near Questa / Taos County	State: New Mexico	
Location: NMDG&F / Red River State Trout Hatchery / NM0030147		
Subject: Algal growth at crest of weir at Outfall 003.

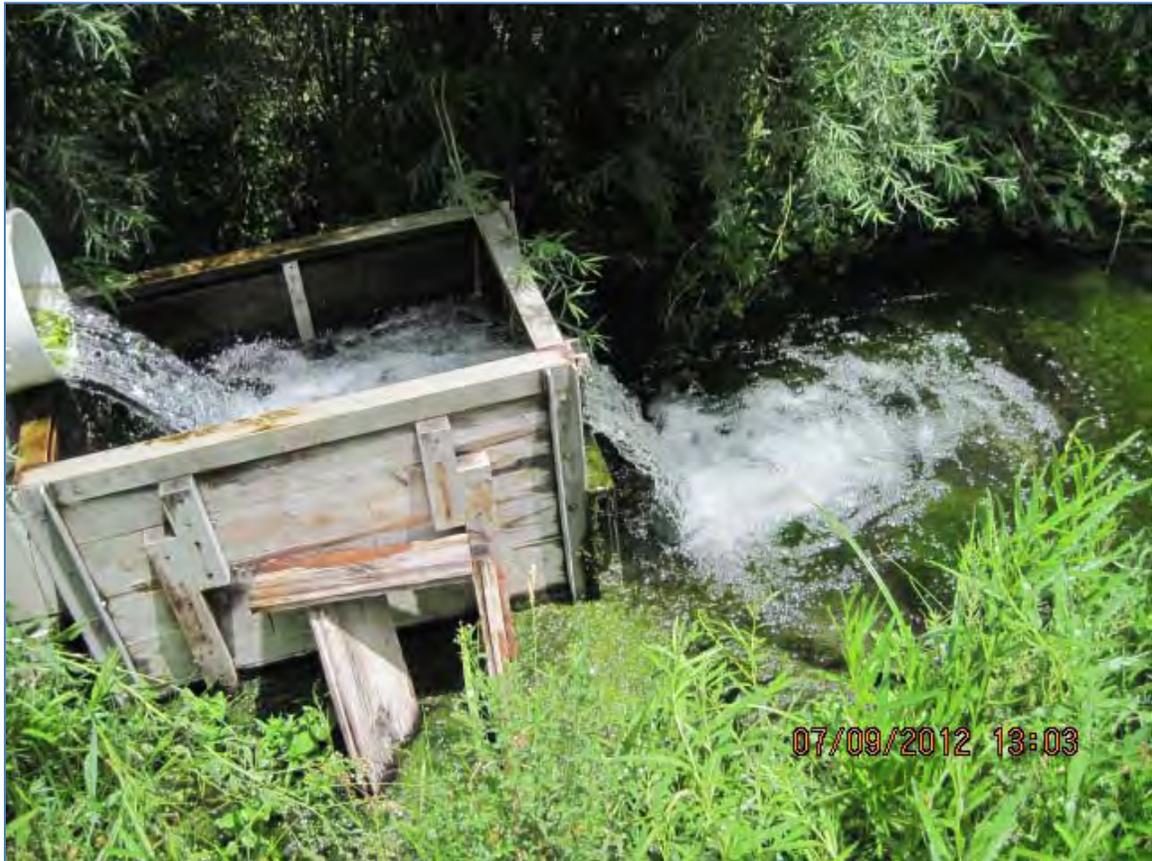
NMED/SWQB
Official Photograph Log
Photo # 9

Flow entering the weir at Outfalls 001, 002 and 003 was not well distributed across the channel and was not free of turbulence on the day of this inspection. Small whirlpools formed in the flow in the channel box above the weir at Outfall 003. Flow from the drain line pipe at Outfall 002 dropped into the channel box above the weir with substantial turbulence at the head measuring location (i.e., there did not appear to be sufficient length of open channel to allow smooth water flow). Backflow at the contractions and substantial turbulence was observed in the channel above the weir at Outfall 001. Water height overtopped weir end contractions (i.e., water level was higher than opening or notch) at Outfall 001. The flow measurement device at Outfall 001 did not appear adequate to handle expected range of flow rates and/or to allow smooth water flow.

Photographer: Erin S. Trujillo	Date: 07/09/2012	Time: 1303 hours
City/County: Near Questa / Taos County	State: New Mexico	
Location: NMDG&F / Red River State Trout Hatchery / NM0030147		
Subject: Flow from drain line pipe from "Show Pond" drops into channel ahead of weir at Outfall 002. Substantial turbulence existed in the approach of the open channel at the head measurement location and before weir.

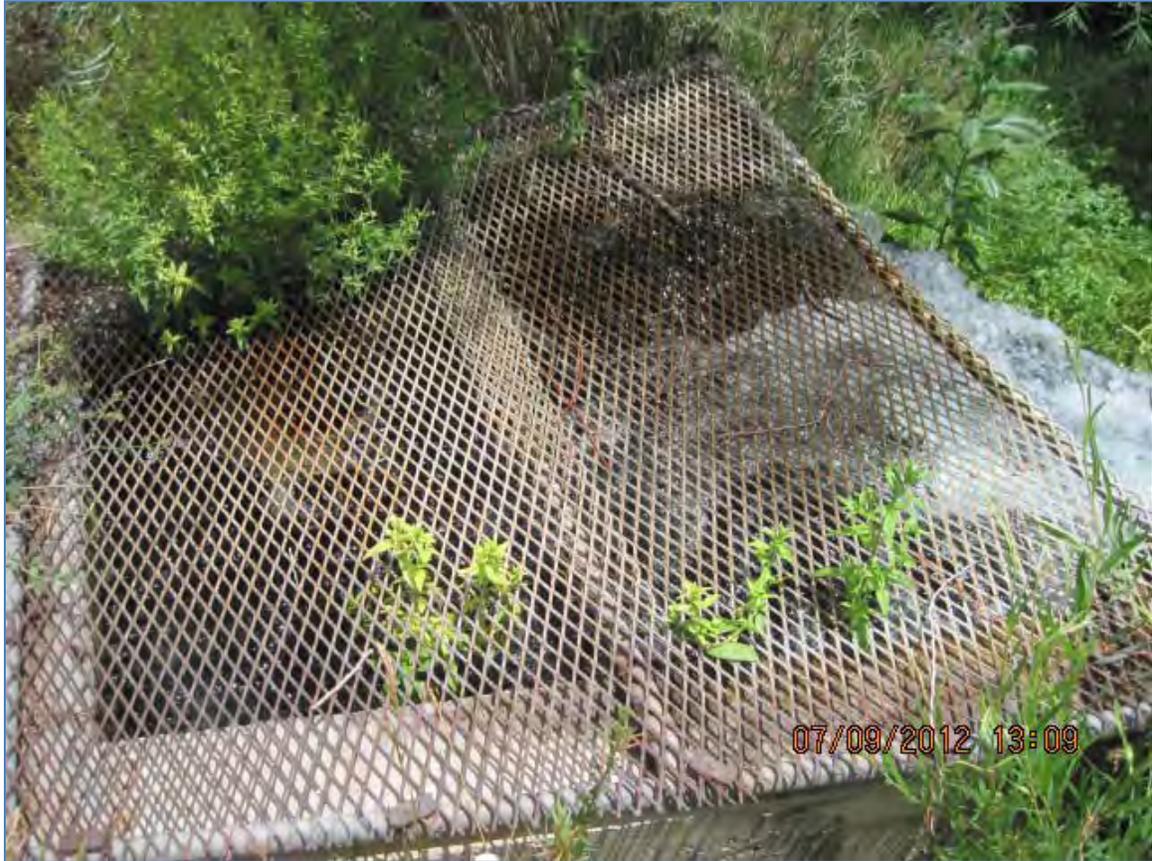
NMED/SWQB
Official Photograph Log
Photo # 10

Photographer: Erin S. Trujillo	Date: 07/09/212	Time: 1309 hours
City/County: Near Questa / Taos County	State: New Mexico	
Location: NMDG&F / Red River State Trout Hatchery / NM0030147		
Subject: Vegetation, roots and turbulence in channel ahead of weir at Outfall 001. Although grate makes observation difficult, the flow at the weir end contractions was very turbulent and overflowed the weir opening notch.

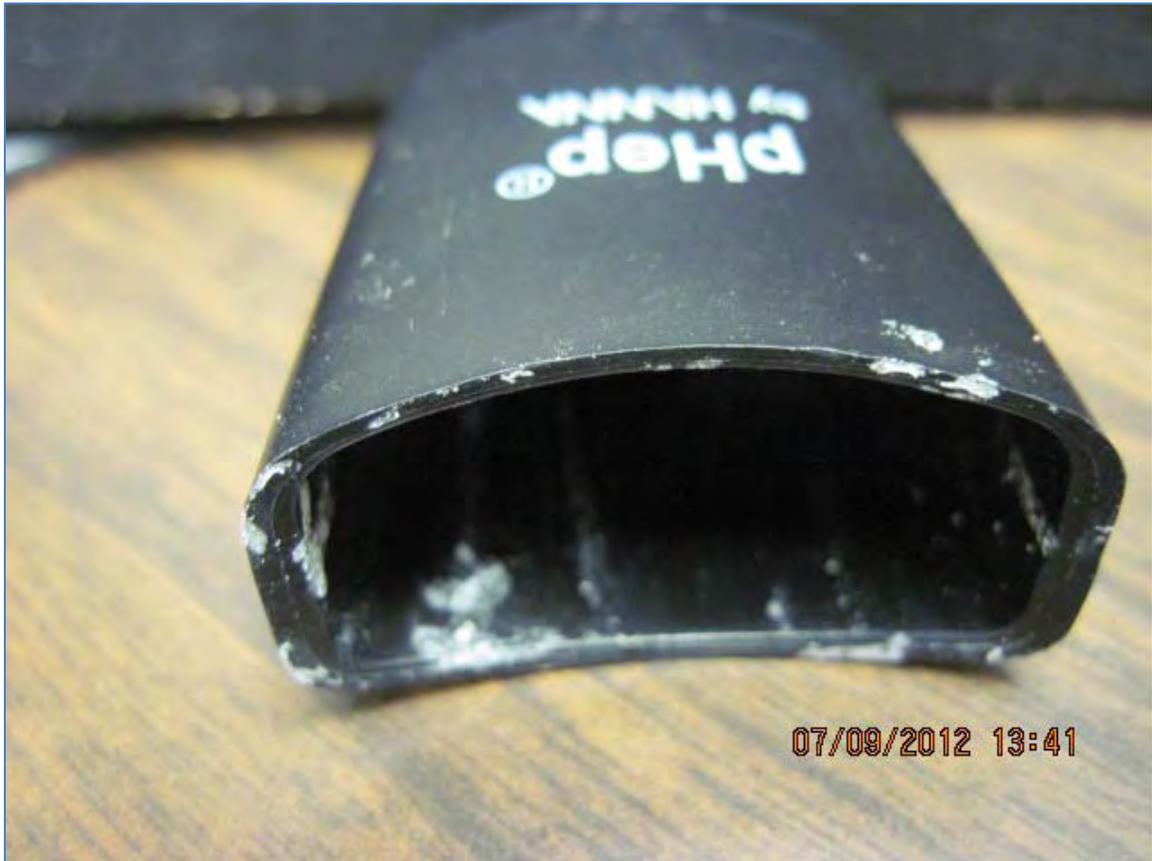
NMED/SWQB
Official Photograph Log
Photo # 11

The pH Tester may not be stored properly to prevent storage solution from draining out of the protective cap. Dried residue that appeared to be from the storage solution existed on the cap. Hanna Instruments HI 98127/98128 Waterproof pH Testers with replaceable Electrode maintenance instructions states, “When not in use, rinse the electrode with water to minimize contamination and store it with a few drops of HI 70300 storage solution in the protective cap....If the electrode has been left dry, soak in storage solution for at least one hour to reactivate it.”

Photographer: Erin S. Trujillo	Date: 07/09/212	Time: 1341 hours
City/County: Near Questa / Taos County	State: New Mexico	
Location: NMDG&F / Red River State Trout Hatchery / NM0030147		
Subject: Dried residue on protective cover of pH tester on day of inspection.
