**NEW MEXICO
ENVIRONMENT DEPARTMENT**

Surface Water Quality Bureau

Re: Minor Industrial, SIC 0921, NPDES Compliance Evaluation Inspection, Rock Lake Fish Hatchery, NM0030155, June 7, 2011

NPDES Compliance Inspection Report

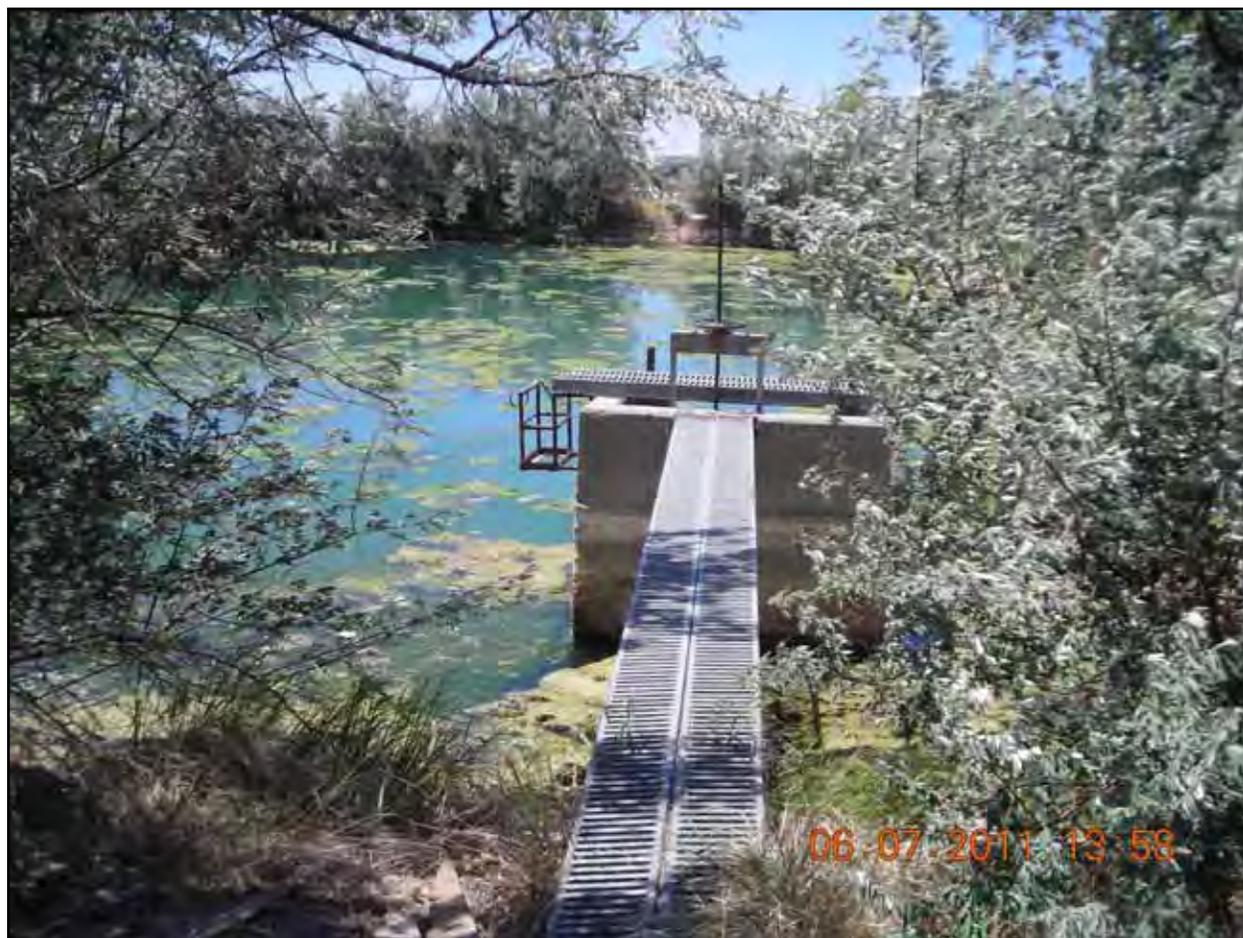
NMED/SWQB
Official Photograph Log
Photo # 1

Photographer: Sandra Gabaldon	Date: 6-7-2011	Time: 1358 hours
City/County: Santa Rosa/Guadalupe County		
Location: NMDGF Rock Lake Hatchery		
Subject: Weir/discharge structure from the warmwater settling pond (Outfall 004)

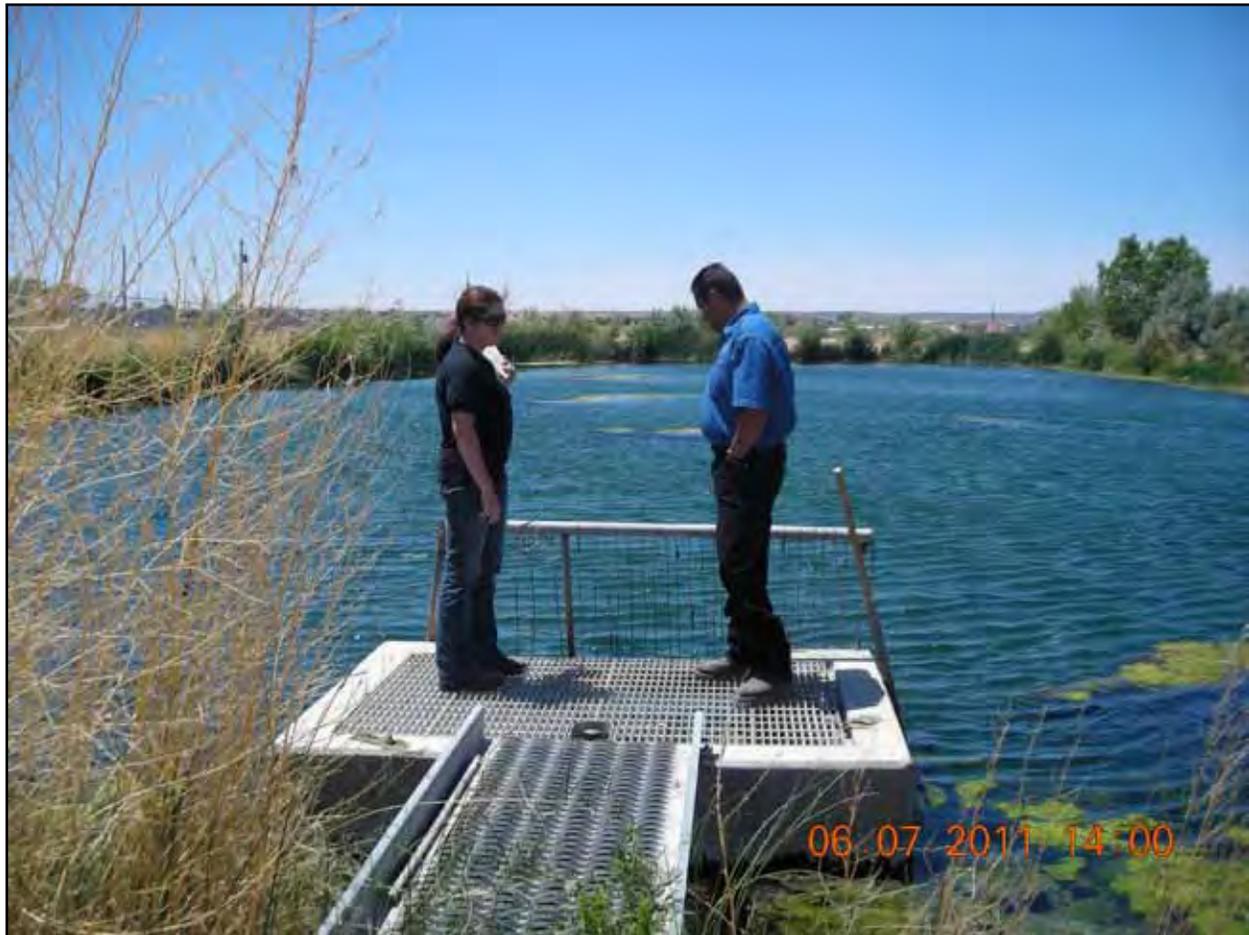
Photo # 2

Photographer: Sandra Gabaldon	Date: 6-7-2011	Time: 1400 hours
City/County: Santa Rosa/Guadalupe County		
Location: NMDGF Rock Lake Hatchery		
Subject: Weir/discharge structure from coldwater settling pond (Outfall 003)

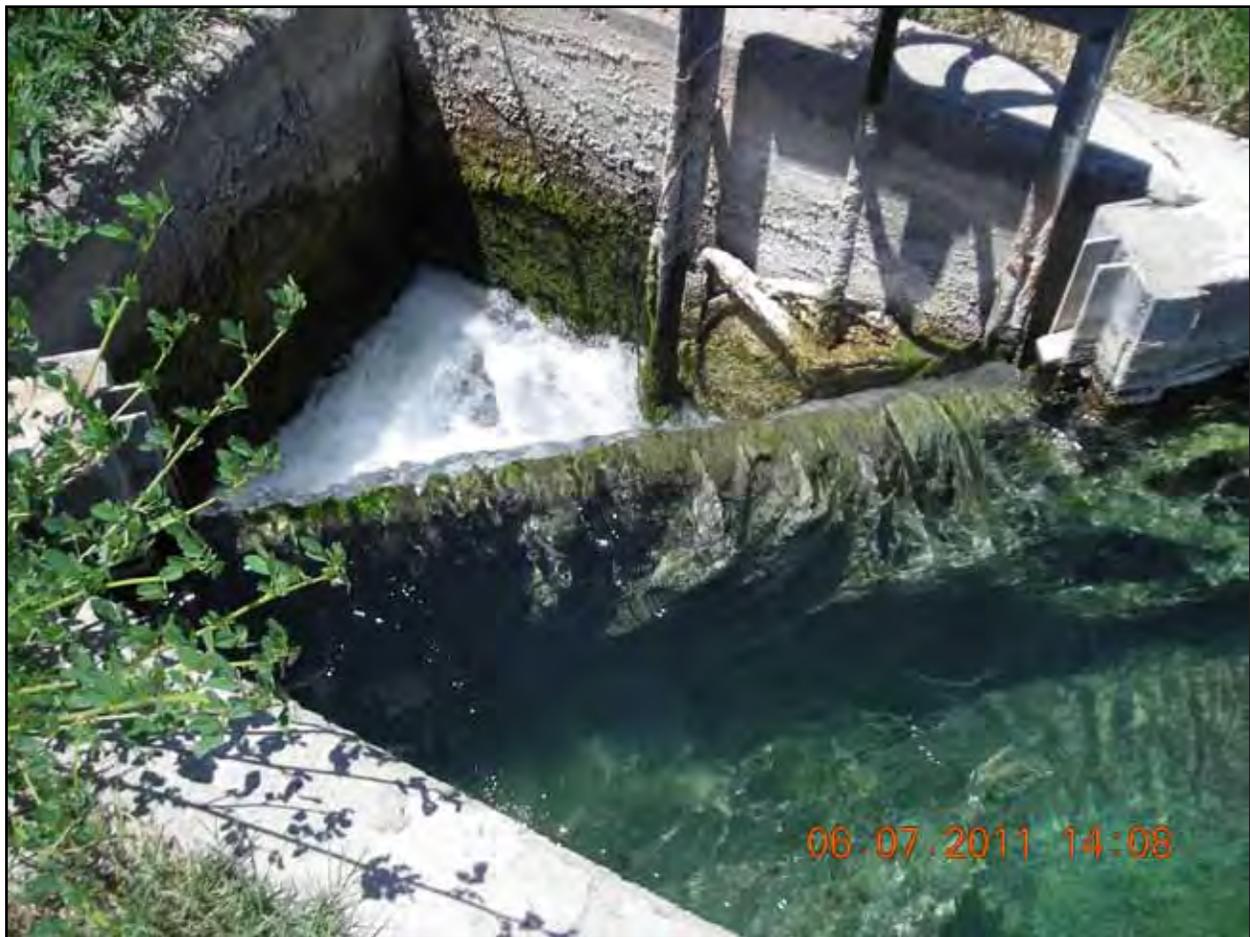
Photo # 3

Photographer: Sandra Gabaldon	Date: 6-7-2011	Time: 1408 hours
City/County: Santa Rosa/Guadalupe County		
Location: NMDGF Rock Lake Hatchery		
Subject: Secondary splitter box at discharge point. The flow coming in to the splitter box from the bottom of the picture is from the coldwater settling pond. There was no discharge from the warmwater settling pond at the time of the inspection.

Outfall 003 and Outfall 004 are both authorized to discharge to the Ortega-Borsich ditch (an irrigation canal), thence to the Pecos River. On the ground, both outfalls from each sedimentation pond are directed to a splitter box, where most of the flow appears to be directed to the irrigation canal. However, because of flow issues, even though only one pond may be discharging at a time, the water overflows the baffle present in the splitter box. The water that flows over the splitter box baffle is directed through another underground pipe, which results in a separate stream of effluent that goes directly to the Pecos River. (Please see Picture #3.) Because the permit is written to allow the discharge to the irrigation canal, thence to the Pecos River (which is about a mile downstream from the splitter box through the irrigation canal) the direct discharge to the Pecos River may be an unpermitted discharge.

When the warmwater pond is discharging in addition to the coldwater pond, the comingled water is also being sent to both discharges and the sampling data that is currently taken at the outfall weir from each pond may not be representative of the actual discharge either going to the Pecos directly, or to the irrigation canal.

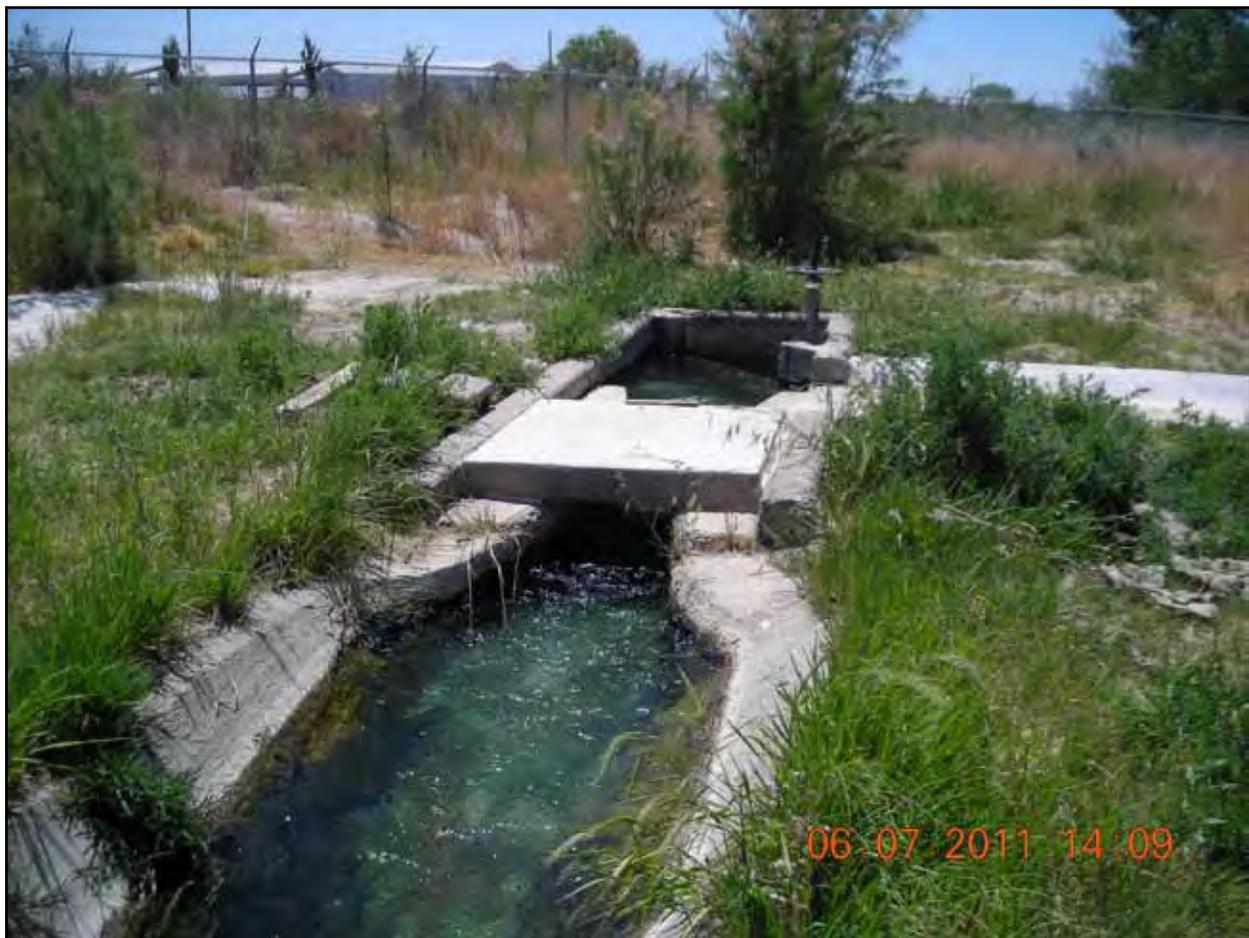
Photo # 4

Photographer: Sandra Gabaldon	Date: 6-7-2011	Time: 1409 hours
City/County: Santa Rosa/Guadalupe County		
Location: NMDGF Rock Lake Hatchery		
Subject: Secondary splitter box at discharge point. View is standing over the Ortega-Borsich ditch. The concrete channel to the right actually covers a pipe going directly to the Pecos River.
