**NEW MEXICO  
ENVIRONMENT DEPARTMENT**

**RE: Minor Industrial; SIC 0921; NPDES Compliance Evaluation Inspection; Rock Lake Fish Hatchery  
NMDG&F; NM0030155; June 3, 2013**

### NPDES Compliance Inspection Report

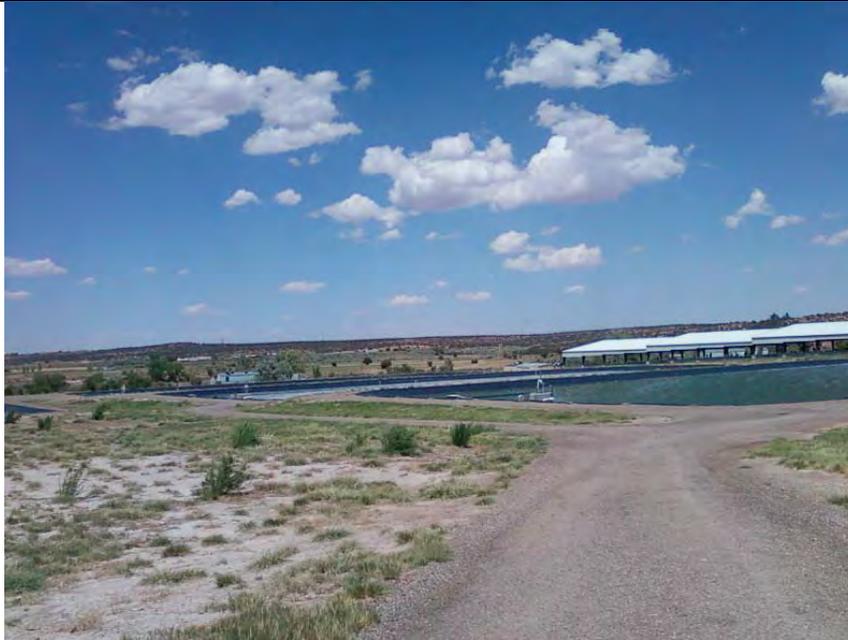
Subject: Warm Water rearing ponds.

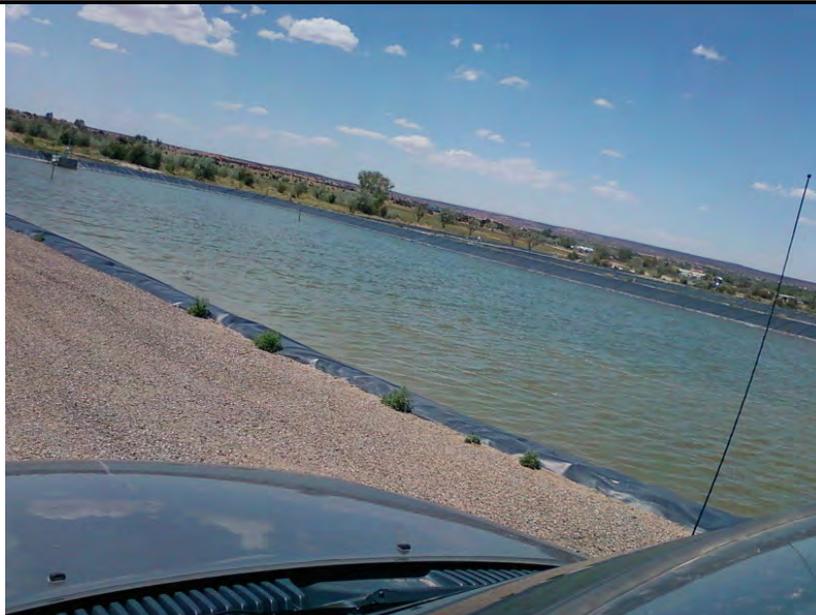
NMED/SWQB  
Official Photograph Log  
Photo #2

Subject: Warm Water Rearing Ponds

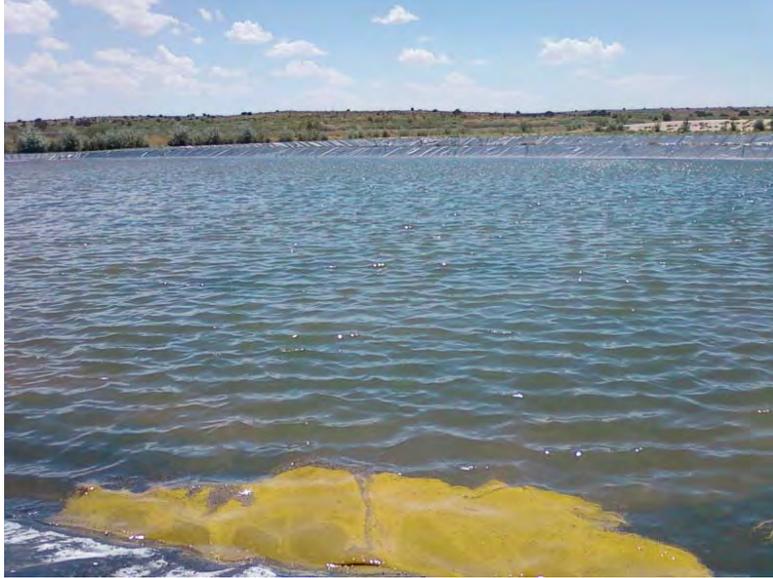
NMED/SWQB  
Official Photograph Log  
Photo # 3

Subject: Warm Water Rearing Ponds With Debris – The facility representative did not know the cause of the debris. It appears to be a combination of algae, fish food and possibly fertilizer used to promote algae growth.

2. Fertilizer is being added to the warmwater rearing ponds to promote algal growth for fish feeding. The addition of this fertilizer may be another source or toxic substances affecting the WET test.

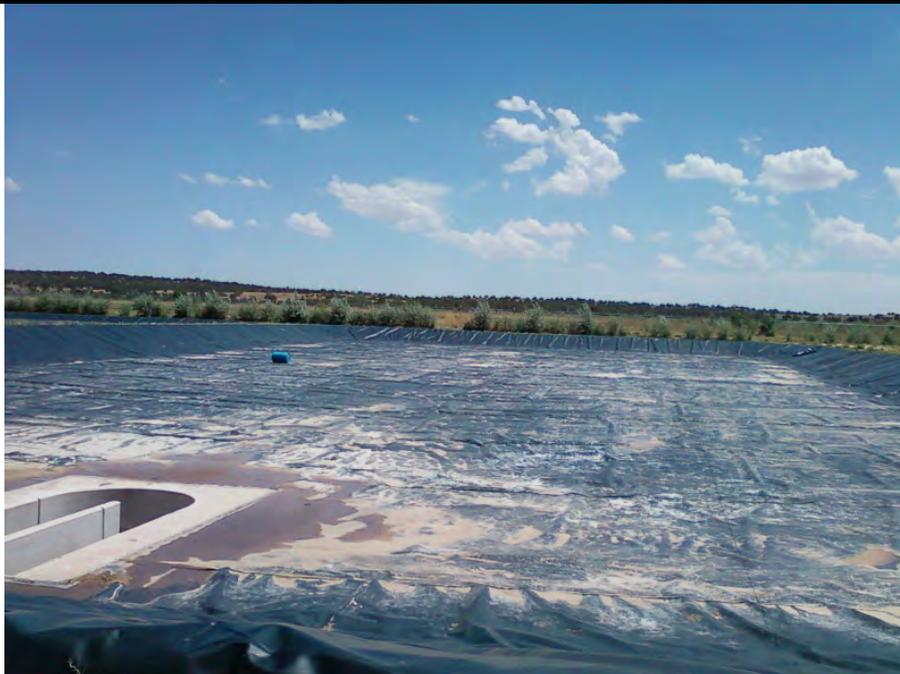
NMED/SWQB  
Official Photograph Log  
Photo # 4

Subject: Warm Water Rearing Pond liner

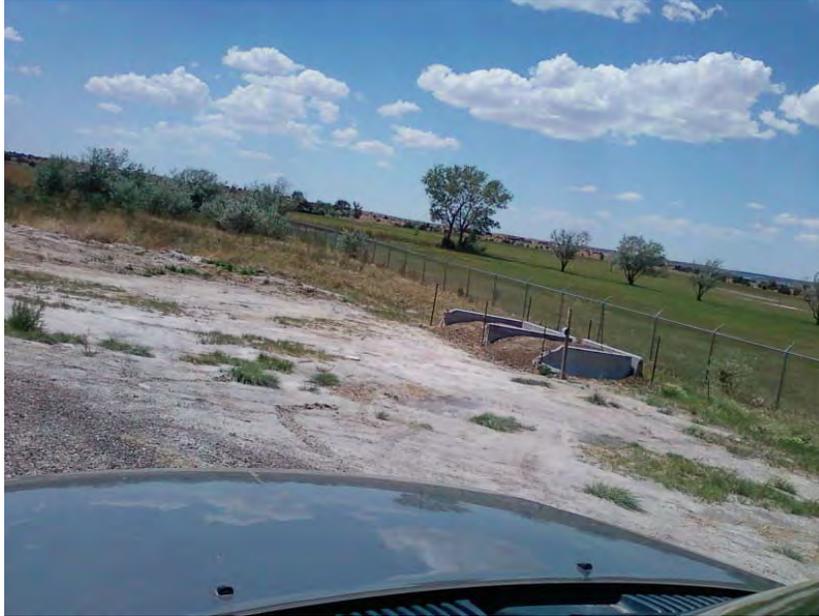
**NMED/SWQB  
Official Photograph Log  
Photo # 5**

DETAILS: The content of the mortality pit is overflowing the barriers.

Subject: Mortality Containers. Note the containers are overflowing and spilling out the sides as well. Final disposal is by burial on site.

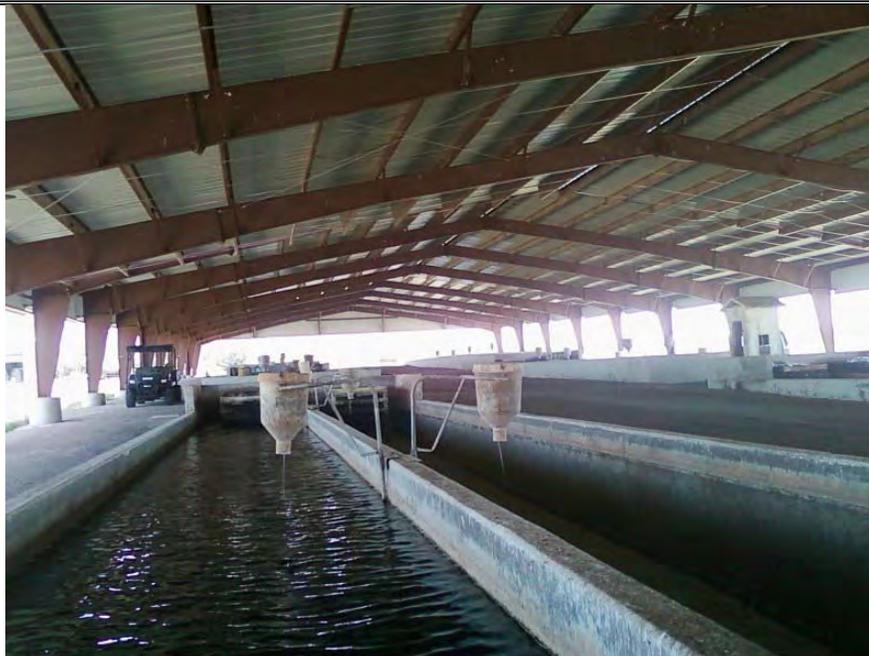
**NMED/SWQB  
Official Photograph Log  
Photo # 6**

Subject: Cold Water Raceway

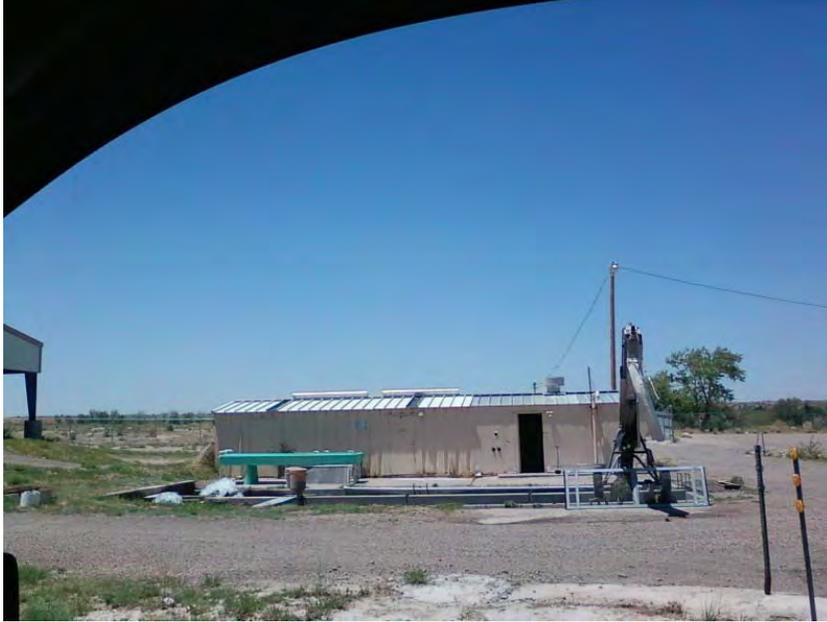
NMED/SWQB  
Official Photograph Log  
Photo # 7

Subject: Walleye building and the cold water raceway with conveyor belt to lift fish to the tanks (Kettles) for transport and release.

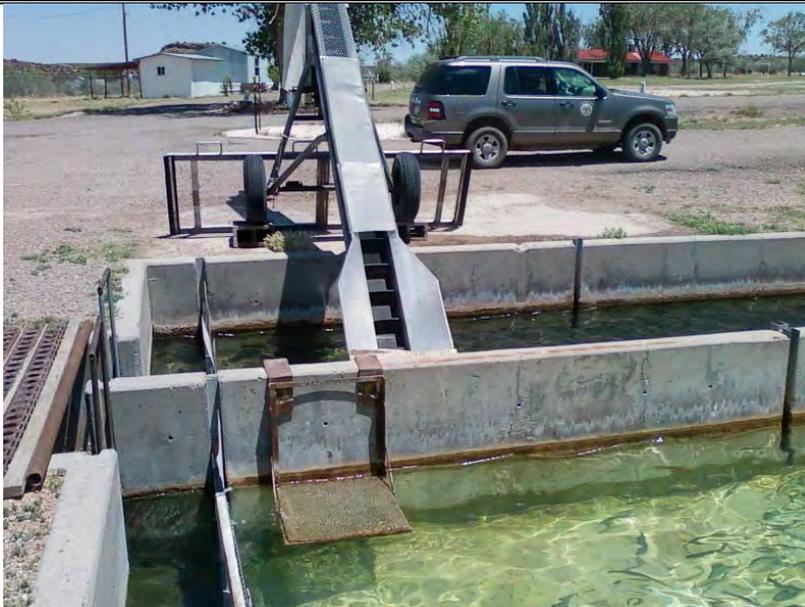
NMED/SWQB  
Official Photograph Log  
Photo # 8

Subject: raceway with conveyor belt to lift fish to the tanks (Kettles) for transport and release.

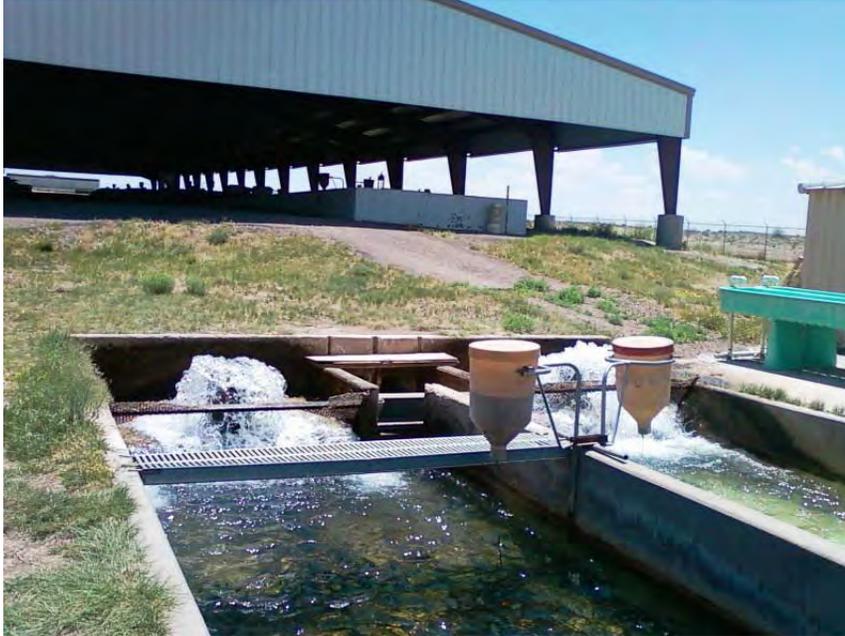
NMED/SWQB  
Official Photograph Log  
Photo # 9

Subject: Final Cold Water Raceway

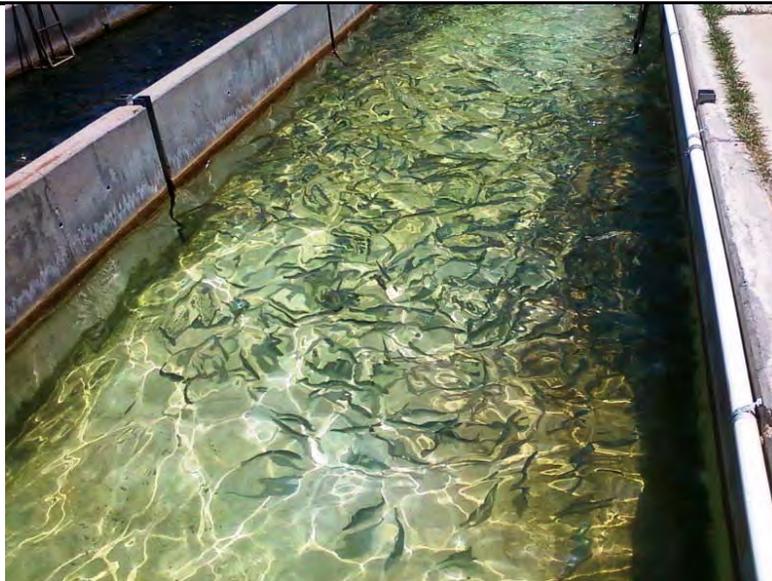
NMED/SWQB  
Official Photograph Log  
Photo # 10

Subject: Final Cold Water Raceway with 4-6 inch long fish

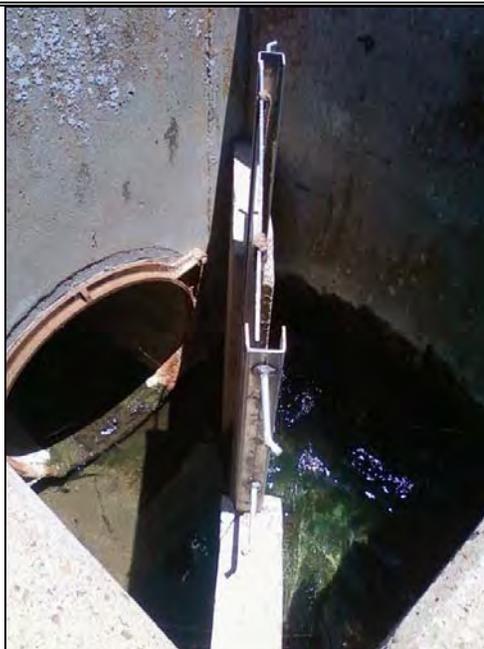
NMED/SWQB  
Official Photograph Log  
Photo # 11

Subject: Splitter box past final raceway and past final warm water rearing pond – a pipe feeds into this splitter box (located at the lower right of the photo that is from the floor drain of the Walleye building). The splitter box directs water to the final settling ponds, either to the warm water pond or the coldwater pond. At the time of this inspection, the flow was being directed to the Cold Water settling pond.

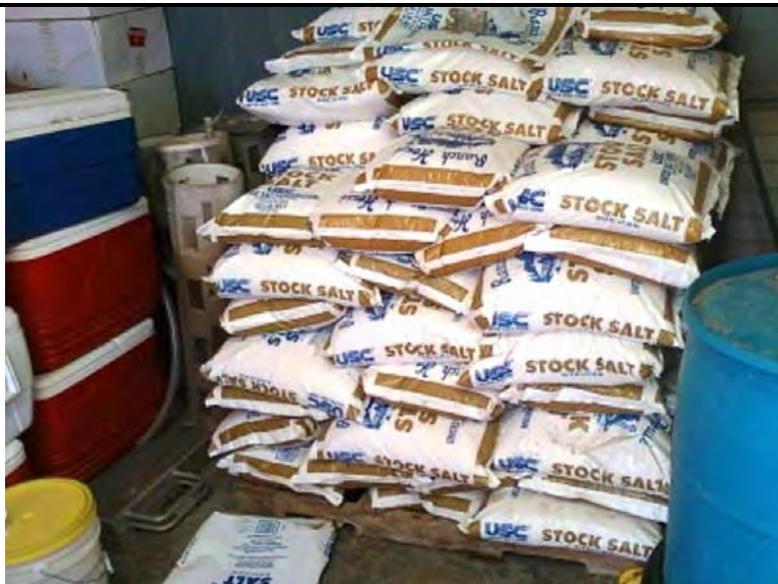
NMED/SWQB  
Official Photograph Log  
Photo # 12

Salt is added to the rearing unit when fish are being prepared to be moved to the “kettles” for transport and release. Operators said the salts help calm down the fish for this process. This addition of salts can increase the Total Dissolved Solids (TDS) suspected of being a factor in the failure of the Whole Effluent Toxicity (WET) Tests.

Subject: In the Walleye building, chemical such as this salt are stored.

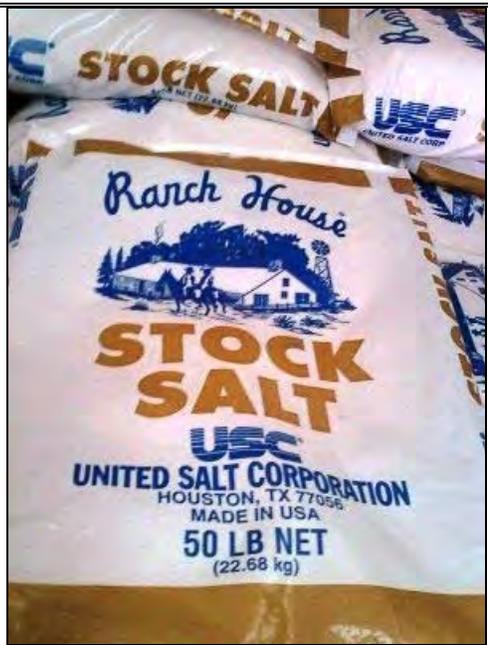
NMED/SWQB  
Official Photograph Log  
Photo # 13

Photographer: B. Cooney	Date: June 3, 2013	Time: Between 1240 and 1600 Exact Time Unknown
City/County: Santa Rosa / Guadalupe	State: New Mexico	
Location: Rock Lake Hatchery, NDG&F		
Subject: : In the Walleye building, chemical such as this salt are stored.

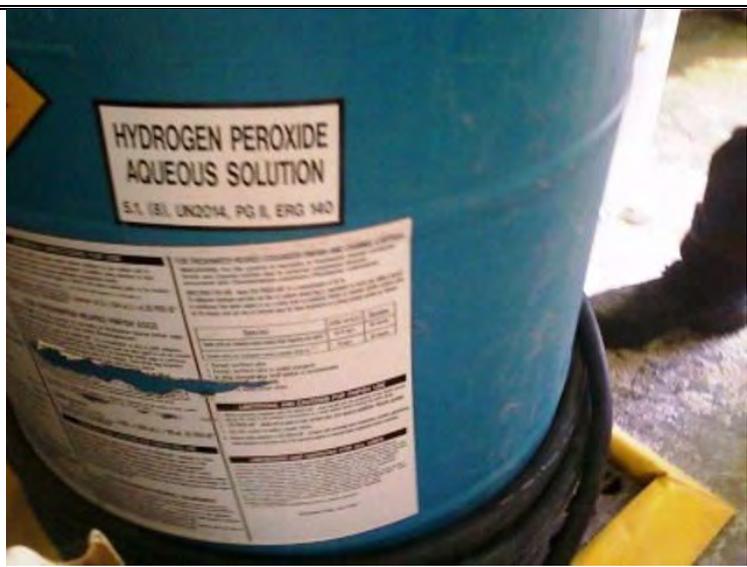
NMED/SWQB  
Official Photograph Log  
Photo # 14

Photographer: B. Cooney	Date: June 3, 2013	Time: Between 1240 and 1600 Exact Time Unknown
City/County: Santa Rosa / Guadalupe	State: New Mexico	
Location: Rock Lake Hatchery, NDG&F		
Subject: : In the Walleye building, chemical such as this Hydrogen peroxide are stored. Though there is a small containment boom around the floor of the barrel, it would not actually contain the contents of the barrel if it were to break and leak.

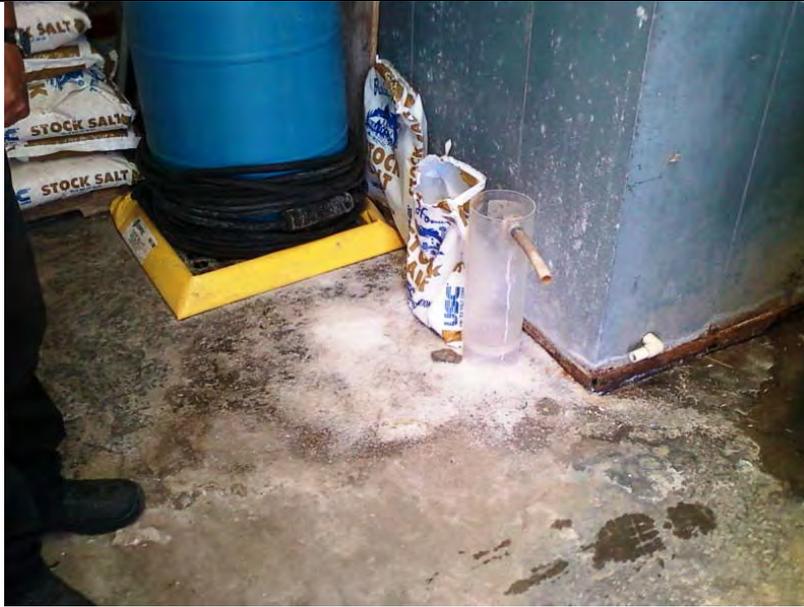
NMED/SWQB  
Official Photograph Log  
Photo # 15

Subject: Walleye Building with salts and other spillage on the floor.

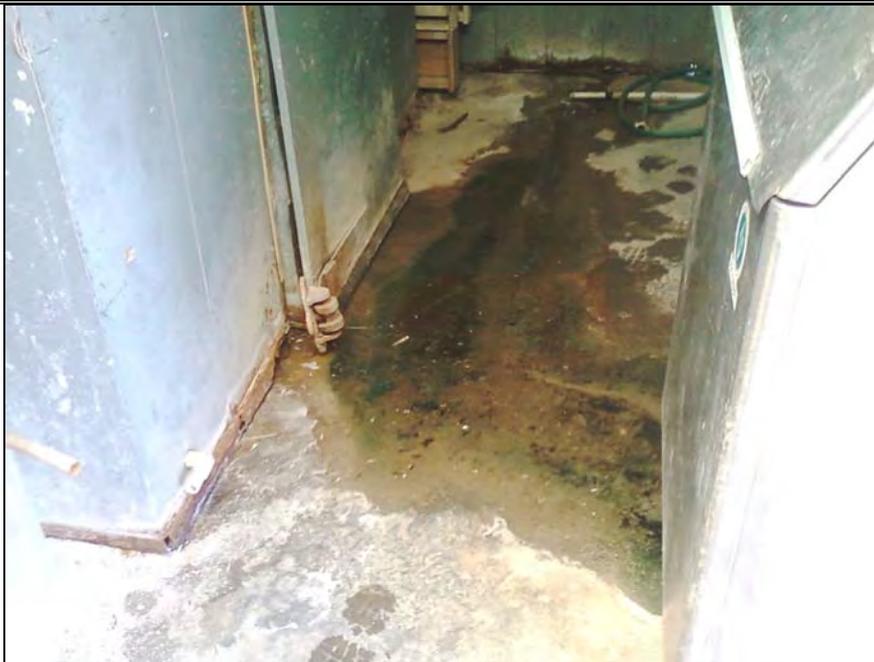
NMED/SWQB  
Official Photograph Log  
Photo # 16

Subject: In the Walleye building, water leaking from the ice machines , chemical stains and flows to a floor drain.

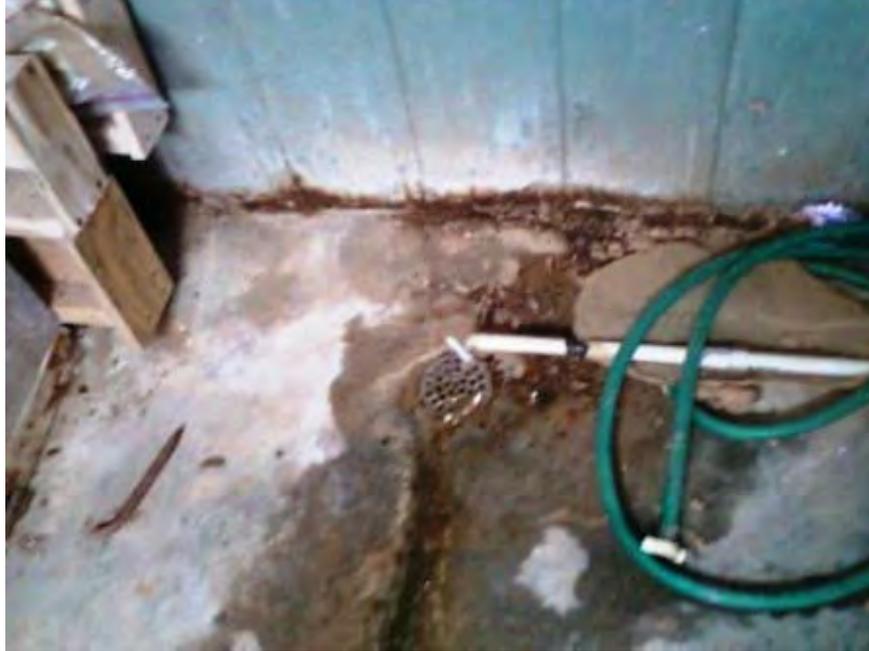
NMED/SWQB  
Official Photograph Log  
Photo # 17

1. The building known as the “Walleye Building” is located near the end of the cold water and warm water streams where they are sent through a splitter box, to the settling ponds. Stored in this building are ice machines, miscellaneous tools and equipment, bagged salt and a 50 gallon barrel of liquid hydrogen peroxide. A floor drain in this building flows directly to the splitter box that directs water to the settling ponds (see photo). This drain is a place where potentially toxic substances can enter the water that is ultimately discharged to the Pecos River.

Subject: Walleye building floor drain that flow to the splitter box and out to the settling ponds – that ultimately discharge to the Borsch ditch and the Pecos River.

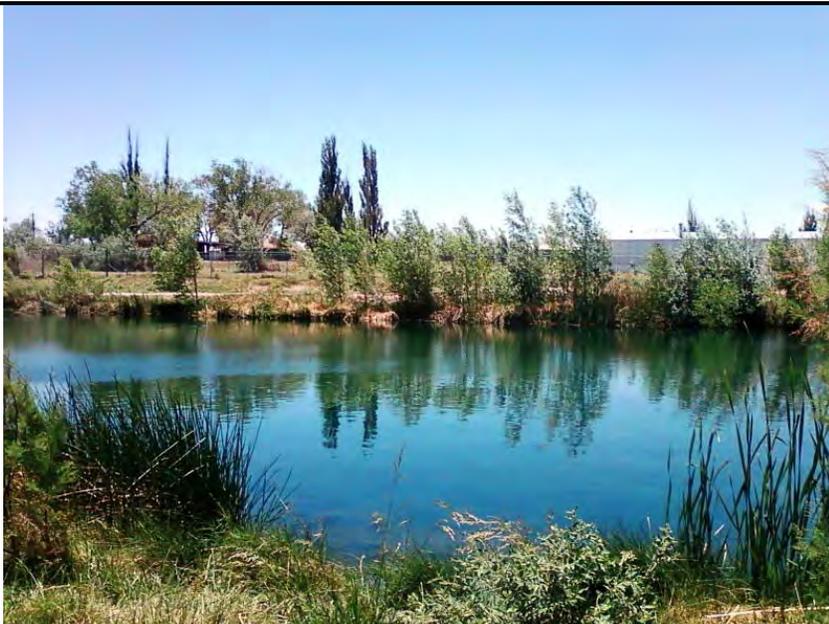
NMED/SWQB  
Official Photograph Log  
Photo # 18

Subject: Cold Water Settling Pond.

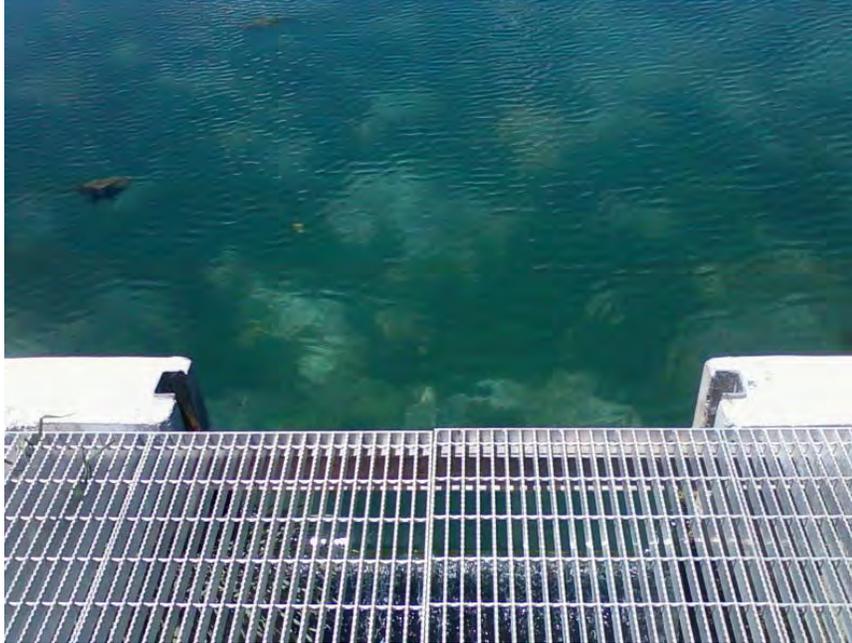
**NMED/SWQB  
Official Photograph Log  
Photo # 19**

A rectangular weir and measuring stick is used to determine the effluent flow volume from both lagoons. There is nothing in place that allows for secondary measurement or for calibration of the flow measurements.

Subject: Square Weir Box at the end of the warmwater settling pond. This is where effluent flow reading are taken.

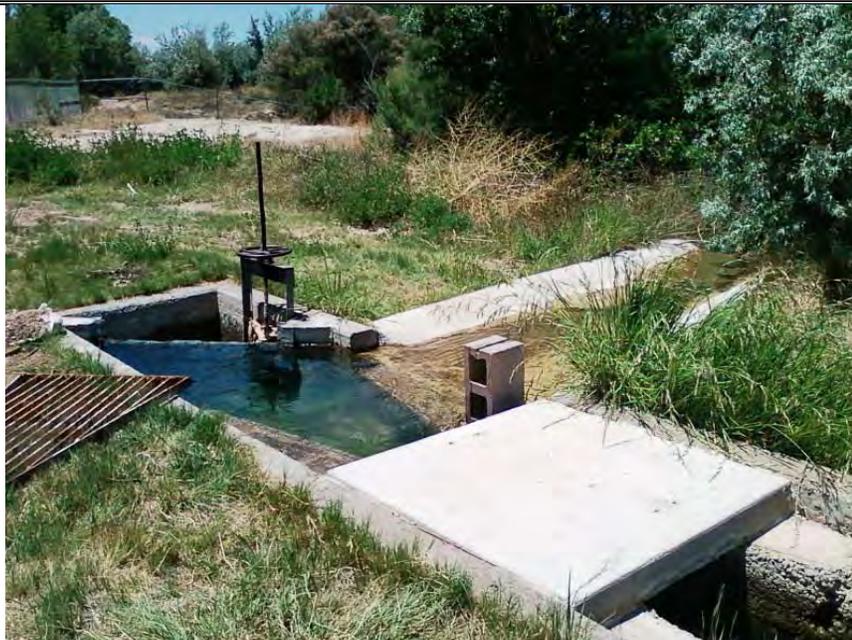
**NMED/SWQB  
Official Photograph Log  
Photo # 20**

PERMITTEE FLOW MEASUREMENT MEETS PERMIT REQUIREMENTS.  
DETAILS: Spill way to the Pecos River and not to the Borsch Ditch. S  M  U  NA (FURTHER EXPLANATION ATTACHED YES.)1. PRIMARY FLOW MEASUREMENT DEVICE PROPERLY INSTALLED AND MAINTAINED.  
TYPE OF DEVICE \_\_\_\_\_ 48" RECTANGULAR WEIR Y  N  NA

Subject: Effluent being discharged to the Borsch ditch for irrigation and a spillway where discharge goes directly to the Pecos River.

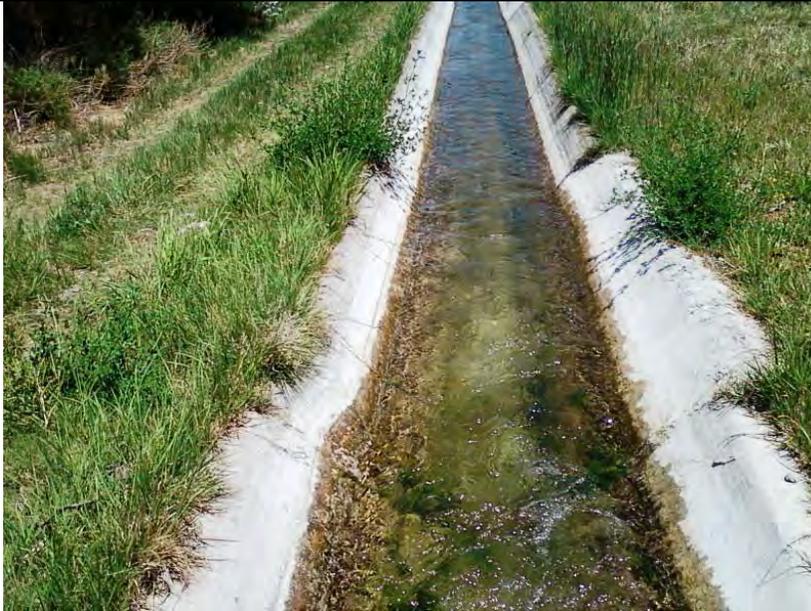
**NMED/SWQB  
Official Photograph Log  
Photo # 21**

Subject: Effluent being discharged to the Borsch ditch for irrigation.
