Re: Minor Non-Municipal, SIC 1221, NPDES Compliance Evaluation Inspection, Chevron Mining, Inc./Ancho Mine, NM0030180, August 7, 2012

NPDES Compliance Inspection Report

**Compliance Evaluation Inspection
Chevron Mining, Inc./Ancho Mine
NPDES Permit NM0030180, August 7, 2012**

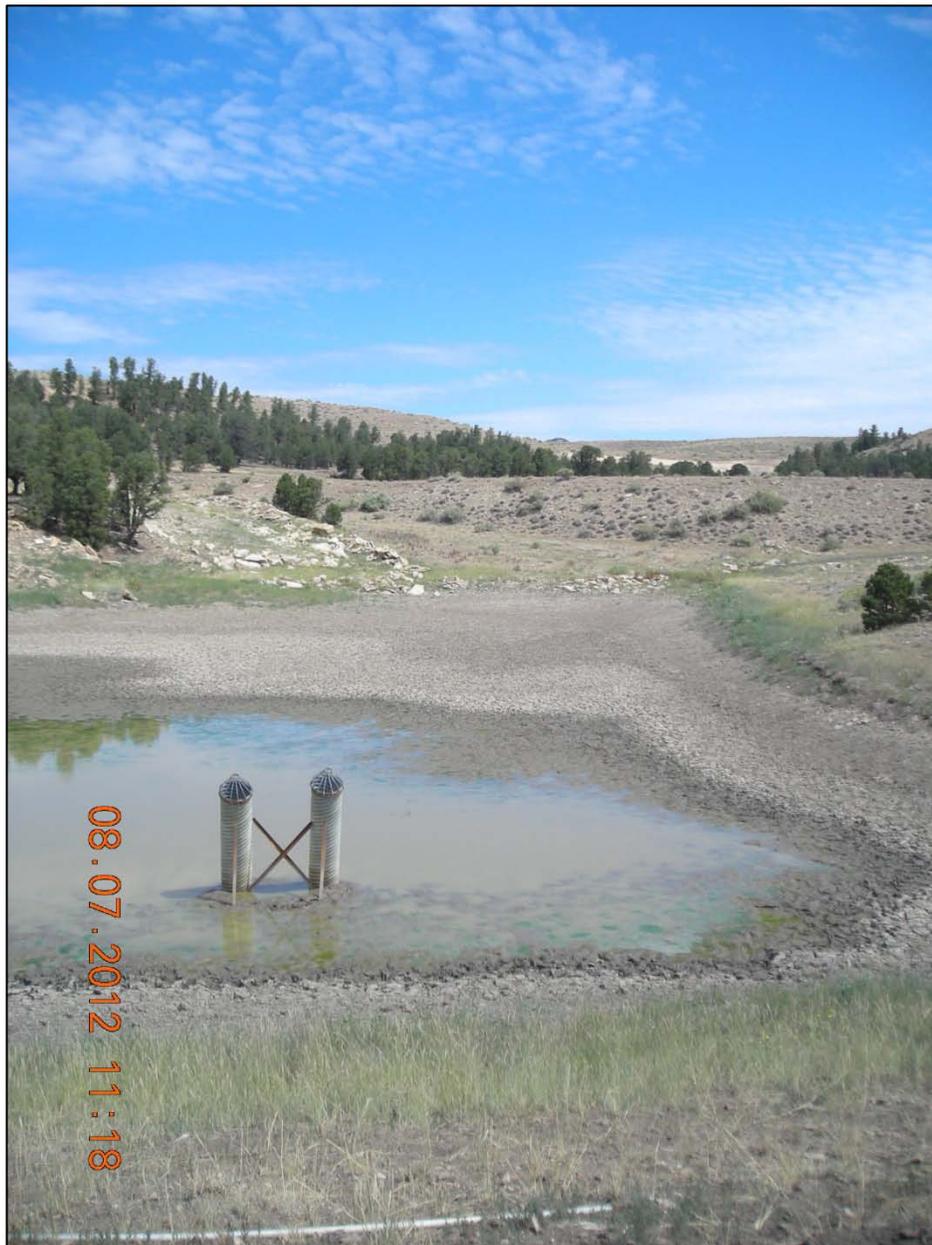
Photo # 1

Outfall 005 consists of a series of two settling ponds with a spillway in between, and the outfall. The facility representative indicated that they have had issues getting vegetation established in this area, and their latest attempt is more straw mulch applied to encourage seed growth. (Please see Photo #1.) It is evident from the data that the effluent is improving, however the latest sampling result is about five times higher than the permit limit.

Photographer: Sarah Holcomb	Date: 8-7-2012	Time: 1118 hours
City/County: Raton/Colfax County		
Location: Chevron/Ancho Mines, 33 miles west of Raton, NM		
Subject: Outfall 005 in Ancho. This photo shows the straw mulch applied to the area behind the pond (visible at the back of the photo, with the light tan color).

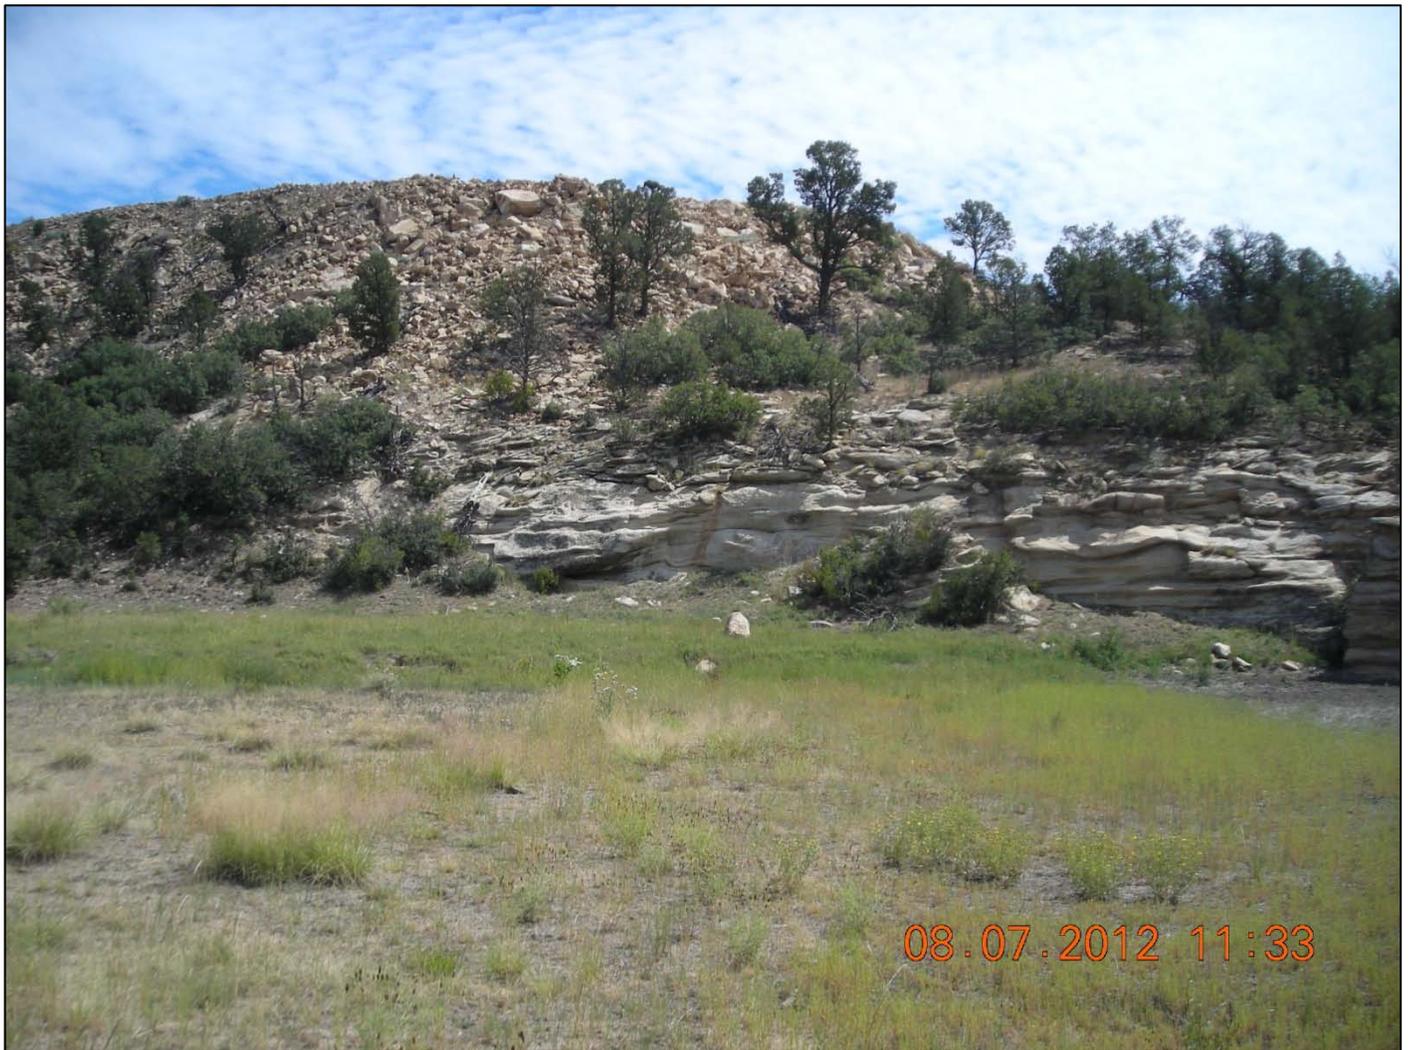
Photo # 2

Outfall 007 consists of another series of two settling ponds. This particular outfall is located in an area where there is a large overburden pile next to the pond. (Please see Photo #2) The inspector questioned whether the overburden could be contributing to the Al exceedances at this particular outfall and whether the facility had done anything to cover or prevent stormwater from coming into contact with that pile. The facility representative indicated that it would be an issue for them to look into.

Photographer: Sarah Holcomb	Date: 8-7-2012	Time: 1133 hours
City/County: Raton/Colfax County		
Location: Chevron/Ancho Mines, 33 miles west of Raton, NM		
Subject: Outfall 007 in Ancho. This photo shows the overburden pile next to the outfall pond. No attempt has been made to cover or somehow divert water from coming into contact with this pile prior to discharge from the site. This could contribute to the AI exceedances from this outfall.
