RE: Minor Municipal, SIC 4952, NPDES Compliance Evaluation Inspection, Sunland Park – Santa Teresa, aka Camino Real Regional Utility Authority, NPDES Permit No. NM0030201, July 25, 2012

NPDES Compliance Inspection Report

Sunland Park – Santa Teresa Wastewater Treatment Plant
(Camino Real Regional Utility Authority)
Permit No. NM0030201
Compliance Evaluation Inspection
July 25, 2012

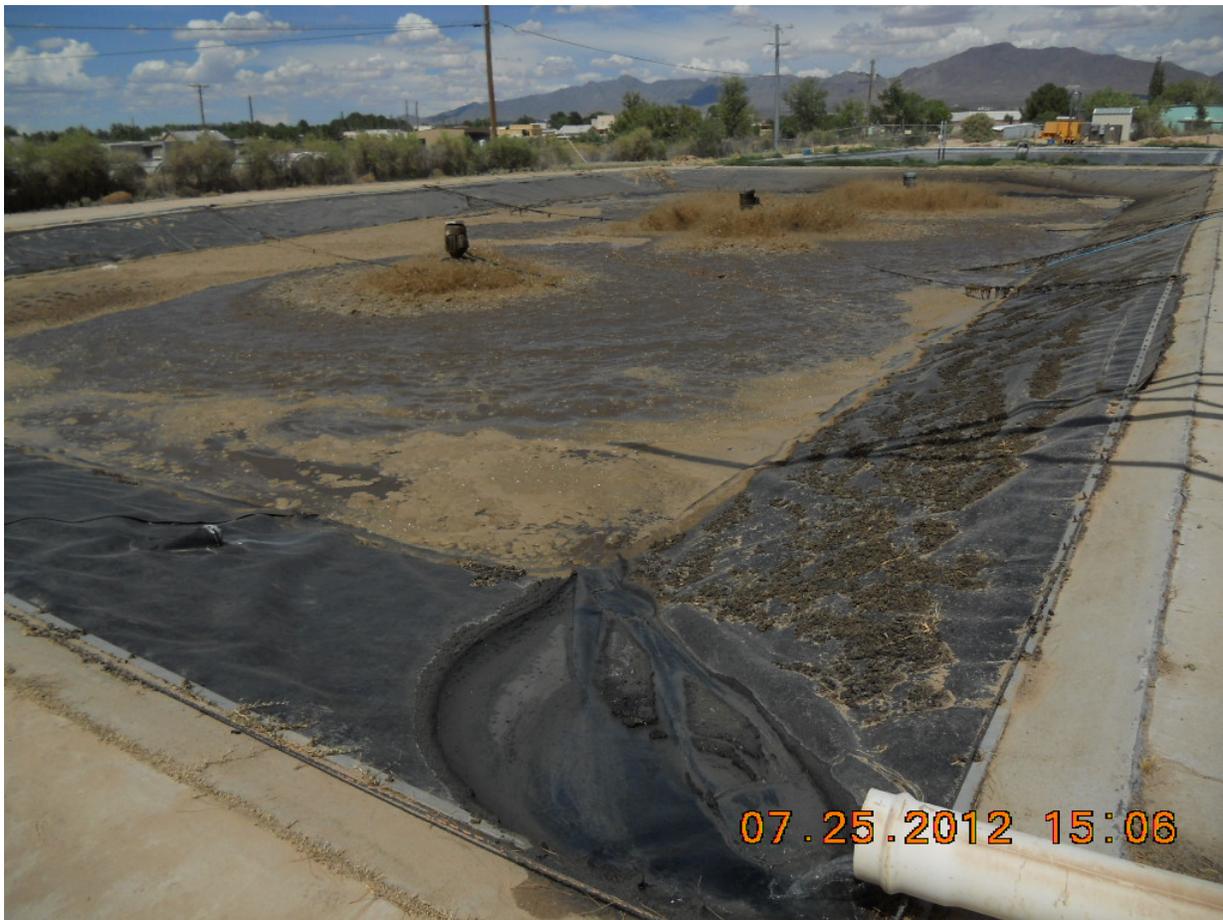
**NMED/SWQB
Official Photograph Log
Photo # 1**

- 1. TREATMENT UNITS PROPERLY OPERATED. Aeration basins have sludge rising, indicating a need for wasting. Clarifiers had some ashing. S M U NA
- 2. TREATMENT UNITS PROPERLY MAINTAINED. Surface aerator in south basin needs to be repaired. S M U NA
- 3. STANDBY POWER OR OTHER EQUIVALENT PROVIDED. Gravity flow. Portable generator available. S M U NA
- 4. ADEQUATE ALARM SYSTEM FOR POWER OR EQUIPMENT FAILURES AVAILABLE. S M U NA
- 5. ALL NEEDED TREATMENT UNITS IN SERVICE S M U NA
- 6. ADEQUATE NUMBER OF QUALIFIED OPERATORS PROVIDED. S M U NA
- 7. SPARE PARTS AND SUPPLIES INVENTORY MAINTAINED. S M U NA
- 8. OPERATION AND MAINTENANCE MANUAL AVAILABLE. Y N NA
 STANDARD OPERATING PROCEDURES AND SCHEDULES ESTABLISHED. Y N NA
 PROCEDURES FOR EMERGENCY TREATMENT CONTROL ESTABLISHED. No written procedures established. Y N NA

Photographer: Sandra Gabaldón	Date: 07-25-2012	Time: 1506
City/County: Santa Teresa / Doña Ana		State: New Mexico
Location: Sunland Park – Santa Teresa (CRRUA)		
Subject: North aeration basin (One of two basins)

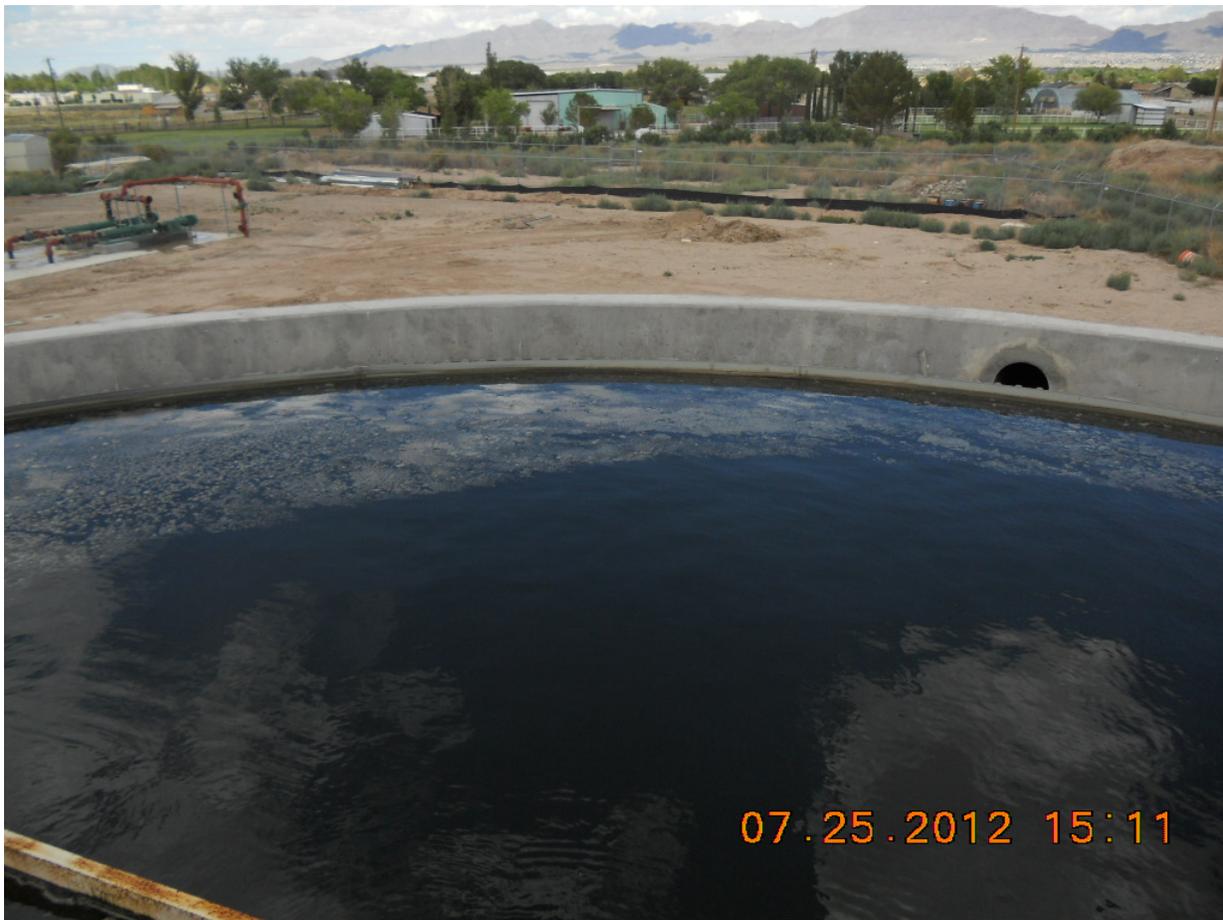
**NMED/SWQB
Official Photograph Log
Photo # 2**

Photographer: Sandra Gabaldón	Date: 07-25-2012	Time: 1511
City/County: Santa Teresa / Doña Ana		State: New Mexico
Location: Sunland Park – Santa Teresa (CRRUA)		
Subject: Clarifier – Note ashing on surface.

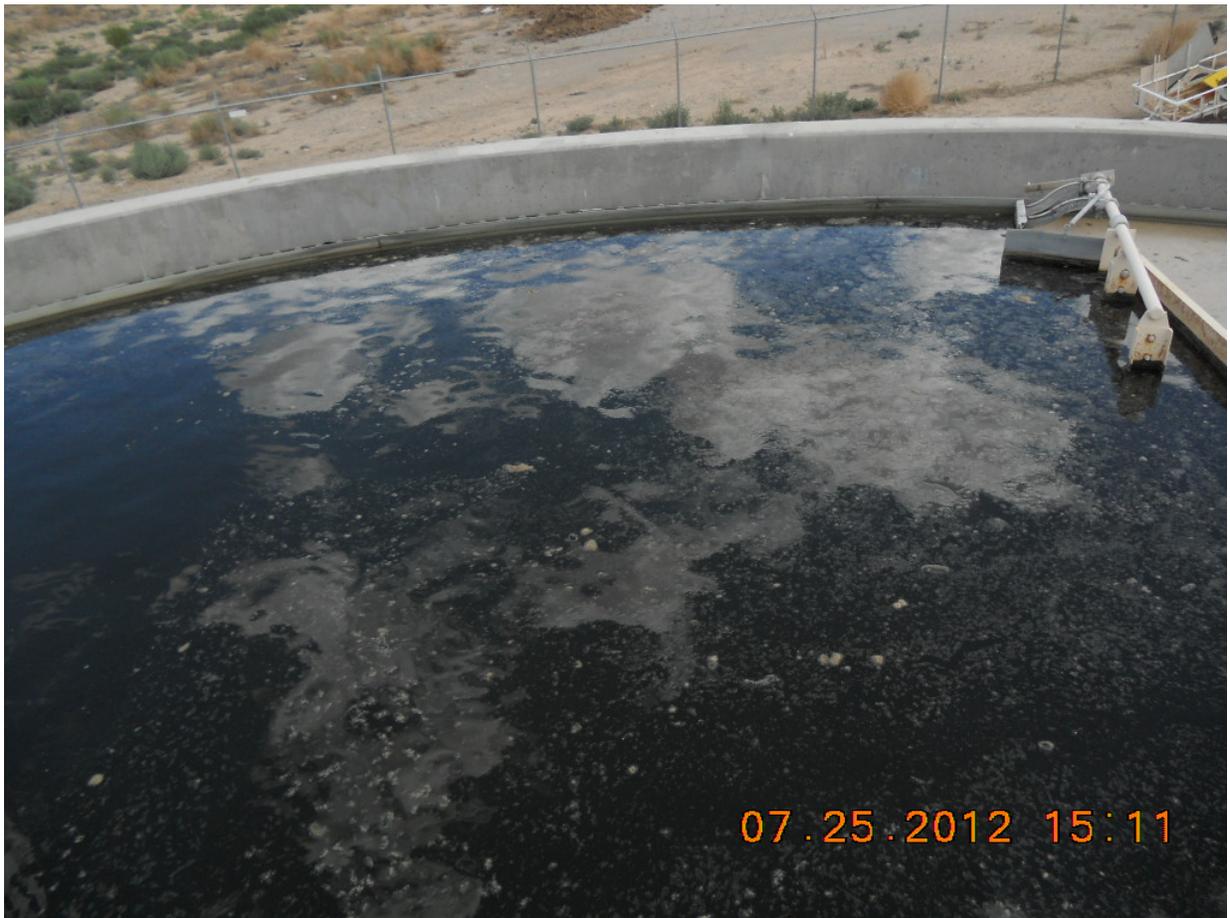
**NMED/SWQB
Official Photograph Log
Photo # 3**

Photographer: Sandra Gabaldón	Date: 07-25-2012	Time: 1511
City/County: Santa Teresa / Doña Ana		State: New Mexico
Location: Sunland Park – Santa Teresa (CRRUA)		
Subject: Close up view of clarifier – Note ashing

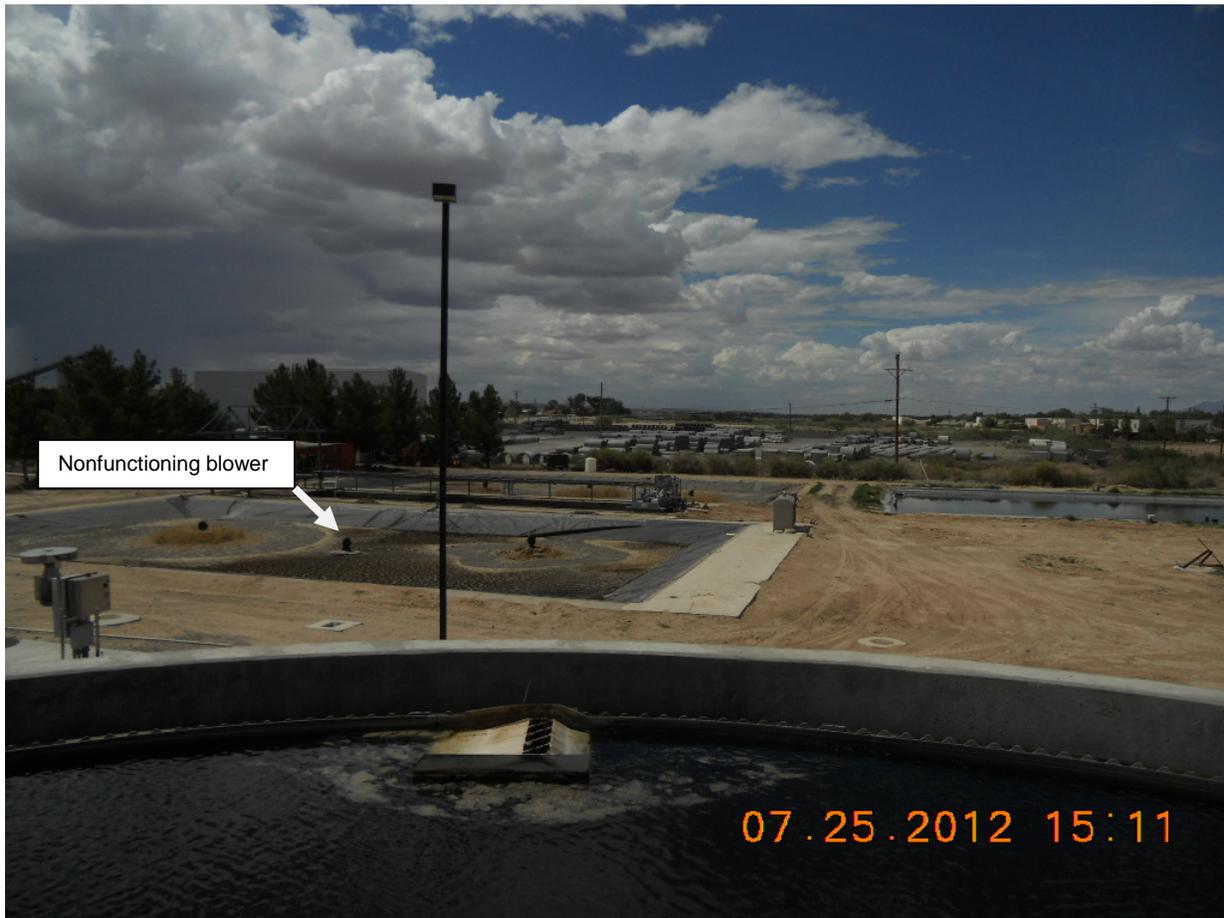
**NMED/SWQB
Official Photograph Log
Photo # 4**

Photographer: Sandra Gabaldón	Date: 07-25-2012	Time: 1511
City/County: Santa Teresa / Doña Ana		State: New Mexico
Location: Sunland Park – Santa Teresa (CRRUA)		
Subject: South aeration basin – Surface aerator in center off line. Parts have been ordered.
