**RE: Minor Municipal, SIC 4952, NPDES Compliance Evaluation Inspection, Town of Springer
Wastewater Treatment Plant, NM0030295, April 18, 2013**

Town of Springer Wastewater Treatment Plant
NPDES Permit No. NM0030295
Compliance Evaluation Inspection
April 18, 2013

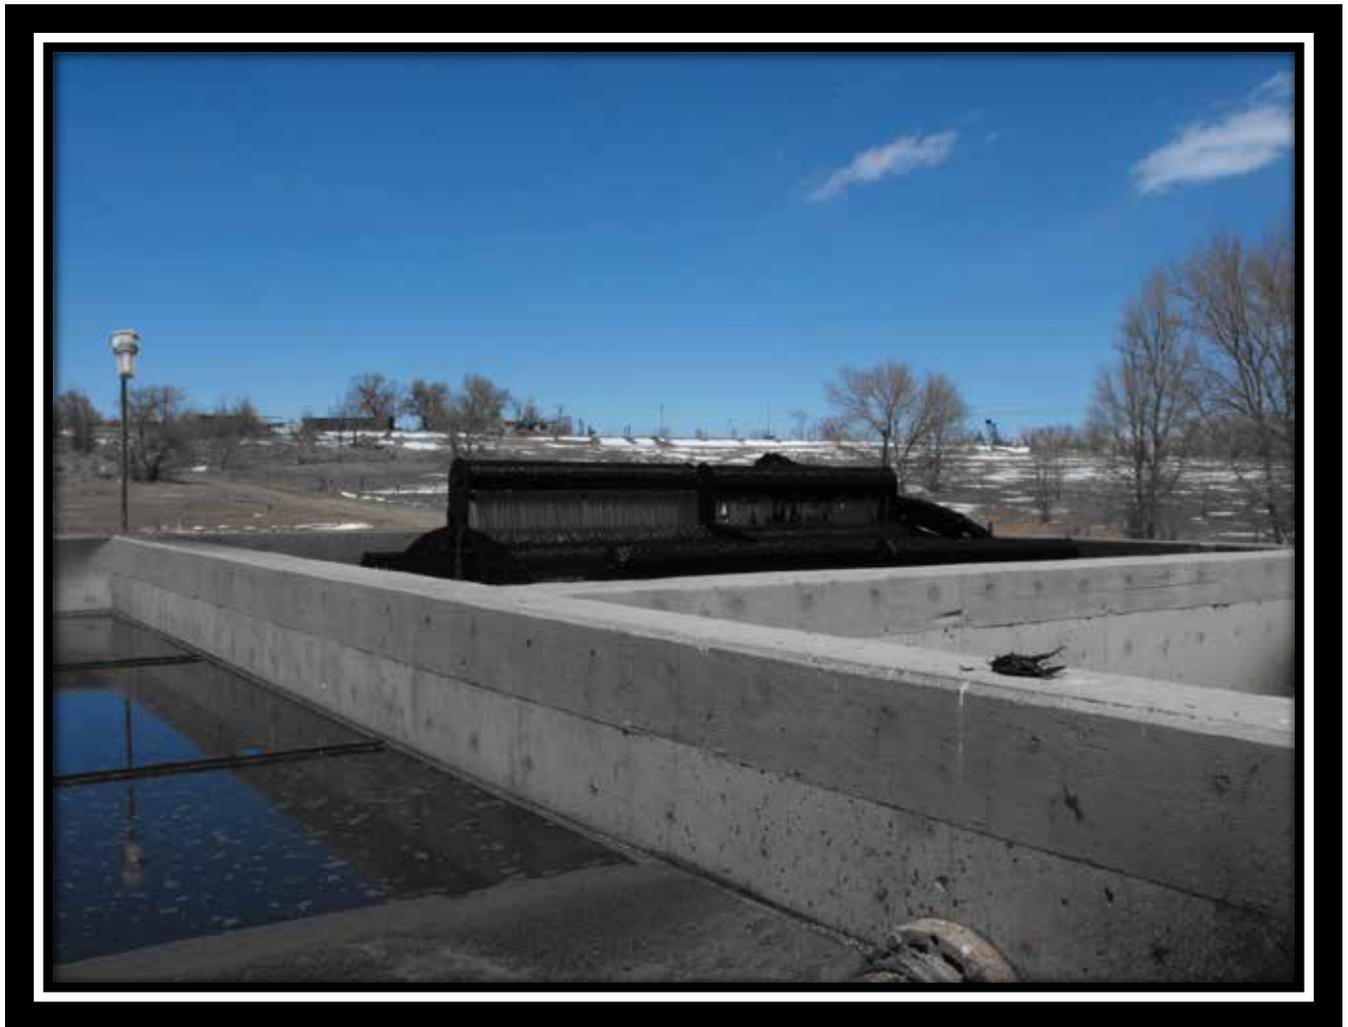
NMED/SWQB
Official Photograph Log
Photo # 1

may be placed back into service. There was also the appearance of floating sludge on both the STM-aerotor and the clarifier.

Photographer: Daniel Valenta	Date: 04-18-2013	Time: 1339 Hours
City/County: Town of Springer / Colfax County		State: New Mexico
Location: Town of Springer WWTP		
Subject: STM – Aerotor – the fixed film on aerotor is black in color.

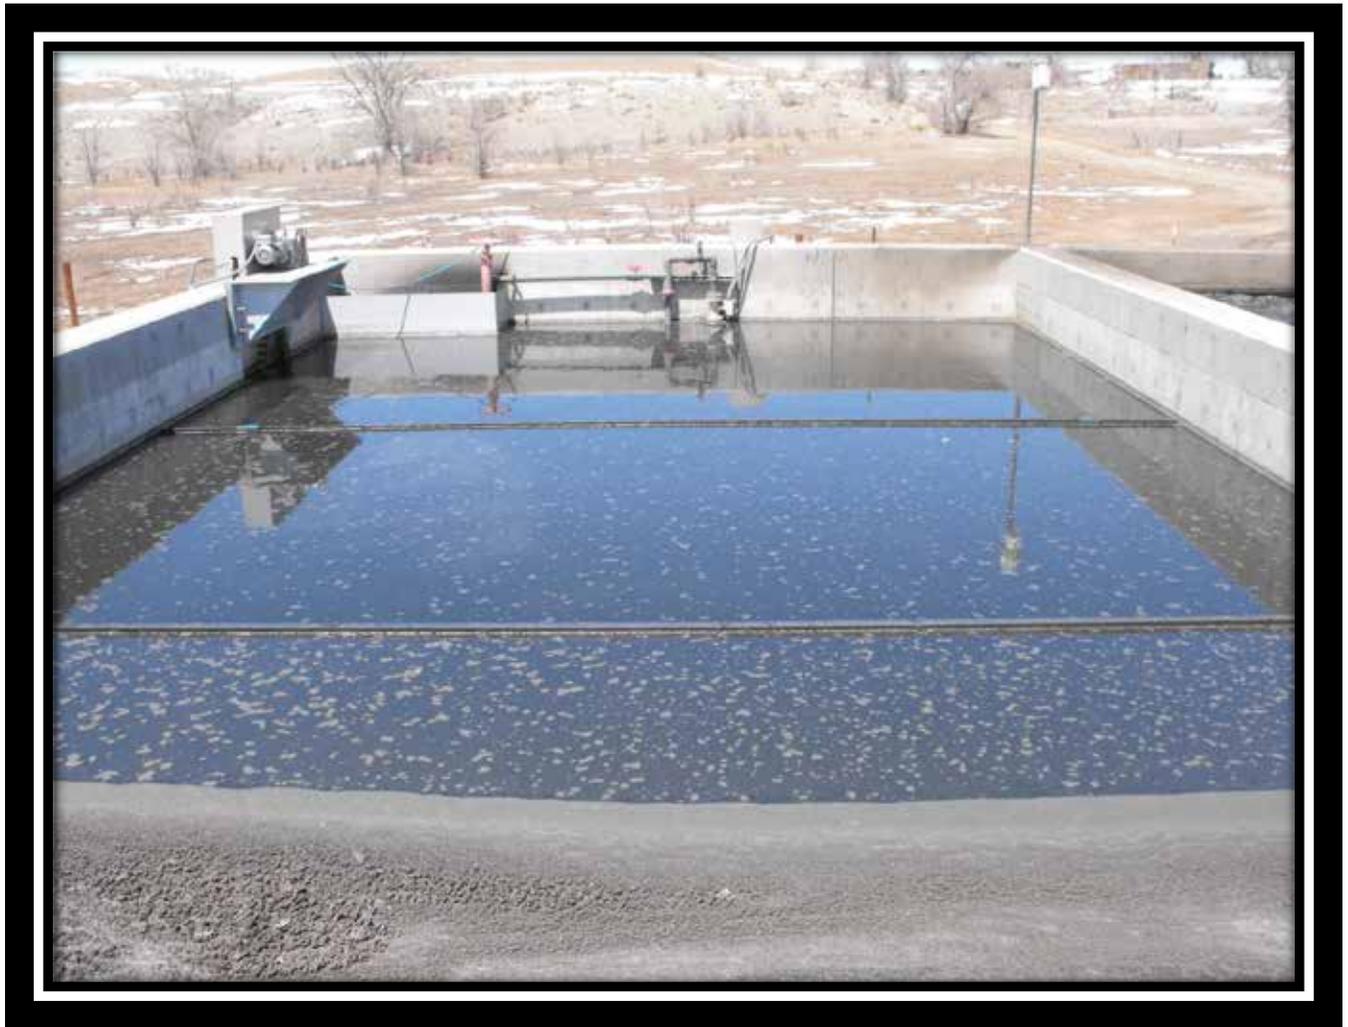
**NMED/SWQB
Official Photograph Log
Photo # 2**

Photographer: Daniel Valenta	Date: 04-18-2013	Time: 1340 Hours
City/County: Town of Springer / Colfax County		State: New Mexico
Location: Town of Springer Wastewater Treatment Plant		
Subject: Clarifier – floating sludge, color is black

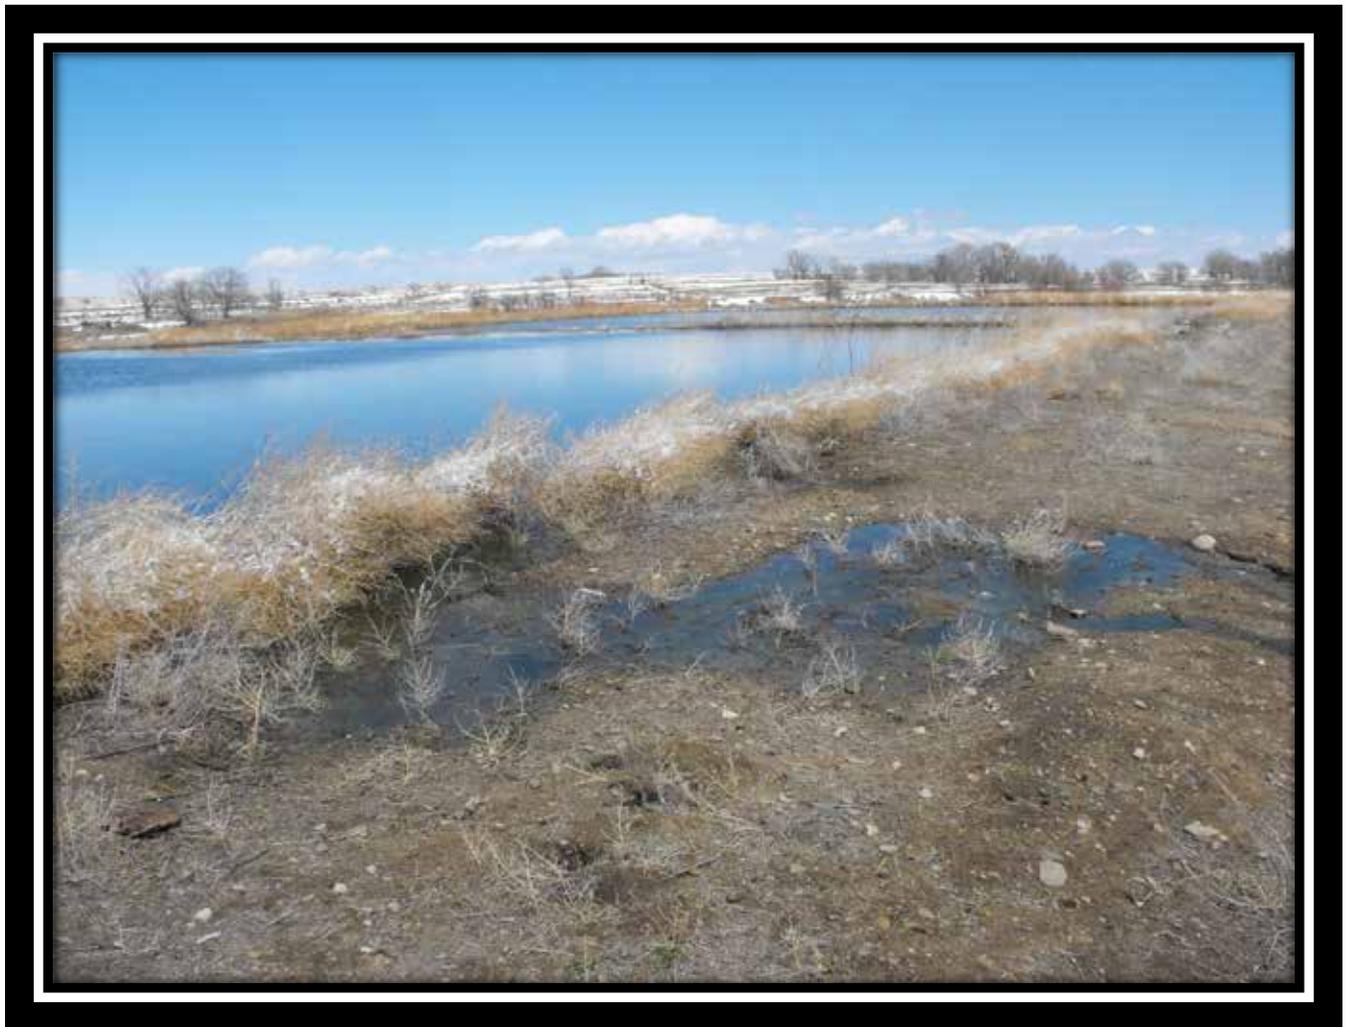
NMED/SWQB
Official Photograph Log
Photo # 3

When the inspectors asked to view the ponds, which are behind a locked gate, the operator stated that no key was available. The inspectors proceeded through the fenced area with the operator's permission to view the ponds. In doing so, the inspectors noticed that the ponds had no free board and the west pond was overflowing. A report has since been sent to the GWQB concerning this discharge. The Water Manager, Laura Danielson, estimated that 259,200 gallons of treated sewage was released to an adjacent field because of a faulty valve. This discharge had been occurring for approximately three weeks before it was noticed by the inspectors on April 18, 2013. The report states that the berming was repaired around this pond on April 24, 2013, and the valve would be installed shortly thereafter. There is no indication that this bypass has been reported to EPA.

Photographer: Daniel Valenta	Date: 04-13-2013	Time: 1414 Hours
City/County: Town of Springer / Colfax County		State: New Mexico
Location: Town of Springer Wastewater Treatment Plant		
Subject: Lagoon ponds – break in pond. Please note the absence of any free board on either pond.

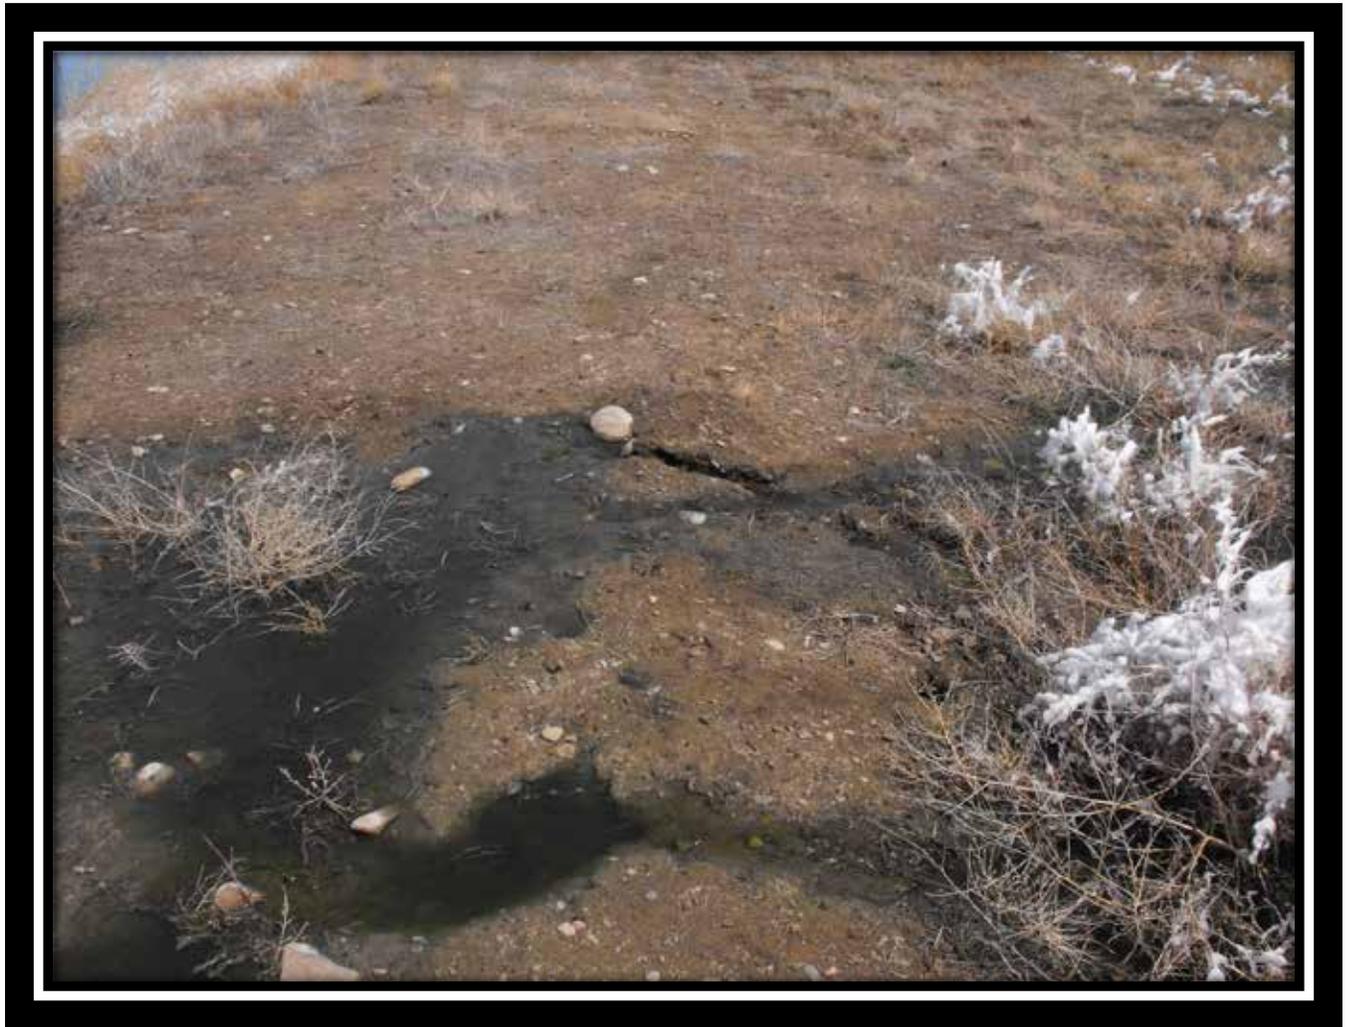
NMED/SWQB
Official Photograph Log
Photo # 4

Photographer: Daniel Valenta	Date: 04-18-2013	Time: 1415 Hours
City/County: Town of Springer / Colfax County		State: New Mexico
Location: Town of Springer Wastewater Treatment Plant		
Subject: Close of view of overflow from pond. There is an appearance of algae already growing in the overflow.

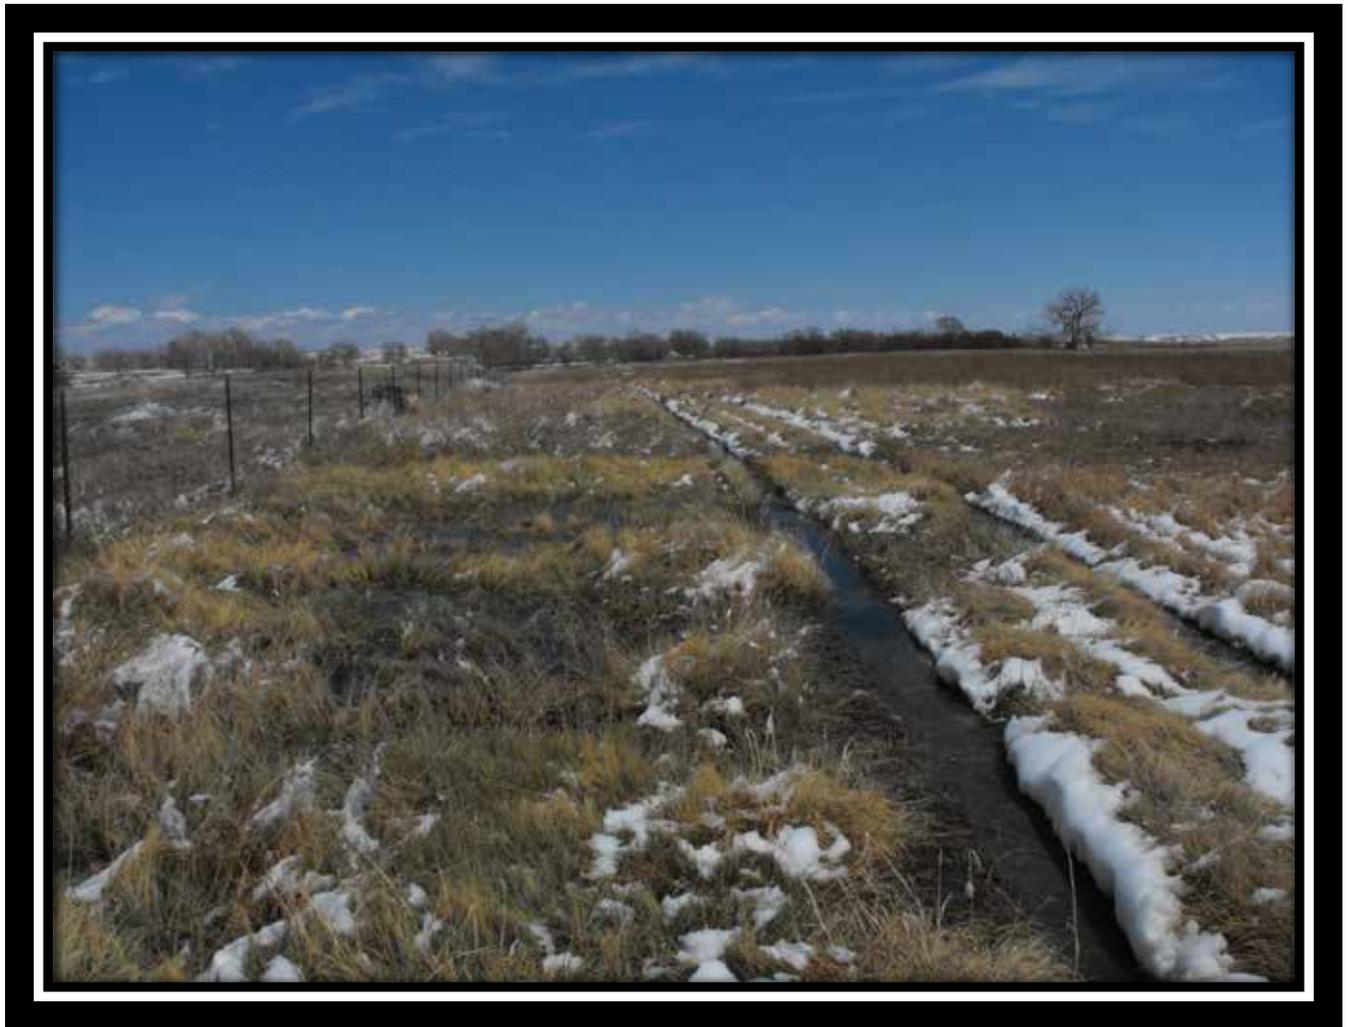
NMED/SWQB
Official Photograph Log
Photo # 5

Photographer: Daniel Valenta	Date: 04-18-2013	Time: 1412 Hours
City/County: Town of Springer / Colfax County		State: New Mexico
Location: Town of Springer Wastewater Treatment Plant		
Subject: Area adjacent to the overflow
