Re: **Major Municipal; SIC 4952; NPDES Compliance Evaluation Inspection; Dona Ana County  
South Central Treatment Plant; NM0030490; February 28, 2013**

### NPDES Compliance Inspection Report

**County of Doña Ana**  
**South Central Regional Wastewater Treatment Facility**  
**Compliance Evaluation Inspection**  
**NPDES Permit No. NM0030490**  
**February 28, 2013**

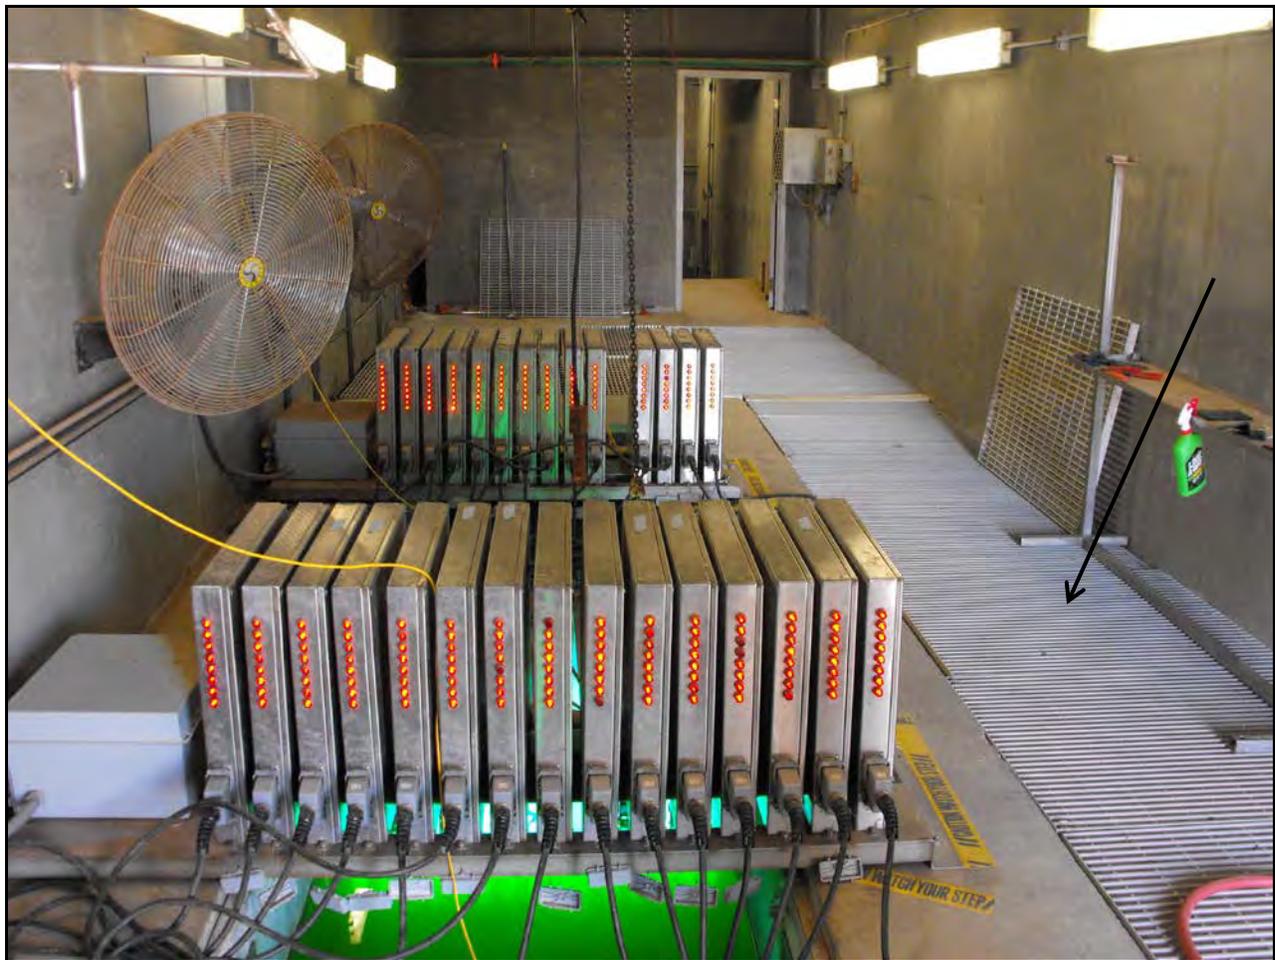
Photo # 1

On the day of the inspection the flume secondary instrument did not read zero when no water was discharging (see photo 1-3). When water is running through the flume the meter appears to read correctly however the meter did not read zero when there is zero flow. Fans are used on site to cool the UV meters, when this air flow is across the flume meter a false positive is recorded. When the fans were turned off the meter reading began to drop. It is unknown if this false positive exceeded the 10% accuracy rule. It is suggested the fans should be redirected or a barrier installed to correct the problem.

Photographer: Daniel Valenta	Date: 2/28/2013	Time: 1009 hours
City/County: Three miles south east of La Mesa /Dona Ana		
Location: Dona Ana County WWTP, UV treatment room, New Mexico 32.09031, -106.65994		
Subject: Effluent flows through the UV chamber and around to the flume, fans keep the UV system cool however the draft interferes with the flow meter.

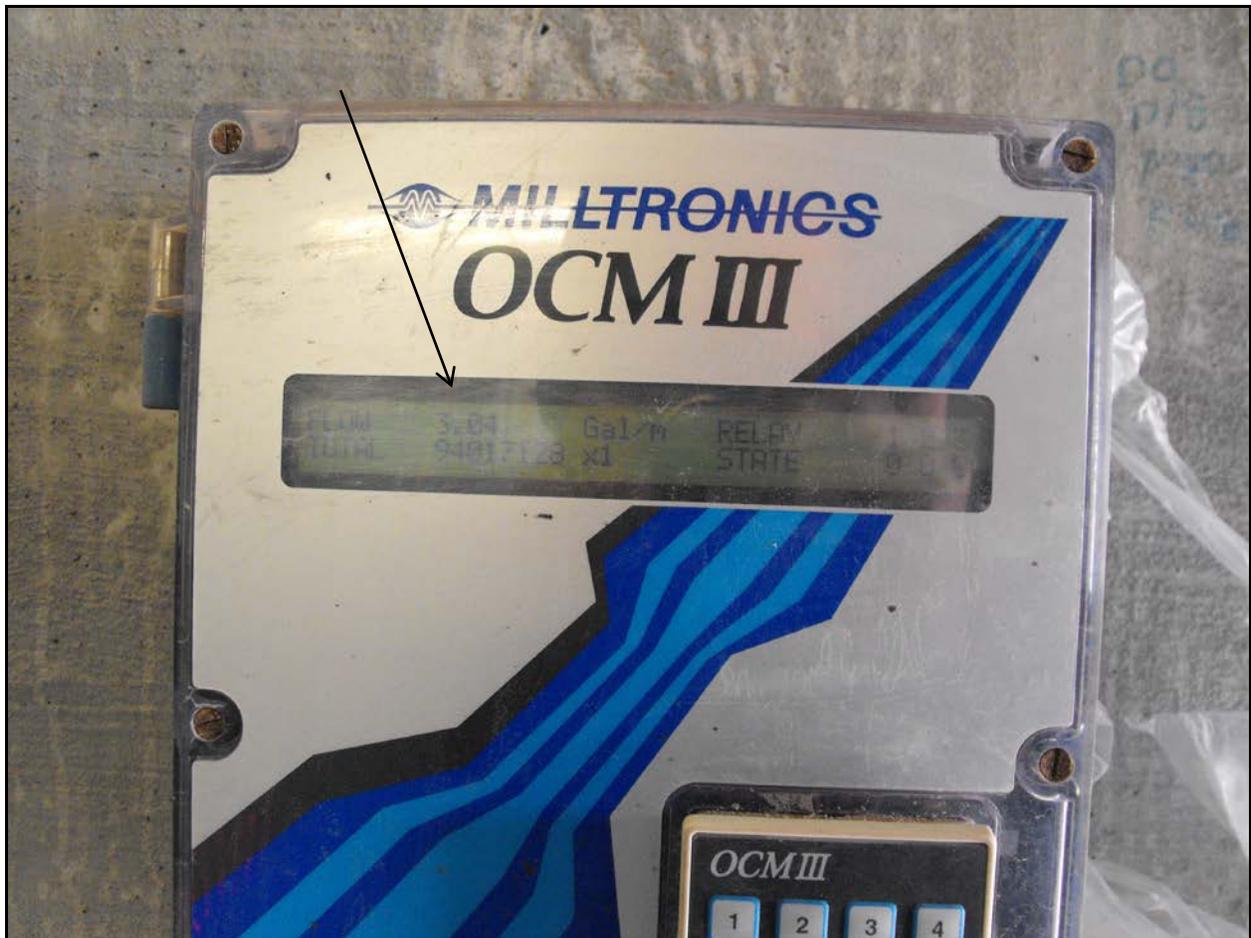
Photo # 2

Photographer: Daniel Valenta	Date: 2/28/2013	Time: 1014 hours
City/County: Three miles south east of La Mesa /Dona Ana		
Location: Dona Ana County WWTP, UV treatment room, New Mexico 32.09031, -106.65994		
Subject: Ultrasonic level transducer meter records flow when no discharge present

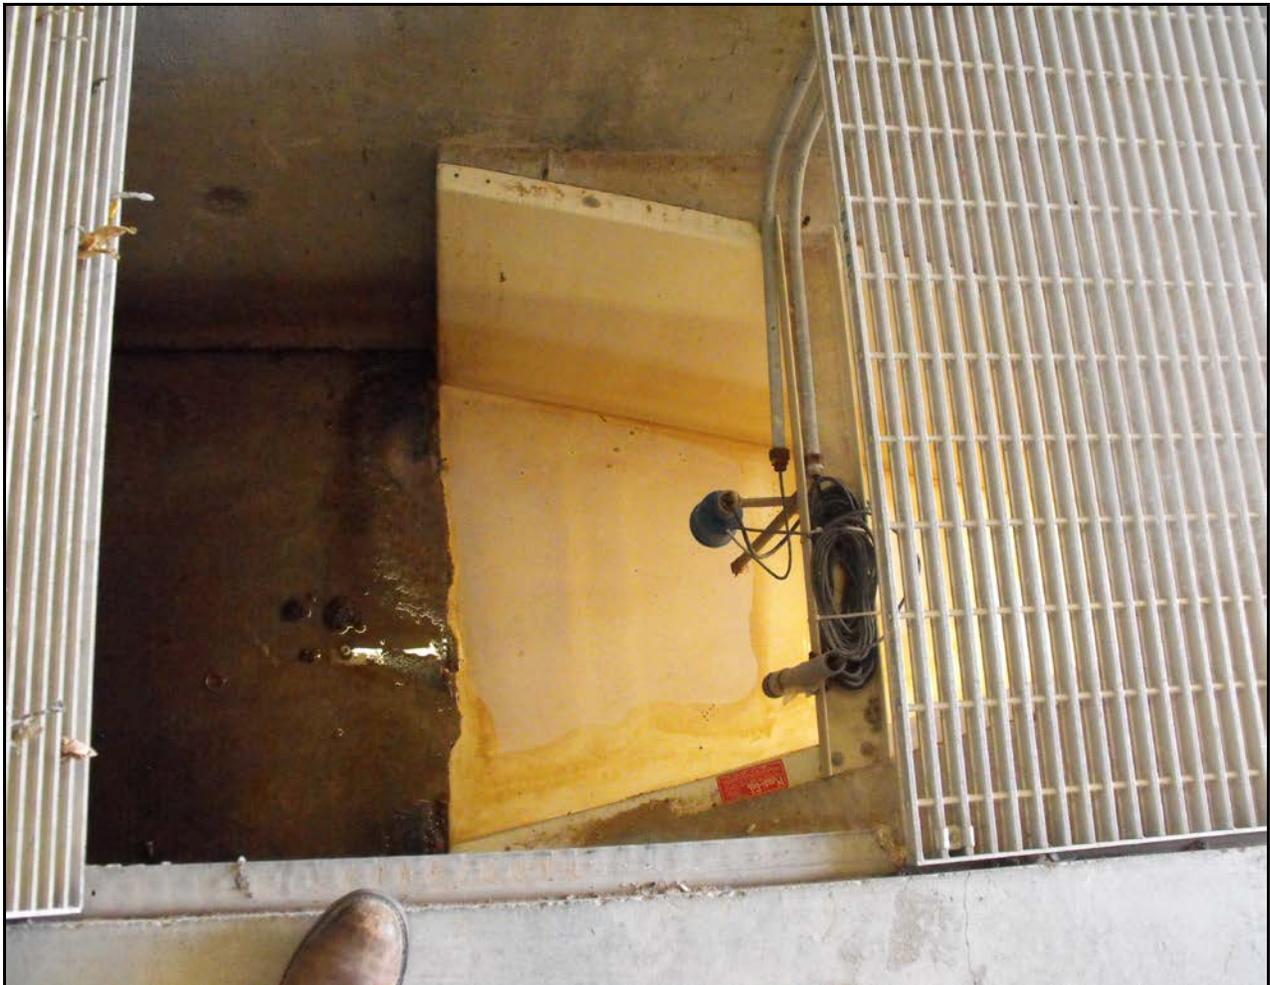
Photo # 3

Photographer: Daniel Valenta	Date: 2/28/2013	Time: 1012 hours
City/County: Three miles south east of La Mesa /Dona Ana		
Location: Dona Ana County WWTP, UV treatment room, New Mexico 32.09031, -106.65994		
Subject: Ultrasonic level transducer meter records flow when no discharge present
