Re: Major-Municipal, SIC 4952, NPDES Compliance Evaluation Inspection, City of Las Cruces, East Mesa Water Reclamation Facility, NM0030872, Doña Ana County, New Mexico, July 7, 2010

NPDES Compliance Inspection Report

**Compliance Evaluation Inspection
City of Las Cruces, East Mesa Water Reclamation Facility
NPDES Permit Number NM0030872
April 6, 2011**

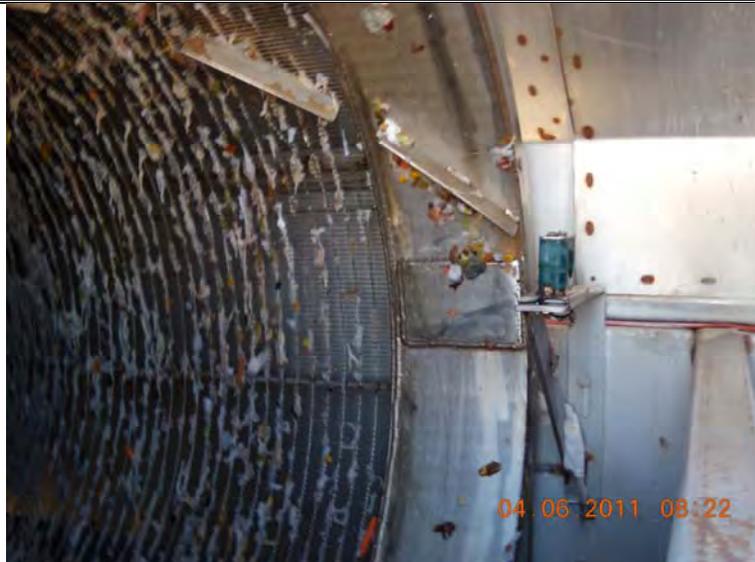
NMED/SWQB
Official Photograph Log
Photo # 1

The fine screen drum filter at the head of the WWTP appears to be shredding some of the solids entering the plant, causing some fine floatable solids to travel through. This increases the amount of floating solids that have to be hand scraped/netted.

Subject: Influent Filter Screen – Operators noted a problem with fine screen causing shredding and allowing small floatable solids to enter the main treatment works.

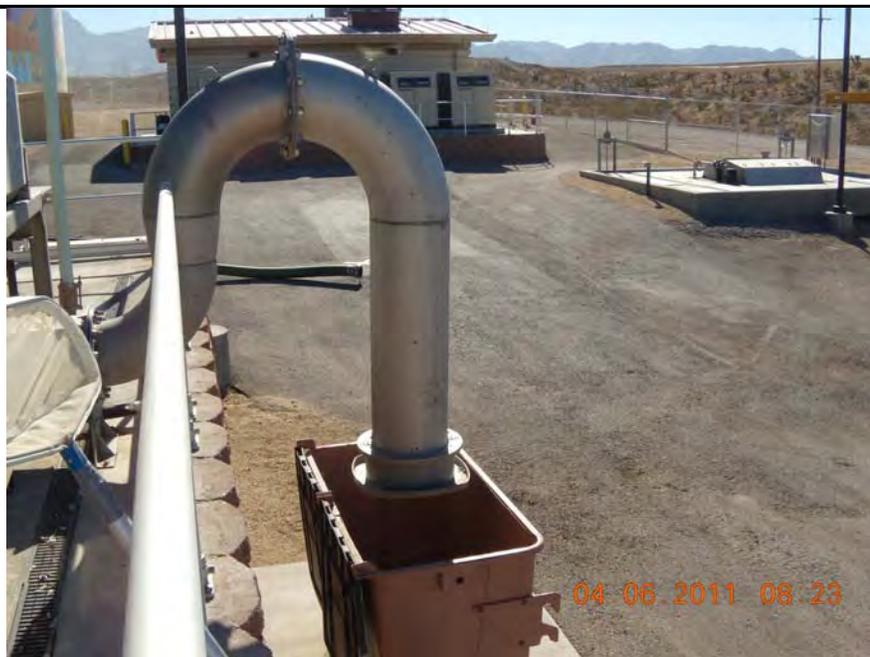
NMED/SWQB
Official Photograph Log
Photo # 2

Subject: Screenings from head works into the hopper. Final disposal at the Land fill.

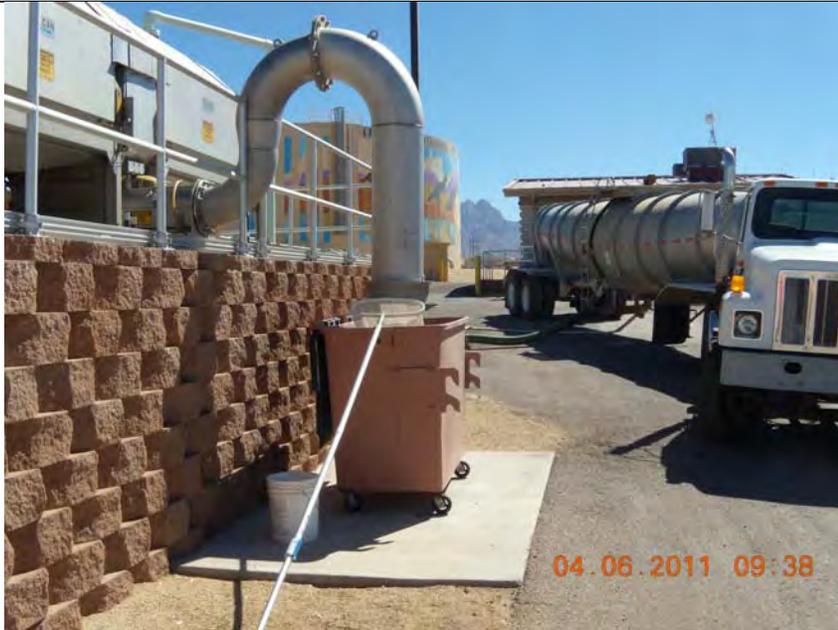
NMED/SWQB
Official Photograph Log
Photo # 3

Subject: Second photo of the Screenings from head works into hopper. Also note the net used to screen off floating solids from the final clarifier.

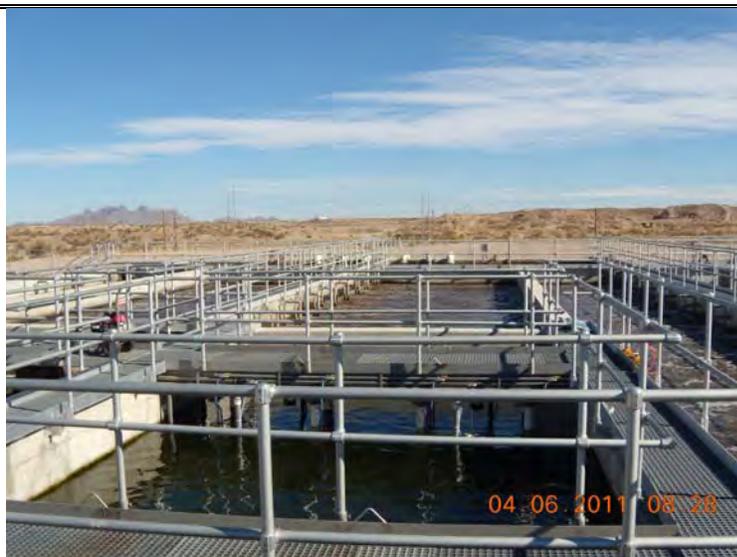
NMED/SWQB
Official Photograph Log
Photo #4

Subject: WWTP final clarifier in foreground.

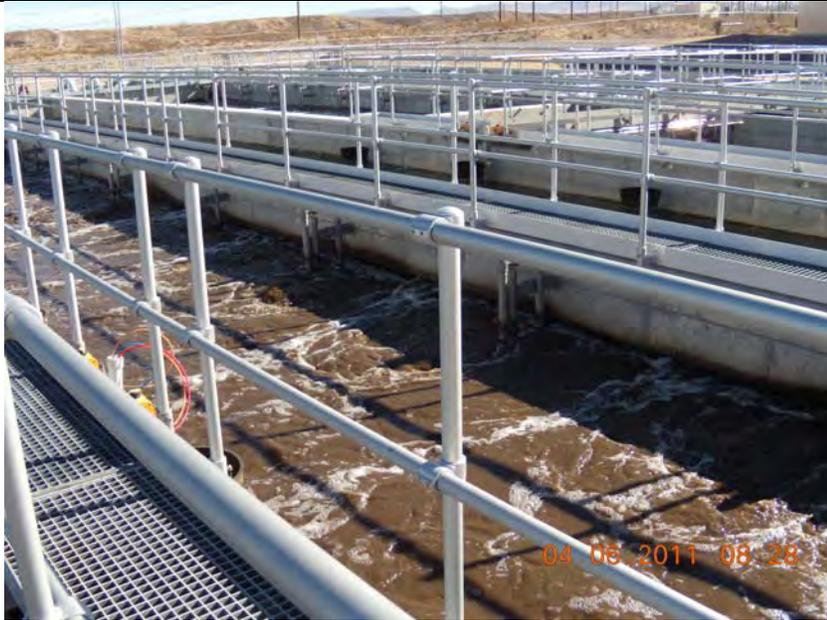
NMED/SWQB
Official Photograph Log
Photo #5

Subject: Stage one basin.

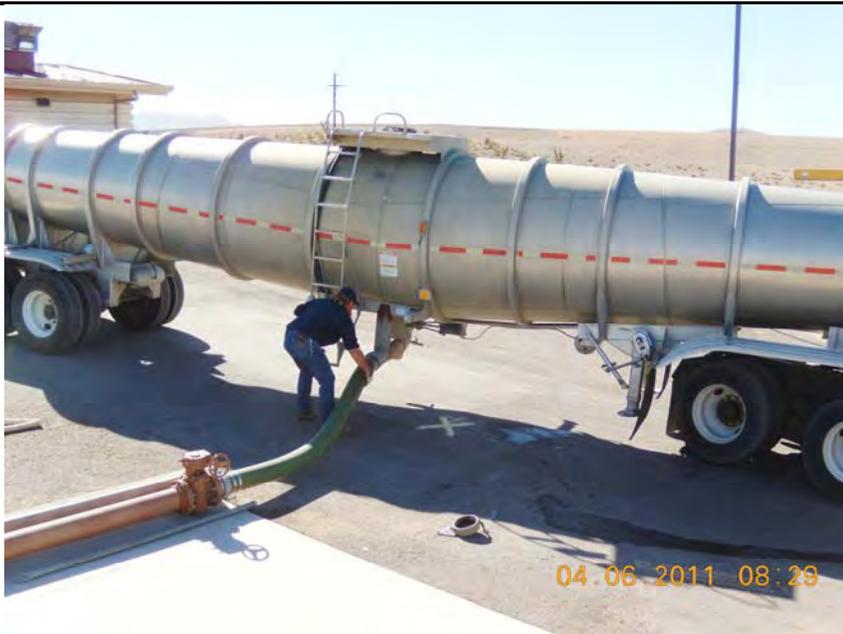
NMED/SWQB
Official Photograph Log
Photo # 6

Subject: Solids being wasted from the digester will be hauled to the Jacob Hand WWTP for processing.

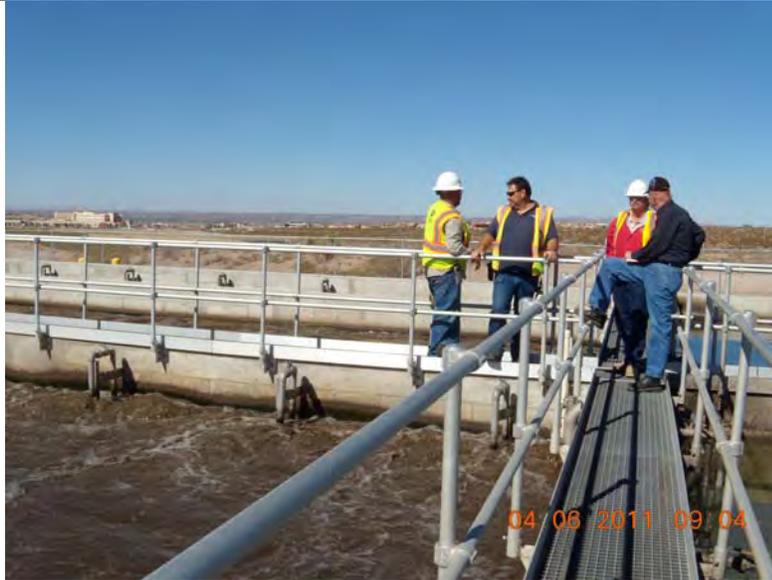
NMED/SWQB
Official Photograph Log
Photo # 7

Subject: First Basin in the second stage treatment process. Note the rich brown color indicating health bacterial growth for the activated sludge treatment process.

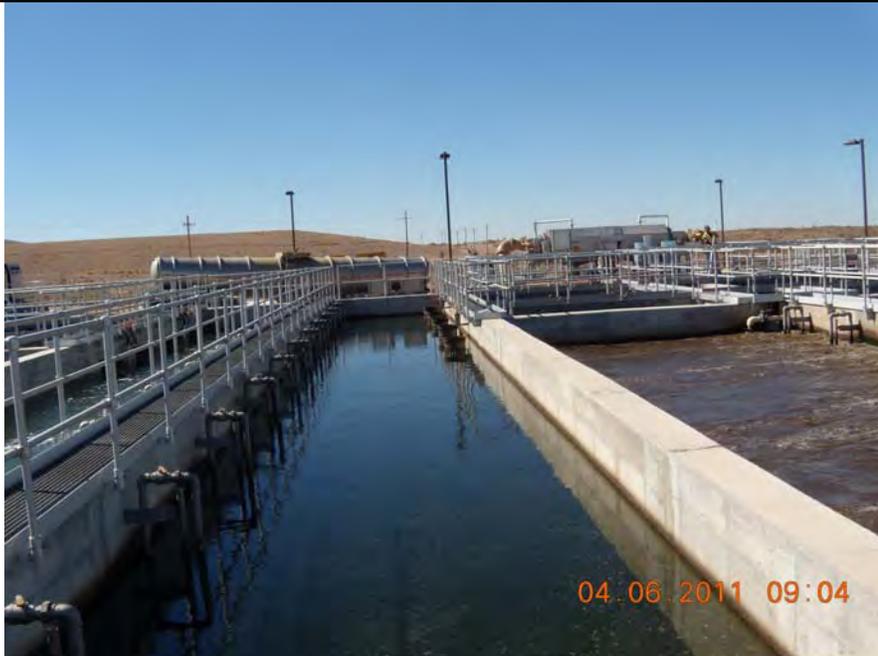
NMED/SWQB
Official Photograph Log
Photo # 8

Subject: Treatment works – the east train w/ treated water – not in use.

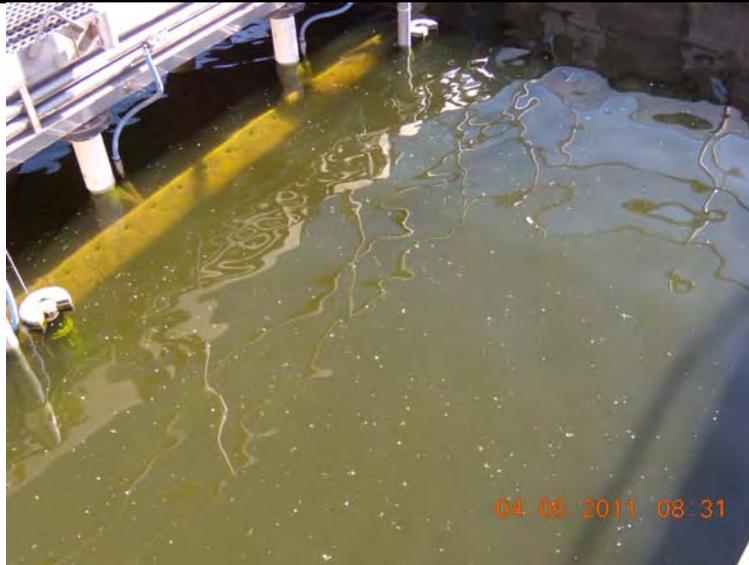
NMED/SWQB
Official Photograph Log
Photo #9

Some floating grease was observed in the final clarifier and was being skimmed off by hand and the auto skimmers. As the influent to the plant increases the City of Las Cruces may consider review it’s grease ordinances to minimize that coming into the WWTP.

Subject: Final Clarifier with surface skimmers and note the floating solids and grease. The floating solids are in part due to the shredding effect of the influent drum filter shredding solids.

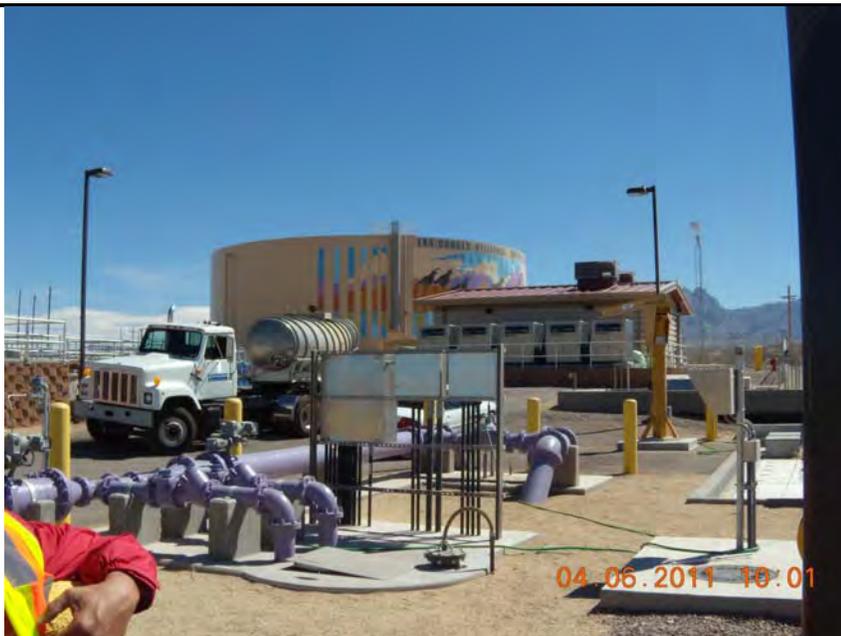
NMED/SWQB
Official Photograph Log
Photo # 10

Subject: Storage Tank in background 2 million gallon capacity, for reuse. Right side of photo is location of the covered UV disinfection unit. Tanker Truck is collecting solids to be transported to the Jacob Hand WWTP for processing.

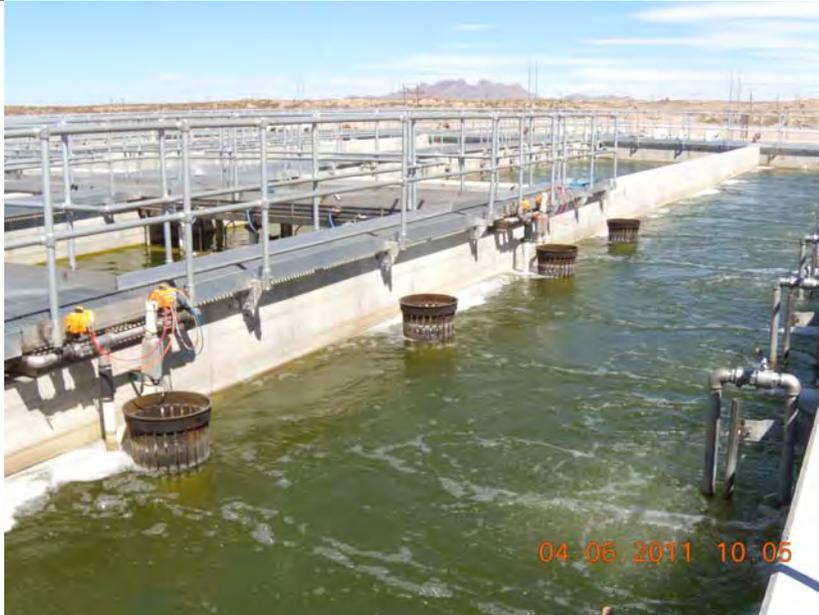
NMED/SWQB
Official Photograph Log
Photo # 11

Subject: East Train – Processed water is kept in the train to protect it from Sun and weather.

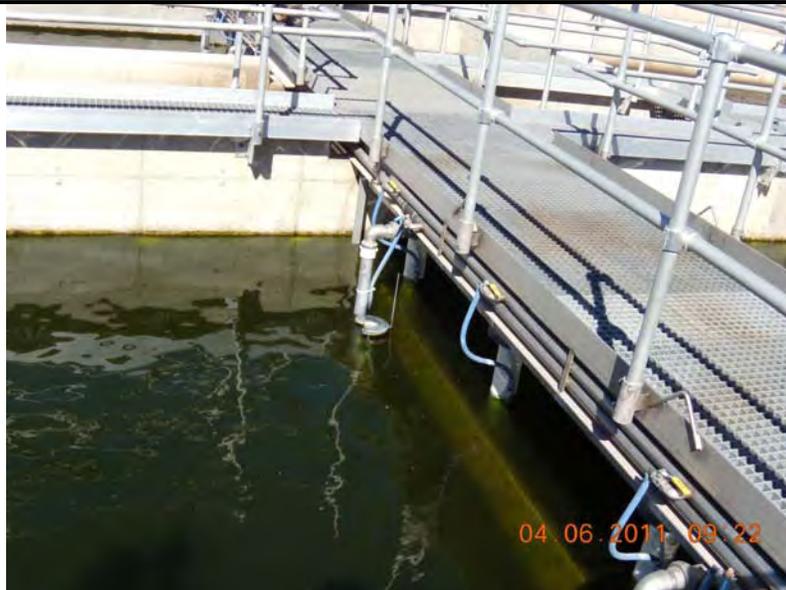
NMED/SWQB
Official Photograph Log
Photo # 12

Subject: Final Clarifier with surface skimmer for floating solids.

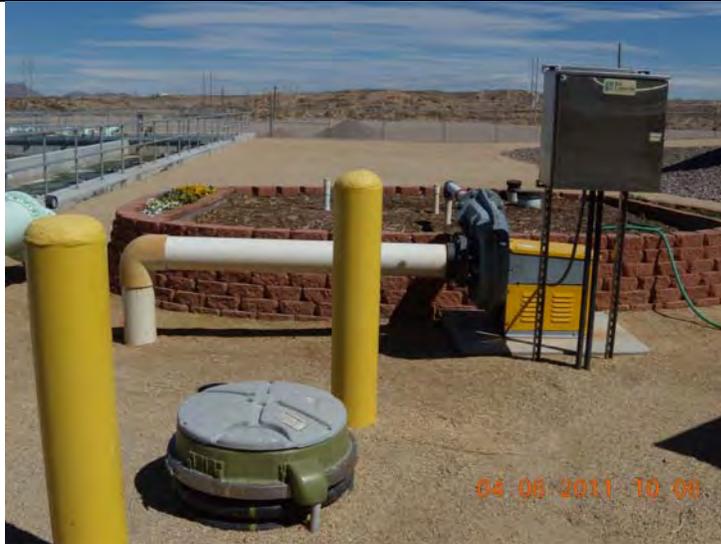
NMED/SWQB
Official Photograph Log
Photo # 13

Air scrubbers using mulch and other organic materials are in place to minimize odors from the treatment works. Air is drawn off the surface of the treatment units and sent through the scrubbers. At the time of the inspection, no noxious odors were observed at the WWTP.

Subject: Top of one of the air scrubbers.
