RE: Minor Non-Municipal, SIC 4941, NPDES Compliance Evaluation Inspection, Navajo Dam DWC&MSW, Inc. /
Water Treatment Plant (WTP), NM0030953, May 15, 2013

NPDES Compliance Inspection Report

Navajo Dam DWC&MSW, Inc. Water Treatment Plant
NPDES Permit No. NM0030953
Compliance Evaluation Inspection
May 15, 2013

Further Explanations

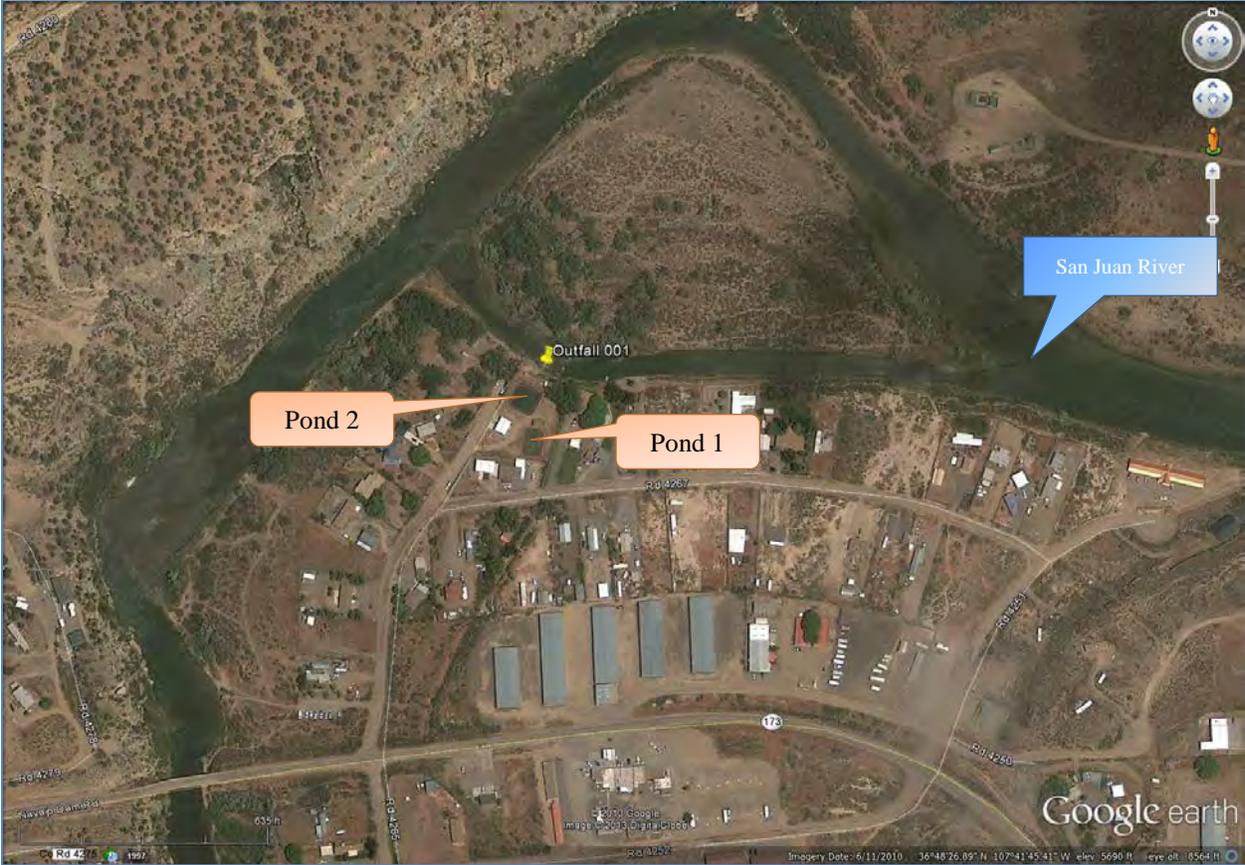
Figure 1: Vicinity Map

Backwash (filter to waste) and rinse water is pumped to a 90,000-gallon earthen bermed backwash pond (pond 1) with High Density Polyethylene Fabrication (HDPE) liner. Overflow from the backwash pond flows to a 200,000-gallon earthen-bermed settling pond (pond 2) with HDPE liner. A floor drain near the flocculation and settling tank inside the treatment plant is connected to a pipe that enters the settling pond. An overflow line (pipe) was installed at the top of the settling pond with an outfall on a braid of the San Juan River (see Figure 1: Vicinity

Map). To allow a discharge at the outfall, the cap of the overflow line pipe would need to be removed by hand. If discharge were to occur, the following discharge flows were estimated on the Navajo Dam DWC&MSW, Inc. 2012 application: maximum daily flow of 4,000 gallons and average daily flow of 3,600 gallons (i.e., 0.004 and 0.0036 million gallons per day (MGD), respectively).

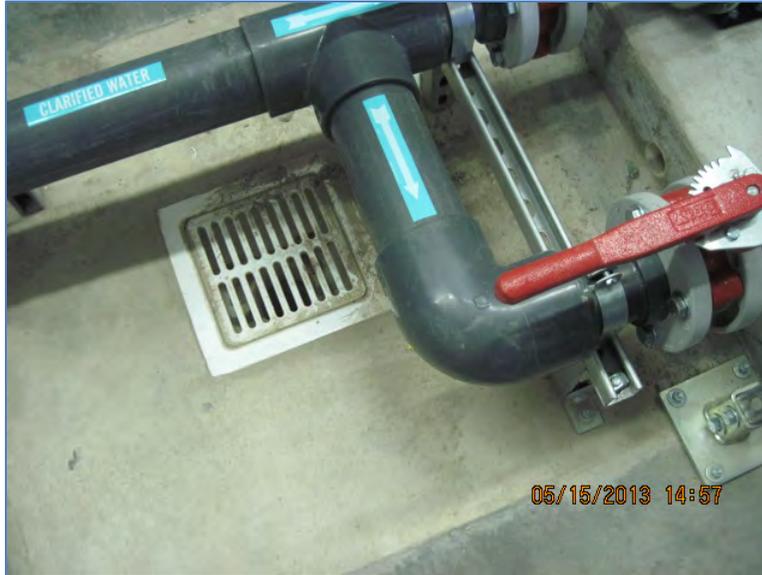
NMED/SWQB
Official Photograph Log
Photo # 1

Photographer: Erin S. Trujillo	Date: 05/15/2013	Time: 1457 hours
City/County: Navajo Dam / San Juan County	State: New Mexico	
Location: Navajo Dam DWC&MSW, Inc. Water Treatment Plant, NM0030953		
Subject: Drain inside treatment plant below tanks valve discharge. According to on-site representatives, drain is connected to pipe that flows to settling basin.

There were no written procedures for emergency treatment control (**this is a repeat finding**), or in this case, reasonable steps to minimize a discharge in the event of high water level conditions, spills within (floor drain) and outside the plant, etc.

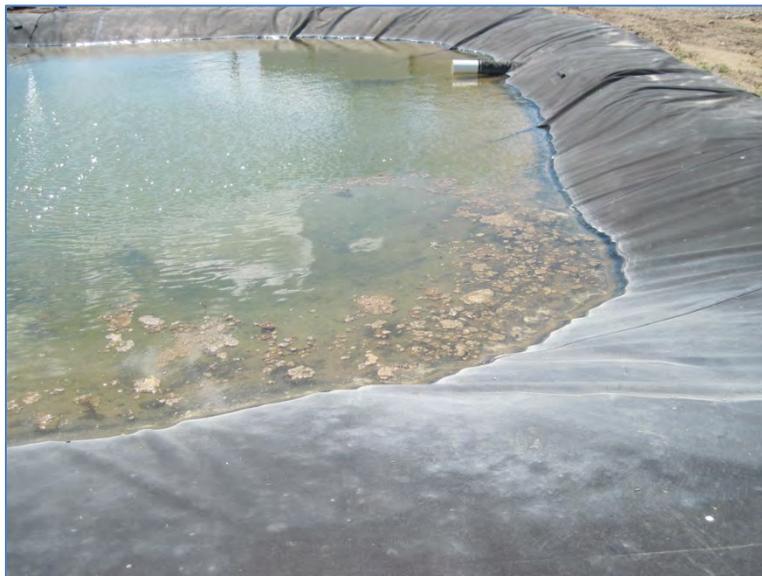
NMED/SWQB
Official Photograph Log
Photo # 2

On the day of this inspection, settled solids had accumulated in the backwash pond reducing the capacity. Floating solids were also observed. According to the on-site representatives, solids from the backwash pond needed to be removed. The pond was last cleaned out in 2009 according to the on-site representatives.

Photographer: Erin S. Trujillo	Date: 05/15/2013	Time: 1528 hours
City/County: Navajo Dam / San Juan County	State: New Mexico	
Location: Navajo Dam DWC&MSW, Inc. Water Treatment Plant, NM0030953		
Subject: Floatable solids and settled solids in backwash basin (pond 1).

Written operation and maintenance procedures and routine inspection logs of the water treatment plant did not include the ponds. Examples of procedures and record keeping include, but are not limited to: pond maintenance schedules, daily or routine pond inspection logs, dates of pond maintenance and repair, proper disposal of removed pond solids.

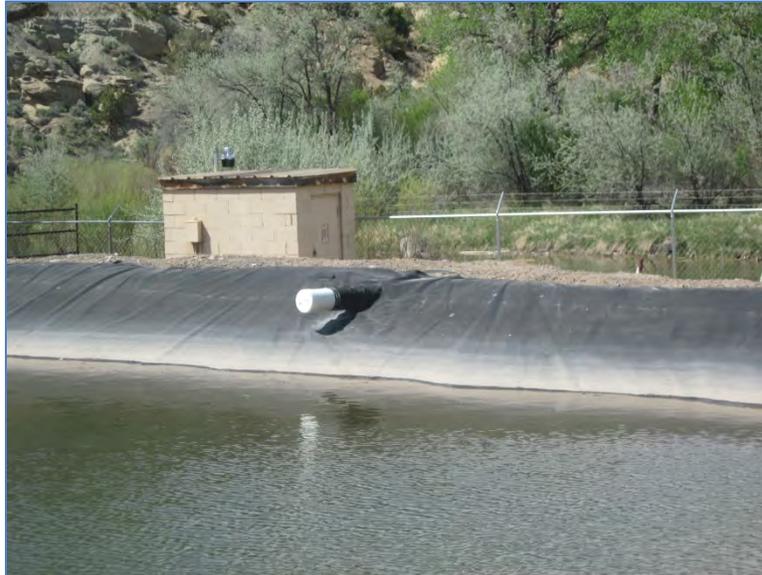
**NMED/SWQB
Official Photograph Log
Photo # 3**

S M U NA (FURTHER EXPLANATION ATTACHED Yes)DETAILS: **Water level in settling basin was below outlet pipe on day of this inspection. Procedures for water treatment system. But, no written procedures for inspections (e.g., routine or daily logs) and maintenance for ponds to avoid discharge.**1. TREATMENT UNITS PROPERLY OPERATED. S M U NA2. TREATMENT UNITS PROPERLY MAINTAINED. **Backwash basin needed to be cleaned of accumulated solids.** S M U NA3. STANDBY POWER OR OTHER EQUIVALENT PROVIDED. **No, but does not appear required for ponds.** S M U NA4. ADEQUATE ALARM SYSTEM FOR POWER OR EQUIPMENT FAILURES AVAILABLE. **SCADA operational** S M U NA5. ALL NEEDED TREATMENT UNITS IN SERVICE S M U NA6. ADEQUATE NUMBER OF QUALIFIED OPERATORS PROVIDED. **Two certified water utility operators** S M U NA7. SPARE PARTS AND SUPPLIES INVENTORY MAINTAINED. S M U NA8. OPERATION AND MAINTENANCE MANUAL AVAILABLE. Y N NASTANDARD OPERATING PROCEDURES AND SCHEDULES ESTABLISHED. **But, no written/routine procedures for ponds.** Y N NAPROCEDURES FOR EMERGENCY TREATMENT CONTROL ESTABLISHED. **MSDSs on site, but no other written procedures.** Y N NA

Photographer: Erin S. Trujillo	Date: 05/15/2013	Time: 1529 hours
City/County: Navajo Dam / San Juan County		State: New Mexico
Location: Navajo Dam DWC&MSW, Inc. Water Treatment Plant, NM0030953		
Subject: Capped outlet pipe in settling basin (pond 2). A dried solid line was observed at the pipe, but there was no evidence of overtopping of the pond.

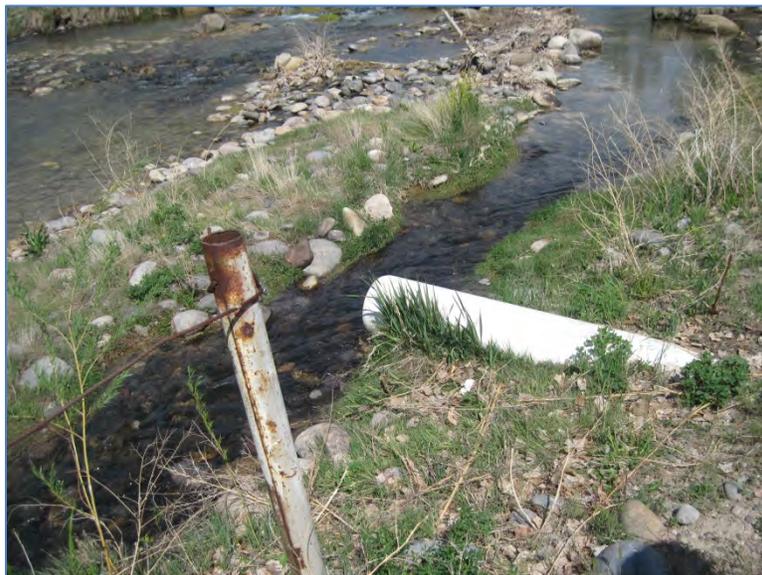
**NMED/SWQB
Official Photograph Log
Photo # 4**

Photographer: Erin S. Trujillo	Date: 05/15/2013	Time: 1539 hours
City/County: Navajo Dam / San Juan County		State: New Mexico
Location: Navajo Dam DWC&MSW, Inc. Water Treatment Plant, NM0030953		
Subject: Outfall 001. No discharge.
