**Re: Minor Municipal; SIC 4952; NPDES Compliance Evaluation Inspection; Village of Cimarron
Wastewater Treatment Plant; NM0031038; August 23, 2011**

Village of Cimarron Wastewater Treatment Plant
NPDES Permit NM0031038
Compliance Evaluation Inspection
August 23, 2011
Page 1 of 7

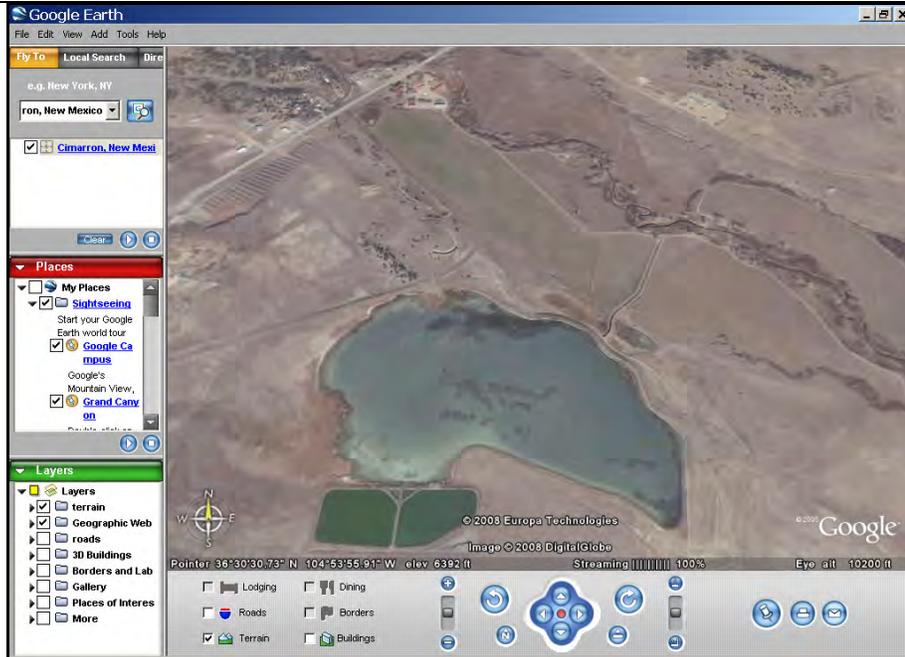
**NMED/SWQB
Official Photograph Log
Photo # 1**

Photographer: Google Earth	Date: 2008	Time: unknown
City/County: Cimarron / Colfax		State: New Mexico
Location: Cimarron Wastewater Treatment Plant at French Lake		
Subject: Aerial Photo of WWTP

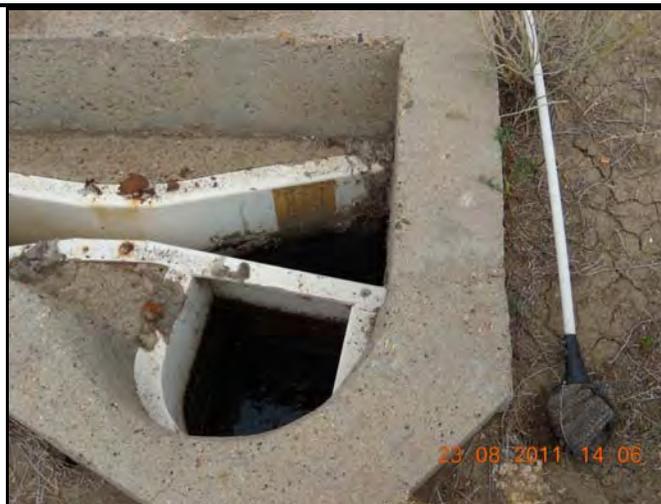
**NMED/SWQB
Official Photograph Log
Photo # 2**

The influent staff gauge and Parshall Flume were heavily coated with dried debris. The staff gauge was unreadable. Operators indicated that a wooden stick, without any measurement markers was used to estimate the depth of the influent flow.

Photographer: B. Cooney	Date: 2011 Aug 23	Time: 14:06 hours
City/County: Cimarron / Colfax		State: New Mexico
Location: Cimarron WWTP		
Subject: Parshall Flume at head works with an approximately 3" throat width. Note the debris along the side wall is so built up that the staff gauge cannot be read. The operator uses a wooden stick he places in the bottom of the flume to guess the depth of the influent. He then extrapolates the flow rate.

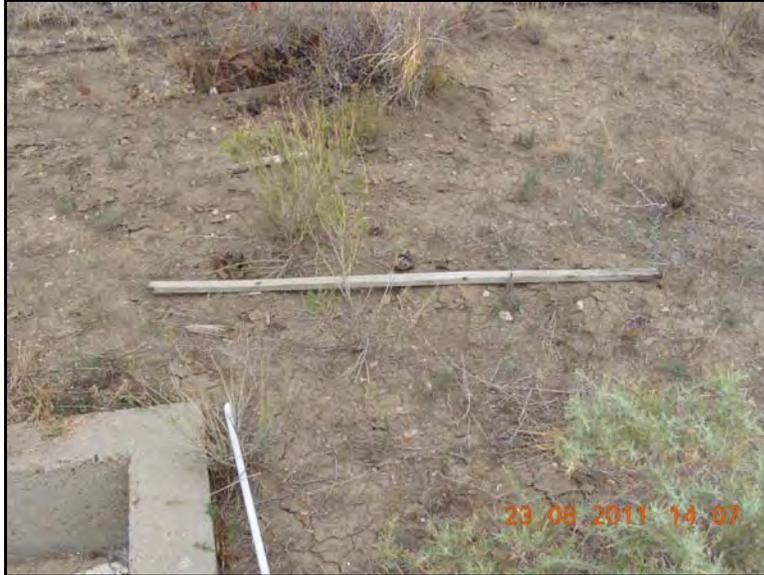
NMED/SWQB
Official Photograph Log
Photo #3

Subject: Stick used by operators to measure depth of flow though the Parshall flume.

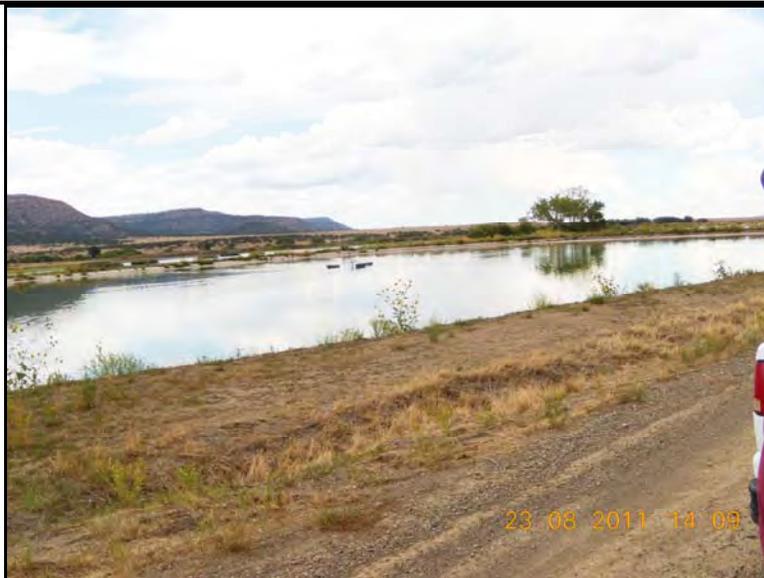
NMED/SWQB
Official Photograph Log
Photo #4

Subject: West Lagoon from the influent Parshall flume. The outfall where flow from both lagoons is combined and discharge to French Lake is on the far side of the lagoon near the tree seen on the horizon. A Solar Bee mixer is in the center of the lagoon.

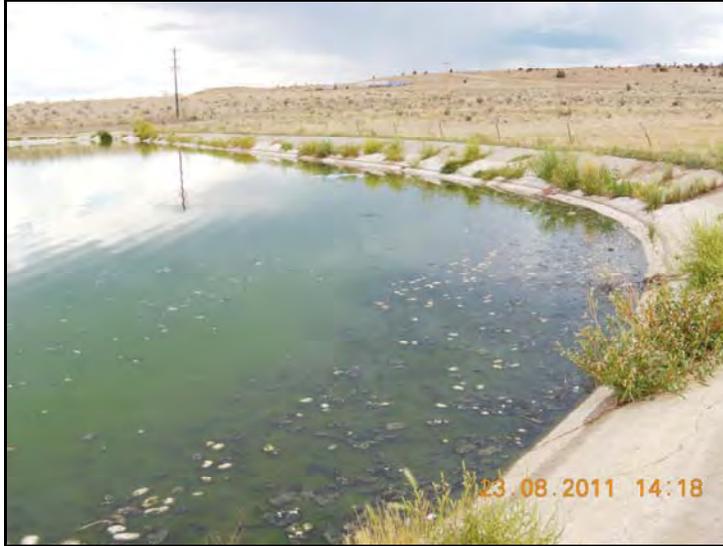
NMED/SWQB
Official Photograph Log
Photo # 5

1) The lagoons are heavily loaded with solids. It appears that solids have never been wasted from this facility. There is very little capacity left in the lagoons because of the extreme solids build up. According to facility representatives, to remove solids and transport them to another facility for processing will cost over \$100,000.00. There are no sludge drying beds at this location.

2) Weeds were growing in the lagoons through the cracks in the cement liners.

Subject: Lagoon is heavily loaded with solids. Note the solids build up in the corner of the lagoon. The cement liner of the lagoon is cracked and leaking. Note the vegetation growing through the cracks of the lagoon.

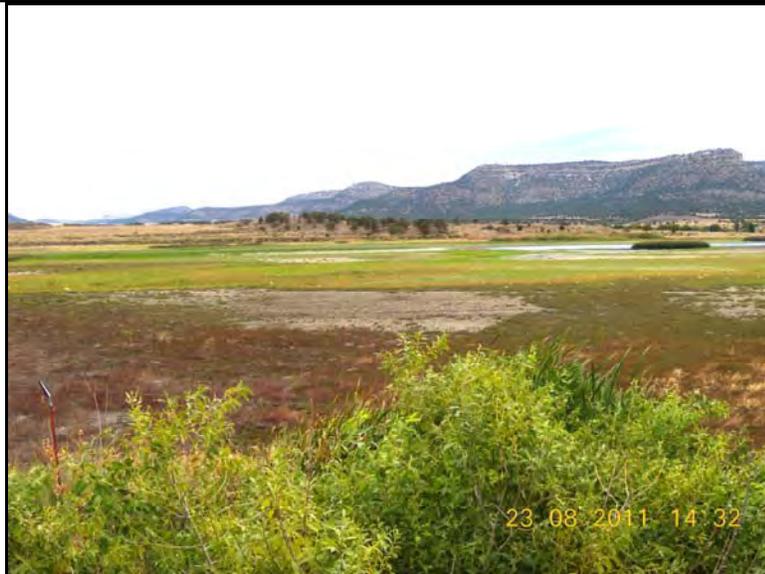
NMED/SWQB
Official Photograph Log
Photo # 6

RECEIVING WATER OBSERVATIONS
 There was no discharge at the time of this inspection. The berms of the lagoons appeared to be leaking or otherwise discharging at the outfall in the recent past, due to the very heavy vegetative growth of wetlands type plants (including cattails) at the outfall.

Observations made at the WWTP by the inspector indicate that discharges have in fact occurred contrary to statement made by facility representatives. Those observations included the low water level of the lagoons, with approximately six feet of free board observed during the inspection. When NMED made observations of the lagoons prior to the effective date of the permit in 2009, only 2 feet of freeboard in the lagoons was evident. This claim by facility representatives would necessitate an evaporative rate far in excess of that normally found in other parts of the state of New Mexico during the same period, as observed by this inspector. Additionally, the outfall location had very heavy growth of wetlands types of plants that were not present anywhere else along the bottom of the berm of the WWTP. These wetland plants include cattails and reeds. The inspector notes that vegetation was growing on the other portions of the berms but not wetland type species. The inspector also notes that no discharge was occurring at the time of the inspection.

Subject: The outfall from the lagoons to French lake. Note the heavy vegetation including riparian plants such as the cattails. Operators state that no discharge has occurred since before October 2009, yet the growth of wetlands plants at the outfall do not support those statements. French lake in the background is being drained for summer irrigation by Vermejo Ranch. During non-irrigation season, the lake extends nearly as close as the outfall from the lagoons. Along the entire outside of the lagoon dikes vegetation was present, the only location where cattails and other wetlands vegetation were observed was at the outfall location.

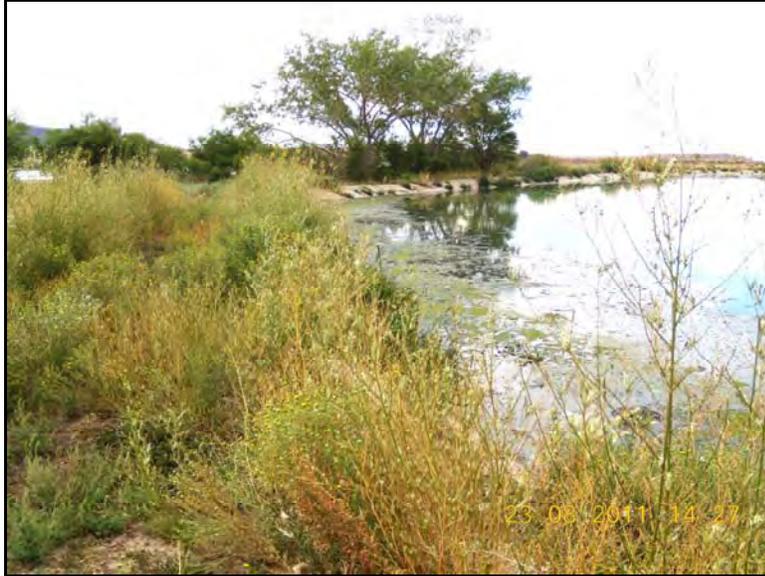
NMED/SWQB
Official Photograph Log
Photo # 7

3) Rodents have burrows along the berms of the lagoons weakening the structures.

Subject: Lagoon dikes and berms have heavy vegetative growth, indicating leaking. Also heavy rodent activity was noted along the lagoon berms also causing break down and adding to the potential for seepage from the lagoons. - The outfall to French lake is near the tree in the background.

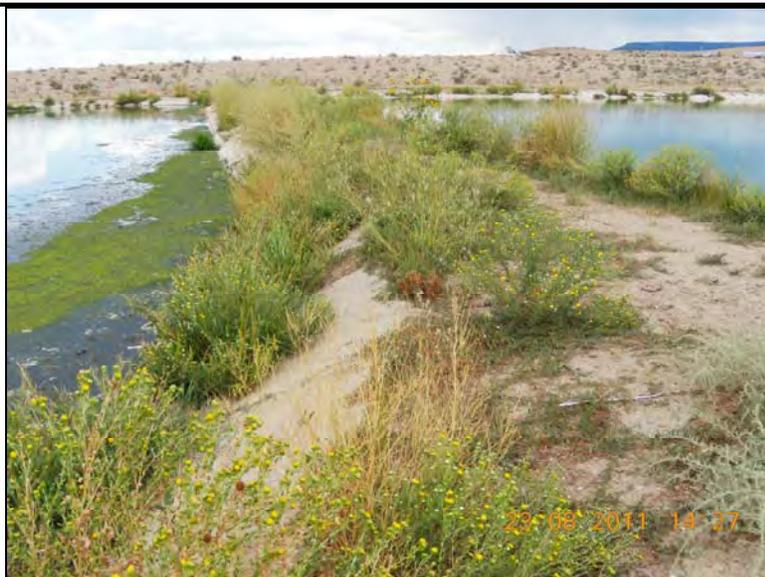
NMED/SWQB
Official Photograph Log
Photo # 8

Subject: The berm between the East and West Lagoons is overgrown with vegetation. Also note the duckweed growing and the solids in the lagoon on the left.

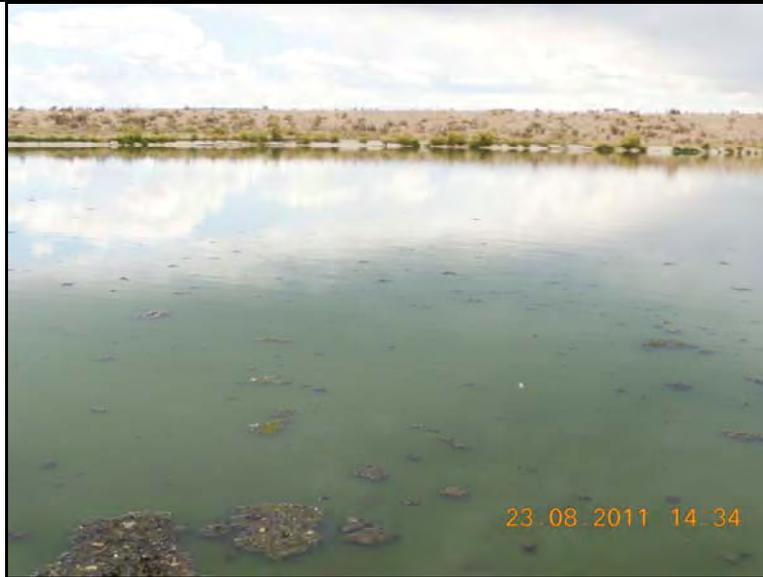
NMED/SWQB
Official Photograph Log
Photo #9

The lagoons are heavily loaded with solids. It appears that solids have never been wasted from this facility. There is very little capacity left in the lagoons because of the extreme solids build up. According to facility representatives, to remove solids and transport them to another facility for processing will cost over \$100,000.00. There are no sludge drying beds at this location.

Subject: Solids and septic conditions in the East Lagoon.

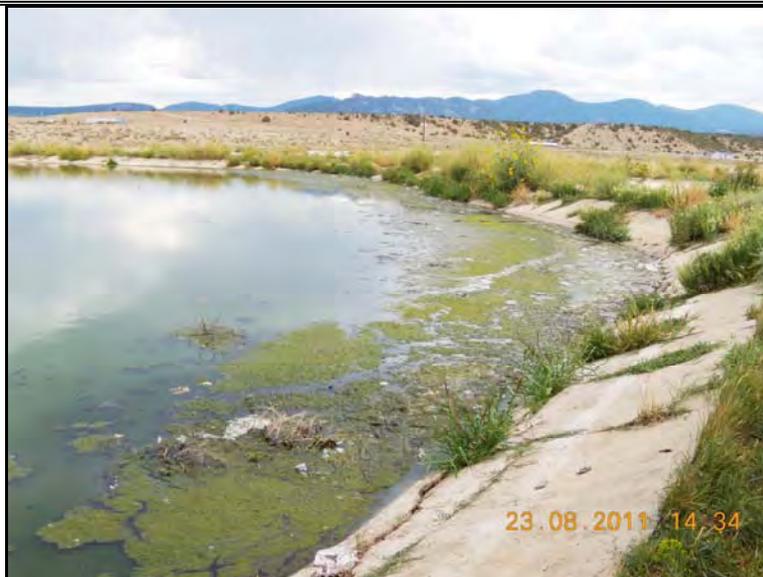
NMED/SWQB
Official Photograph Log
Photo #10

Subject: WWTP lagoons with excessive solids and plants growing in the cement liner of the lagoon.

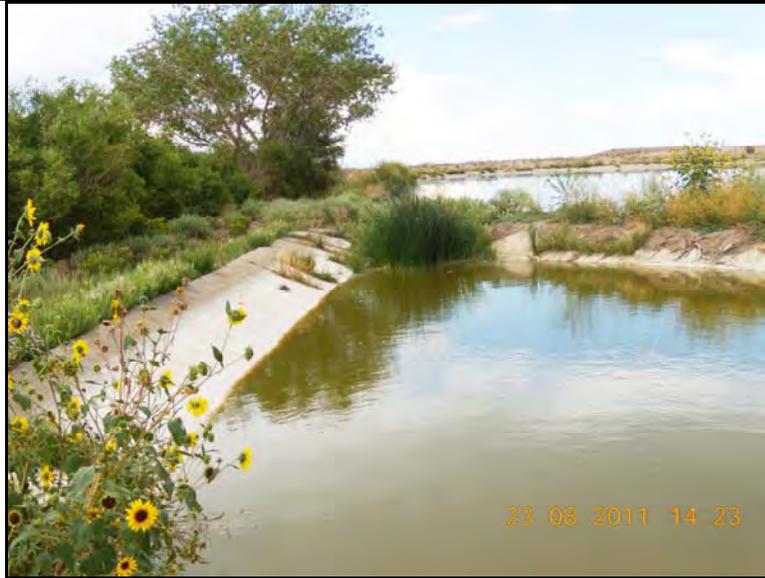
NMED/SWQB
Official Photograph Log
Photo #11

Subject: Sand filter, not maintained - plants growing - also, sandfilter has water indicating that lagoons had at some time been drained though the sand filter for discharge to French Lake.
