Re: Minor Industrial, SIC 4971, NPDES Compliance Evaluation Inspection, Mora Independent School District Athletic Field, NM0031097, July 2, 2013

NPDES Compliance Inspection Report

Compliance Evaluation Inspection
Mora Independent School District Athletic Field Project
NPDES Permit No. NM0031097
July 2, 2013

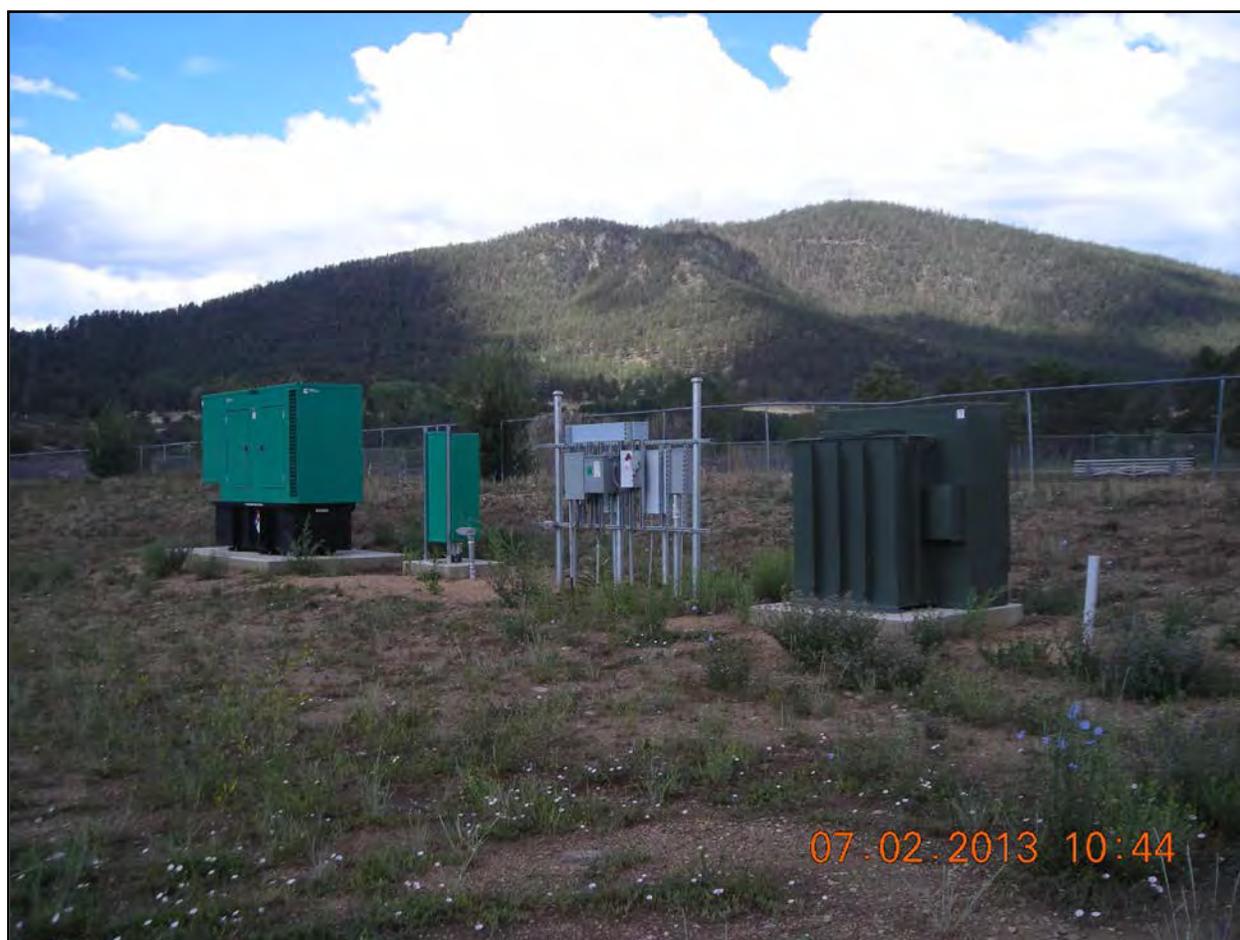
Photo # 1

Photographer: Sarah Holcomb	Date: 7-2-2013	Time: 1044 hours
City/County: Mora, Mora County		
Location: Mora Independent School District, High School Athletic Field		
Subject: Backup generator and one of three pumps to dewater the field.

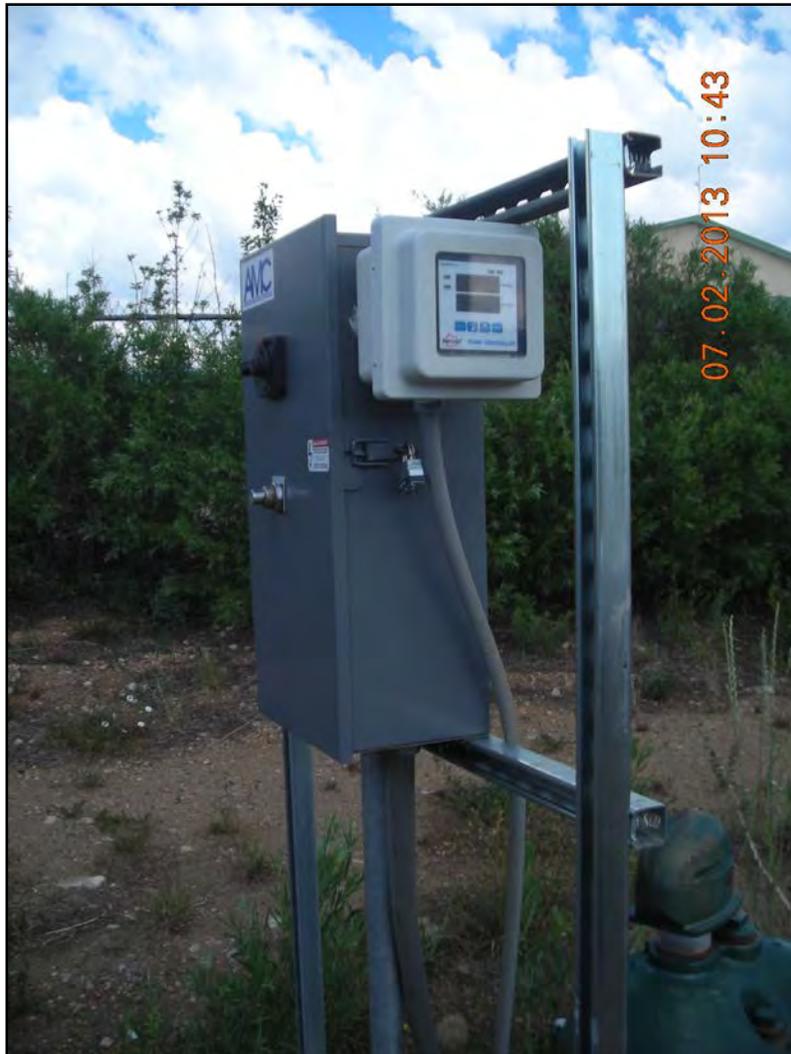
Photo # 2

Photographer: Sarah Holcomb	Date: 7-2-2013	Time: 1043 hours
City/County: Mora, Mora County		
Location: Mora Independent School District, High School Athletic Field		
Subject: Close up view of pump system. The same system is replicated three times for this facility. The pump controller starts pumping groundwater when it reaches a depth of 21 feet from the surface.

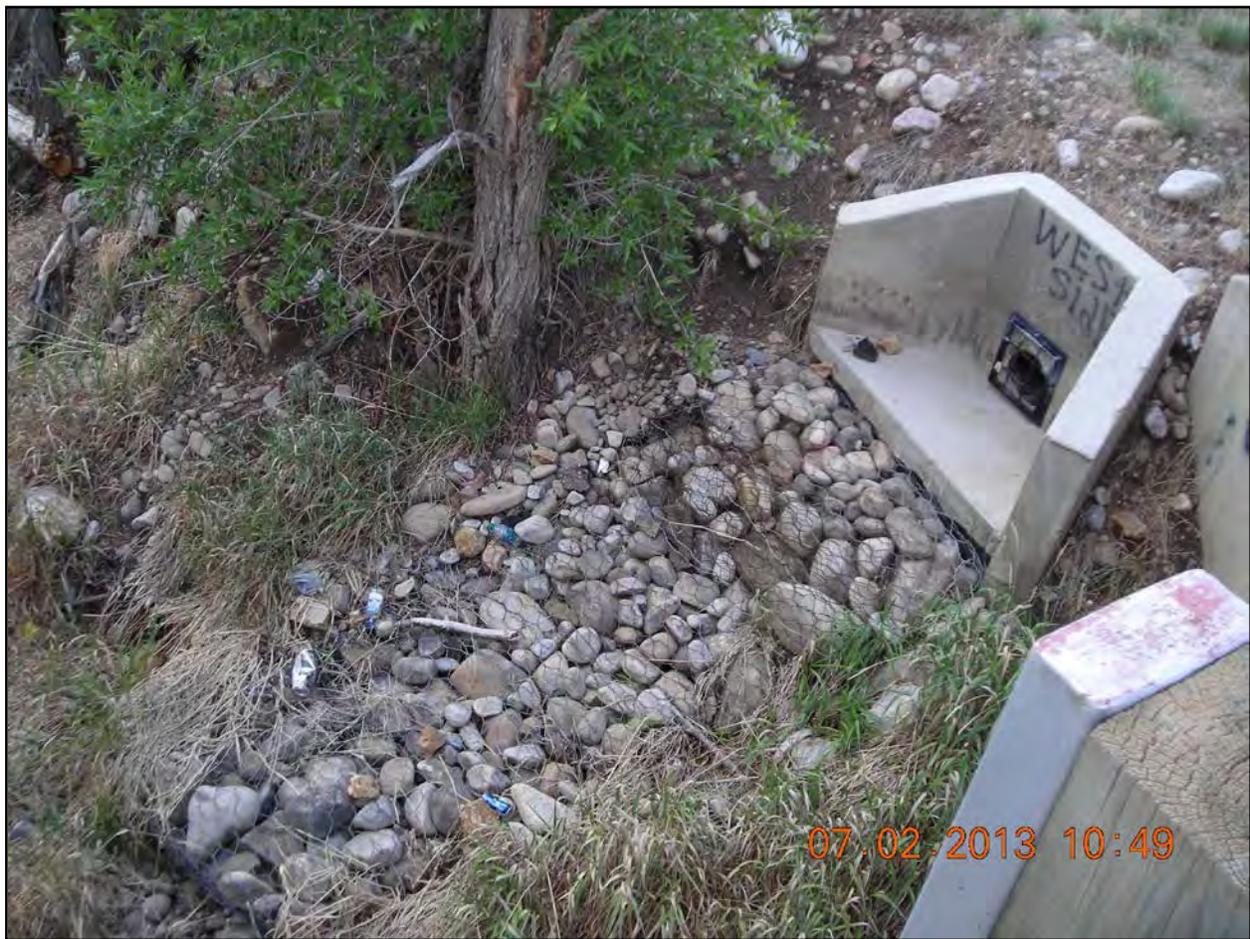
Photo # 3

Photographer: Sarah Holcomb	Date: 7-2-2013	Time: 1049 hours
City/County: Mora, Mora County		
Location: Mora Independent School District, High School Athletic Field		
Subject: Outfall to the Mora River, which was dry at the time of this inspection.

According to the permittee's representatives, there has been no discharge from this facility since the permit was issued in September 2012. The only discharge occurred in May and June 2012, prior to coverage under the NPDES permit. The permittee must take care to ensure that the proper procedures are in place to adequately sample and evaluate the discharge as per the permit terms prior to the next discharge occurring.
