RE: Industrial Storm Water, SIC 1479, NPDES Compliance Evaluation Inspection, St. Cloud Mining Company / St. Cloud Zeolite Operation-Winston Mill Site, NMR05GA97, April 26, 2012

NPDES Compliance Inspection Report

NPDES Industrial Storm Water Checklist (MSGP)

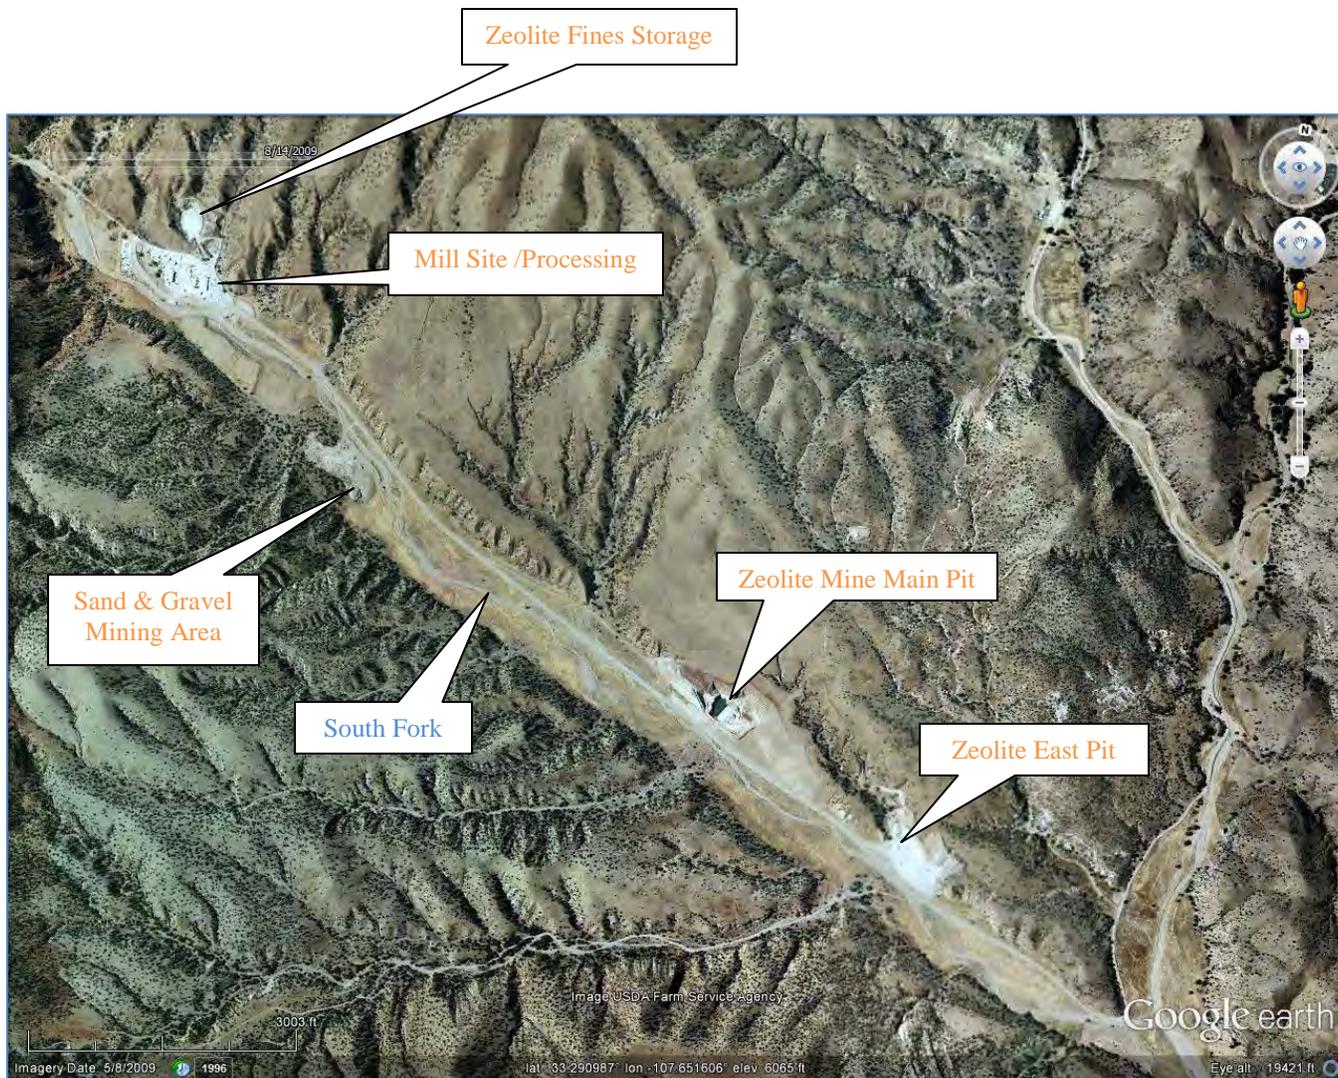
Figure 1: Aerial Photograph imagery dated 05/08/2009

The mill site and zeolite mine main pit is shown on aerial photograph imagery dated 10/08/1996. A dike along South Fork west of the mill site is visible on imagery dated 05/08/2009. This dike is not identified on the site map and was not listed on inspection forms. Disturbance for the zeolite east pit and sand and gravel area is visible on imagery dated 05/08/2009 (see Figures 1 and 2).

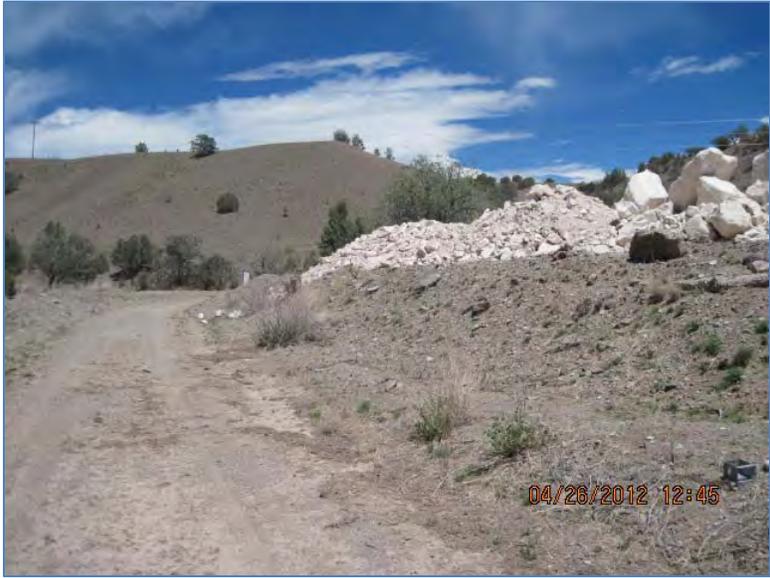
NMED/SWQB Official Photograph Log Photo # 1		
Photographer: Erin S. Trujillo	Date: 04/26/2012	Time: 1245 hours
City/County: South of Winston / Sierra County		State: New Mexico
Location: St. Cloud Zeolite Operation, Winston Mill Site, NMR05GA97		
Subject: Zeolite was outside containment dike at control measure labeled Z-1 on site map. Road continues to low water crossing at South Fork Cuchillo Negro Creek (South Fork).

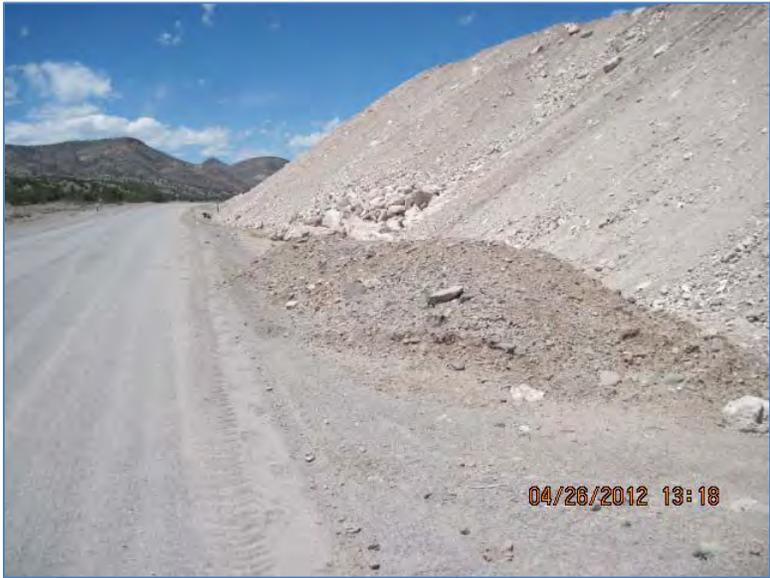
NMED/SWQB Official Photograph Log Photo # 2		
Photographer: Erin S. Trujillo	Date: 04/26/2012	Time: 1318 hours
City/County: South of Winston / Sierra County		State: New Mexico
Location: St. Cloud Zeolite Operation, Winston Mill Site, NMR05GA97		
Subject: Overburden material from zeolite mining covered containment dike measure labeled Y-1 on site map.

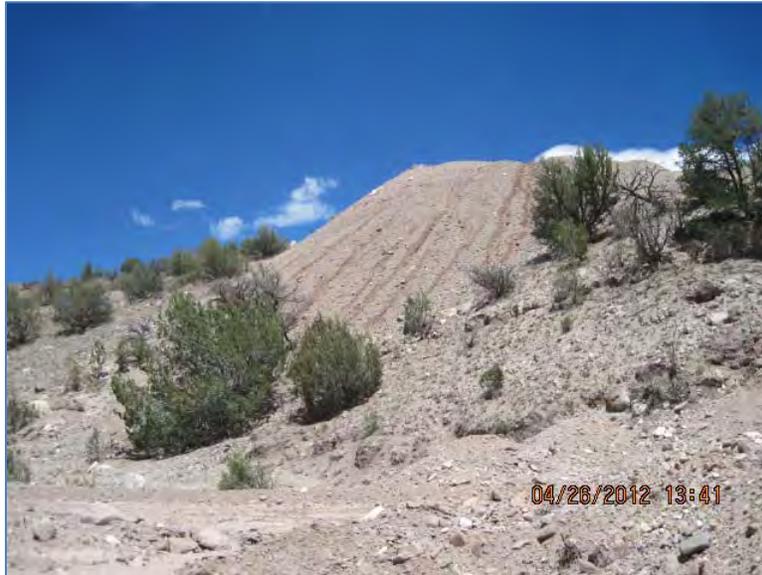
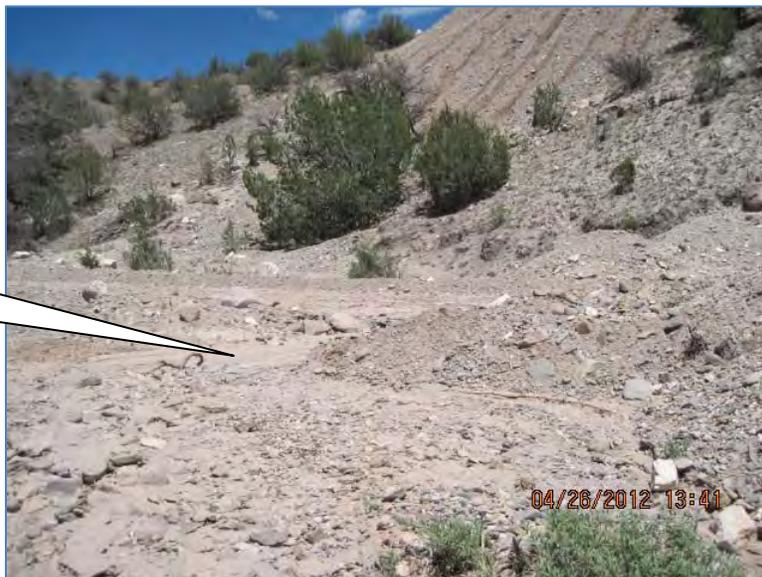
NMED/SWQB
Official Photograph Log
Photos # 3 and 4

Subject: Disturbed area, north of Zeolite East Pit, was not stabilized and had erosion rills. Example where direction of storm water flow was not indicated by arrows on site map.

Evidence of storm water flow along access road

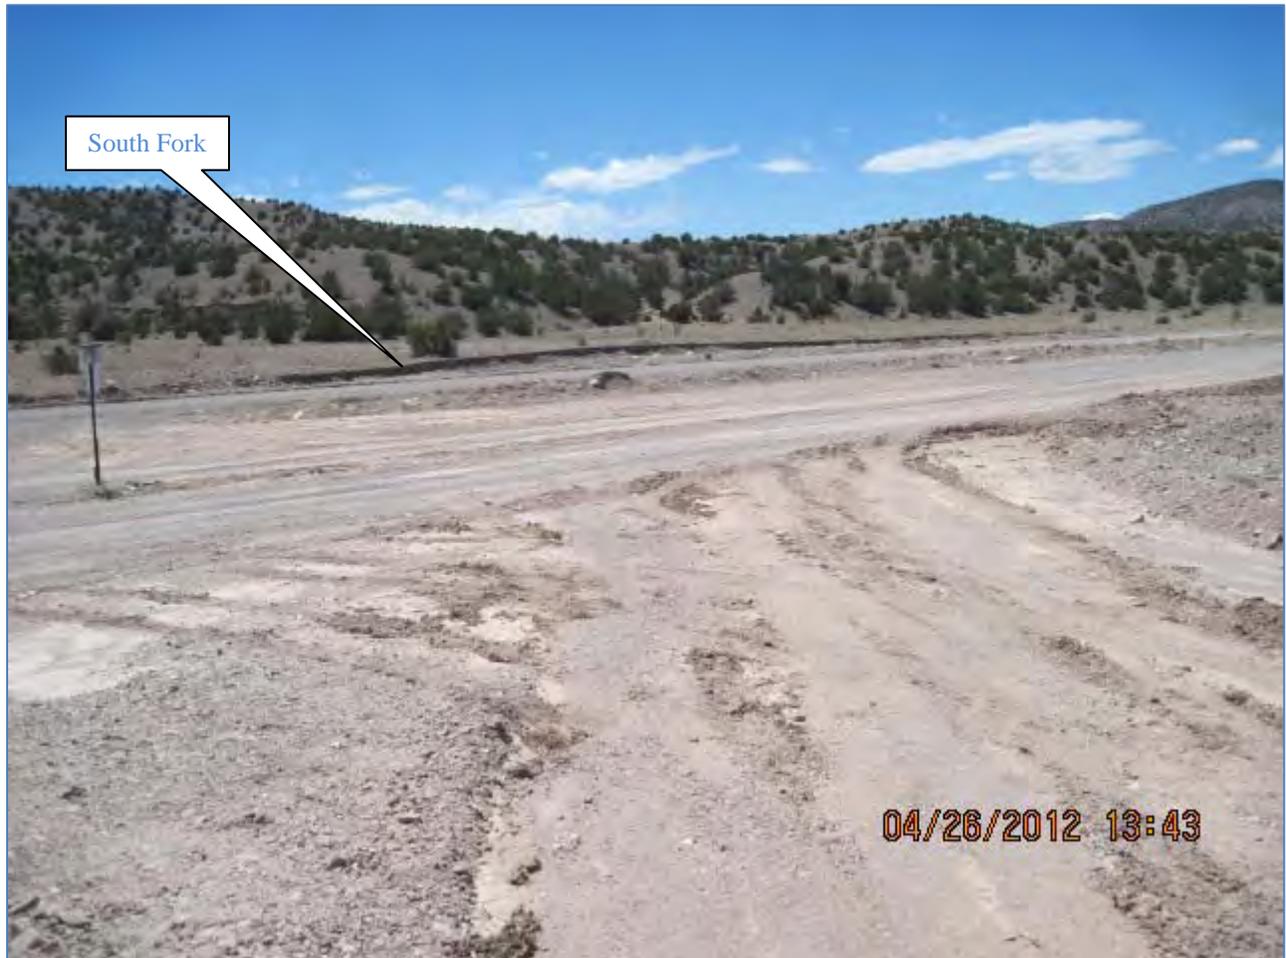
NMED/SWQB
Official Photograph Log
Photo # 5

Subject: Photo taken from access road at entrance to Zeolite East Pit. There was no evidence that runoff had crossed the road and discharged into South Fork on the day of this inspection. But, additional measures may need to be considered for this area if increased flows or erosion are observed or anticipated.

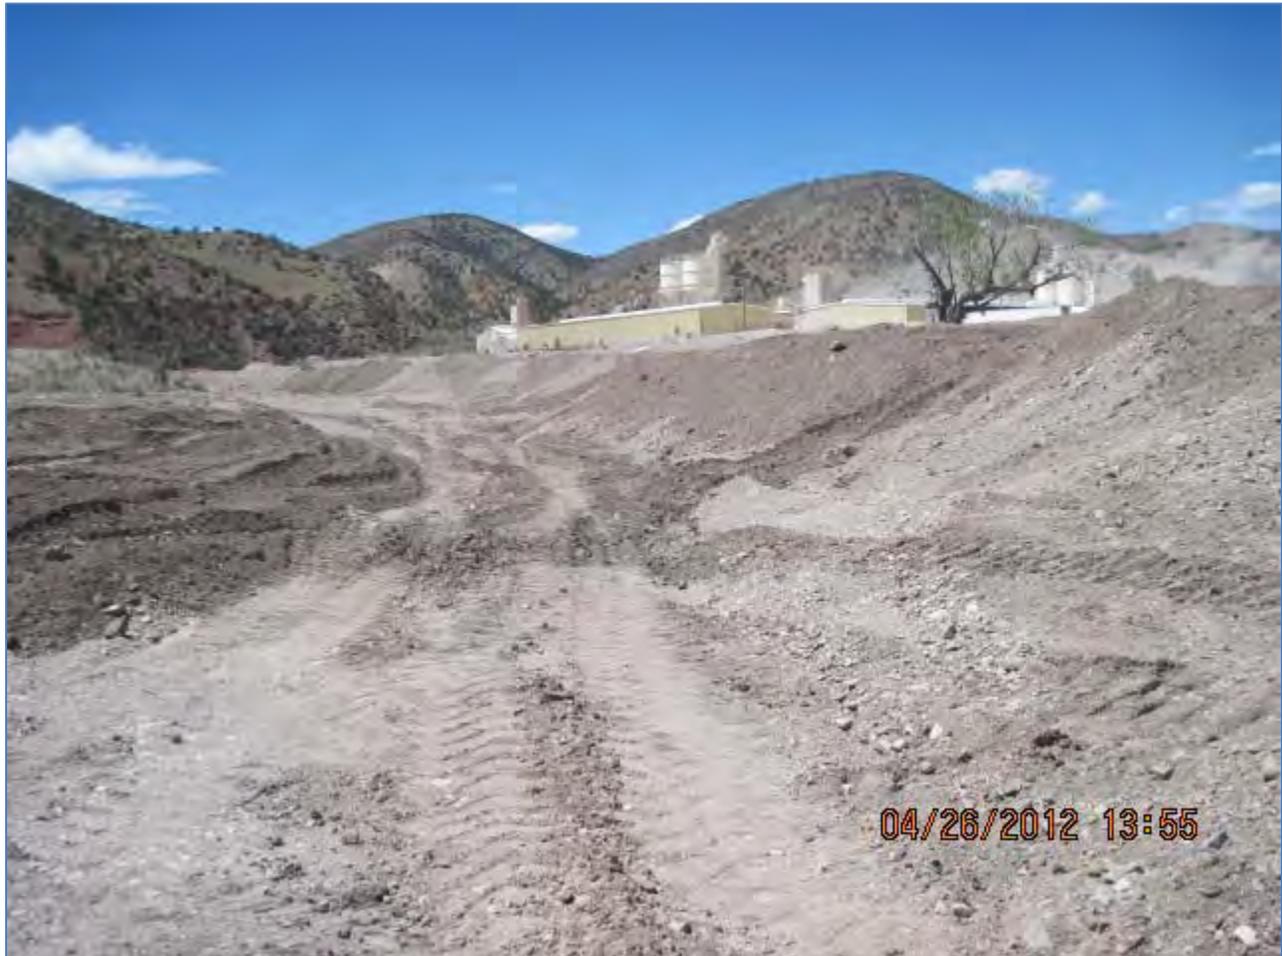
NMED/SWQB
Official Photograph Log
Photos # 6

Subject: Photo taken from stream bed of the disturbed channel of South Fork. Disturbed area had substantially more fines that other observed segments of South Fork. No temporary erosion or sediment control measures observed. No documentation of Section 404 Clean Water Act permit, if applicable, or coordination with USACE, was contained in SWPPP.

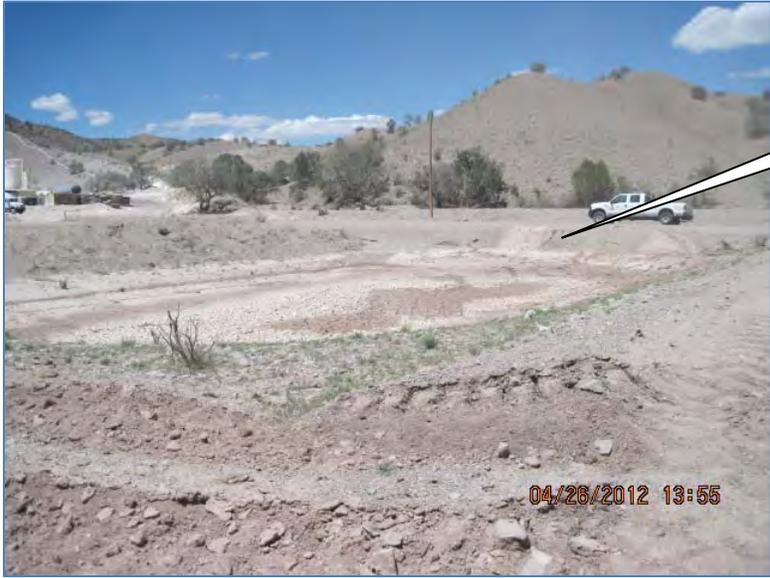
NMED/SWQB Official Photograph Log Photos # 7		
Photographer: Erin S. Trujillo	Date: 04/26/2012	Time: 1355 hours
City/County: South of Winston / Sierra County		State: New Mexico
Location: St. Cloud Zeolite Operation, Winston Mill Site, NMR05GA97		
Subject: Containment pond east of Zeolite Plant appeared to be labeled Z-4b on site map printed for this inspection; however, a copy of a site map in Permittee files show this pond as Z-4c. Permittee needs to confirm proper labeling on documents.

Erosion rills on slope that is not stabilized.

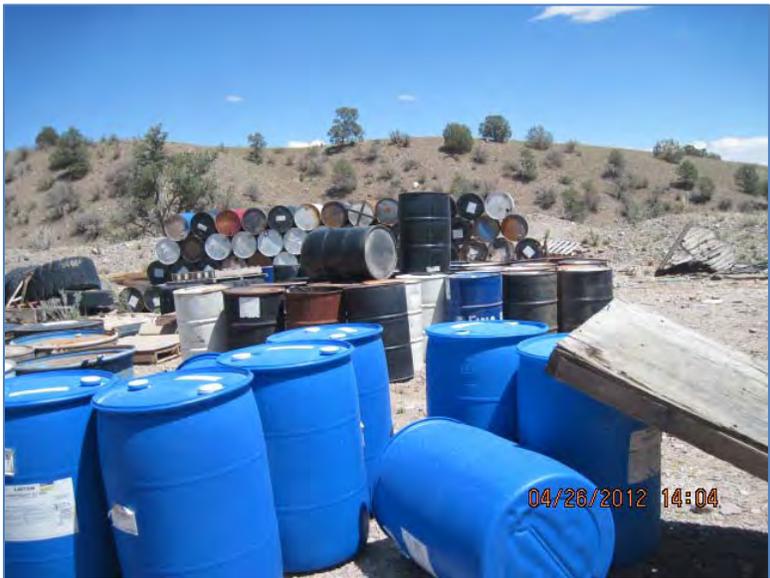
NMED/SWQB Official Photograph Log Photos # 8		
Photographer: Erin S. Trujillo	Date: 04/26/2012	Time: 1404 hours
City/County: South of Winston / Sierra County		State: New Mexico
Location: St. Cloud Zeolite Operation, Winston Mill Site, NMR05GA97		
Subject: Drum and equipment storage north of mill site below zeolite fines storage area was bermed, but area did not appear orderly.

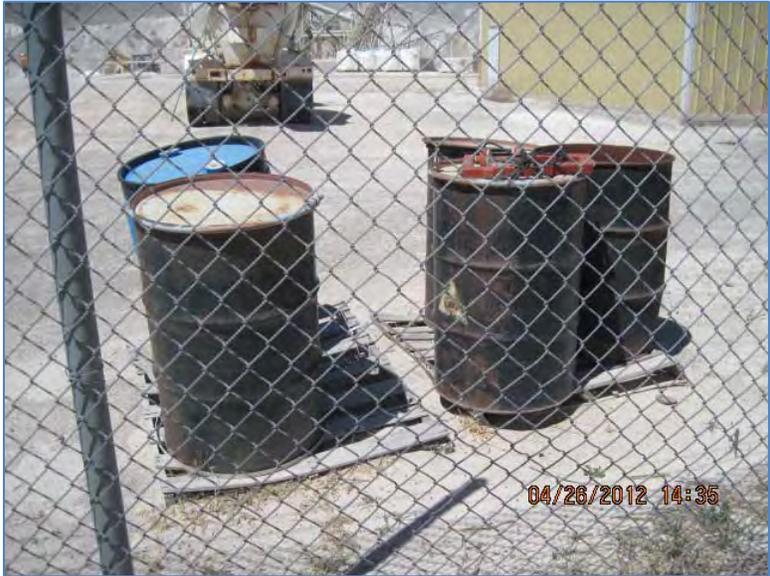
NMED/SWQB Official Photograph Log Photos # 9		
Photographer: Erin S. Trujillo	Date: 04/26/2012	Time: 1435 hours
City/County: South of Winston / Sierra County		State: New Mexico
Location: St. Cloud Zeolite Operation, Winston Mill Site, NMR05GA97		
Subject: Unlabeled drum storage in mill site. Material storage not protected (e.g., barriers) from vehicles.

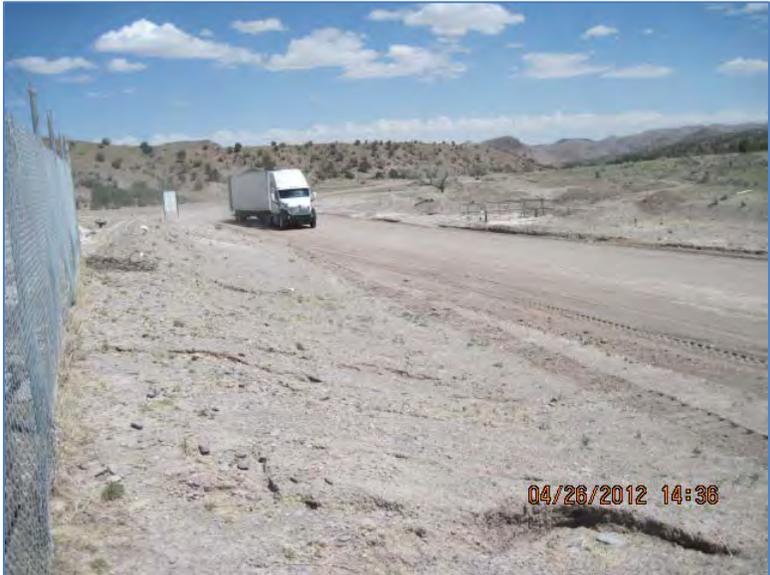
NMED/SWQB Official Photograph Log Photos # 10		
Photographer: Erin S. Trujillo	Date: 04/26/2012	Time: 1436 hours
City/County: South of Winston / Sierra County		State: New Mexico
Location: St. Cloud Zeolite Operation, Winston Mill Site, NMR05GA97		
Subject: Sparsely vegetated slopes with erosion rills at mill site along road.

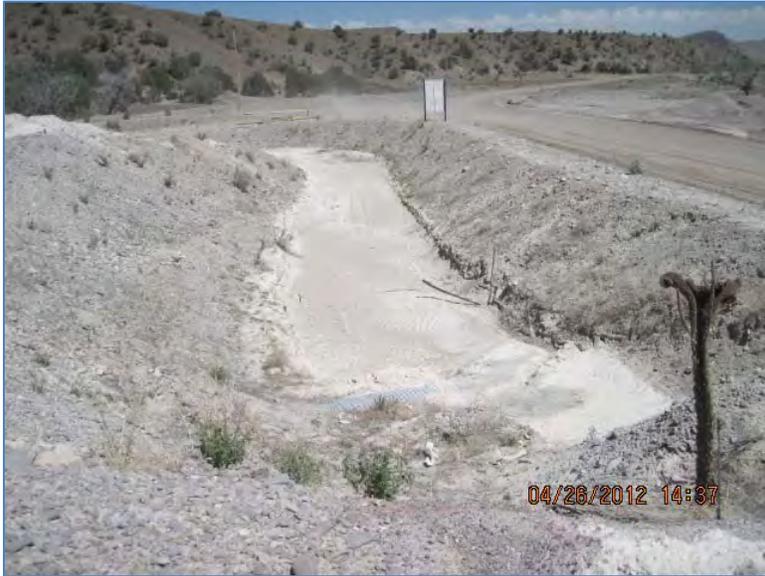
NMED/SWQB Official Photograph Log Photos # 11		
Photographer: Erin S. Trujillo	Date: 04/26/2012	Time: 1437 hours
City/County: South of Winston / Sierra County		State: New Mexico
Location: St. Cloud Zeolite Operation, Winston Mill Site, NMR05GA97		
Subject: Runoff from mill site enters containment ditch. Conveyance not identified on site map. Preventative maintenance procedures, including inspection, appears needed for ditch. Removal of solids did not appear required on the day of this inspection.

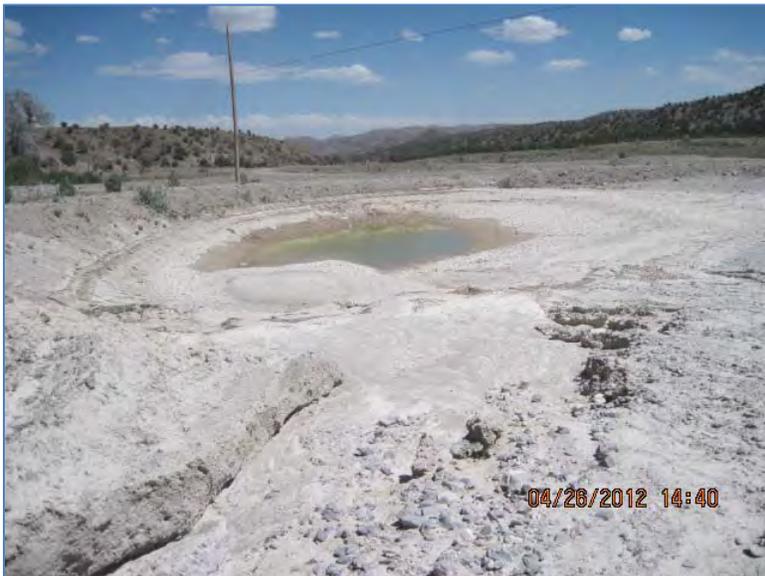
NMED/SWQB Official Photograph Log Photos # 12		
Photographer: Erin S. Trujillo	Date: 04/26/2012	Time: 1440 hours
City/County: South of Winston / Sierra County		State: New Mexico
Location: St. Cloud Zeolite Operation, Winston Mill Site, NMR05GA97		
Subject: Containment pond was not clearly labeled on site maps and may be measure Z-4a or b on site map.

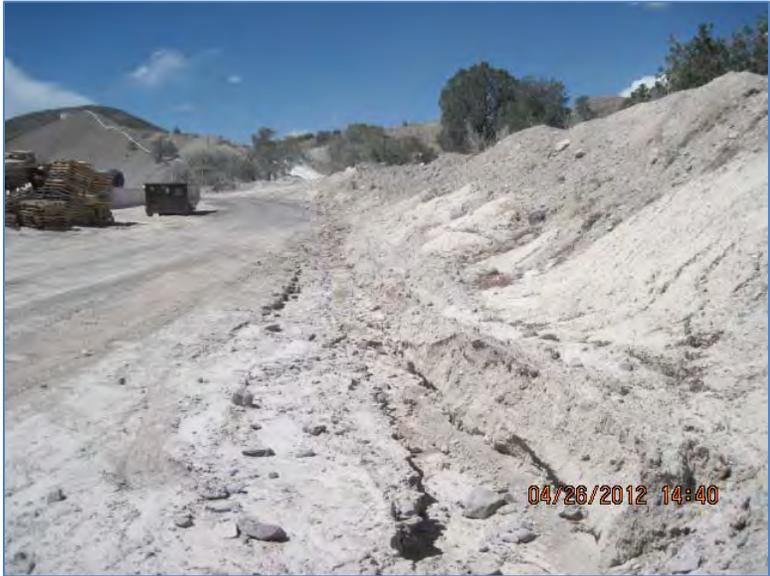
NMED/SWQB Official Photograph Log Photos # 13		
Photographer: Erin S. Trujillo	Date: 04/26/2012	Time: 1440 hours
City/County: South of Winston / Sierra County		State: New Mexico
Location: St. Cloud Zeolite Operation, Winston Mill Site, NMR05GA97		
Subject: Erosion along road and plant diversion dike. Flow from this area was to pond shown in previous photo.

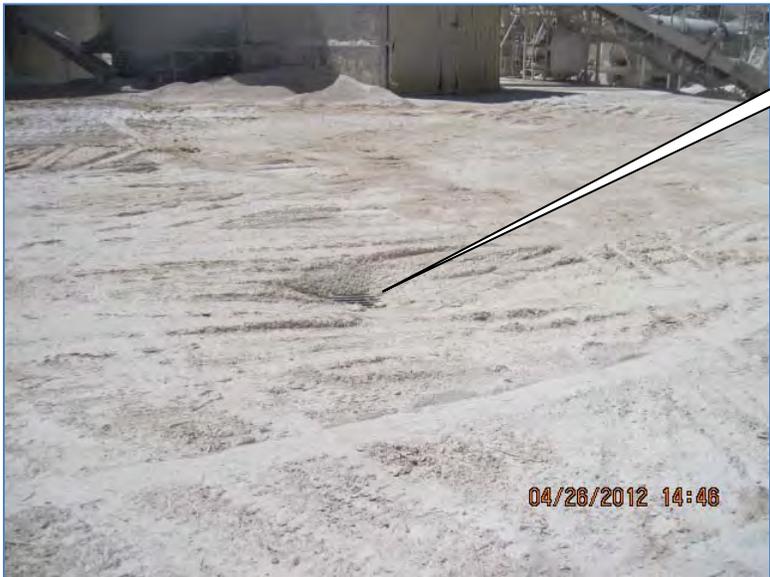
NMED/SWQB Official Photograph Log Photos # 14		
Photographer: Erin S. Trujillo	Date: 04/26/2012	Time: 1446 hours
City/County: South of Winston / Sierra County		State: New Mexico
Location: St. Cloud Zeolite Operation, Winston Mill Site, NMR05GA97		
Subject: Zeolite surrounds inlet at mill site.
