Re: Industrial Storm Water, SIC 3272, NPDES Compliance Evaluation Inspection, Cemex Ruidoso Concrete Batch Plant, NMR05GF64, July 23, 2013

NPDES Compliance Inspection Report

Compliance Evaluation Inspection
Cemex, Inc., Sector E
NPDES Permit #NMR05GF64, July 23, 2013

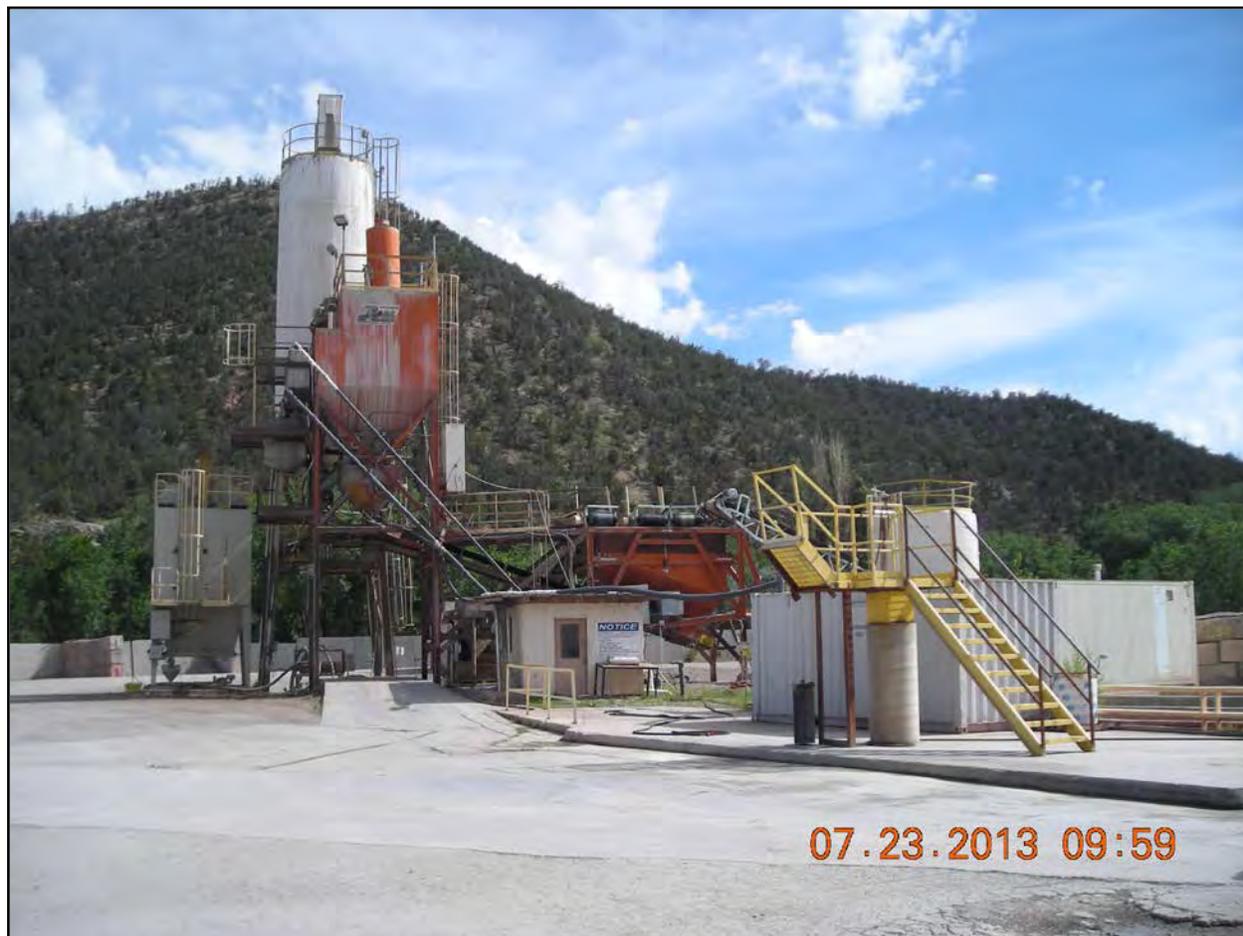
Photo # 1

| Subject: Batch plant operations. Rio Ruidoso is located behind the wall in the rear of the photo. | | |

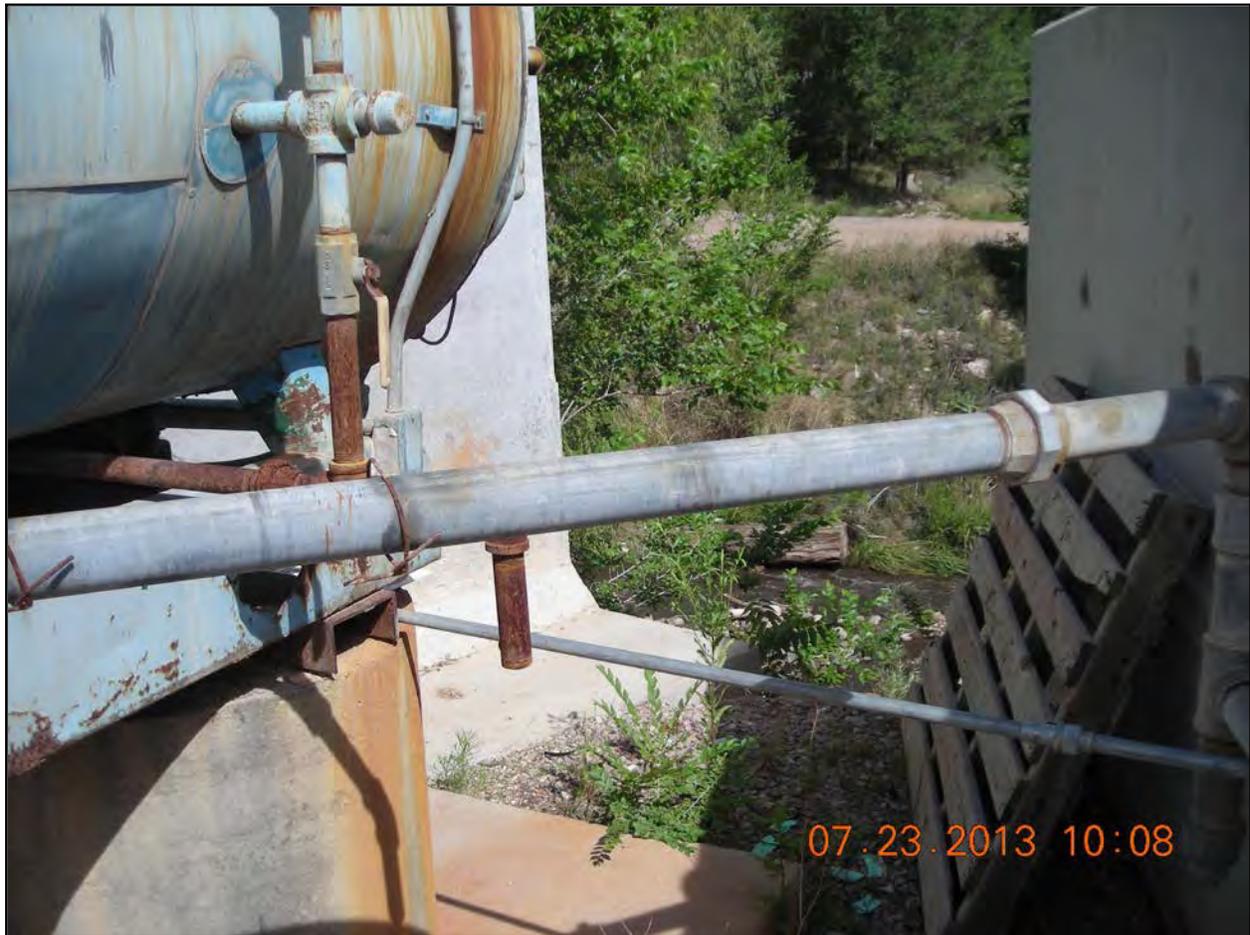
Photo # 2

| Subject: Blue piping and tank is the rock steamer located at the back north corner of the yard. There is the potential to discharge TSS laden water directly to the Rio Ruidoso. | | |

On the day of the inspection, some pollutant sources observed on site that were exposed outside and could potentially come into contact with storm water included: 1) aggregate piles, 2) the concrete batch plant, and 3) the steamer, which the inspectors had specific questions about. The inspector's concern was specifically regarding where the water from the steamer is discharged when it is changed out. Mr. Hernandez was a temporary employee at this location while the manager was on vacation and was unable to answer this process question. According to a later phone conversation with Mr. Isaac Sterks, who is normally at this facility, the steamer has not been used in a few years and that while it was in use, the water from the steamer was captured and not discharged to the Rio Ruidoso.

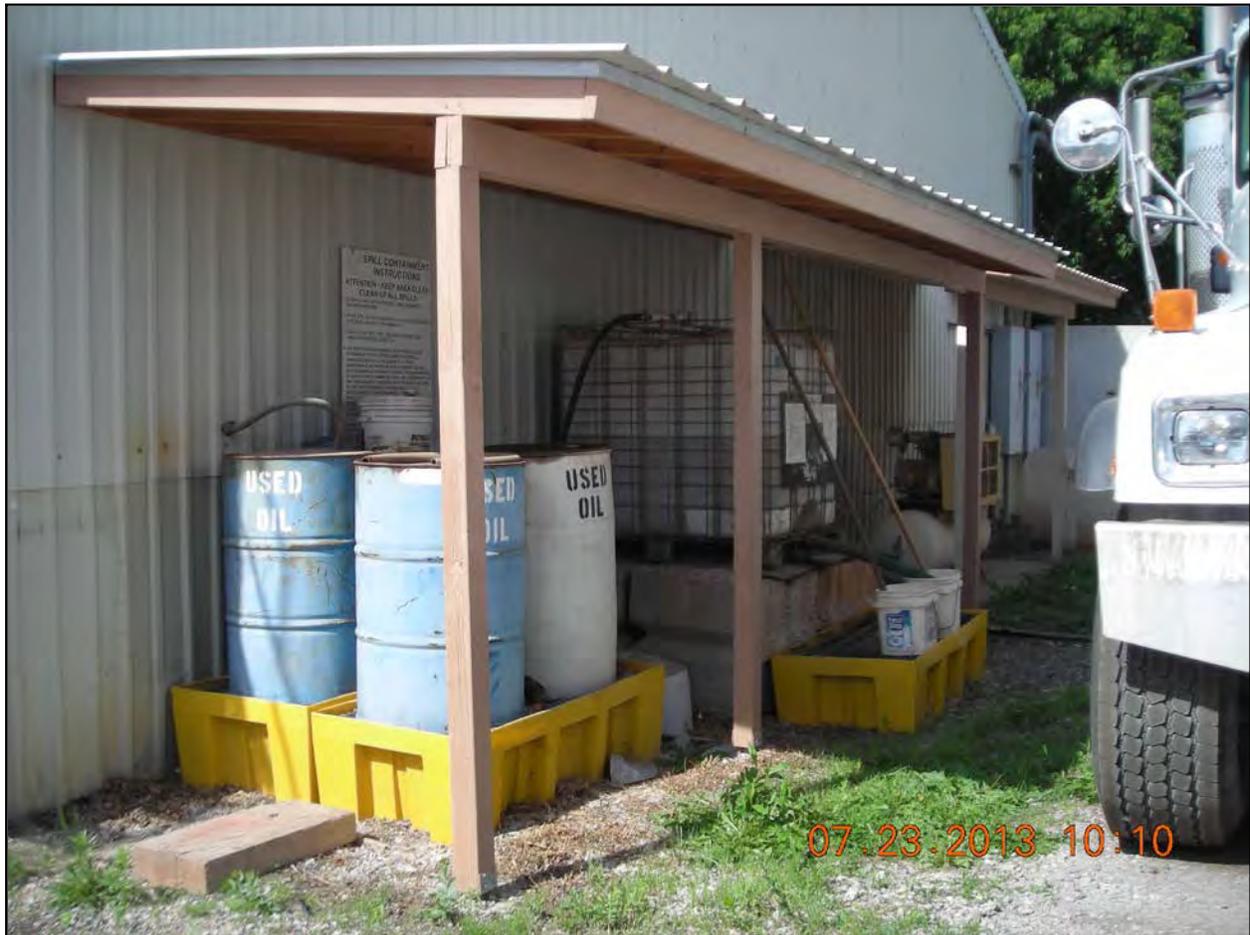
Photo # 3

| Subject: Chemical storage outdoors. Acid wash shown in the tote is used for truck washing. Washing occurs in a part of the yard which drains to the concrete washout/water reuse basins. | | |
