NEW MEXICO  
ENVIRONMENT DEPARTMENT

*Surface Water Quality Bureau*

**RE: Construction Storm Water, SIC 1542, NPDES Compliance Evaluation Inspection, San Antonio Self Storage, NMR10GR04, December 3, 2010**

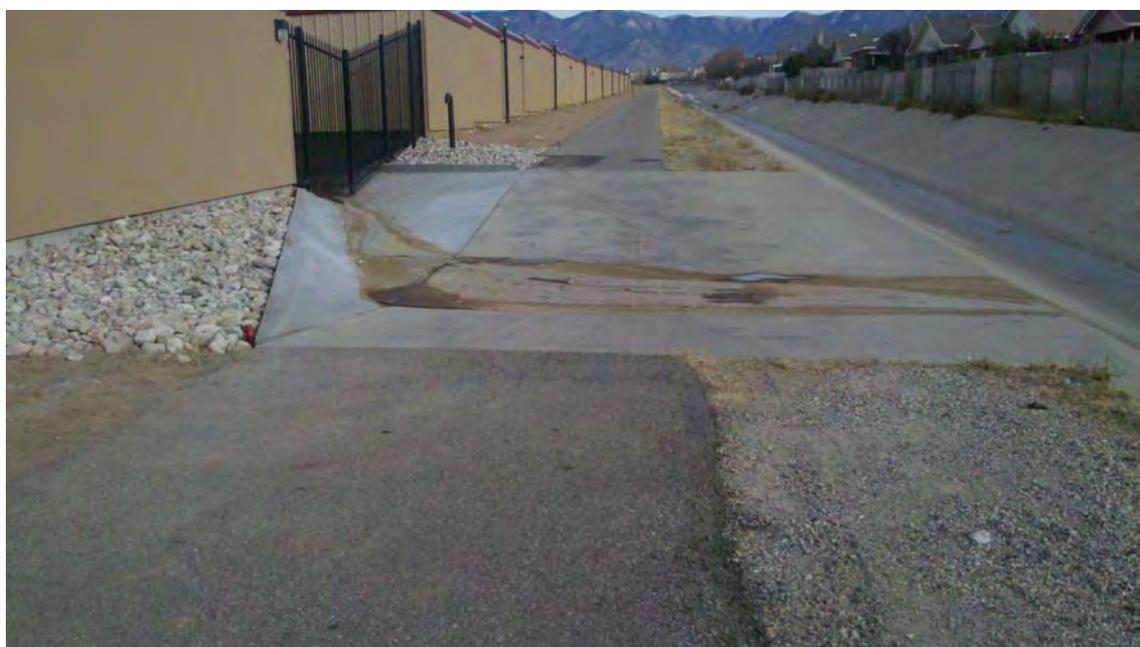
NMED/SWQB  
**Official Photograph Log**  
Photo # 1

Photographer: Sarah Holcomb	Date: 12-3-2010	Time: 1445 hours
City/County: Albuquerque/Bernalillo County		
Location: Discharge point along Piño Arroyo.		
Subject: Discharge point from construction site. Site was being paved and according to the site owner/contractor, there was a hydraulic fluid leak combined with a water truck releasing much more water than was supposed to occur for dust control.

This inspection was prompted by a discharge from the construction site. The interior of the self storage units is currently being paved. The hydraulic machine being used had a leak of hydraulic fluid, and concurrently, a water truck being used for dust control purposes let large amounts of water go, flushing the hydraulic fluid into the adjacent Piño Arroyo. The fluid traveled about a mile and a half down the arroyo and most likely made it into the North Diversion Channel. The inspector observed that the water at least made it past Jefferson Blvd., which is about a mile and a half.

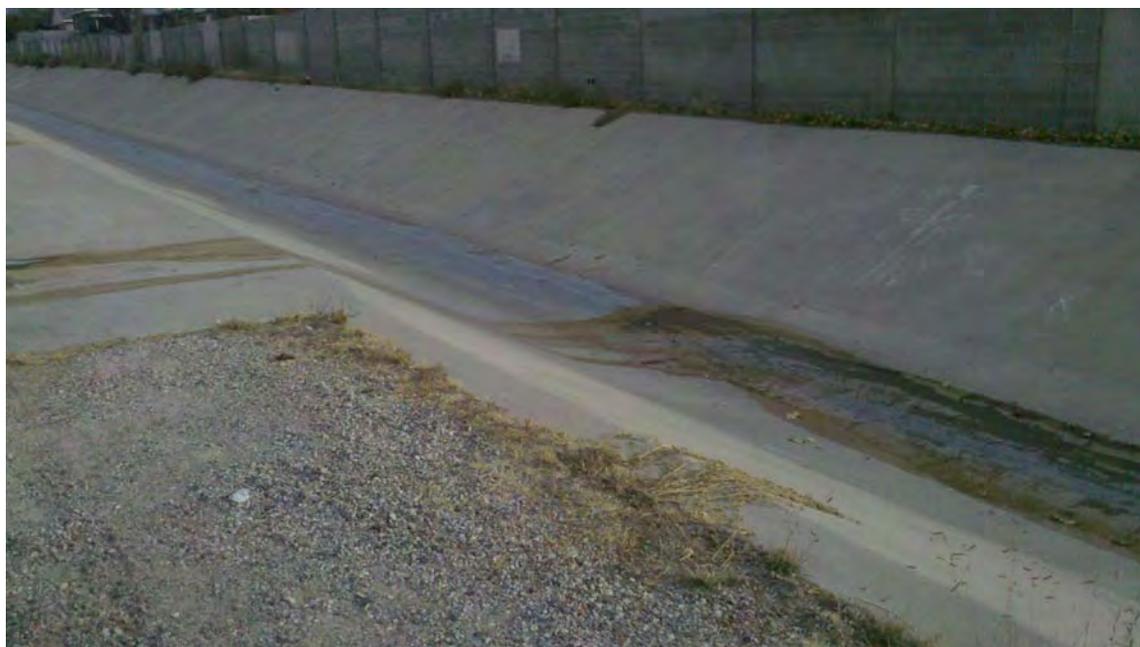
NMED/SWQB  
**Official Photograph Log**  
Photo # 2

Photographer: Sarah Holcomb	Date: 12-3-2010	Time: 1445 hours
City/County: Albuquerque/Bernalillo County		
Location: Discharge point along Piño Arroyo.		
Subject: Another view of the discharge into the arroyo. The inspector was able to note the color of the discharge down the arroyo for about a mile and a half. It is possible that the discharge made it to the North Diversion Channel.
