NEW MEXICO
ENVIRONMENT DEPARTMENT

Surface Water Quality Bureau

RE: Construction Storm Water, SIC 1542, NPDES Compliance Evaluation Inspection, Terrain Management Project, NMR10GS27, December 7, 2010

NPDES Industrial Storm Water Worksheet (Construction)

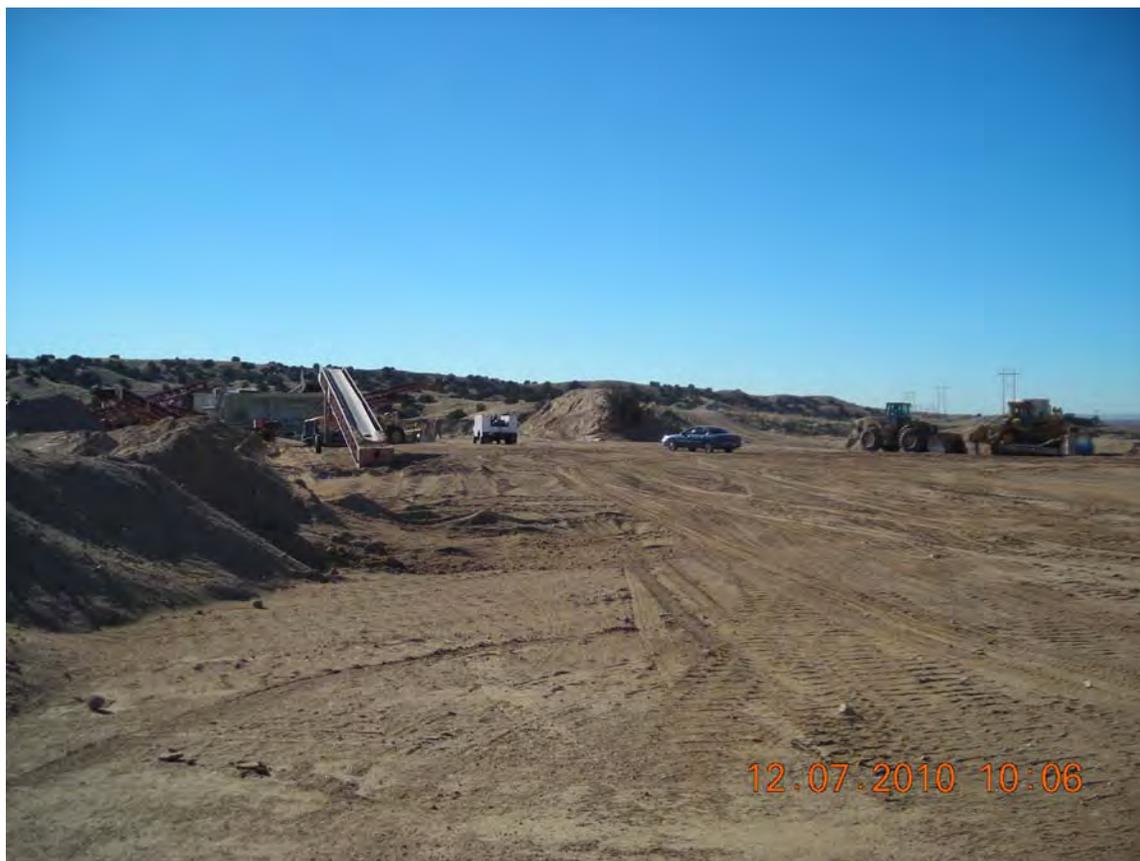
NMED/SWQB
Official Photograph Log
Photo # 1

Photographer: Sarah Holcomb	Date: 12-7-2010	Time: 1006 hours
City/County: Placitas/Sandoval County		
Location: Fisher Sand and Gravel land just south of Placitas along I-25.		
Subject: Equipment on site to filter material being removed from the site.
