NEW MEXICO  
ENVIRONMENT DEPARTMENT

*Surface Water Quality Bureau*

**RE: Construction Storm Water, SIC 1623, NPDES Compliance Evaluation Inspection, Shiya Strepheps Contracting Co., San Juan County and Valley Water, NMR10GW11, September 13, 2010**

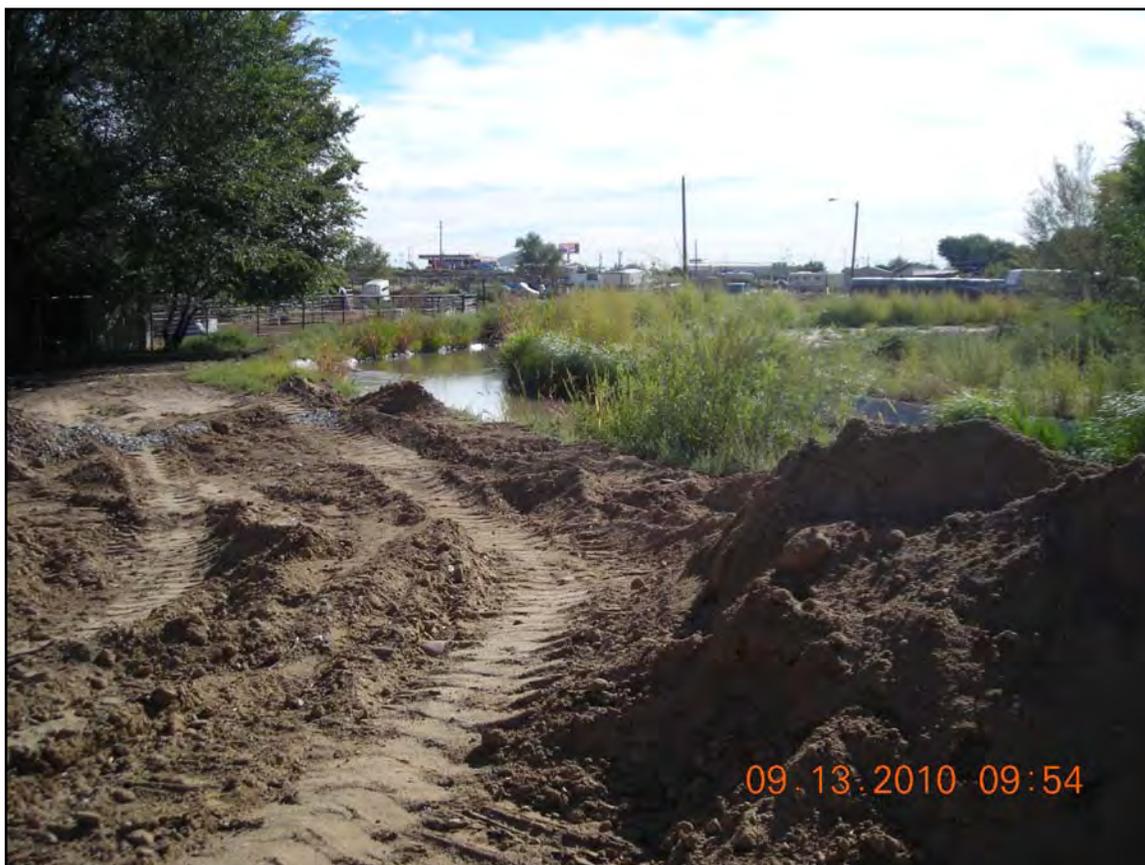
NMED/SWQB  
**Official Photograph Log**  
Photo # 1

Photographer: Sarah Holcomb	Date: 9-13-2010	Time: 0954 hours
City/County: Kirtland/San Juan		
Location: Lift station #1 installation site off of County Road 6500.		
Subject: Berm along irrigation canal had been compromised. Needed to be re-installed.

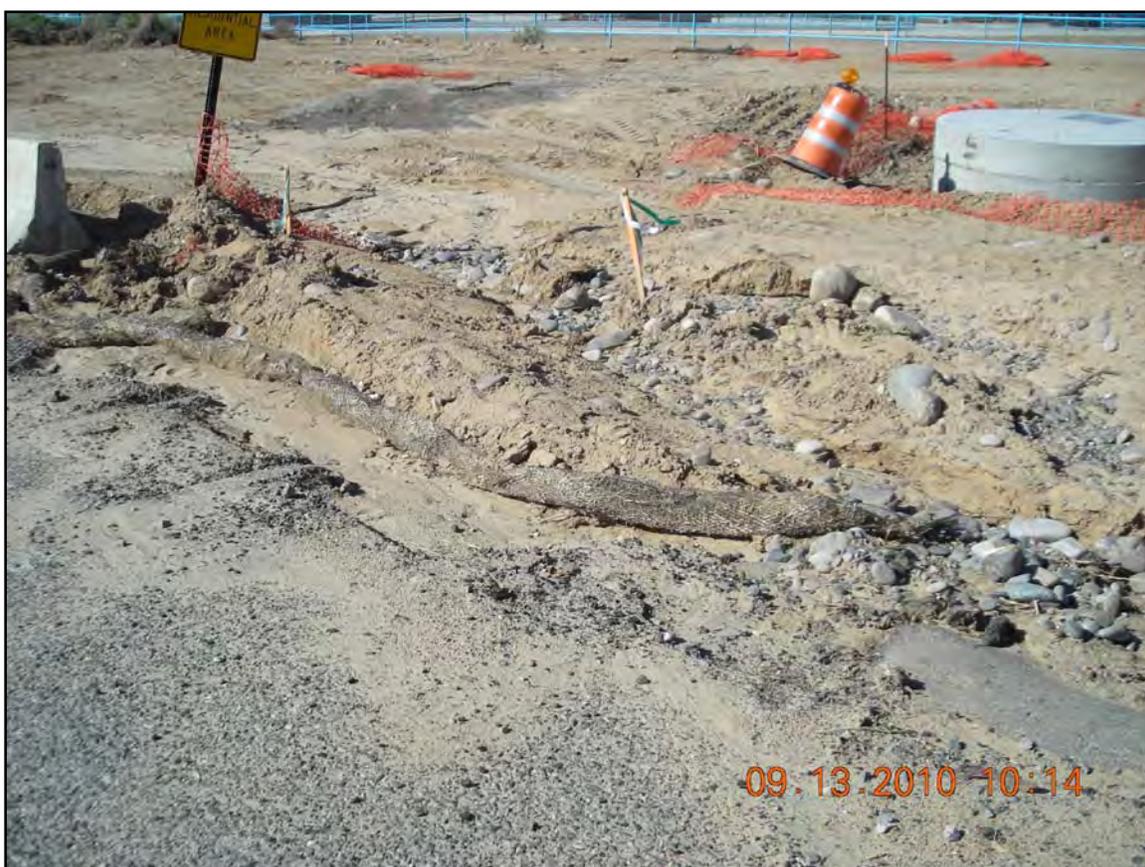
NMED/SWQB  
**Official Photograph Log**  
Photo # 2

Photographer: Sarah Holcomb	Date: 9-13-2010	Time: 1014 hours
City/County: Kirtland/San Juan		
Location: Lift station #2 near Hwy 64 and CR 6299		
Subject: Erosion socks at this location were in dire need of repair and reinstallation.

The inspections generally indicated that things were well with the site, but upon the on site observations during this inspection, there were questions raised as to whether BMPs and discharge locations were truly being looked at. BMPs were in general disrepair. For example, erosion socks installed along disturbed areas looked as if they had been run over and not maintained.

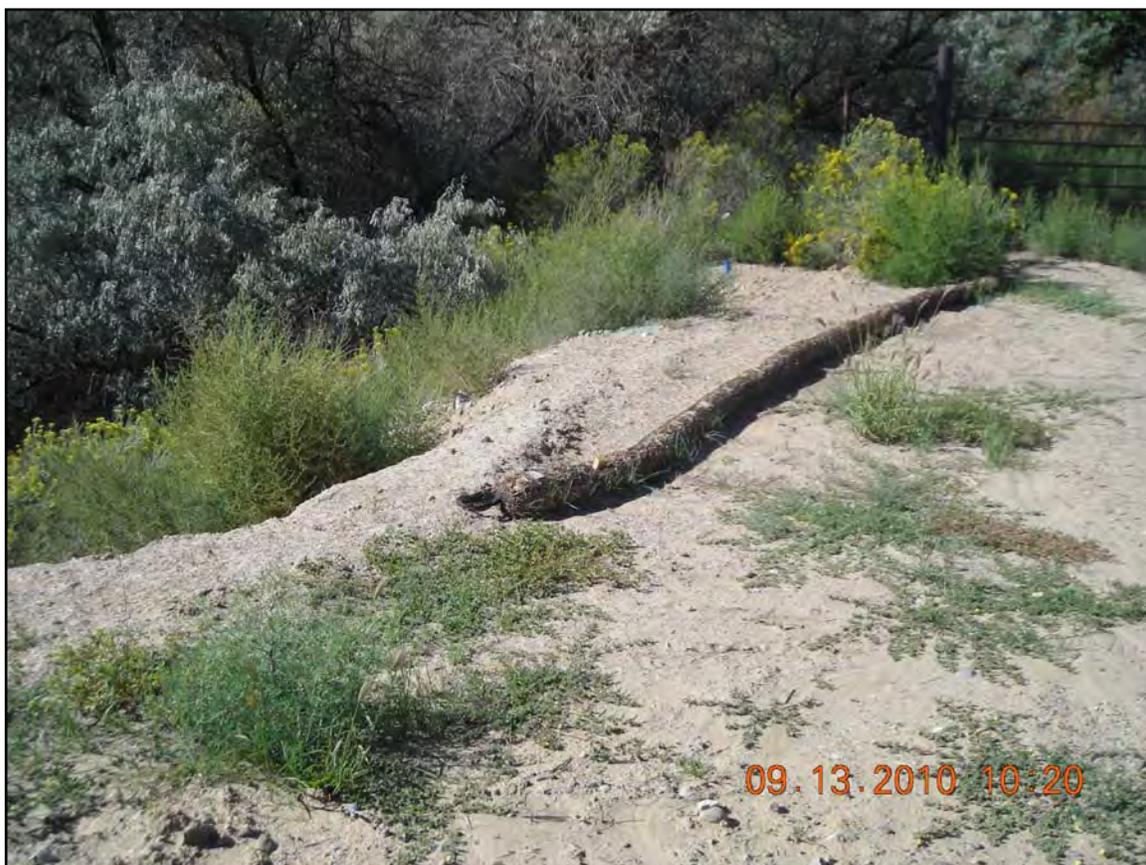
NMED/SWQB  
**Official Photograph Log**  
Photo # 3

Photographer: Sarah Holcomb	Date: 9-13-2010	Time: 1020 hours
City/County: Kirtland/San Juan		
Location: Coolidge Arroyo at east end of project site.		
Subject: Inadequate BMPs/protection for arroyo from all of the upstream activity.
