NEW MEXICO  
ENVIRONMENT DEPARTMENT

**RE: Construction Stormwater; SIC 1611; NPDES Compliance Evaluation; Los Alamos County; NMR10GX70; October 6, 2010**

### NPDES Compliance Inspection Report

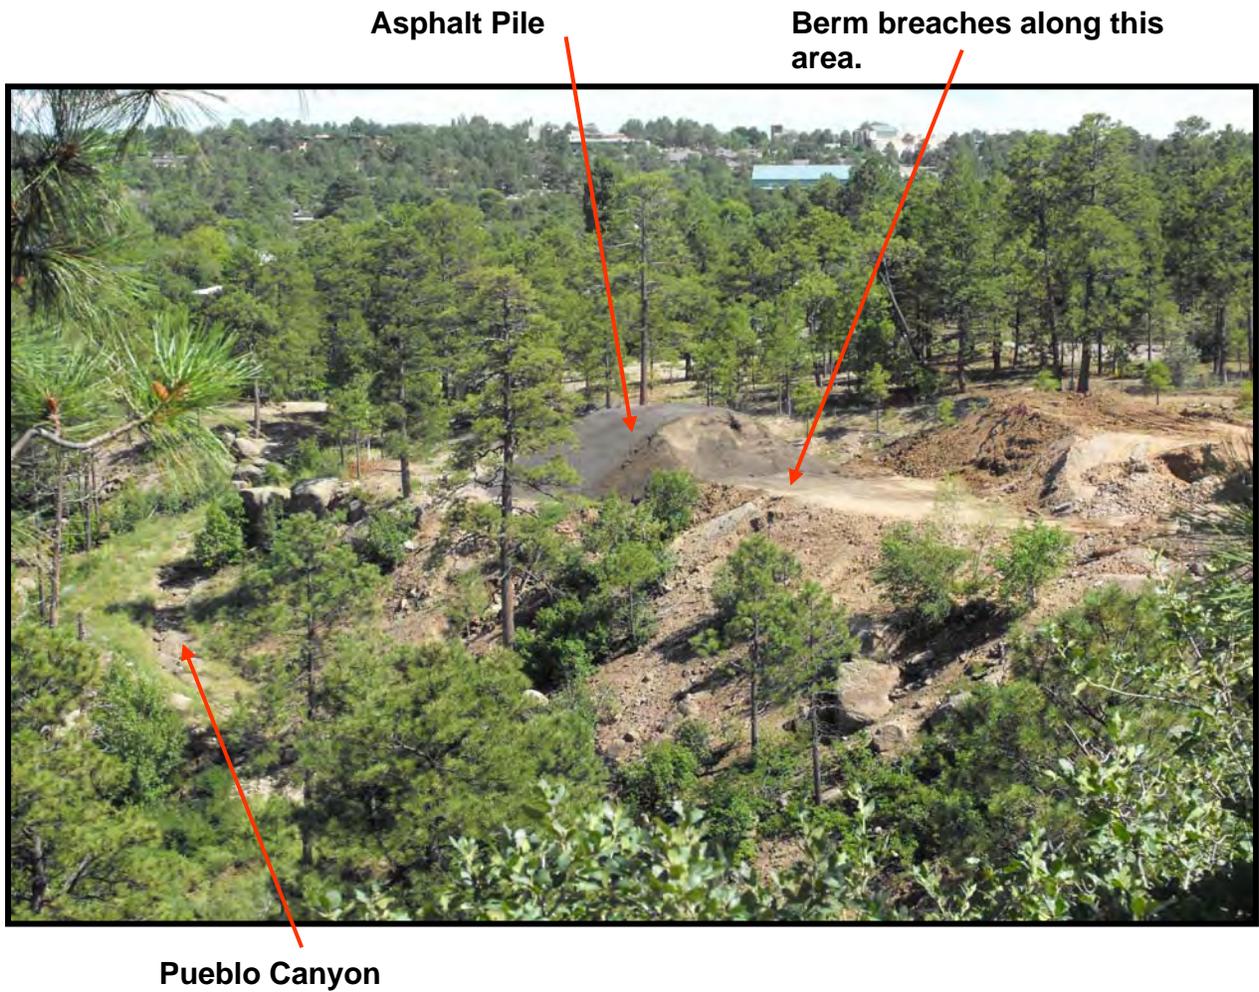
Photo # 1

Photographer: Daniel Valenta	Date: 8/18/2010	Time: 1519
City/County: Los Alamos/Los Alamos County		
Location: 1900 Diamond Drive, Los Alamos, NM, picture taken from in back of the Los Alamo's Schools Credit Union Building, facing southeast.		
Subject: Pueblo Canyon Rim storage site, photographed from north side of canyon. The site was first noticed from Diamond Drive on 8/18/2010.

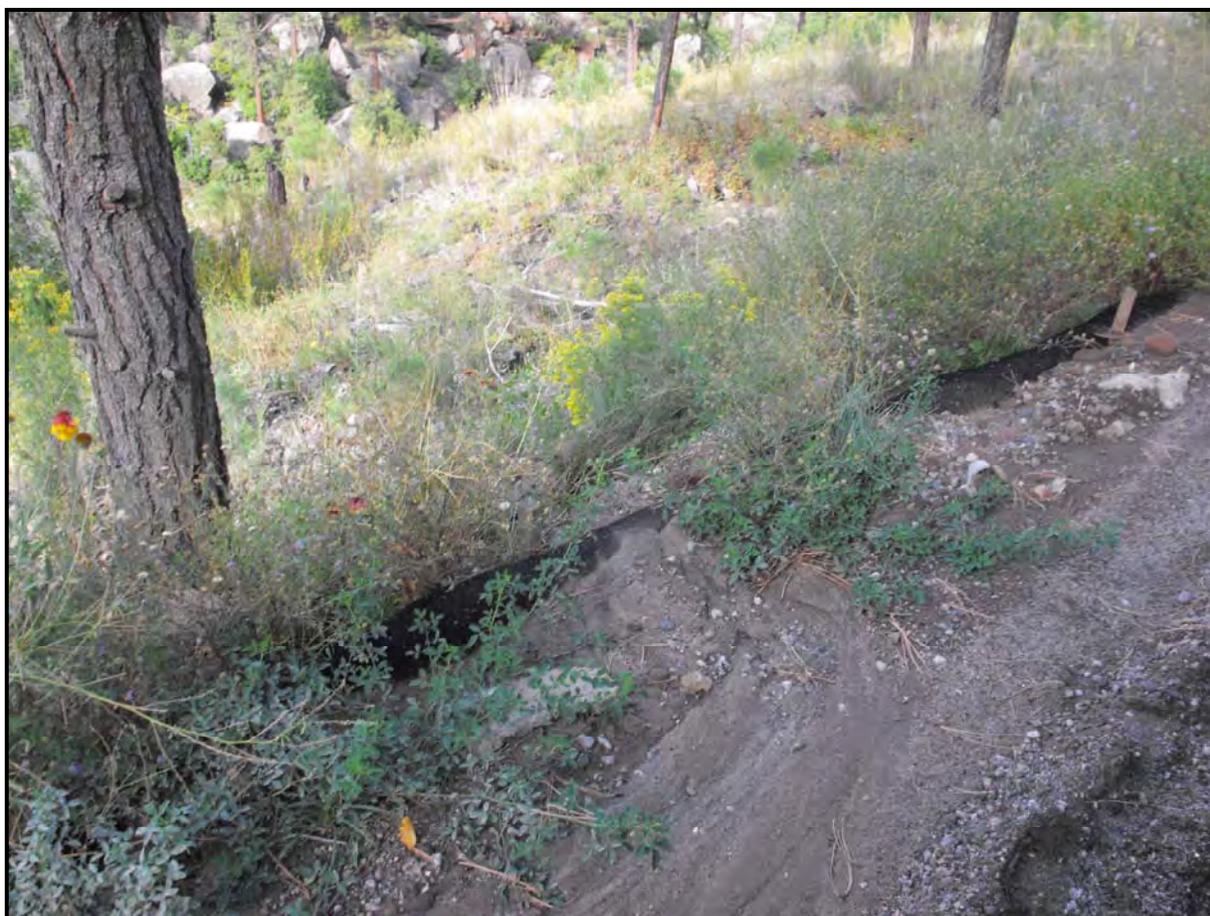
Photo # 2

Silts fences (see photo 2)

Photographer: Daniel Valenta	Date: 10/6/2010	Time: 1546
City/County: Los Alamos/Los Alamos County		
Location: Entrance road from Diamond Road to the Pueblo Canyon Rim storage area. Approximately 1900 Diamond Drive, Los Alamos, NM.		
Subject: Unmaintained BMP's along the entrance road.

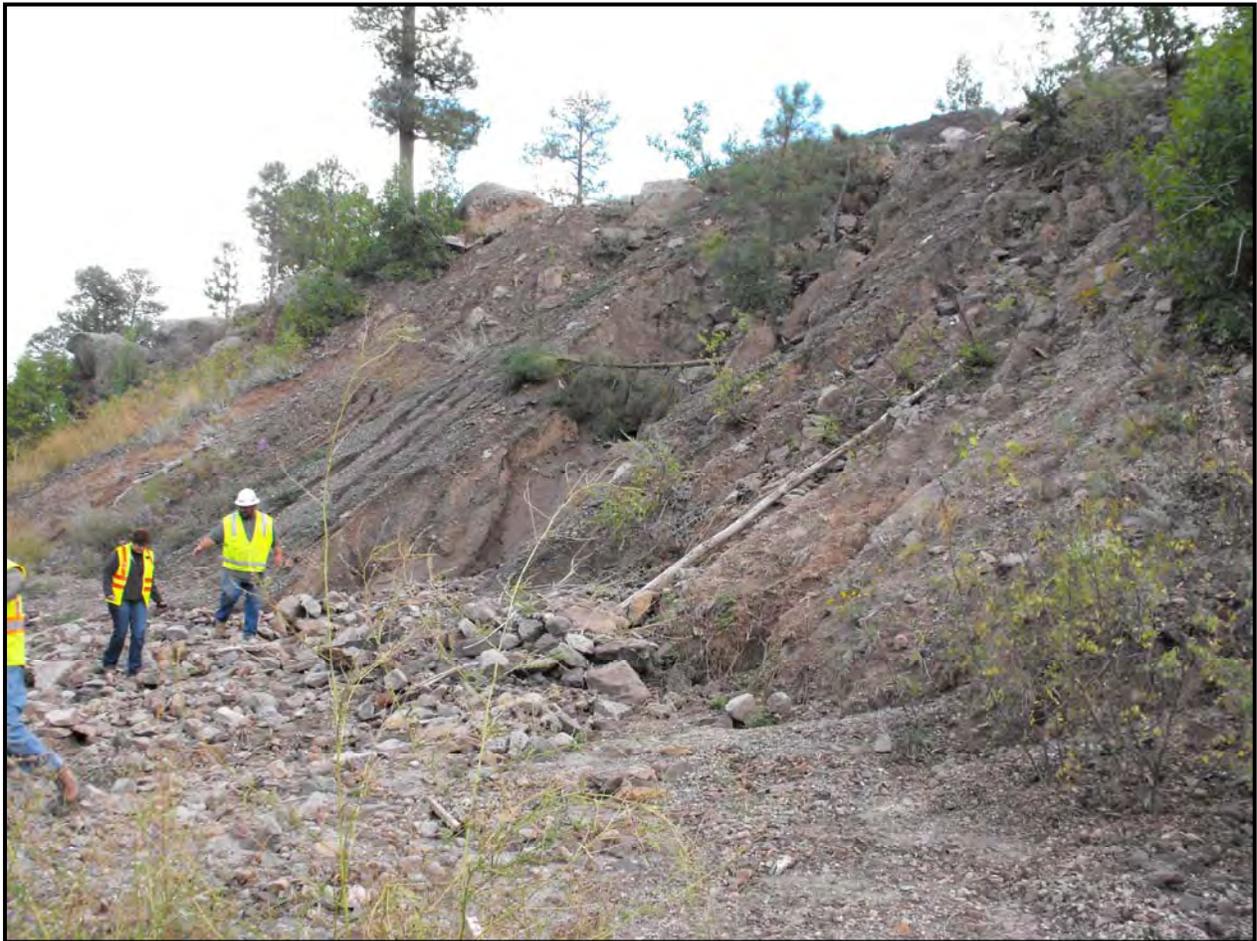
Photo # 3

All pollution control measures inspected to ensure proper operation? <i>ESO Element 35</i>	Y <input type="checkbox"/> N <input checked="" type="checkbox"/>	The Pueblo Canyon Rim site had berms around piles of recycled asphalt, dirt and concrete. However, these berms failed as noted in the pictures provided. The lower berm was not repaired after failure.
All discharge locations inspected if accessible, or if not accessible, are nearby downstream locations inspected? <i>ESO Element 36; 37</i>	Y <input type="checkbox"/> N <input checked="" type="checkbox"/>	Failure of lower containment berm at Pueblo Canyon Rim area not noted or corrected prior to this inspection.
Entrance/exit inspected for off-site tracking? <i>ESO Element 38</i>	Y <input type="checkbox"/> N <input checked="" type="checkbox"/>	No documentation or off-site tracking BMP in place at Pueblo Canyon Rim site.
Inspection report contain all required items and certified? <i>ESO Element 39; 40</i>	<input checked="" type="checkbox"/> Y <input type="checkbox"/> N

Photographer: Daniel Valenta	Date: 5/6/2010	Time: 1603
City/County: Los Alamos/Los Alamos County		
Location: Below Pueblo Canyon Rim staging area. Approximately 1900 Diamond Drive, Los Alamos, NM, facing southeast.		
Subject: Site breaches along north side in various places. Discharge knocks down trees and carries rocks and material down Pueblo Canyon.

The SWPPP does not contain any reference or maps of the Pueblo Canyon Rim staging area. After the berm breaches, no changes or reviews of BMP in the area were documented.

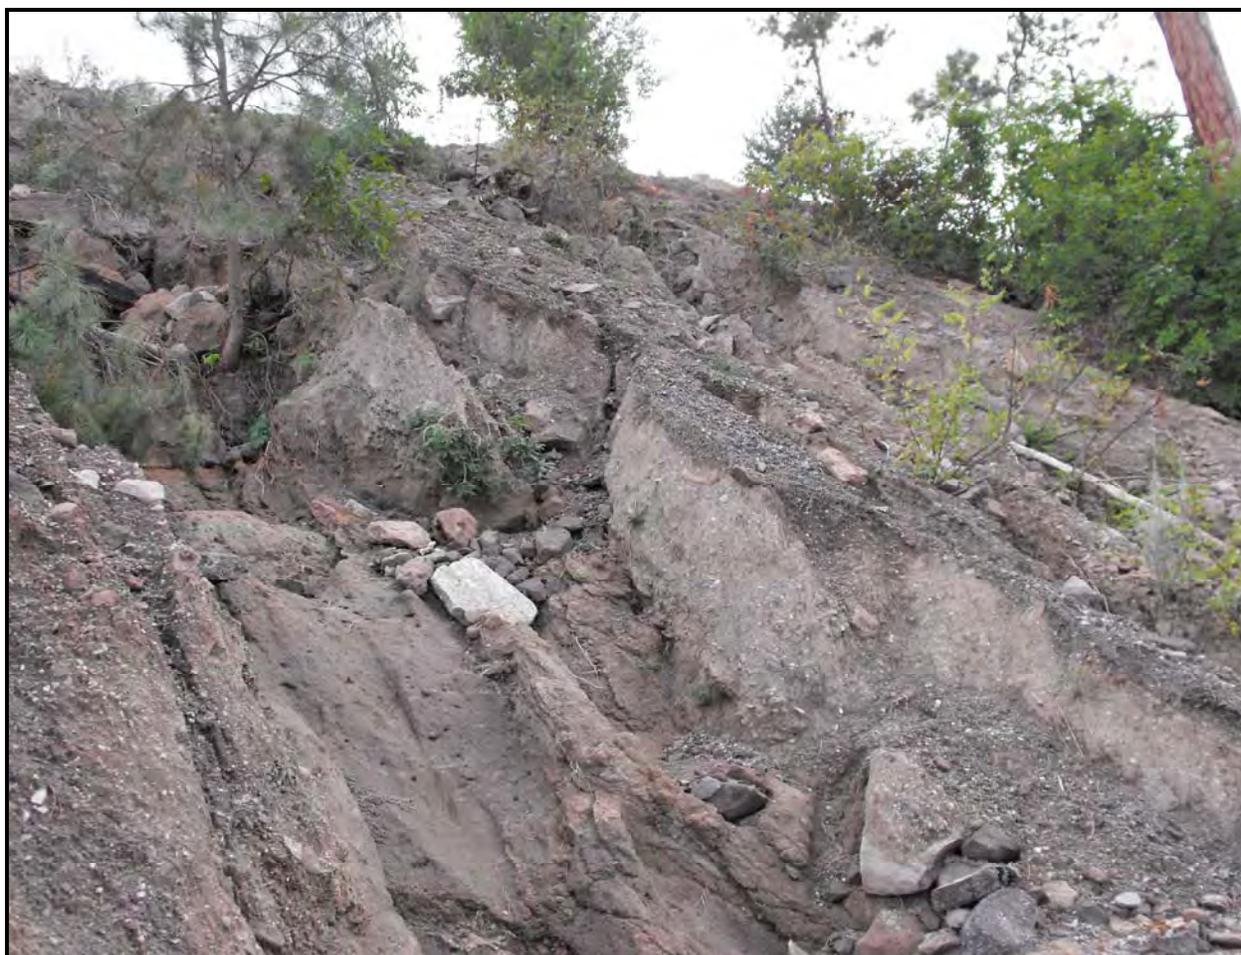
Photo # 4

Photographer: Daniel Valenta	Date: 5/6/2010	Time: 1603
City/County: Los Alamos/Los Alamos County		
Location: Below Pueblo Canyon Rim staging area. Approximately 1900 Diamond Drive, Los Alamos, NM, facing southeast.		
Subject: Discharge down cuts through sediment to bedrock.

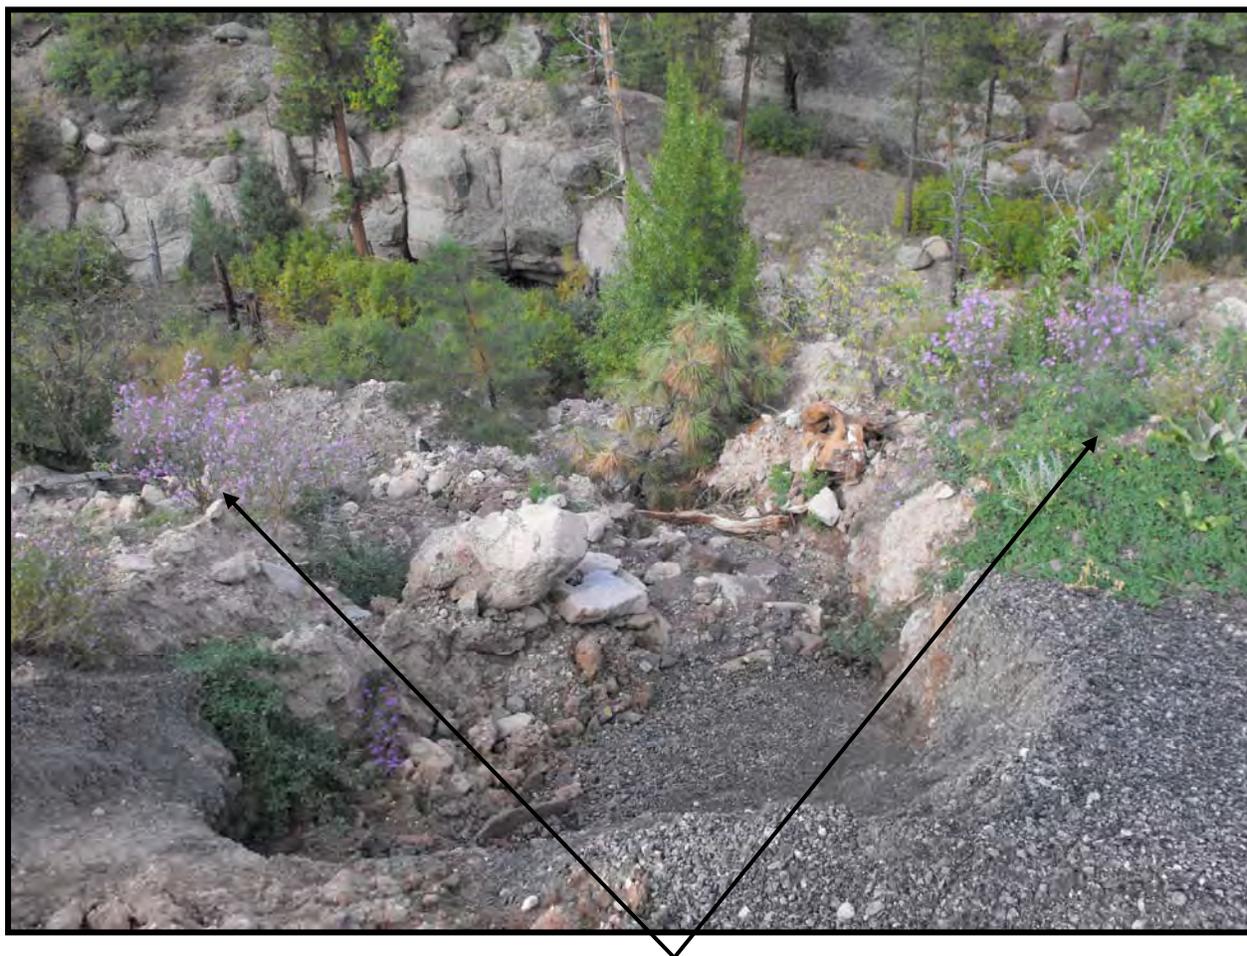
Photo # 5

Photographer: Daniel Valenta	Date: 10/6/2010	Time: 1558.25
City/County: Los Alamos/Los Alamos County		
Location: Pueblo Canyon Rim staging area. Approximately 1900 Diamond Drive, Los Alamos, NM, facing northwest .		
Subject: Breach in upper containment berm discharges to breach lower berm and discharge to Pueblo Canyon stream.

**Pueblo Canyon**

**Containment berms fail at top and bottom at this location.**
