**RE: Construction Storm Water, SIC 1623, NPDES Compliance Evaluation Inspection, J & H Services, Inc., Sangre De Cristo Regional MDWC & MSWA Water System Phase 3, NMR10H157, Anton Chico, New Mexico, September 7, 2010**

### NPDES Compliance Inspection Report

## NPDES Industrial Storm Water Worksheet (Construction)

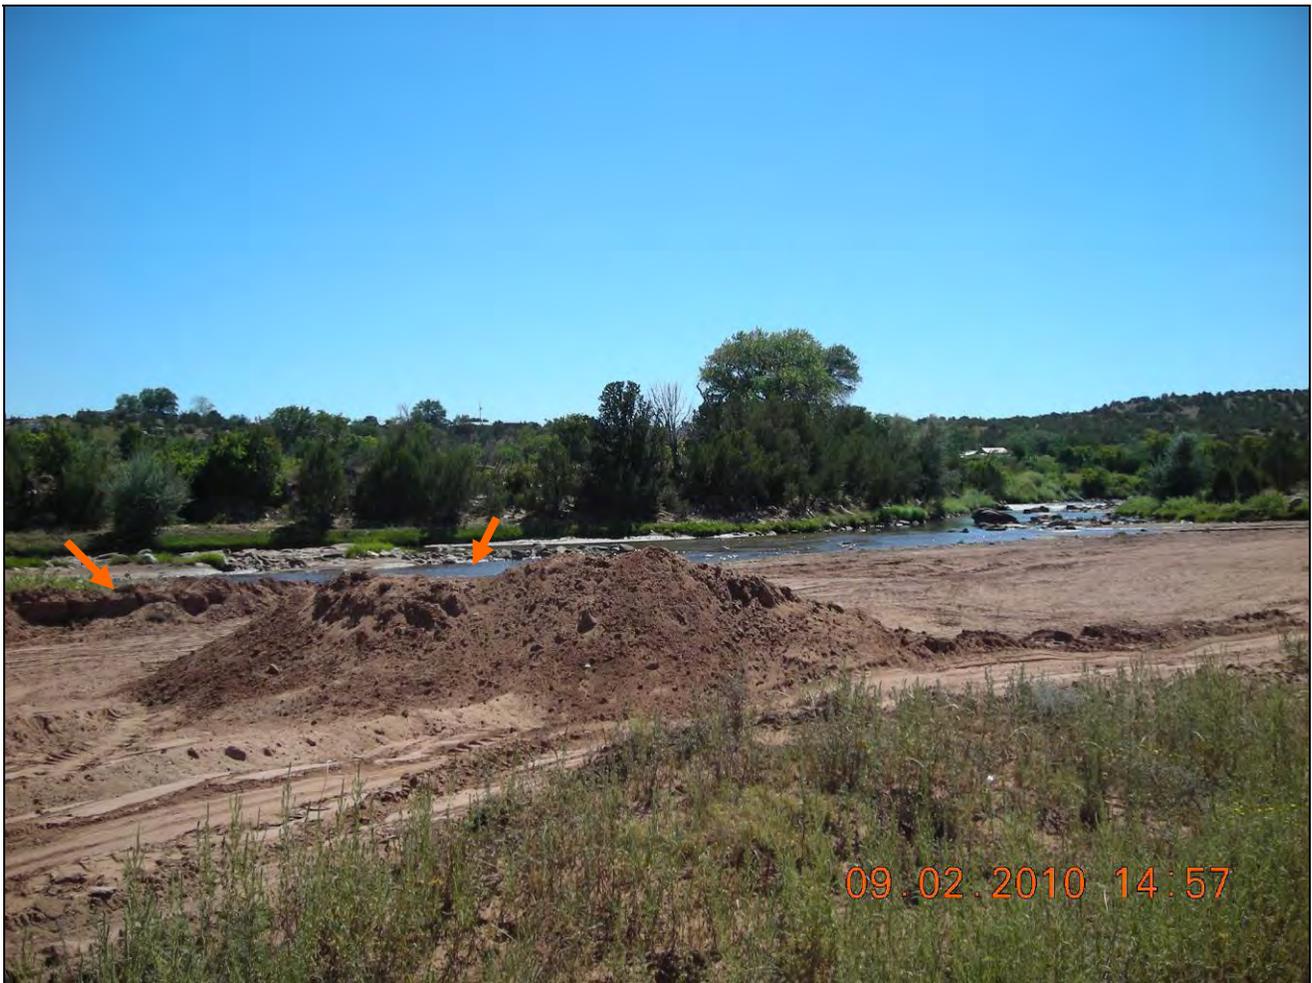
NMED/SWQB Official Photograph Log Photo # 1		
Photographer: Charles Dentino, NMED SWQB	Date: 09/02/2010	Time: 1457 hours
City/County: North of Tecolotito / San Miguel County		State: New Mexico
Location: Confluence of Tecolote Creek and Pecos River		
Subject: Photograph taken prior to NPDES inspection provided for information. Not all disturbance at the confluence and banks of the Pecos River can be attributed to the general contractor's construction sand mining/borrow activities. The road adjacent to Pecos River and Tecolote Creek and that crosses Tecolote Creek is used by others to access the area. On-site permittee representatives stated that the road adjacent to the Pecos River and along Tecolote Creek was maintained by J & H Services, Inc. for their heavy equipment to haul sand. Arrows point to recent tire tracks/cutting and stockpile directly adjacent to Pecos River on 09/02/2010. Sand and gravel stockpile likely from recent activities shown in this photo on 09/02/2010 had been removed by 09/07/2010.

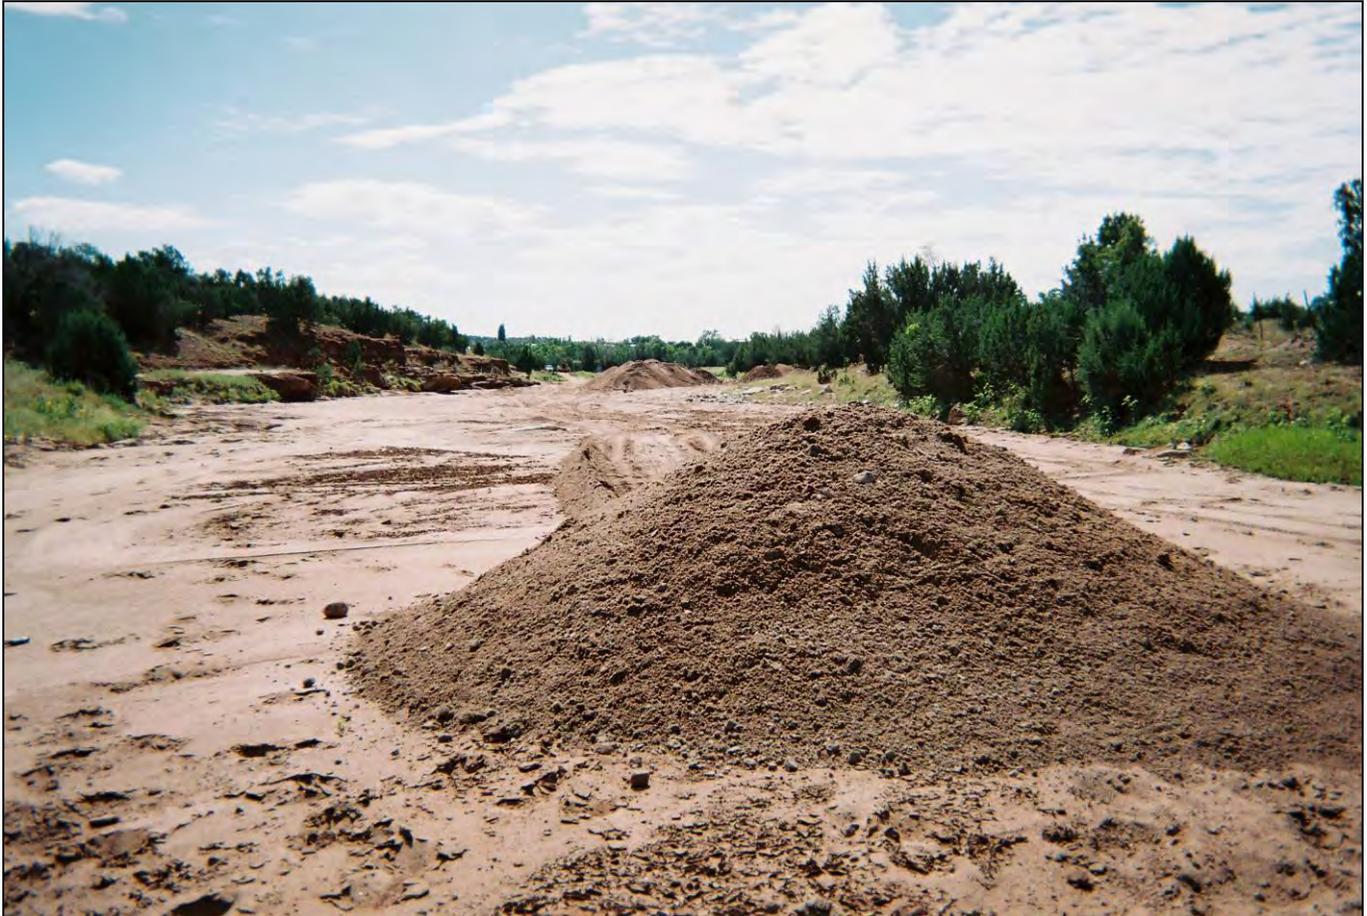
NMED/SWQB  
Official Photograph Log  
Photo # 2

Subject: Looking downstream at sand and gravel stockpile in Tecolote Creek (location is approximately 1,000 feet upstream from the confluence of Tecolote Creek and Pecos River). Stockpile would not meet compaction specifications for the water utility line and was moved by the general contractor to this upstream location according to on-site permittee representatives.

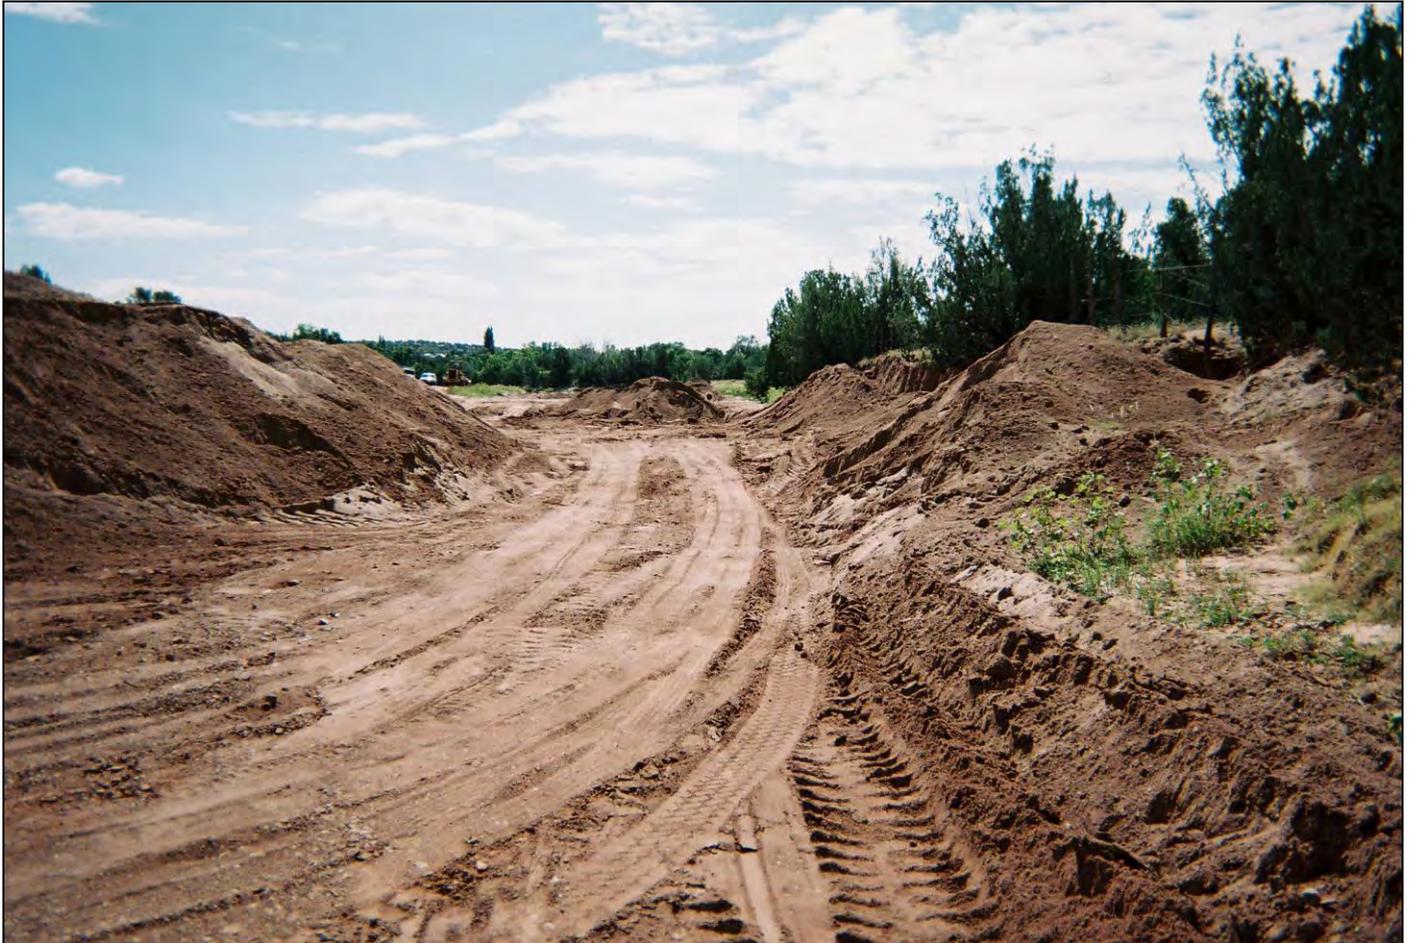
<b>NMED/SWQB Official Photograph Log Photo # 3</b>		
Photographer: Erin S. Trujillo	Date: 09/07/2010	Time: btw approx 1100-1115 hours
City/County: North of Tecolotito / San Miguel County		State: New Mexico
Location: Sangre De Cristo Regional MDWC & MSWA Water System Phase 3, Construction Sand Mining/Borrow Area		
Subject: Looking downstream at recent disturbance from construction sand mining and stockpile activities in and along the bank of Tecolote Creek by the general contractor.

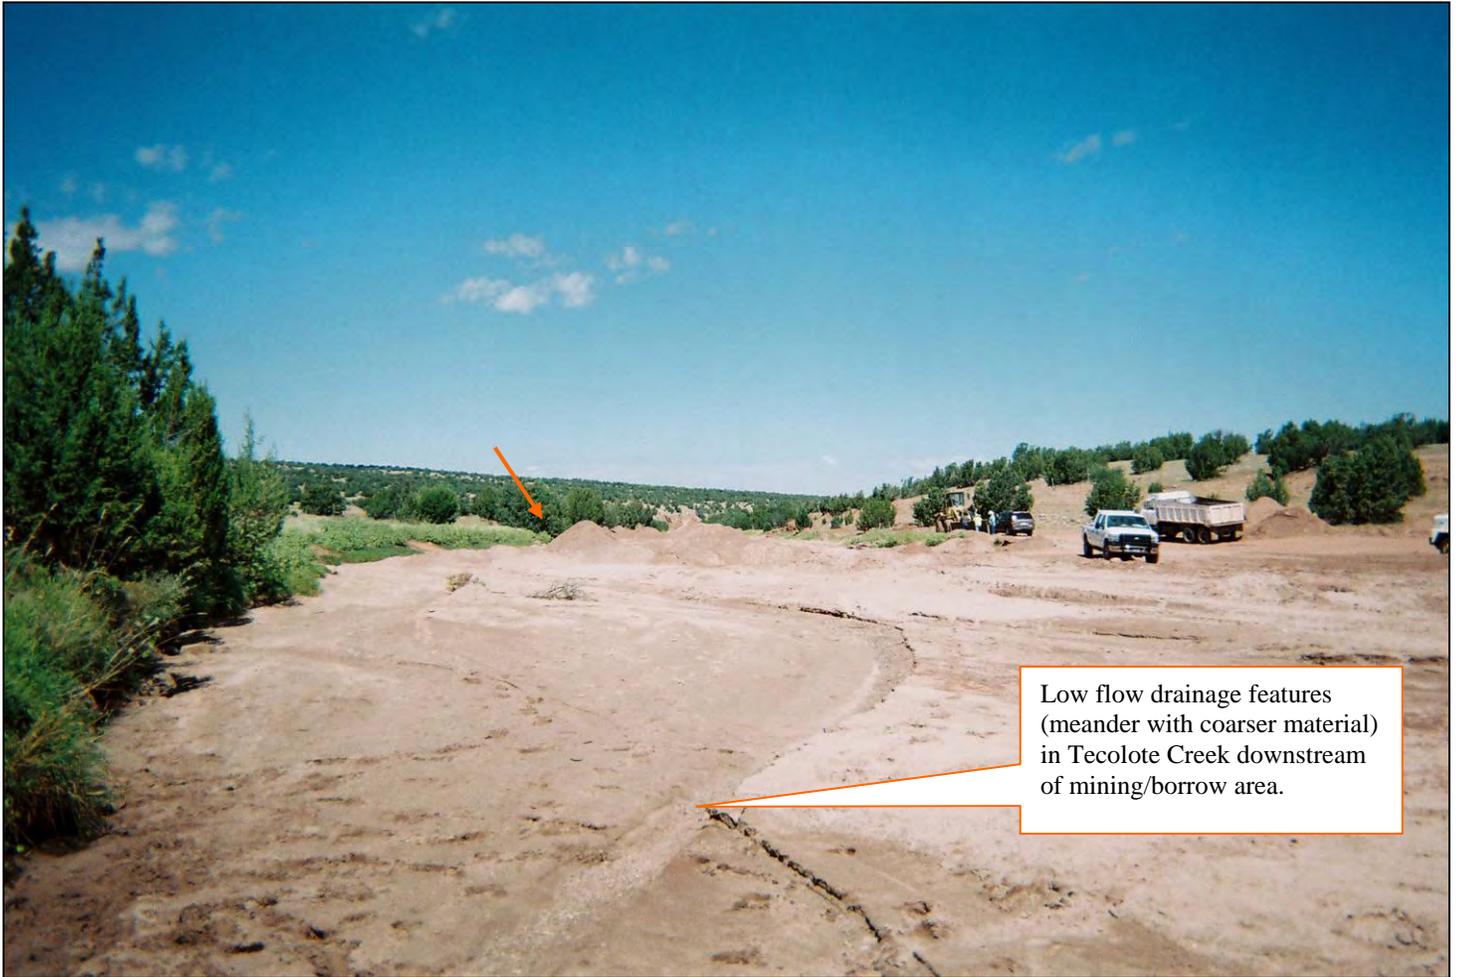
NMED/SWQB Official Photograph Log Photo # 4		
Photographer: Erin S. Trujillo	Date: 09/07/2010	Time: btw approx 1115-1130 hours
City/County: North of Tecolotito / San Miguel County		State: New Mexico
Location: Sangre De Cristo Regional MDWC & MSWA Water System Phase 3, Construction Sand Mining/Borrow Area		
Subject: Looking upstream at Tecolote Creek from the confluence at Pecos River. Arrow points to limits of J & H Services, Inc. construction sand mining in Tecolote Creek approximately 140 feet upstream from the confluence at Pecos River.

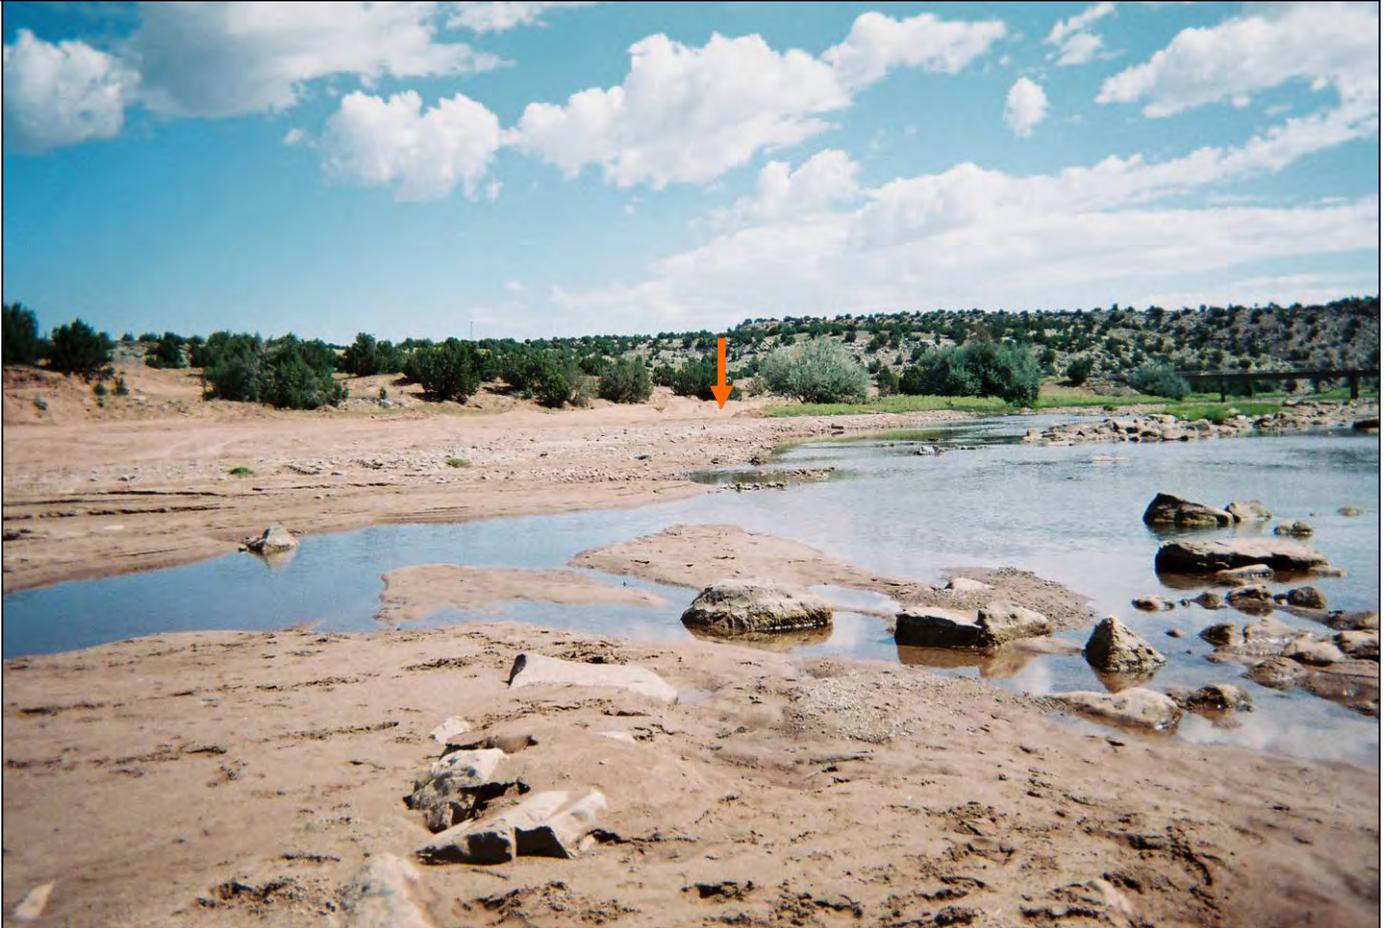
NMED/SWQB Official Photograph Log Photo # 5		
Photographer: Erin S. Trujillo	Date: 09/07/2010	Time: btw approx 1115-1130 hours
City/County: North of Tecolotito / San Miguel County		State: New Mexico
Location: Confluence of Tecolote Creek and Pecos River		
Subject: Looking downstream at confluence and north bank of Pecos River on day of inspection. Arrow points to approximate area shown in Photo 1.

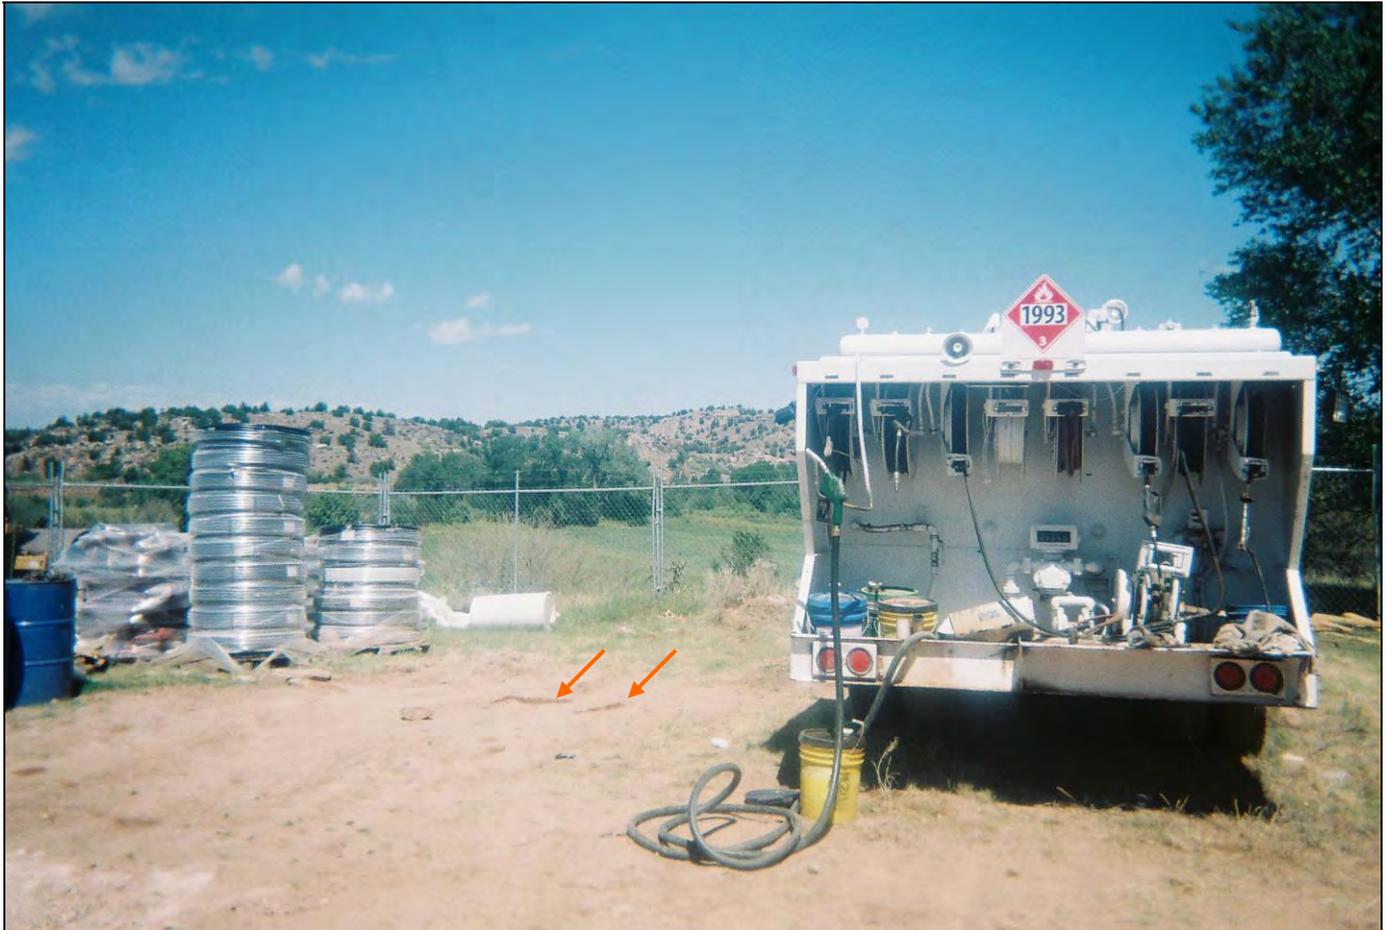
NMED/SWQB Official Photograph Log Photo # 6		
Photographer: Erin S. Trujillo	Date: 09/07/2010	Time: approximately 1245 hours
City/County: Anton Chico / Guadalupe County		State: New Mexico
Location: Sangre De Cristo Regional MDWC & MSHA Water System Phase 3		
Subject: Mobile re-fueling truck at equipment and material yard in Anton Chico. Arrows point to oil spills on ground. Hose on ground with green fuel nozzle is not protected from possible damage by vehicle traffic.
