**RE: Construction Storm Water, SIC 1542, NPDES Compliance Evaluation Inspection, Makwa Builders, LLC / New Mexico Highlands University Student Union, NMR10H379, June 9, 2011**

### NPDES Compliance Inspection Report

## NPDES Industrial Storm Water Worksheet (Construction)

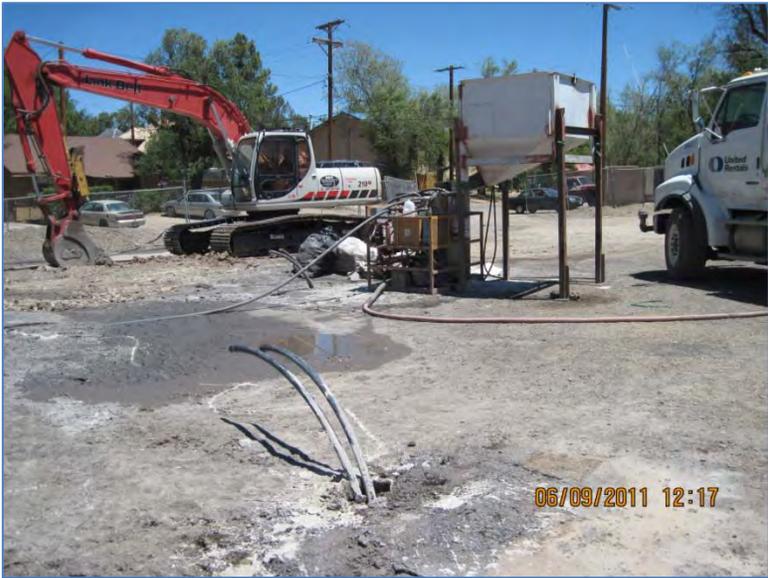
<b>NMED/SWQB Official Photograph Log Photo #1</b>		
Photographer: Erin S. Trujillo	Date: 06/09/2011	Time: 1217 hours
City/County: Las Vegas / San Miguel County		State: New Mexico
Location: New Mexico Highlands University, Student Union, Geothermal Well Drilling Area		
Subject: Pulvarized cuttings, grout and sand at surface.

<b>SWPPP Implementation</b> <i>(complete in field)</i>	
<b>Stabilization Practices</b>	
<p><b>List and describe stabilization practices</b> <i>ESO Element 42, 48</i></p>	<p><i>(e.g., seeding, mulching, geotextiles, sod stabilization)</i></p> <p><u>Student Union</u>: Stabilization had occurred in the areas with vertical construction. Some artificial grass where runoff was anticipated had not been disturbed.</p> <p><u>Off-Site Support Area (Equipment Staging/Material Storage)</u>: Most existing vegetation in the off-site equipment staging and material storage area at the corner of Reynolds Avenue and 9<sup>th</sup> Street had been preserved which provided stabilization. Mulching that existed at this off-site support activity area prior to construction also remained. However, an excavated material stockpile in the off-site support activity area had not been stabilized.</p> <p><u>Geothermal Well Drilling Area</u>: Gravel of the former parking lot provided stabilization. The portion of the area where drilling had occurred was disturbed and pulverized cuttings were at the surface.</p>

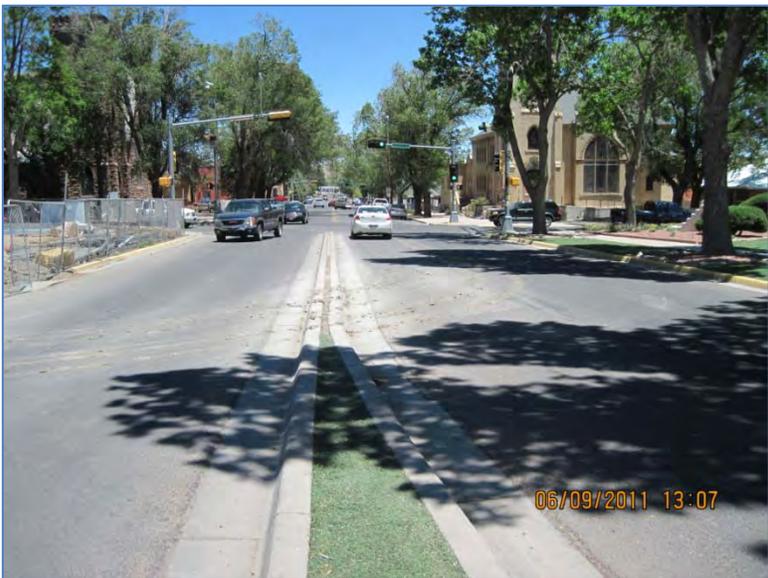
<b>NMED/SWQB Official Photograph Log Photo #2</b>		
Photographer: Erin S. Trujillo	Date: 06/09/2011	Time: 1307 hours
City/County: Las Vegas / San Miguel County		State: New Mexico
Location: New Mexico Highlands University, Student Union, Building Construction Area		
Subject: Vehicle tracking at exit/entrance shown in next photo.

<b><u>Non-Structural Practices</u></b>	
<p><b>Street Cleaning</b> ESO Element 43</p>	<p><i>(e.g., describe measures taken to remove offsite accumulation of sediment)</i></p> <p>Inspection logs refer to sweeping drive. Off-site accumulation of sediment/mud needed to be removed at a temporary exit at the Student Union construction area. The temporary exit was not noted on the site map.</p>
<p><b>Good Housekeeping &amp; Waste Disposal Practices</b> ESO Element 44</p>	<p><i>(e.g., describe measures taken to prevent litter and debris from becoming a pollutant source)</i></p> <p>No windblown litter or trash was observed. Most materials were protected from precipitation or stormwater (stored on pallets or stored in covered shipping containers). Trash and recycled materials were disposed and stored in roll offs. Off-site disposal and removal of recycled materials conducted routinely according to on-site owner/operators' representatives.</p>

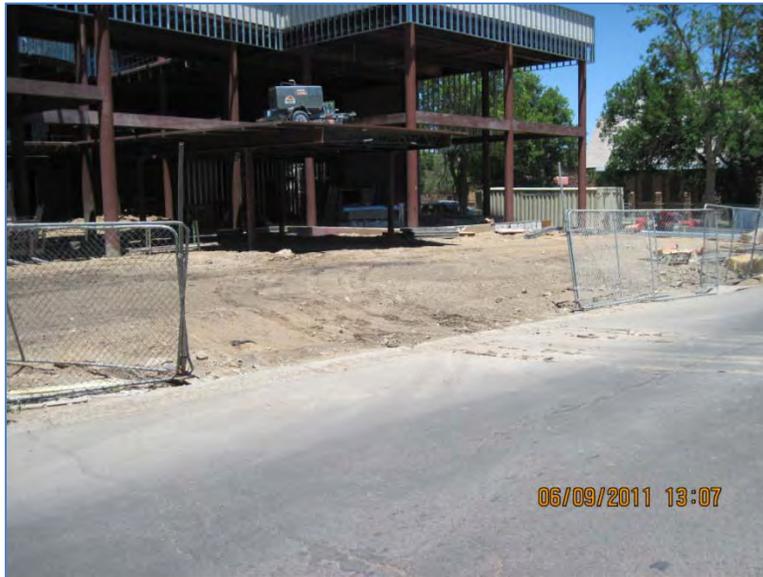
<b>NMED/SWQB          Official Photograph Log          Photo # 3</b>		
Photographer: Erin S. Trujillo	Date: 06/09/2011	Time: 1307 hours
City/County: Las Vegas / San Miguel County		State: New Mexico
Location: New Mexico Highlands University, Student Union, Building Construction Area		
Subject: No vehicle tracking control measures observed at exit/entrance. On-site mud is from watering for dust control according to owner/operators' on-site representatives.

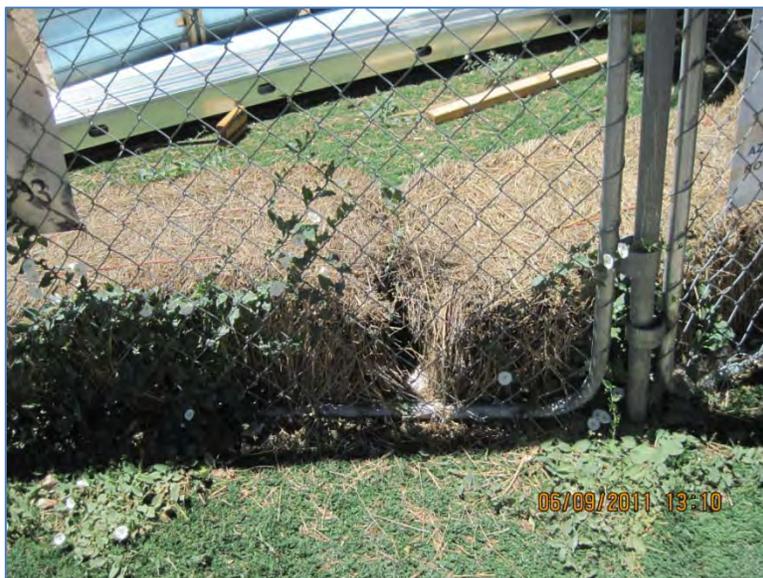
<b>NMED/SWQB          Official Photograph Log          Photo # 4</b>		
Photographer: Erin S. Trujillo	Date: 06/09/2011	Time: 1310 hours
City/County: Las Vegas / San Miguel County		State: New Mexico
Location: New Mexico Highlands University, Student Union, Building Construction Area		
Subject: Gap in bale. Artificial grass and vegetation was preserved in this area.

<b><u>Structural Practices</u></b>	
<p><b>List and describe structural controls</b> ESO Element 41, 42, 46</p>	<p><i>(e.g., silt fences, hay bales, storm drain inlet protection, sedimentation pond, rip rap, check dam, diversion structure, off-site vehicle track-out)</i></p> <p><b>Student Union:</b> Details on how hay or straw bales would be linked and anchored to the ground was not provided in the SWPPP. Hay bales and straw wattles were placed where runoff was anticipated, but these control measures had small gaps and were not overlapped.</p> <p><b>Geothermal Well Drilling Area:</b> Coarse gravel berm, hale bales and wattle at this area were not sufficient to contain discharges of process waters and pulverized drilling cuttings on site. Therefore, additional measures may also be needed for stormwater discharges in the disturbed areas and material storage in this area.</p> <p><b>Off-Site Support Area (Equipment Staging/Material Storage Area):</b> Except for the excavated material stockpile, the preservation of vegetation appeared to be sufficient to control erosion. However, additional pollution prevention measures including track-out control may be needed if access or disturbance is anticipated when removing the equipment, materials and perimeter fencing.</p>

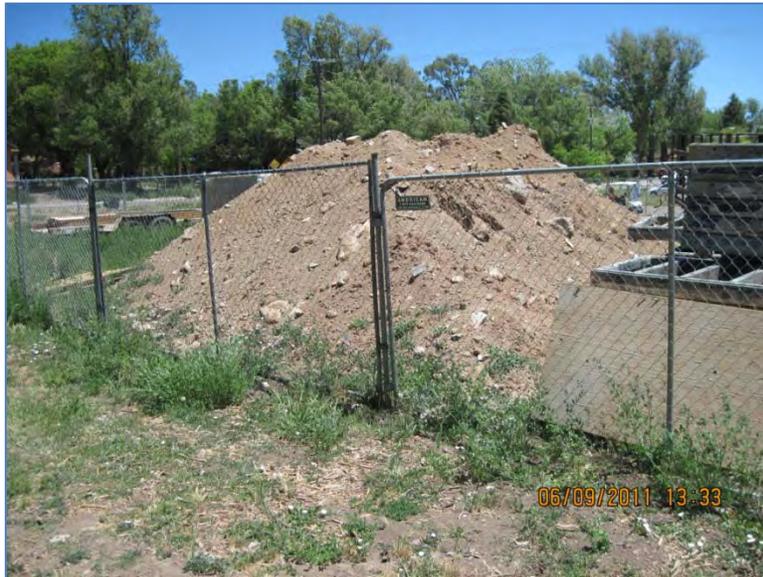
<b>NMED/SWQB Official Photograph Log Photo #5</b>		
Photographer: Erin S. Trujillo	Date: 06/09/2011	Time: 1333 hours
City/County: Las Vegas / San Miguel County		State: New Mexico
Location: New Mexico Highlands University, Student Union, Off-site Support Area		
Subject: Excavated material stockpile was not stabilized. There were no structural erosion or sediment control measures for the stockpile.

<p><b>Are stabilization measures initiated no more than 14 days after temporary or permanent construction cessation?</b> <i>ESO Element 45</i></p>	<p><i>(e.g., indicate "yes" or "no"; if "yes", how long without stabilization measures?)</i></p> <p>Based on information from owner/operators representatives, the excavated material stockpile in the off-site support activity area had existed for more than 14 days and was not stabilized.</p>

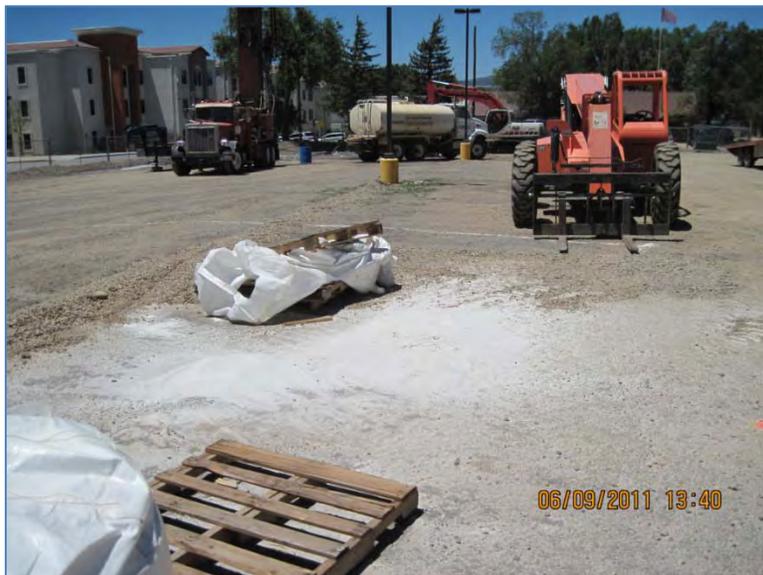
<b>NMED/SWQB Official Photograph Log Photo # 6</b>		
Photographer: Erin S. Trujillo	Date: 06/09/2011	Time: 1340 hours
City/County: Las Vegas / San Miguel County		State: New Mexico
Location: New Mexico Highlands University, Student Union, Geothermal Well Drilling Area		
Subject: Sand used in geothermal well completion was stored in central location of area away from property boundaries. But, clean up and/or additional measures appear needed to prevent the material from discharging off-site during a rain event.
