**RE: Construction Stormwater, SIC 1542, NPDES Compliance Evaluation Inspection, Enchanted 528 Development LLC, Enchanted Hills Plaza Construction Project, NPDES Permit NMR10H765, Rio Rancho, New Mexico, May 10, 2011**

### NPDES Compliance Inspection Report

## Official Photograph Log

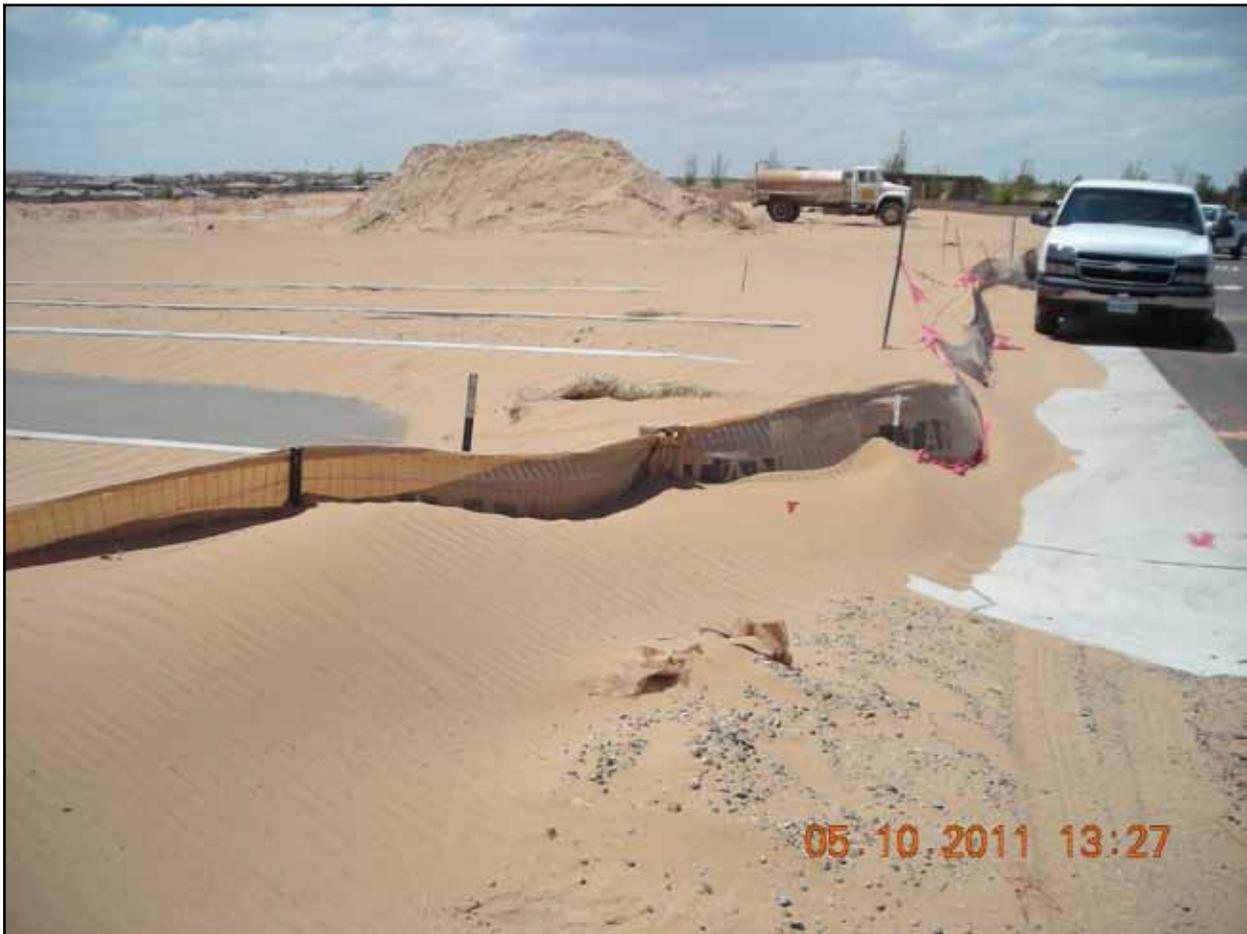
Photo # 1

Photographer: Sarah Holcomb	Date: 5-10-2011	Time: 1327 hours
City/County: Rio Rancho/Sandoval		
Location: Enchanted Hills Plaza construction site, near Hwy 528 and Enchanted Hills Blvd.		
Subject: Failing silt fence on northern end of the project.

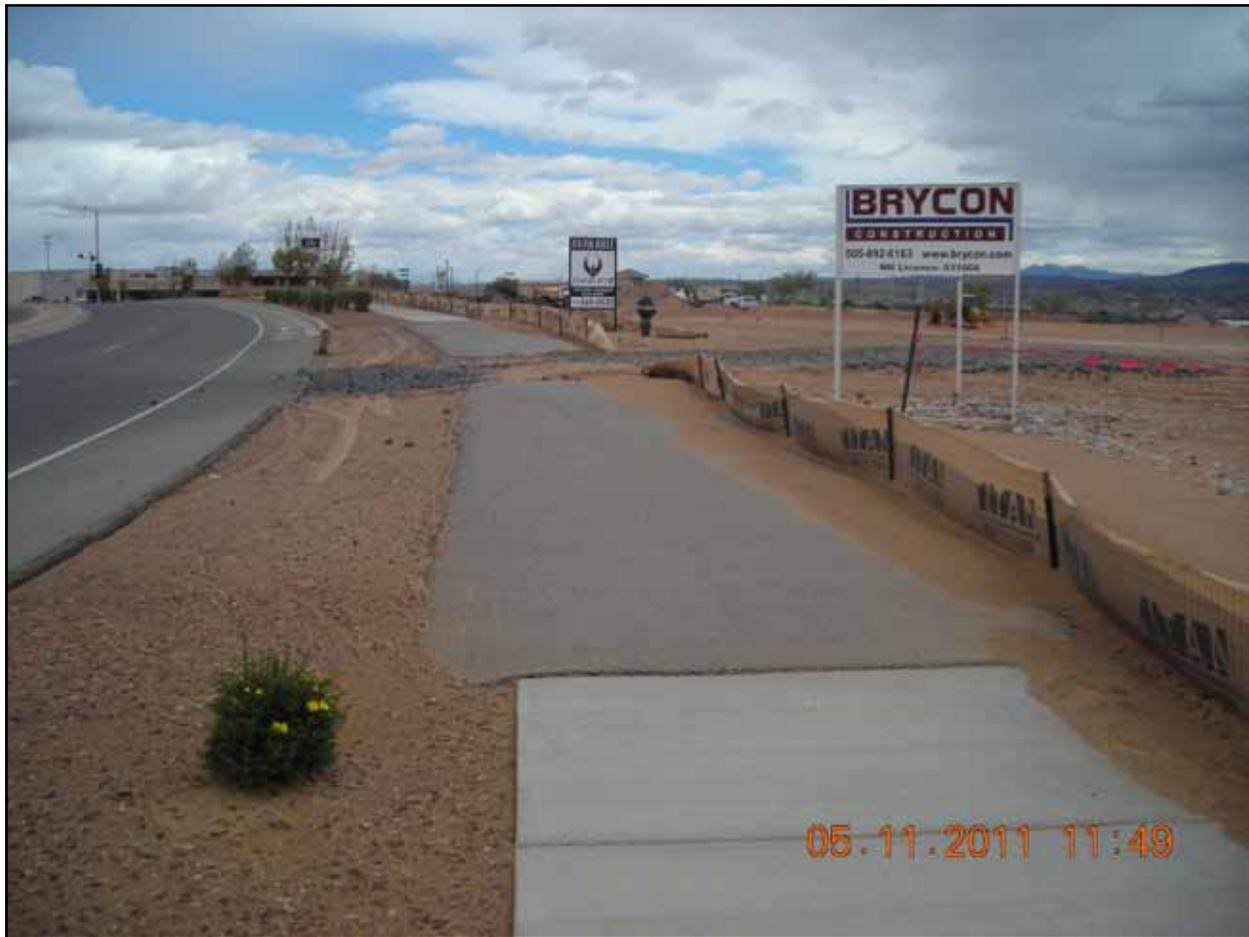
Photo # 2

Photographer: Sarah Holcomb	Date: 5-11-2011	Time: 1149 hours
City/County: Rio Rancho/Sandoval		
Location: Enchanted Hills Plaza construction site, near Hwy 528 and Enchanted Hills Blvd.		
Subject: Construction site entrance. Cobble needs to be maintained. Also, note silt fence needs to be maintained on this (western) side of the site as well.

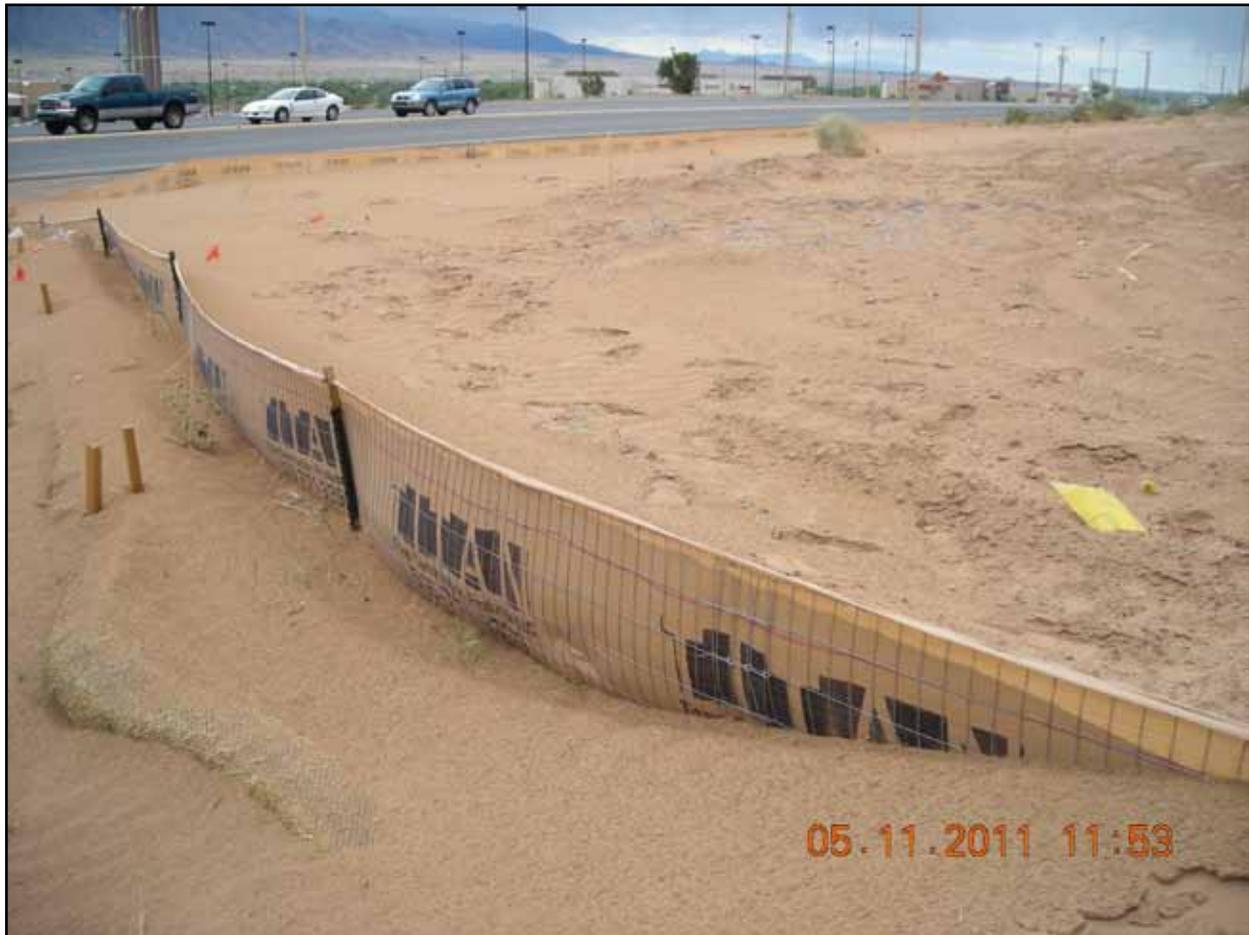
Photo # 3

Photographer: Sarah Holcomb	Date: 5-11-2011	Time: 1153 hours
City/County: Rio Rancho/Sandoval		
Location: Enchanted Hills Plaza construction site, near Hwy 528 and Enchanted Hills Blvd.		
Subject: Failing silt fence at northeastern corner of the site.

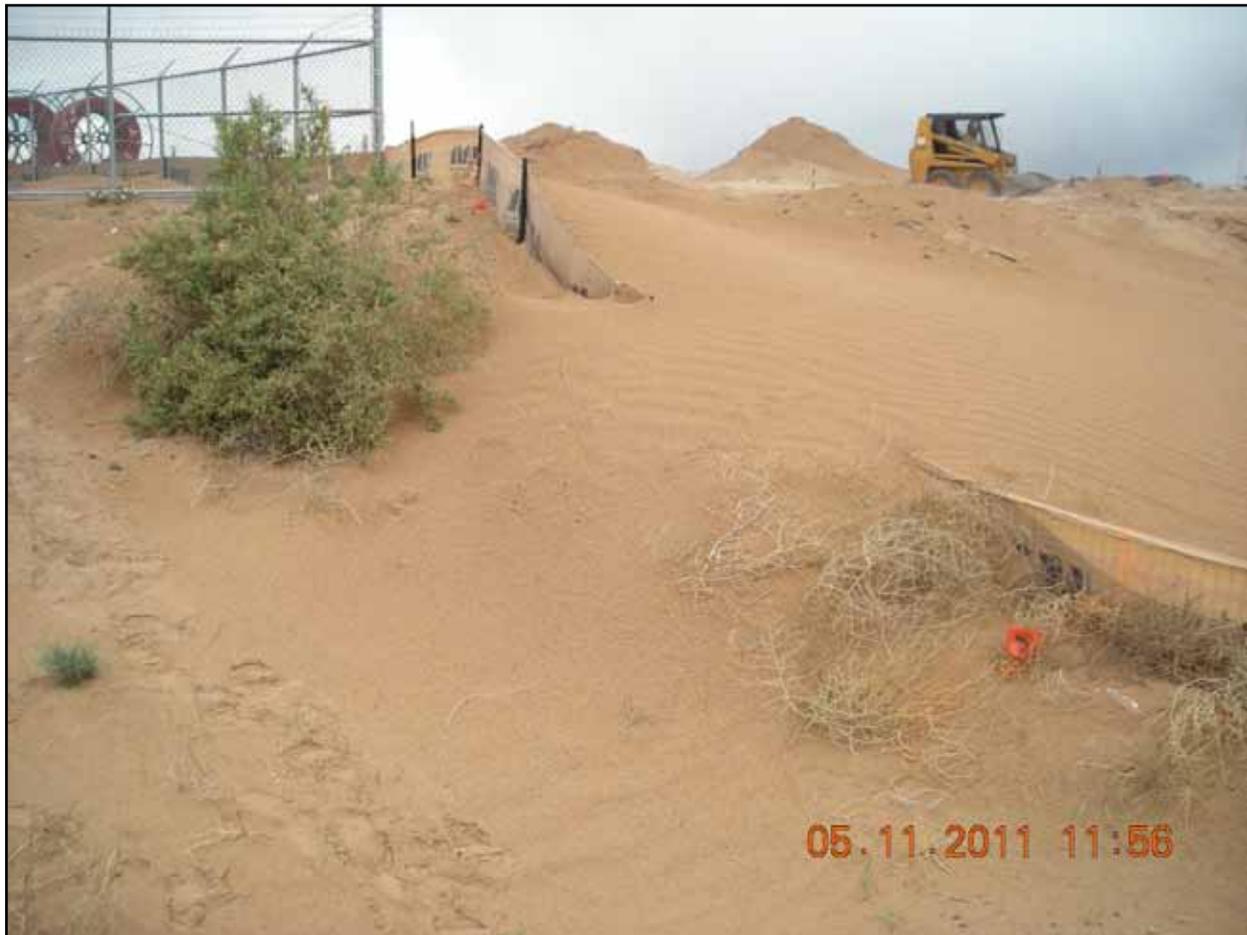
Photo # 4

Photographer: Sarah Holcomb	Date: 5-11-2011	Time: 1156 hours
City/County: Rio Rancho/Sandoval		
Location: Enchanted Hills Plaza construction site, near Hwy 528 and Enchanted Hills Blvd.		
Subject: Failed silt fencing at southeastern corner of the site.

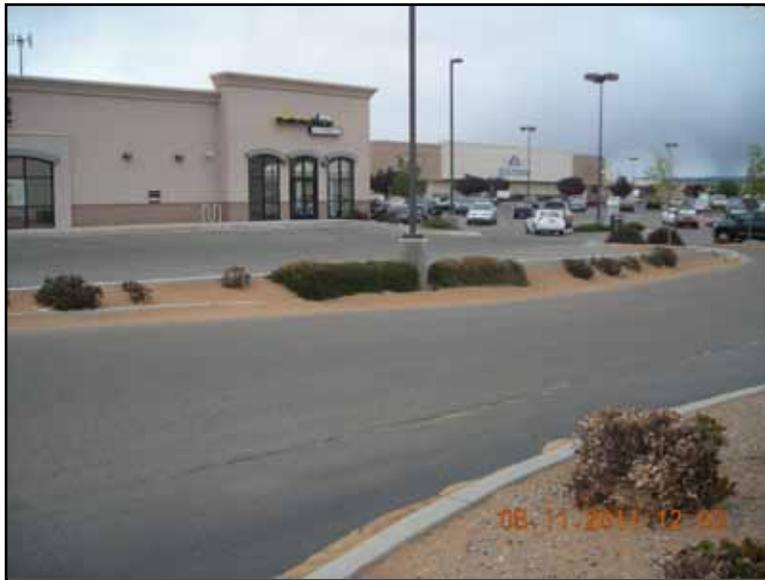
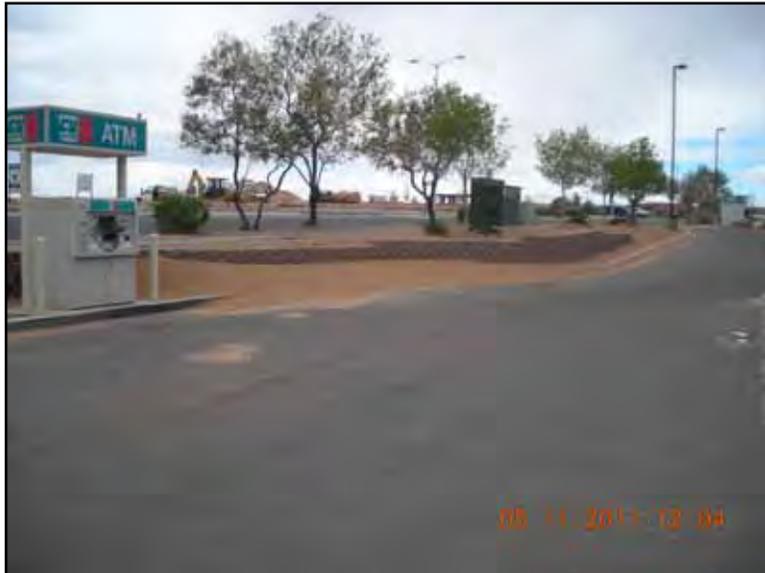
Photo # 5

Photographer: Sarah Holcomb	Date: 5-11-2011	Time: 1203 & 1204 hours
City/County: Rio Rancho/Sandoval		
Location: Enchanted Hills Plaza construction site, near Hwy 528 and Enchanted Hills Blvd.		
Subject: Sediment has overwhelmed the adjacent parking lot and landscaping of the businesses next to the construction site. No street sweeping has occurred.
