NEW MEXICO  
ENVIRONMENT DEPARTMENT

*Surface Water Quality Bureau*

**RE: Construction Storm Water; SIC 1611; NPDES Compliance Evaluation Inspection; Las Vegas Solar Energy Center; NMR10HC67; June 29, 2011**

### NPDES Compliance Inspection Report

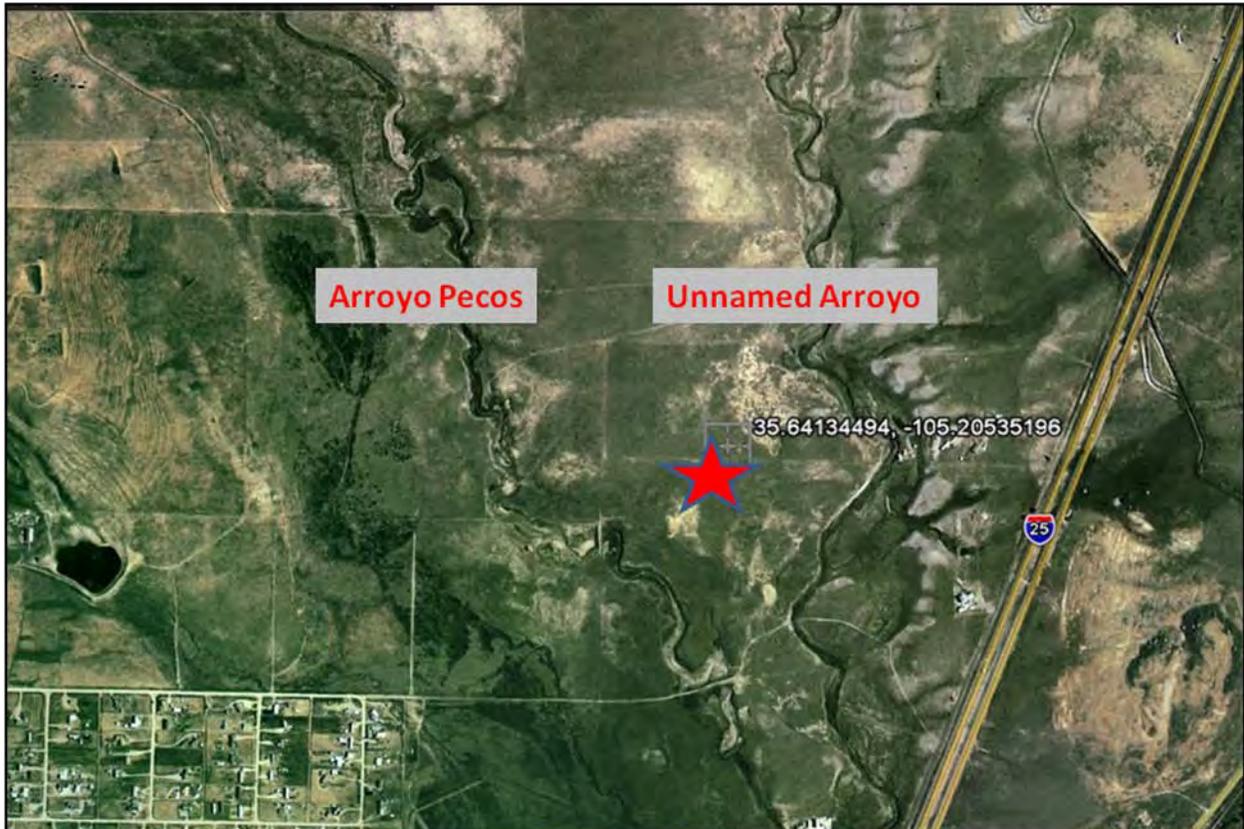
**NMED/SWQB  
Site Overview**

City/County: North of the City of Las Vegas/San Miguel County	
Location: 3140 7 <sup>th</sup> Street, Las Vegas, New Mexico 87701	
Subject: Location of the Las Vegas Solar Energy Center

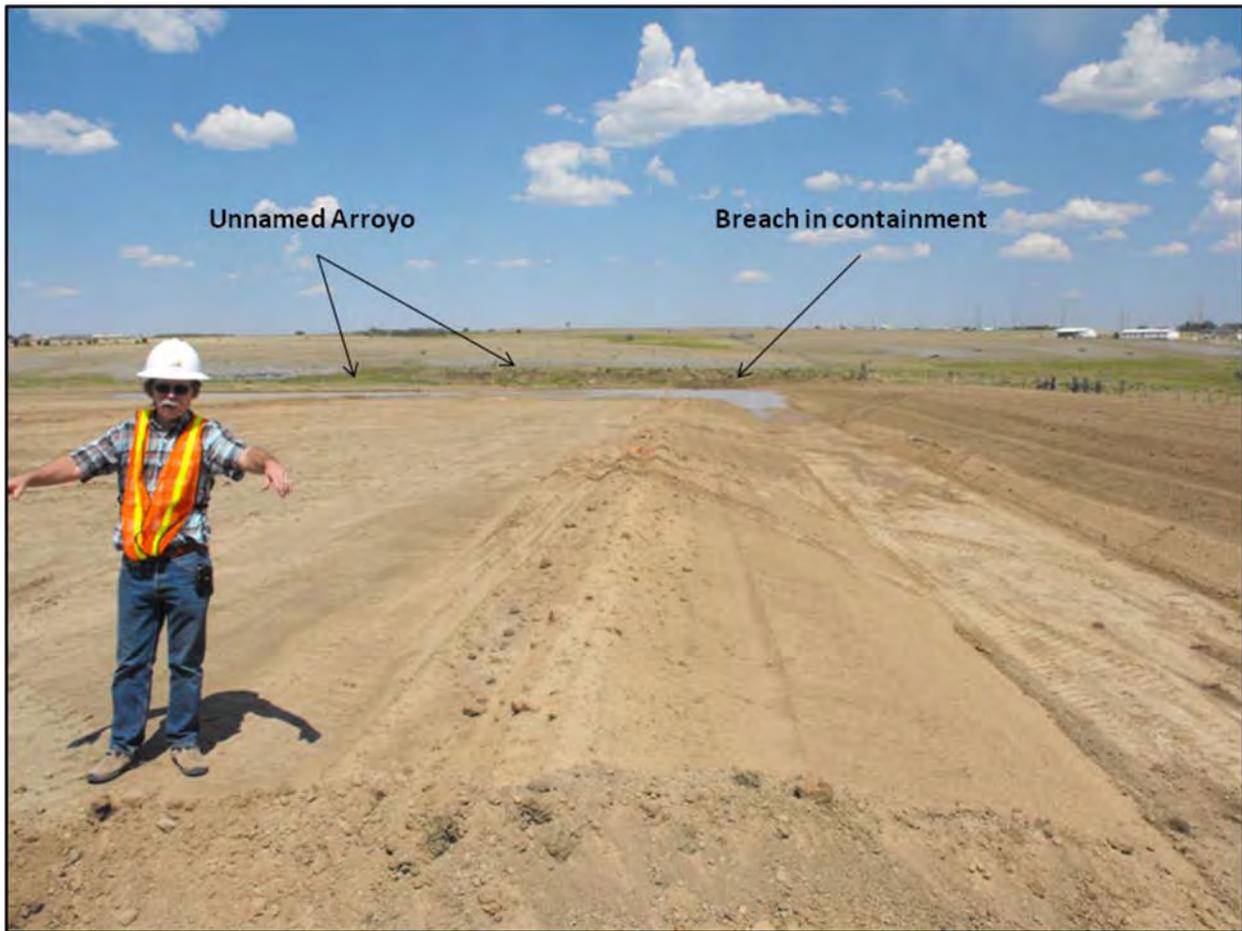
Photo # 1

The road leading into the site had the BMP's as described in the SWPPP. The road crossing through the Arroyo Pecos had the described BMP's. However the main disturbed area, (see photo 1-4) had no BMP's in place, along the Arroyo Pecos and the unnamed arroyo to the east, (see overview). The small detention pond on the east side had been intentionally breached and the contents discharged into the unnamed arroyo by the digging of a trench.

Photographer: Daniel Valenta	Date: 6/29/2011	Time: 1525 hours
City/County: North of the City of Las Vegas/San Miguel County		
Location: Las Vegas Solar Energy Center, 3140 7 <sup>th</sup> Street, Las Vegas, New Mexico 87701, facing east.		
Subject: East sloping site of side toward the unnamed arroyo.

Pictures have been sent to the Inspector during the writing of this report documenting the completion of the sediment ponds and silt fences to correct the missing BMP's on the east and west side of the construction project.

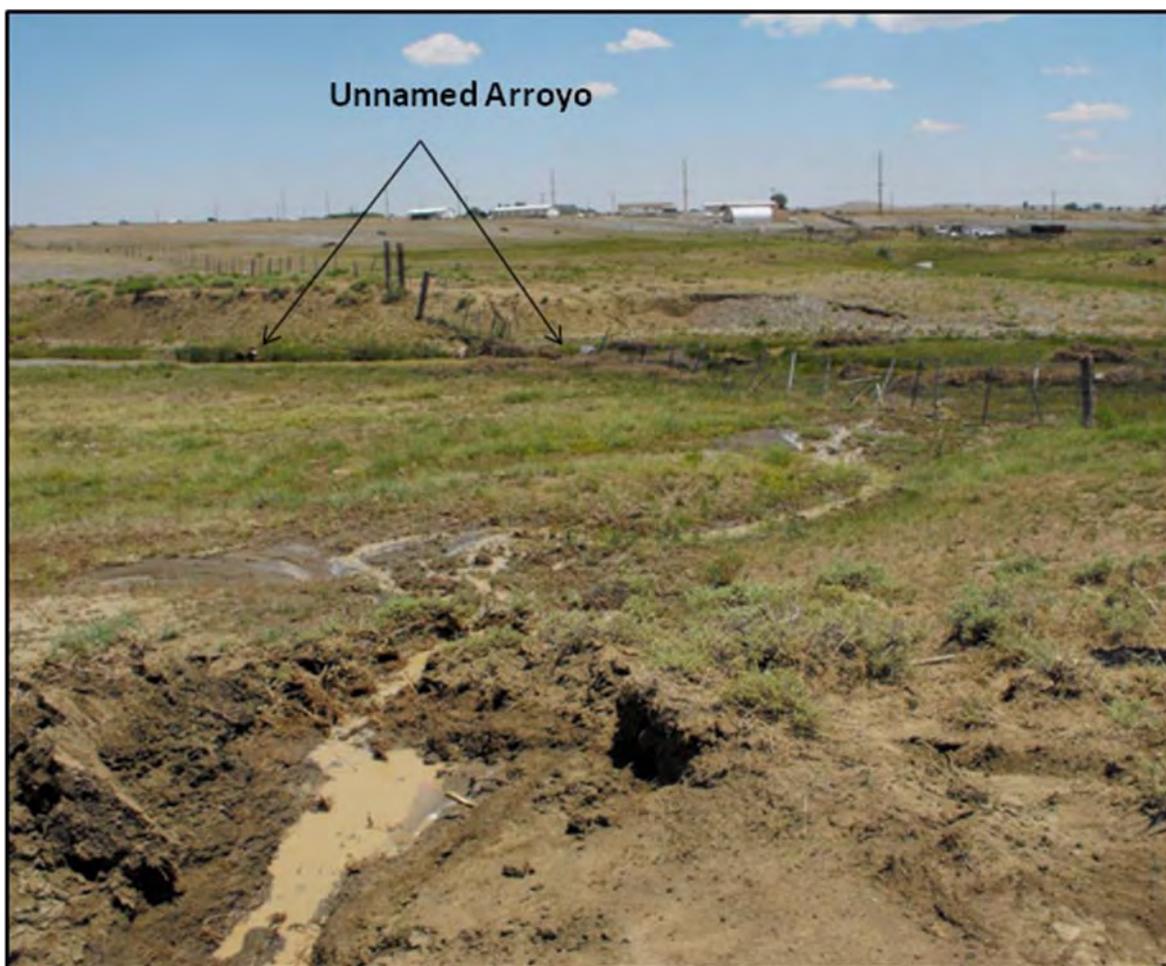
Photo # 2

Photographer: Daniel Valenta	Date: 6/29/2011	Time: 1528 hours
City/County: North of the City of Las Vegas/San Miguel County		
Location: Las Vegas Solar Energy Center, 3140 7 <sup>th</sup> Street, Las Vegas, New Mexico 87701, facing east.		
Subject: Ditch was dug to breach the containment berm and discharge to the unnamed arroyo.

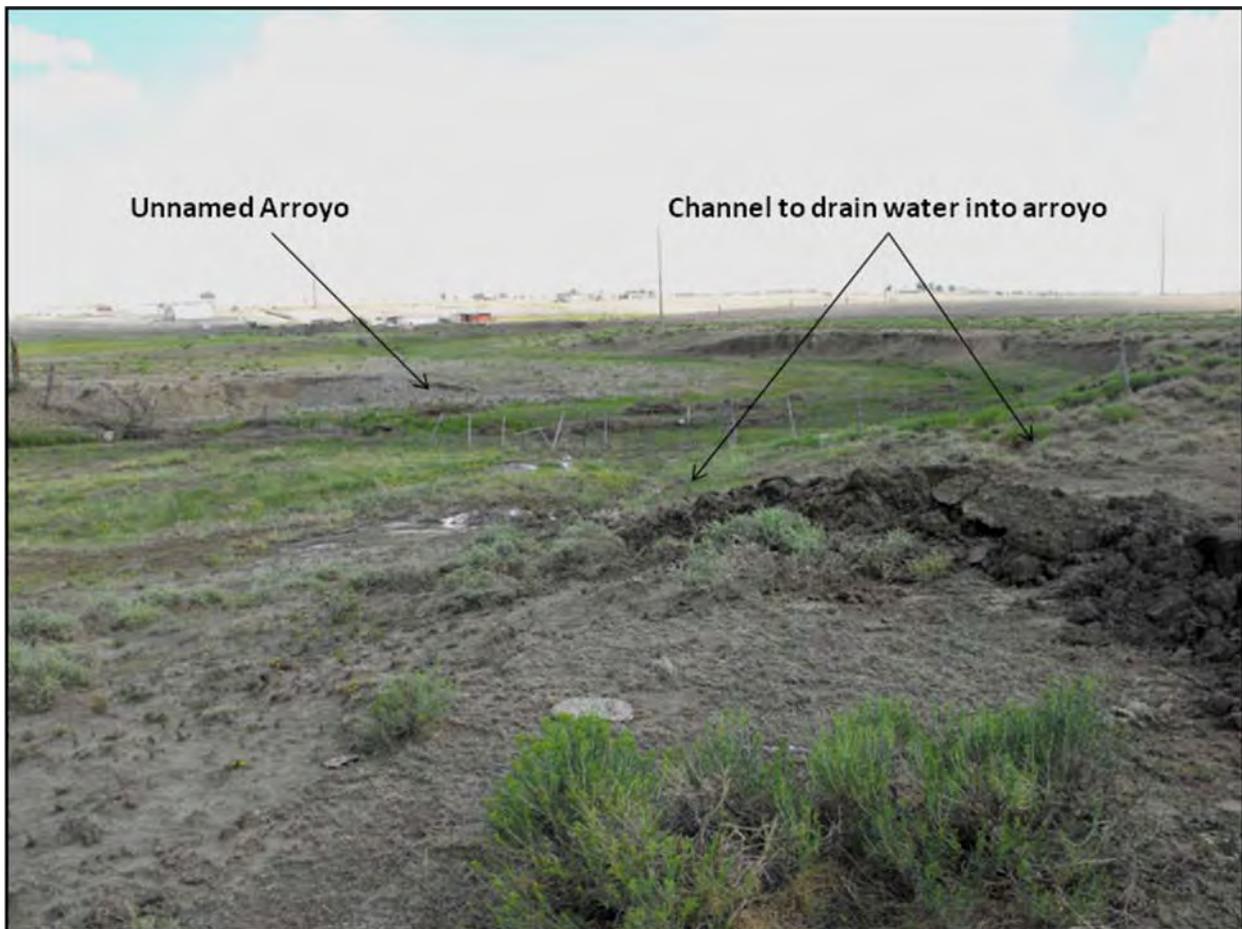
Photo # 3

Photographer: Daniel Valenta	Date: 6/29/2011	Time: 1529 hours
City/County: North of the City of Las Vegas/San Miguel County		
Location: Las Vegas Solar Energy Center, 3140 7 <sup>th</sup> Street, Las Vegas, New Mexico 87701, facing southeast.		
Subject: Ditch was dug to breach the containment berm and discharge to the unnamed arroyo.

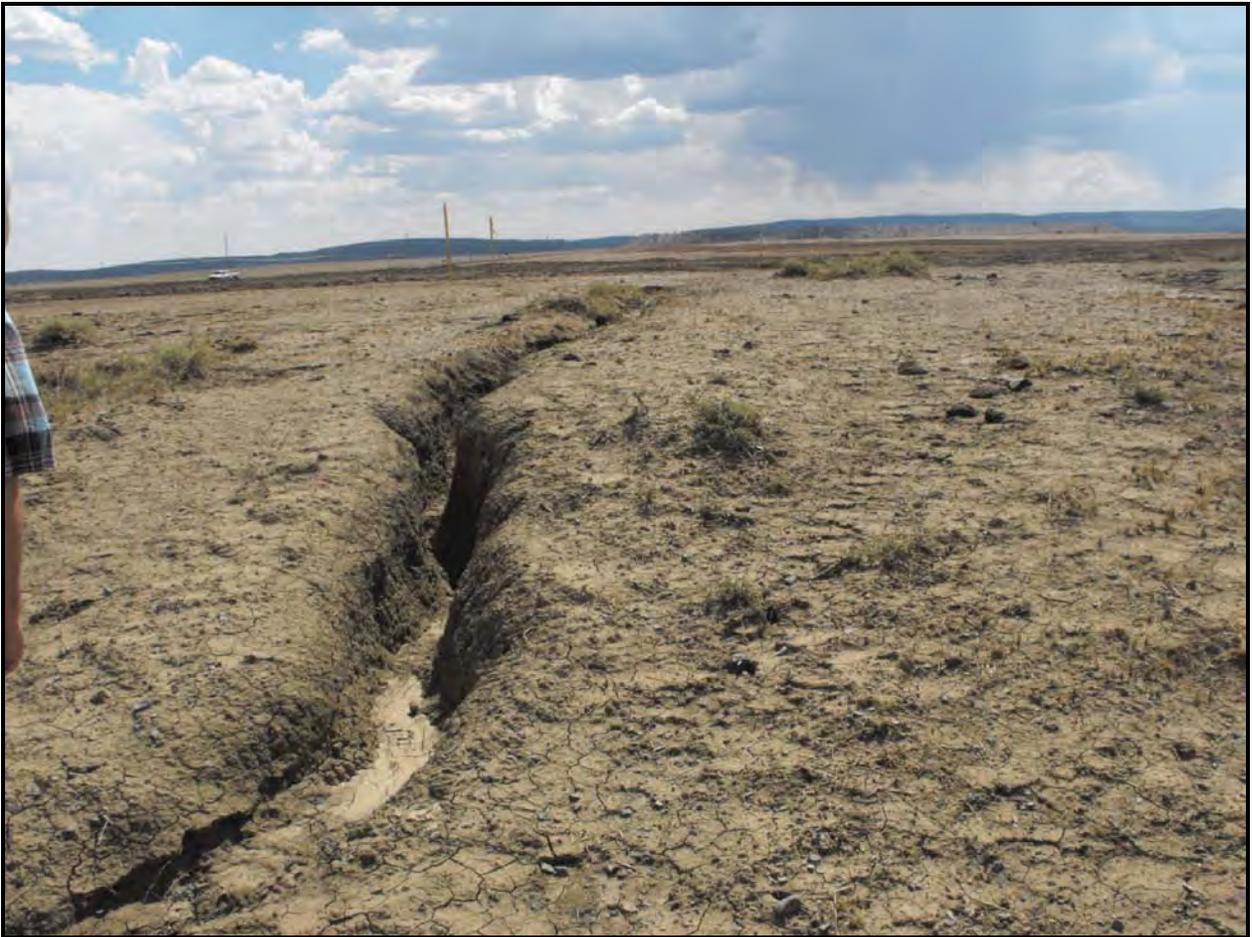
Photo # 4

All discharge locations inspected if accessible, or if not accessible, are nearby downstream locations inspected? <i>ESO Element 36; 37</i>	Y <input checked="" type="checkbox"/> N	Inspection reports note discharge points were inspected and no sediment deposits found. However Inspectors on 6/29/11 found sheet flow and down cutting from water/sediment leaving the site and entering the arroyo along with a channel that was dug to drain the sediment pond into the arroyo, see photos.
Entrance/exit inspected for off-site tracking? <i>ESO Element 38</i>	<input checked="" type="checkbox"/> Y <input type="checkbox"/> N	
Inspection report contain all required items and certified? <i>ESO Element 39; 40</i>	<input checked="" type="checkbox"/> Y <input type="checkbox"/> N

Photographer: Daniel Valenta	Date: 6/29/2011	Time: 1536 hours
City/County: North of the City of Las Vegas/San Miguel County		
Location: Las Vegas Solar Energy Center, 3140 7 <sup>th</sup> Street, Las Vegas, New Mexico 87701, facing west.		
Subject: Facing west away from the unnamed arroyo toward the construction site. Visible traces of flow discharging from the construction site along channels.
