RE: Construction Storm Water; SIC 1611; NPDES Compliance Evaluation Inspection; Les File Drywall; NMR10HK37; January 4, 2012

NPDES Industrial Storm Water Worksheet (Construction)

Facility Location Information					
Name/Location/ Mailing Address	Dollar General Retail Store/ 1811 Coors Blvd (NM Hwy 45), Albuquerque, NM 87107				
GPS Coordinates	Latitude	N. 35° 03' 10.79"	Longitude	W. -106° 42' 26.33"	
Receiving Water(s)	Albuquerque MS4; thence to Arenal Canal; thence to the Rio Grande				
Disturbed Area	1.2 acres	Start Date	10/26/2011	Stop Date	2/29/2012

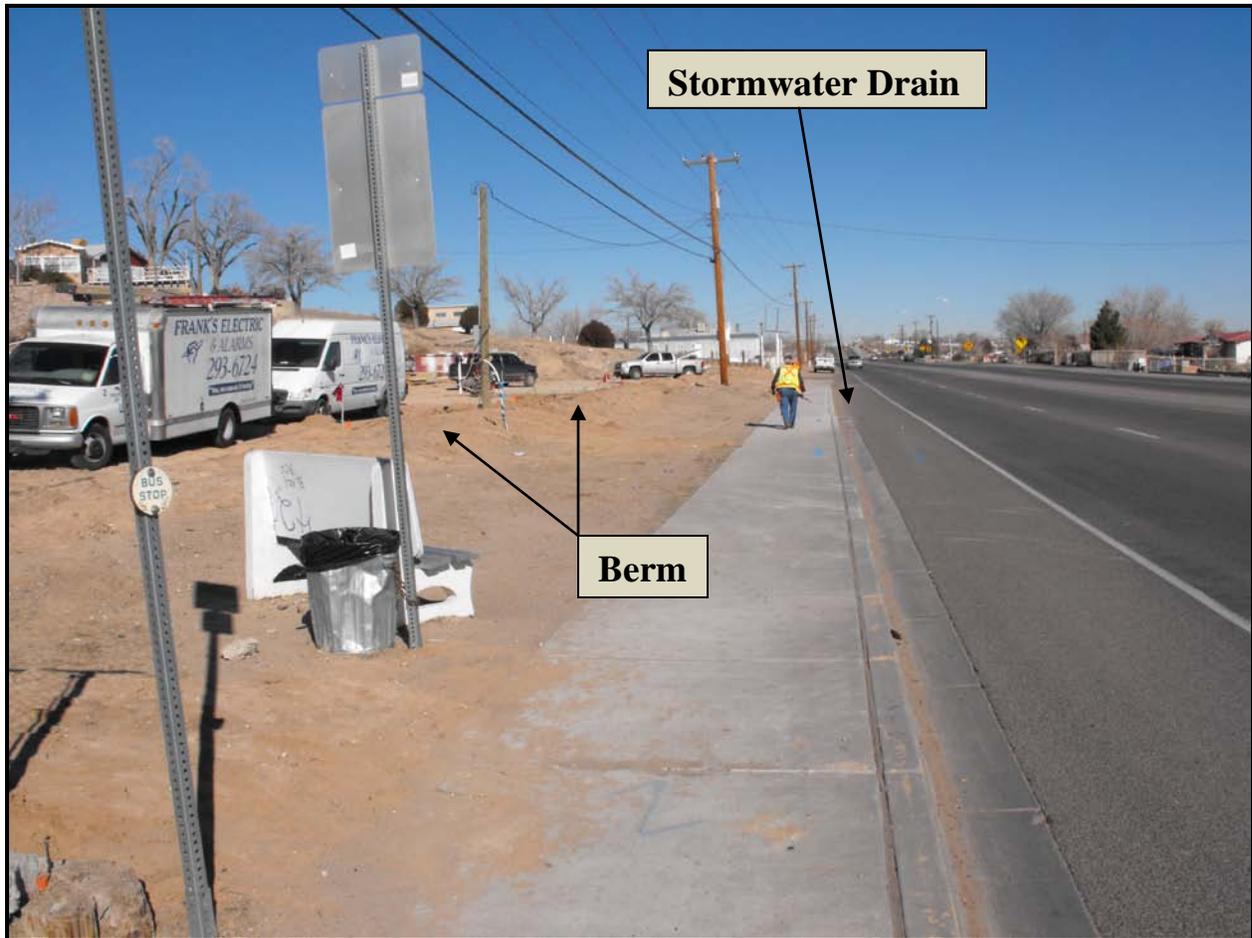
Photo # 1

The site is a 1.2 acre lot facing Coors Blvd, a busy four lane road (see photo 1). The back of the site is an undeveloped lot which has a higher elevation, water would flow from the back to the front. The north and south side of the site is bermed on one side, cinder block wall on the other; thus stormwater could not flow on to the property or off the site in this direction. The front of the site has a small berm approximately 15 feet from the sidewalk; The construction site is lower in elevation than the sidewalk.

<u>Non-Structural Practices</u>	
<p>Good Housekeeping & Waste Disposal Practices ESO Element 45</p>	<p><i>(e.g., describe measures taken to prevent litter and debris from becoming a pollutant source)</i></p> <p>Good housekeeping practices are discussed in detail the SWPPP. Site appeared clean and ordered.</p>
<p>Equipment Wash/Maintenance Area ESO Elements 43</p>	<p><i>(provide brief description)</i></p> <p>Apparently, no equipment maintenance is conducted on-site.</p>
<p>Concrete Washout Areas ESO Elements 43</p>	<p><i>(provide brief description)</i></p> <p>At one corner of the property there appeared to be dried concrete wash out. It was contained in this area.</p>
<u>Miscellaneous</u>	
<p>Evidence of Sediment Deposition to Surface Waters <i>*ESO Eligibility - if "yes," site not eligible for ESO</i></p>	<p><i>(e.g., significant turbidity observed in a receiving water body)</i></p> <p>Sediment from the entrance/exit had been tracked to the street and into the stormwater drain, (see photo 1).</p>

Photographer: Daniel Valenta	Date: 1/4/2012	Time: hours 1142
City/County: Albuquerque/Bernalillo		
Location: 1811 Coors Blvd (NM Hwy 45), Albuquerque, New Mexico, facing north.		
Subject: Front of Dollar General retail store construction site.
