**RE: Construction Storm Water; SIC 1611; NPDES Compliance Evaluation Inspection; Los Alamos Municipal Building; NMR10HM32; February 29, 2012**

### NPDES Compliance Inspection Report

## NPDES Industrial Storm Water Worksheet (Construction)

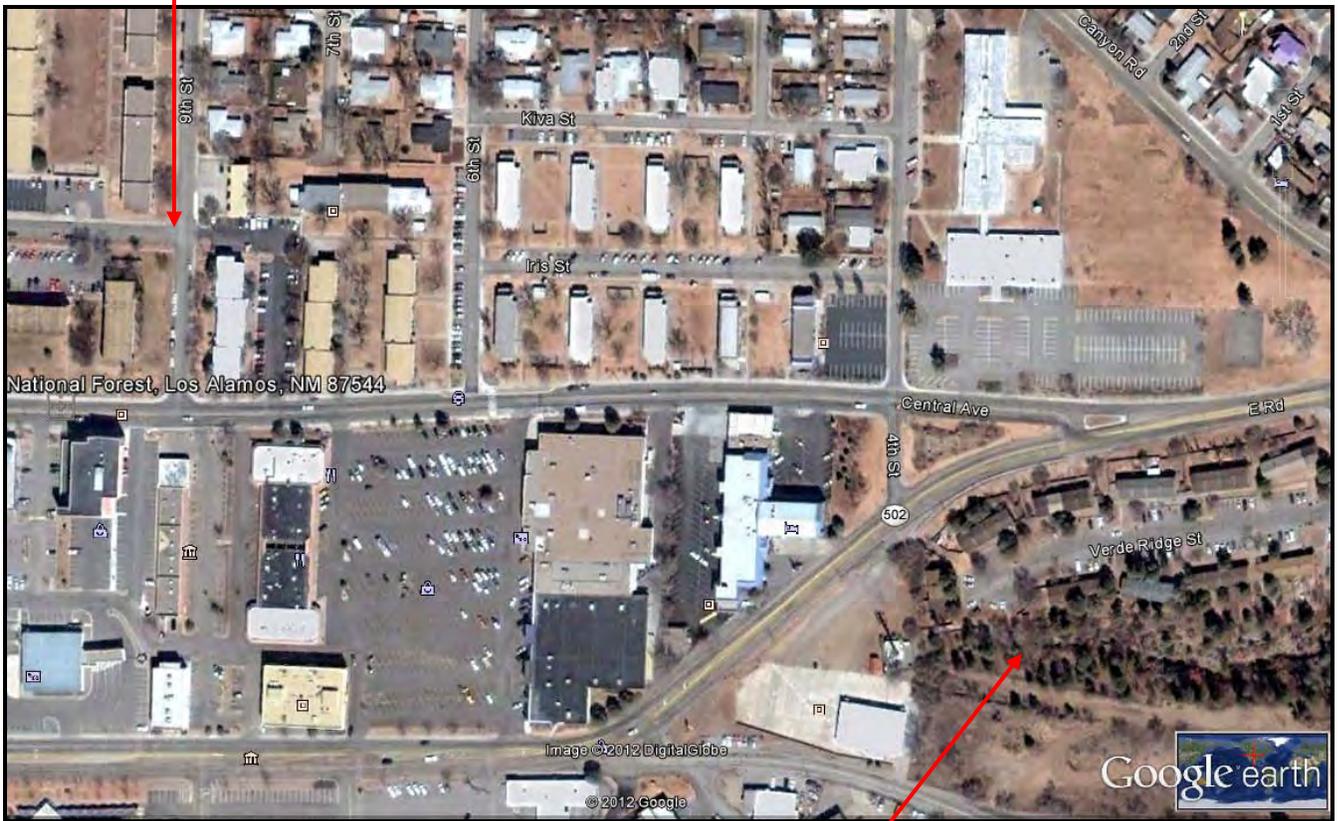
Site Overview

City/County: Los Alamos/Los Alamos County	
Location: Intersection of Central Ave and 502/Trinity Drive Los Alamos	
Subject: Overview of stormwater inlets and discharge point into side channel of the Los Alamos Canyon.

**Stormwater Drain Inlets**

**Outfall to Canyon**

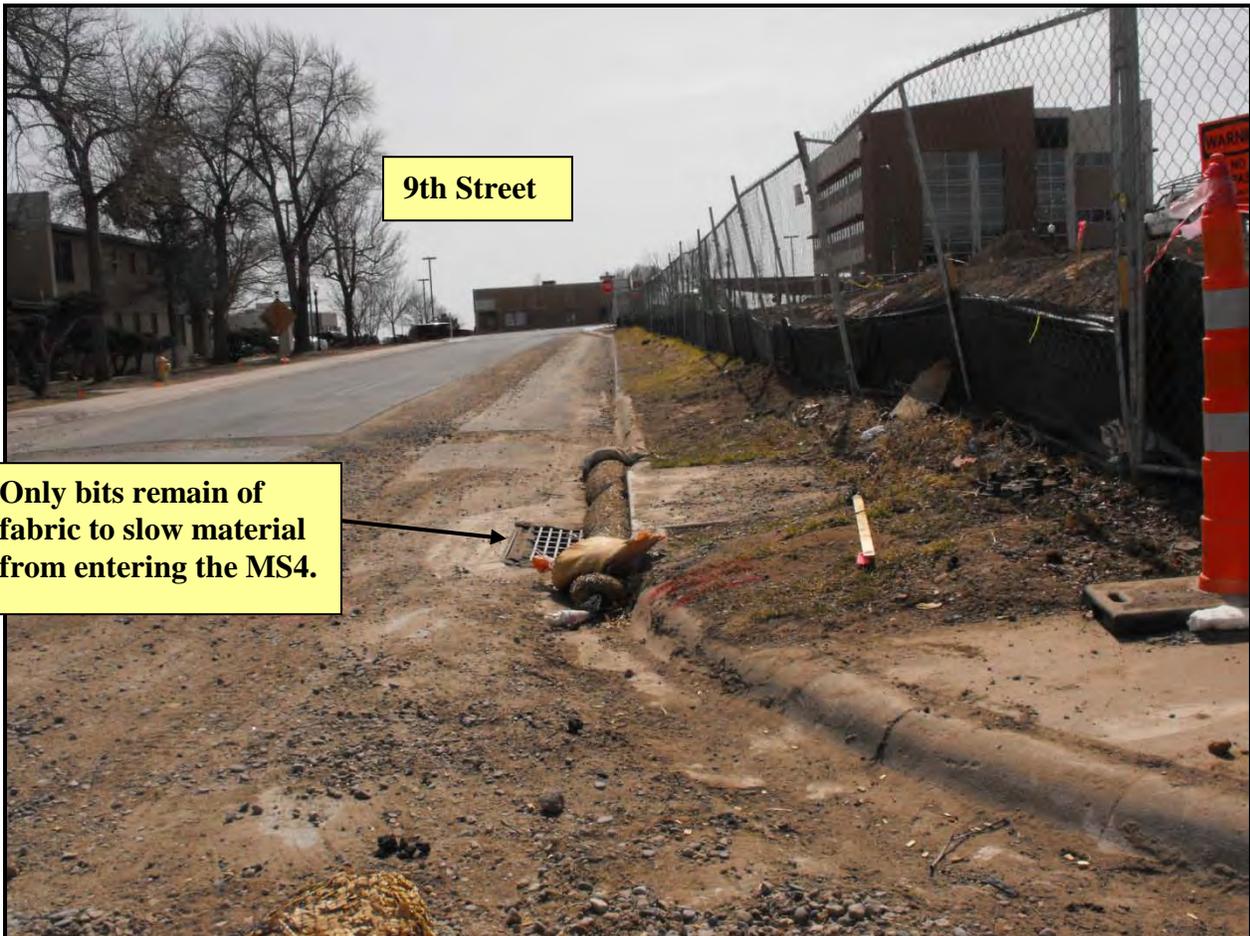
Photo # 1

Photographer: Daniel Valenta	Date: 2/29/2012	Time: 1241 hours
City/County: Los Alamos/Los Alamos County		
Location: 9 <sup>th</sup> Street, Los Alamos, New Mexico, facing south.		
Subject: Storm drain with unmaintained BMPs. At the time of the inspection the drain had filled up with sand/silt/sediment.

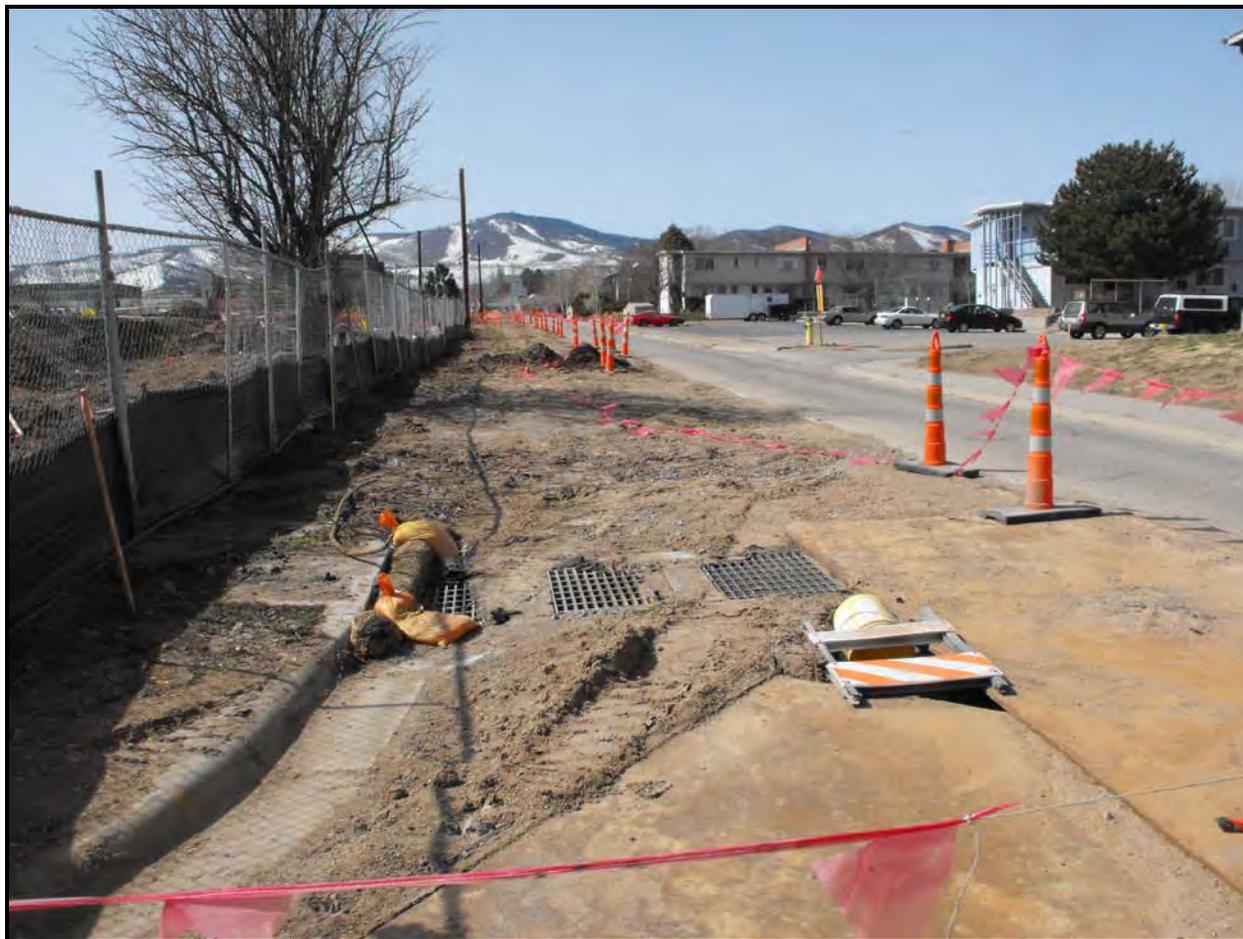
Photo # 2

Photographer: Daniel Valenta	Date: 2/29/2012	Time: 1240 hours
City/County: Los Alamos/Los Alamos County		
Location: Corner of 9 <sup>th</sup> and Iris, Los Alamos, New Mexico, facing west.		
Subject: Storm drains with BMPs that were not maintained. The drains appeared to be open and functioning.

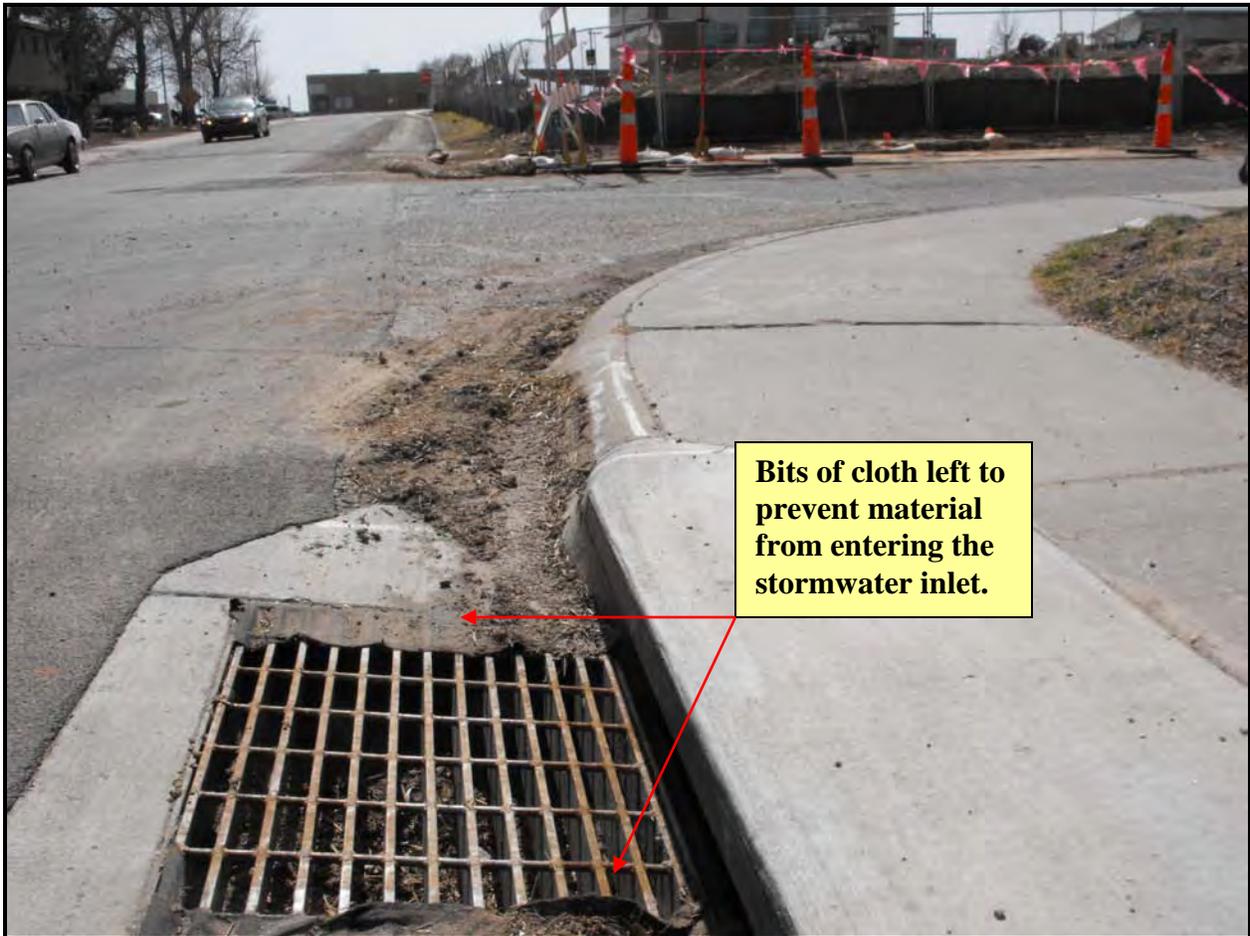
Photo # 3

<p>Two of the four stormwater inlets had filled completely up with sand/gravel/sediment, (see photo 3). The other two may still discharge during a rain or snow event to the side canyon. Although the area was documented to have been inspected it was in great need of maintance on the day of the inspection and it did not appear to have been maintained in the past.</p>		2/17/2012	Inspected North End	2/6/2012	Inspected North End	11/10/2012	Inspected North End	12/14/2011	Inspected Iris St.	11/14/2011	Sweep Iris St.	11/14/2011	Sweep 9 <sup>th</sup> St.	10/27/2011	Sweep Iris St	10/24/2011	Inspected North Side	10/10/2011	Inspected North Side	10/5/2011	Inspected/Sweep Iris St.
2/17/2012	Inspected North End																				
2/6/2012	Inspected North End																				
11/10/2012	Inspected North End																				
12/14/2011	Inspected Iris St.																				
11/14/2011	Sweep Iris St.																				
11/14/2011	Sweep 9 <sup>th</sup> St.																				
10/27/2011	Sweep Iris St																				
10/24/2011	Inspected North Side																				
10/10/2011	Inspected North Side																				
10/5/2011	Inspected/Sweep Iris St.

Photographer: Daniel Valenta	Date: 2/29/2012	Time: 1238 hours
City/County: Los Alamos/Los Alamos County		
Location: Corner of 9 <sup>th</sup> and Iris, Los Alamos, New Mexico, facing south.		
Subject: Storm drain with no BMPs. The drain had almost filled up completely with sand/silt/sediment.
