**NEW MEXICO  
ENVIRONMENT DEPARTMENT**

Re: Construction Stormwater, SIC 1623, NPDES Compliance Evaluation Inspection, David Montoya Construction Inc.,  
Osuna Road Channel Notch, NPDES Permit NMR10HM54, March 29, 2012

### NPDES Compliance Inspection Report

**Official Photograph Log**

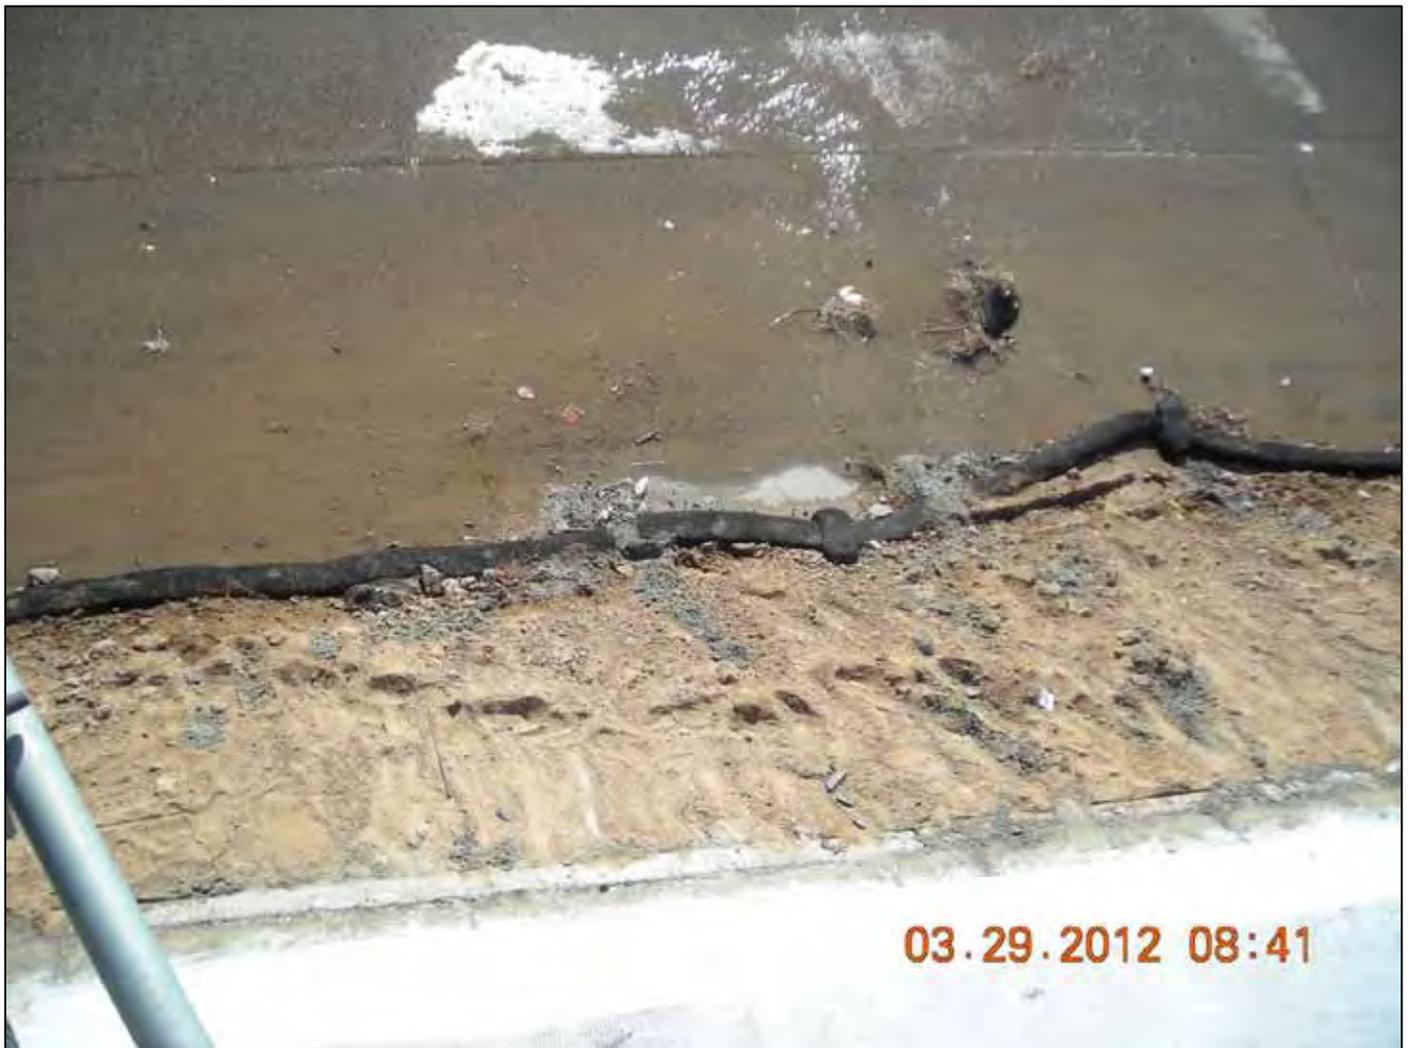
Photo # 1

Photographer: Sarah Holcomb	Date: 3-29-2012	Time: 0841 hours
City/County: Albuquerque/Bernalillo County		
Location: North Diversion Channel near Osuna Road.		
Subject: BMPs along the channel in need of maintenance/repair.

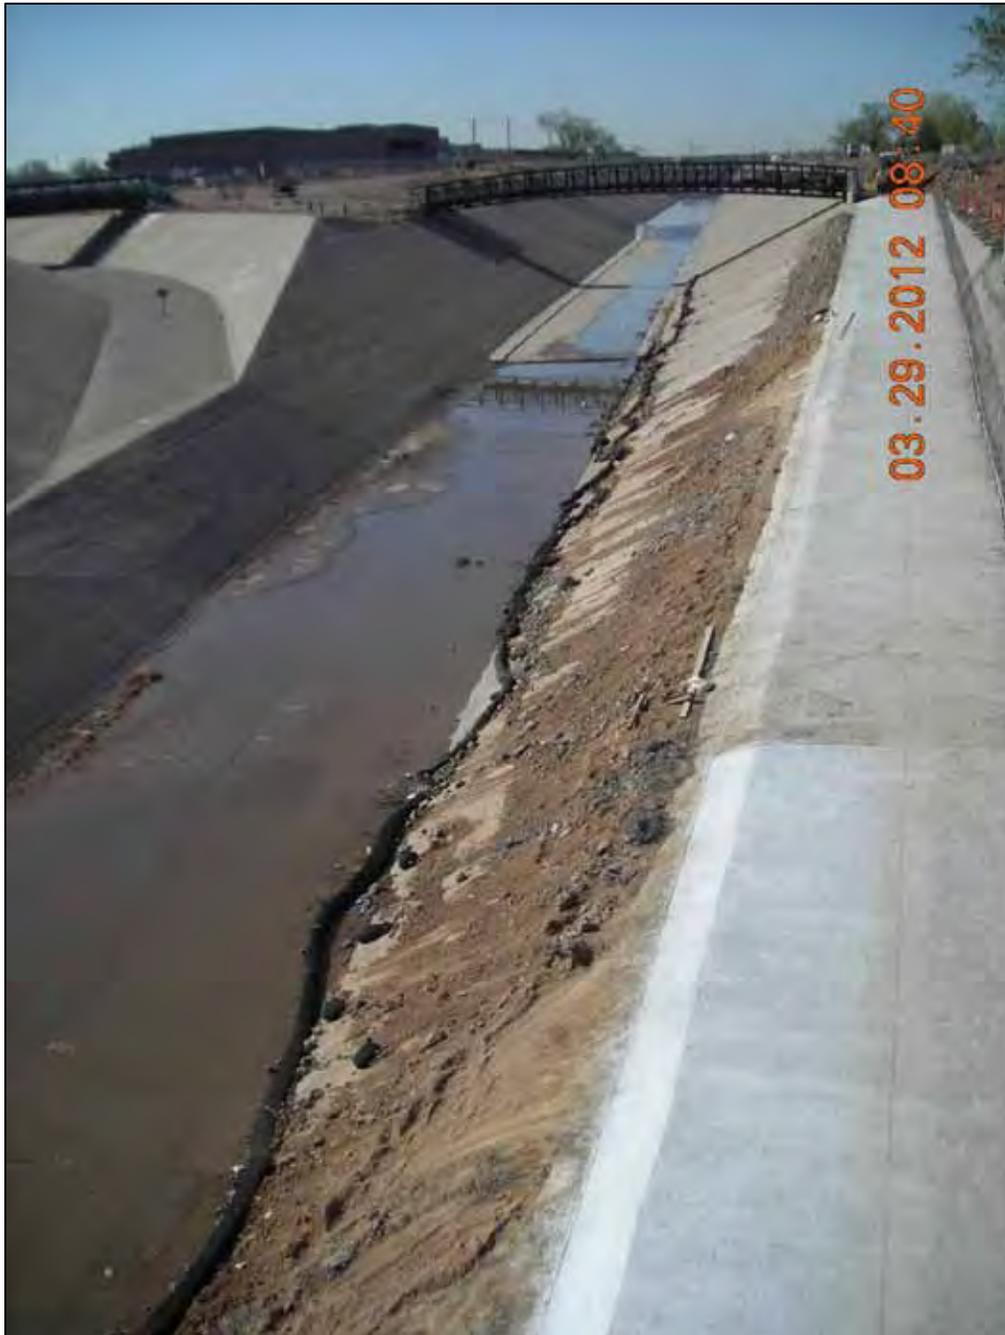
Photo # 2

Photographer: Sarah Holcomb	Date: 3-29-2012	Time: 0840 hours
City/County: Albuquerque/Bernalillo County		
Location: North Diversion Channel near Osuna Road.		
Subject: Southern end of the project.

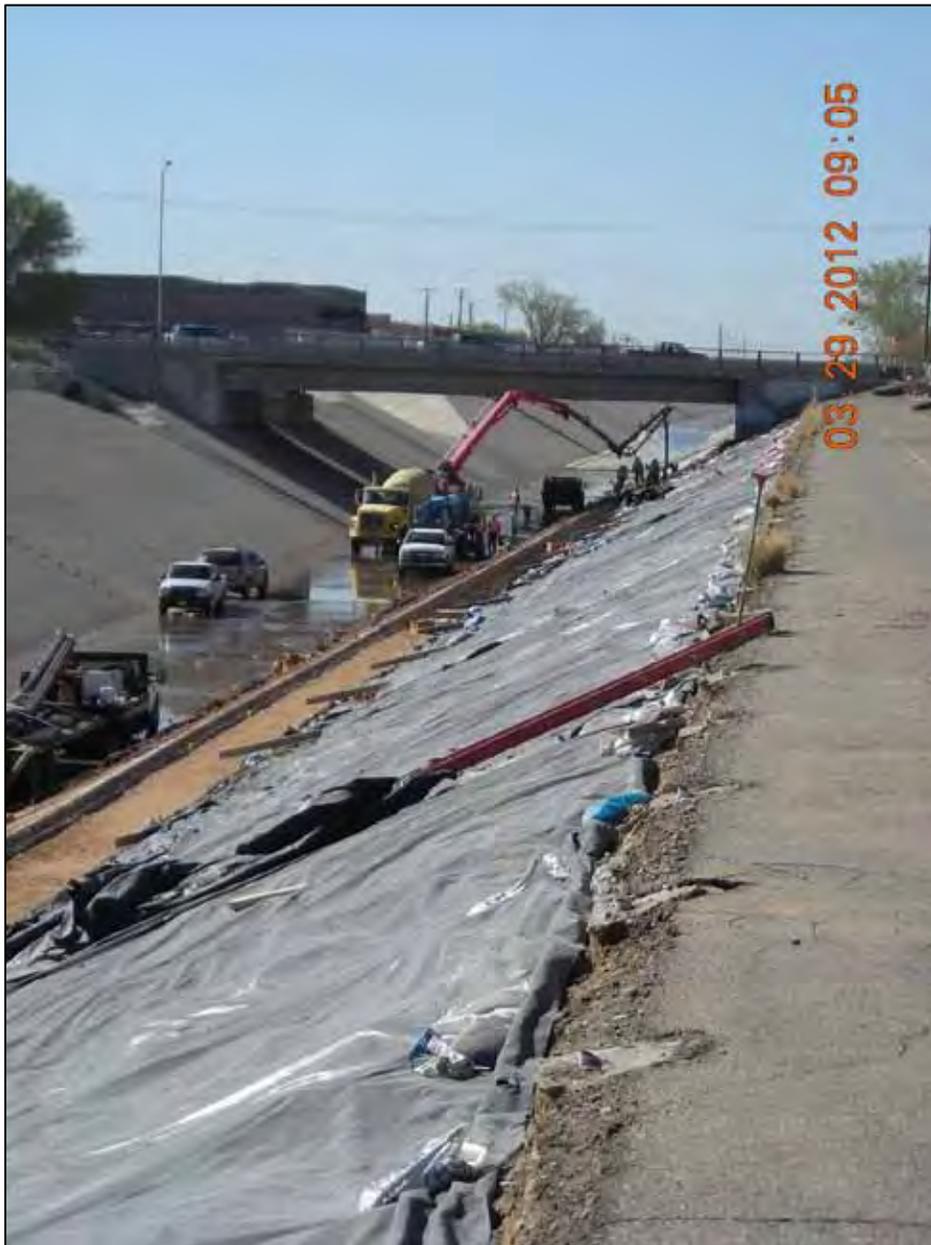
Photo # 3

Photographer: Sarah Holcomb	Date: 3-29-2012	Time: 0905 hours
City/County: Albuquerque/Bernalillo County		
Location: North Diversion Channel near Osuna Road.		
Subject: Northern end of the project. Tarp is in place to cover exposed soil overnight.
