RE: Construction Storm Water, SIC 1542, NPDES Compliance Evaluation Inspection, NMC, Inc / New Mexico Consortium Biological Research Facility, Los Alamos, NMR12A057, November 15, 2012

NPDES Compliance Inspection Report

Industrial Storm Water Worksheet (Construction) – State of New Mexico

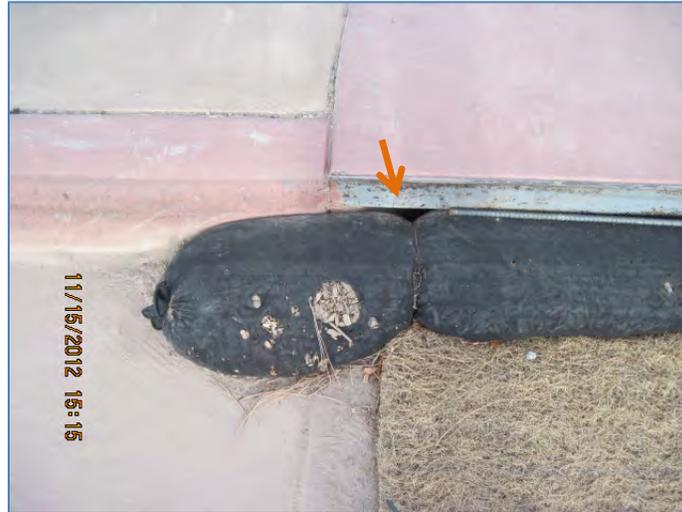
NMED/SWQB Official Photograph Log Photo # 1		
Photographer: Erin Trujillo	Date: 11/15/2012	Time: 1515 hours
City/County: Los Alamos / Los Alamos		State: New Mexico
Location: New Mexico Consortium Biological Research Facility, 100 Entrada Drive, Los Alamos, 87544		
Subject: Entrada Drive (northside—east of construction entrance) inlet control had damaged wood mulch filled wattle. Arrow points to small gap at top of inlet.

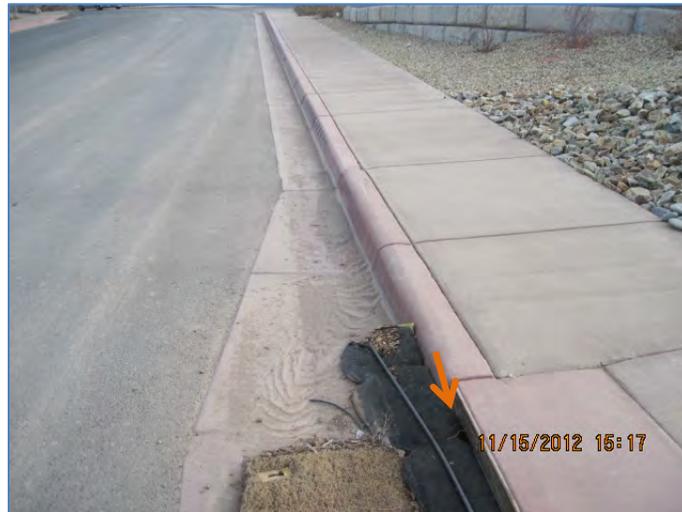
NMED/SWQB Official Photograph Log Photo # 2		
Photographer: Erin Trujillo	Date: 11/15/2012	Time: 1517 hours
City/County: Los Alamos / Los Alamos		State: New Mexico
Location: New Mexico Consortium Biological Research Facility, 100 Entrada Drive, Los Alamos, 87544		
Subject: Entrada Drive (southside—east of construction entrance) inlet control had damaged wattle. Arrow points to gap at top of inlet. Not all accumulated sediment in gutter could be attributed to this project.

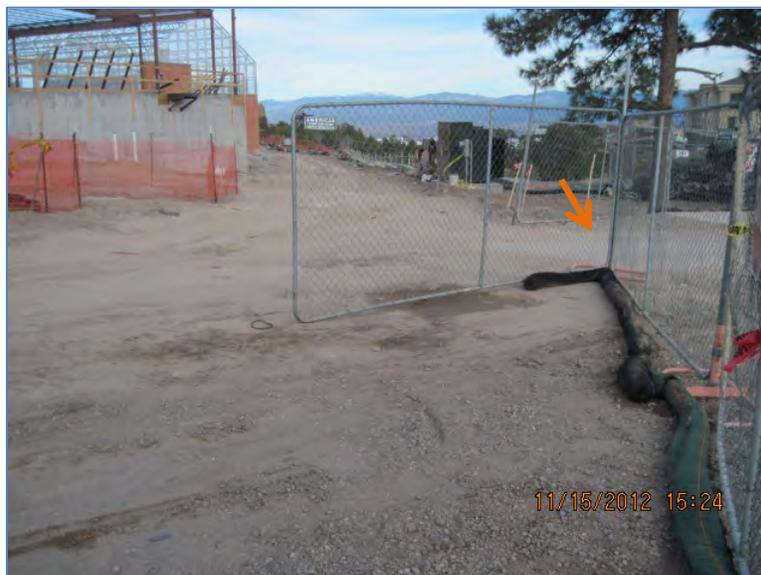
NMED/SWQB Official Photograph Log Photo # 3		
Photographer: Erin Trujillo	Date: 11/15/2012	Time: 1524 hours
City/County: Los Alamos / Los Alamos		State: New Mexico
Location: New Mexico Consortium Biological Research Facility, 100 Entrada Drive, Los Alamos, 87544		
Subject: Arrow points to construction entrance/exit that did not have control measure as described in SWPPP.

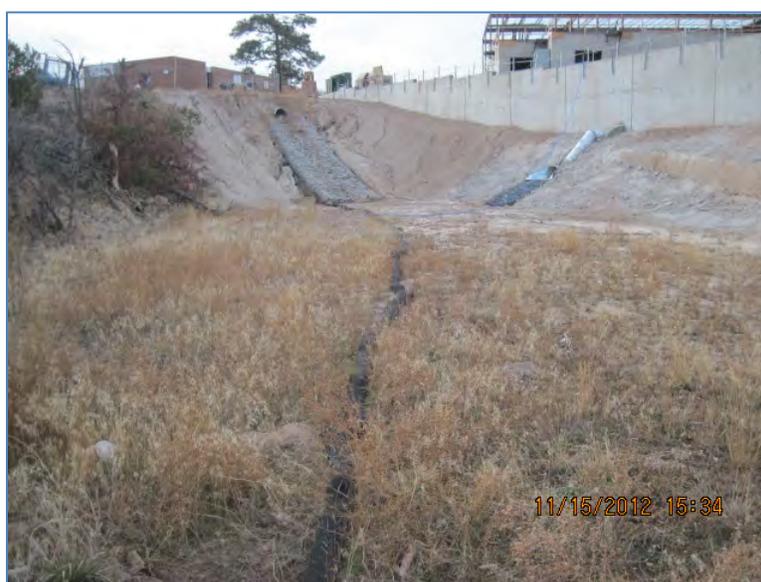
NMED/SWQB Official Photograph Log Photo # 4		
Photographer: Erin Trujillo	Date: 11/15/2012	Time: 1534 hours
City/County: Los Alamos / Los Alamos		State: New Mexico
Location: New Mexico Consortium Biological Research Facility, 100 Entrada Drive, Los Alamos, 87544		
Subject: Wattle was located in Entrada Subdivision retention pond (basin or area), but not on slope as shown on Site Map. See next photo.

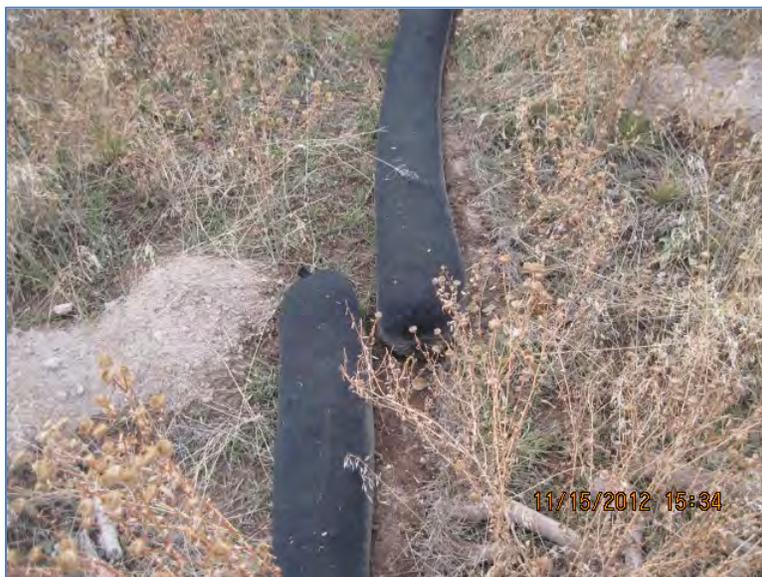
NMED/SWQB Official Photograph Log Photo # 5		
Photographer: Erin Trujillo	Date: 11/15/2012	Time: 1534 hours
City/County: Los Alamos / Los Alamos		State: New Mexico
Location: New Mexico Consortium Biological Research Facility, 100 Entrada Drive, Los Alamos, 87544		
Subject: Wattle shown in previous photo had gap and was not secured (e.g., staked).

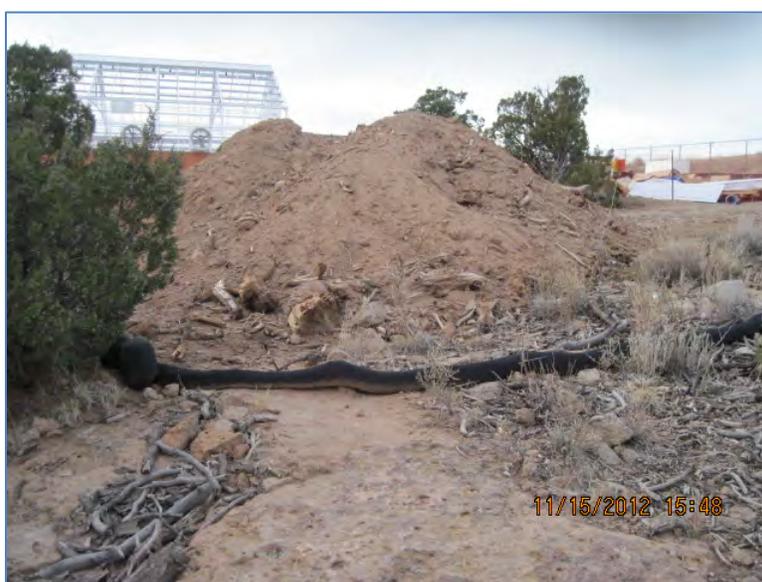
NMED/SWQB Official Photograph Log Photo # 6		
Photographer: Erin Trujillo	Date: 11/15/2012	Time: 1548 hours
City/County: Los Alamos / Los Alamos		State: New Mexico
Location: New Mexico Consortium Biological Research Facility, 100 Entrada Drive, Los Alamos, 87544		
Subject: Topsoil stockpile did not have erosional features. Activities for the stockpile appeared to have temporarily ceased.

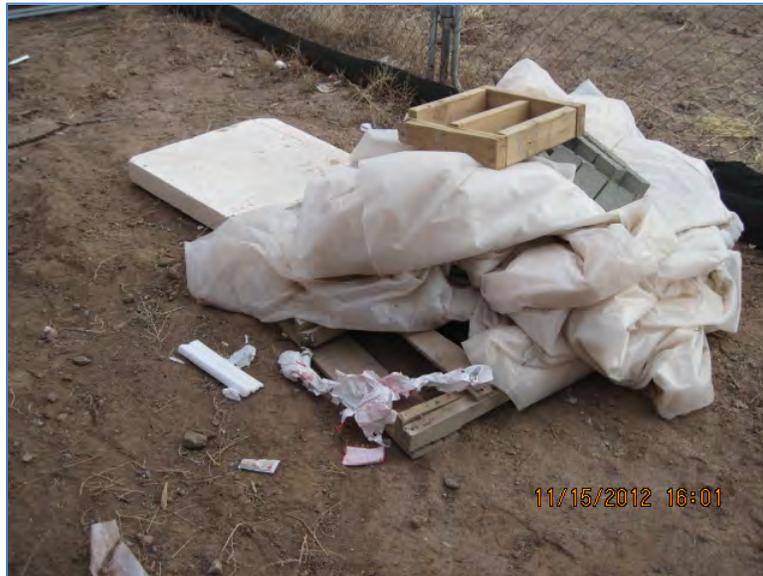
NMED/SWQB Official Photograph Log Photo # 7		
Photographer: Erin Trujillo	Date: 11/15/2012	Time: 1601 hours
City/County: Los Alamos / Los Alamos		State: New Mexico
Location: New Mexico Consortium Biological Research Facility, 100 Entrada Drive, Los Alamos, 87544		
Subject: Example of construction waste and litter in southwest area of site.

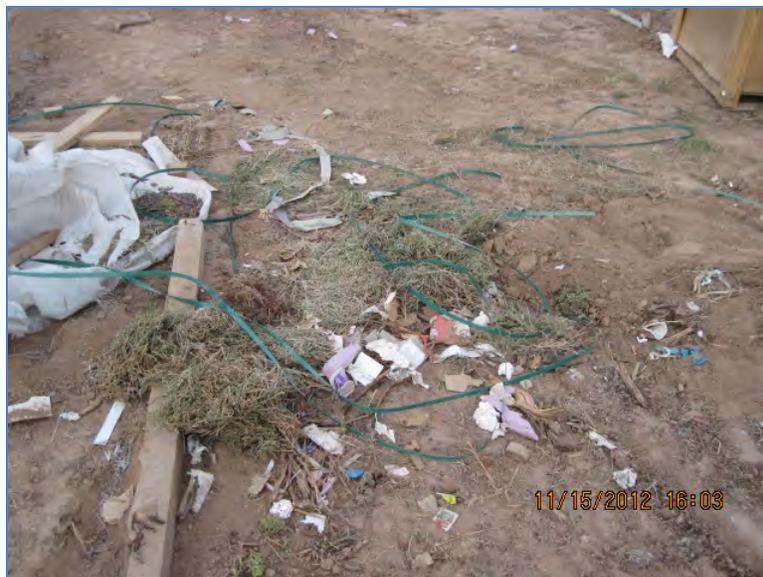
NMED/SWQB Official Photograph Log Photo # 8		
Photographer: Erin Trujillo	Date: 11/15/2012	Time: 1603 hours
City/County: Los Alamos / Los Alamos		State: New Mexico
Location: New Mexico Consortium Biological Research Facility, 100 Entrada Drive, Los Alamos, 87544		
Subject: Example of construction waste and litter in southwest area of site.
