NEW MEXICO  
ENVIRONMENT DEPARTMENT  
*Surface Water Quality Bureau*

**RE:** Construction Storm Water, SIC 1522, NPDES Compliance Evaluation Inspection, DSW Santa Fe, LLC/  
Drury Plaza Hotel Project, Santa Fe, NMR12A077, October 4, 2012

## Industrial Storm Water Worksheet (Construction) – State of New Mexico

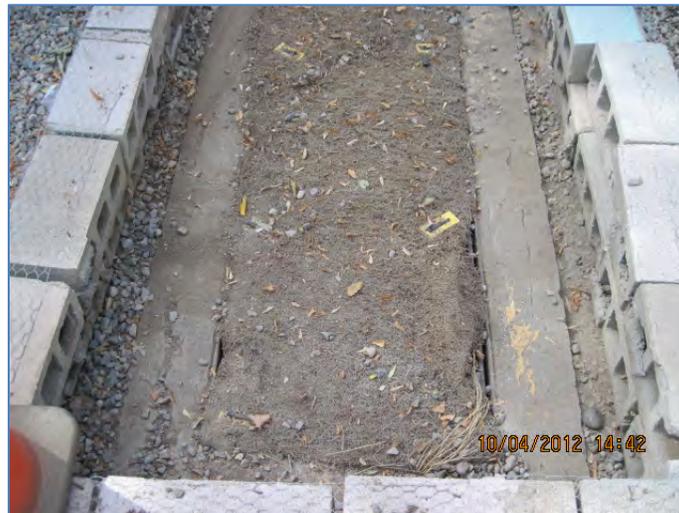
| <b>Erosion and Sediment Control Practices – Continued</b> | |
|---|---|
| <b>Storm drain inlet protection:</b> | <p><i>(e.g., fabric filters, sandbags, concrete blocks, gravel barriers)</i></p> <p>Filter fabric and gravel barrier was installed at on-site storm sewer drop inlet. Small gaps at the edge of filter fabric were observed. Details for grated inlet control on site map stated, “The width, “W”, of the filter sack shall match the inside width of the grated inlet box.” Cleaning, additional fabric, and/or other measure appeared needed.</p> |

| <b>Evidence of sediment deposition to surface waters or MS4?</b> | <p><i>(e.g. significant turbidity observed in a receiving water body)</i></p> <p>Potential sediment deposition observed as discussed above. Some accumulated sediment observed on adjacent paved street with unprotected storm water sewer drop inlets. Gaps in on-site drop inlet protection also observed.</p> |

| <b>NMED/SWQB<br/> Official Photograph Log<br/> Photo # 1</b> | | |
|---|---|---|
| Subject: Fiber mat at inlet control had accumulated sediment. Mat did not cover entire grate (gaps at edge) | | |

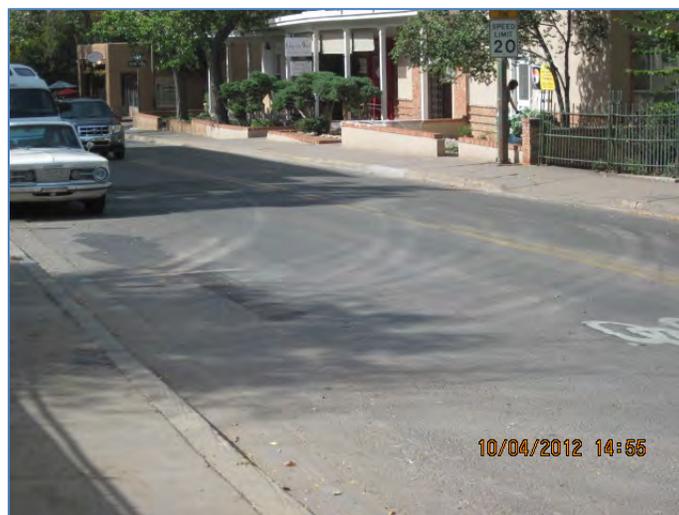
| <b>NMED/SWQB<br/> Official Photograph Log<br/> Photo # 2</b> | | |

| <b>Implementation (complete in field)</b><br><i>(Narrative Description if Control Measures Installed, Operational, Effective and Maintained)</i> | |
|--|---|
| <b>Exit point or sediment track out:</b> | <i>(e.g., aggregate stone with an underlying geotextile or non-woven filter fabric, or turf mats, wheel washing, rumble strips, plates, sweeping)</i><br><br>Accumulated sediment was observed in gravel pad at main construction entrance and maintenance appeared needed. Perimeter (access control) construction fence appeared to restrict vehicles to exit at gates. A second entrance for demolition/renovation waste removal did not have sediment track out controls. Some accumulated sediment was observed on the paved street at the second/northern entrance that had unprotected storm drain drop inlet grates. Site map was not updated for additional vehicle exit. On-site representative described sweeping measures to remove tracked out sediment on sidewalks and streets at the end of work day. |

| <b>NMED/SWQB<br/> Official Photograph Log<br/> Photo # 2</b> | | |
|--|---|---|
| Subject: Some sediment tracking was observed at northern entrance used for waste/trash disposal pick up according to on-site representative. There was no sediment control measure observed for entrance at this location. | | |

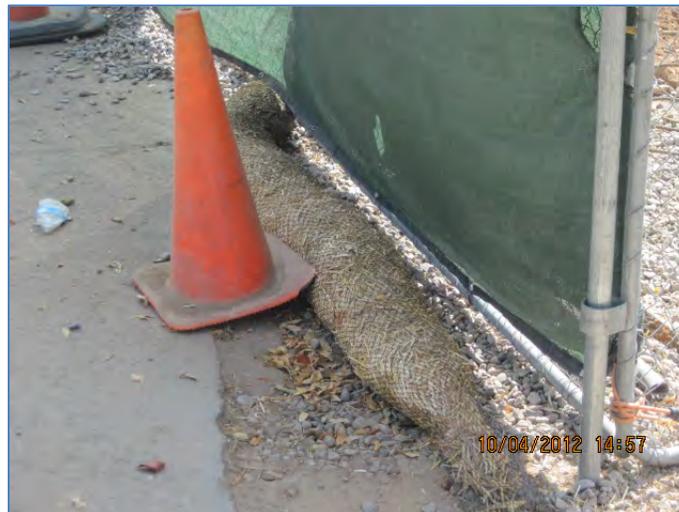
| <b>NMED/SWQB<br/> Official Photograph Log<br/> Photo # 3</b> | | |

| <b>Erosion and Sediment Control Practices – Continued</b> | |
|---|---|
| <b>Other erosion and sediment controls or practices:</b> | <p><i>(Provide brief description)</i></p> <p>Straw wattle used at main entrance gate for run on control according to Permittee on-site representative. Portion of wattle was damaged. Addition of wattle was not updated on Site Map.</p> |

| <b>NMED/SWQB<br/> Official Photograph Log<br/> Photo # 3</b> | | |
|--|---|---|
| Subject: Straw wattle at main entrance was damaged. Location of wattle was not shown on site map. Use of wattle at entrance was intended for run on control according to on-site representative. | | |

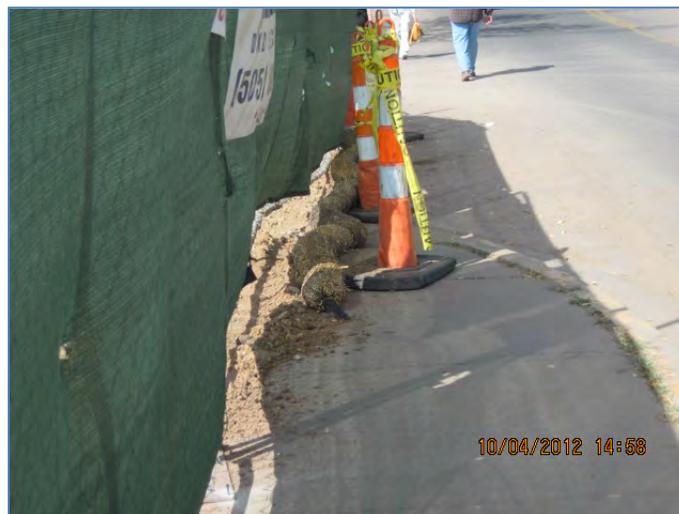
| <b>NMED/SWQB<br/> Official Photograph Log<br/> Photo # 4</b> | | |

| <b>NMED/SWQB<br/> Official Photograph Log<br/> Photo # 4</b> | | |
|--|---|---|
| Subject: Sediment was observed on adjacent side walk outside construction site. No structural control measures were observed in this area. | | |

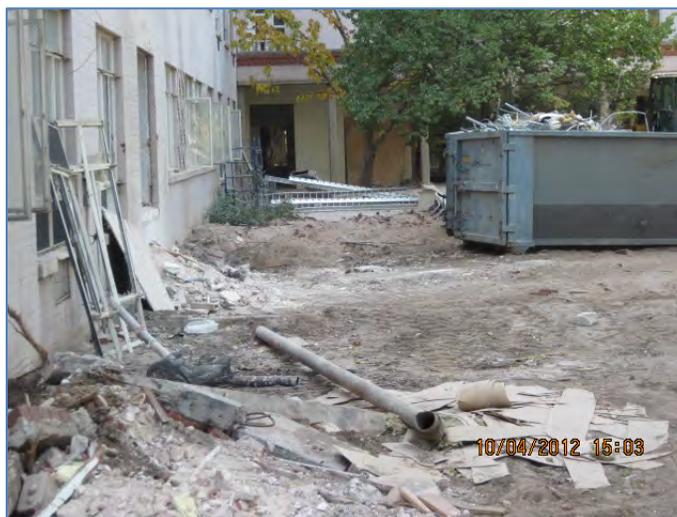
| <b>NMED/SWQB<br/> Official Photograph Log<br/> Photo # 5</b> | | |

| <b>NMED/SWQB<br/> Official Photograph Log<br/> Photo # 5</b> | | |
|--|---|---|
| Subject: Use of shoots and dumpsters for renovation on lower floors was not practicable according to on-site representative. There were no additional controls to prevent debris from contaminating soils (e.g., tarps, immediate removal to containers). Waste was not near property boundaries on day of this inspection, but could be a source of pollution during a rain event. Photo also shows example of roll off with debris above top of container. | | |

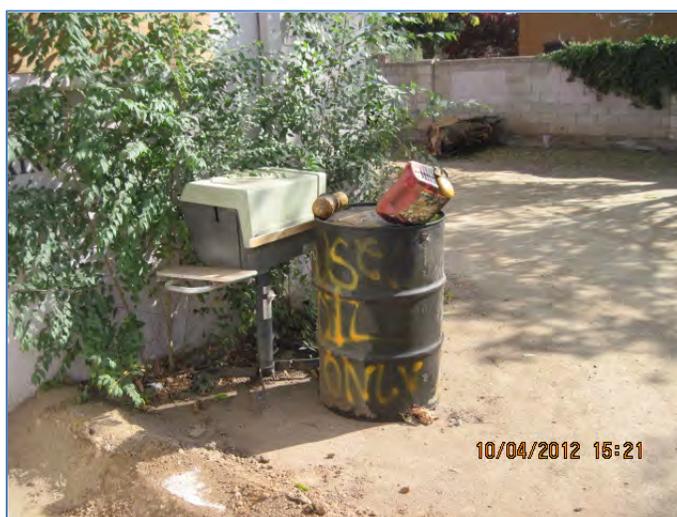
| <b>NMED/SWQB<br/> Official Photograph Log<br/> Photo # 6</b> | | |

| <b>NMED/SWQB<br/> Official Photograph Log<br/> Photo # 6</b> | | |
|---|---|---|
| Subject: Labeled used oil drum, with containers draining into drum, was not on pallet or inside containment area. | | |

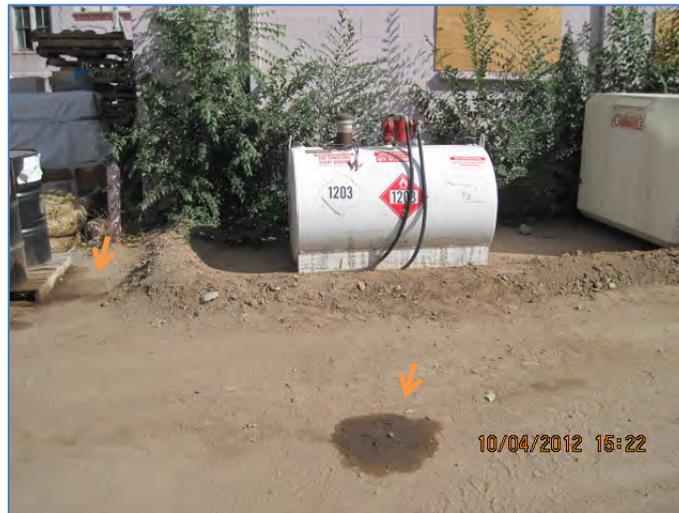
| <b>NMED/SWQB<br/> Official Photograph Log<br/> Photo # 7</b> | | |

| <b>NMED/SWQB<br/> Official Photograph Log<br/> Photo # 7</b> | | |
|--|---|---|
| Subject: Arrows point to examples of staining near vehicle fueling and fluid storage area. | | |

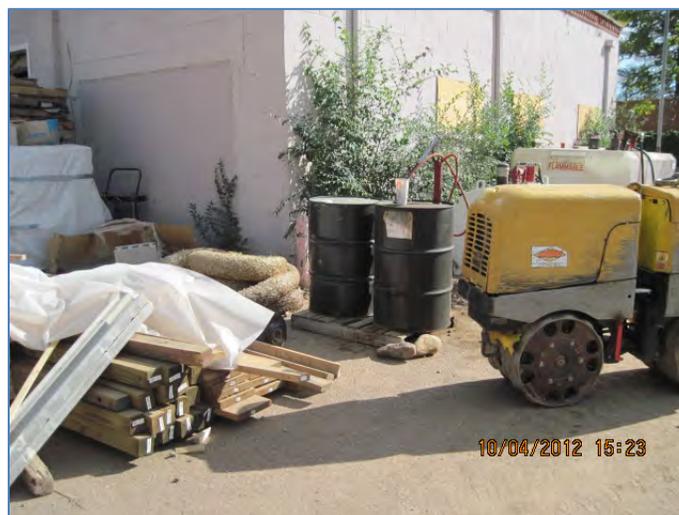
| <b>NMED/SWQB<br/> Official Photograph Log<br/> Photo # 8</b> | | |

| <b>NMED/SWQB<br/> Official Photograph Log<br/> Photo # 8</b> | | |
|--|---|---|
| Subject: Vehicle fluid storage (drums on pallets) did not have secondary containment and did not appear protected from equipment traffic (e.g., barriers). | | |

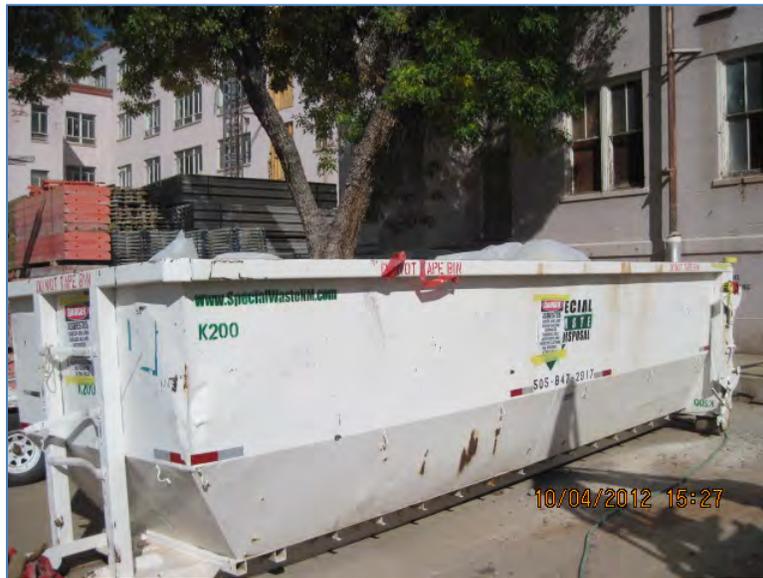
| NMED/SWQB<br>Official Photograph Log<br>Photo # 9 | | |

| NMED/SWQB<br>Official Photograph Log<br>Photo # 9 | | |
|---|---|---|
| Subject: Example of dumpster, in this case special waste (asbestos), not indicated on site map. | | |

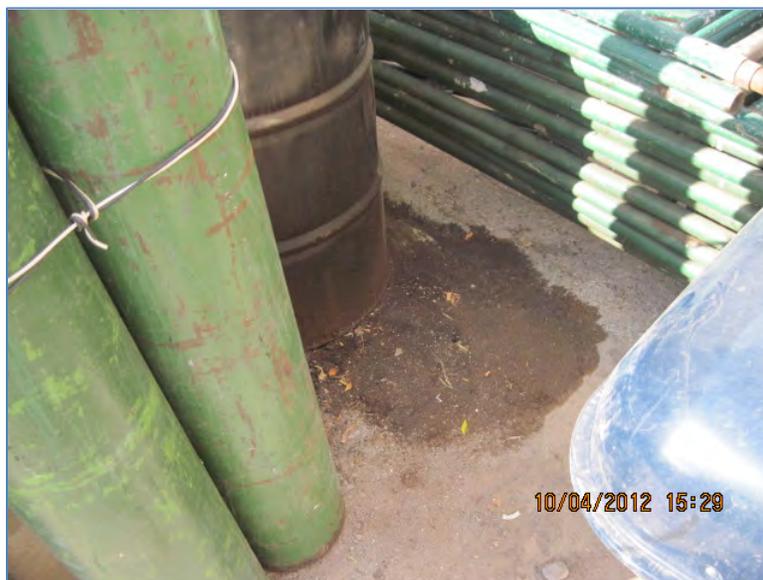
| NMED/SWQB<br>Official Photograph Log<br>Photo # 10 | | |

| <b>Pollution Prevention Measures Part 2.3</b> | |
|--|--|
| | <p><i>Diesel fuel, oil, hydraulic fluids, other petroleum products, and other chemicals:</i></p> <p>See notes above on fueling and maintenance of vehicles. Stains were below drum labeled as DOWTHERM* SR-1 Heat Transfer Fluid (contains ethylene glycol with additives). Drum was located in area that was difficult to inspect for leaks and spills.</p> |

| NMED/SWQB<br>Official Photograph Log<br>Photo # 10 | | |
|--|---|---|
| Subject: Stain below drum labeled as DOWTHERM* SR-1 Heat Transfer Fluid (label not visible in this photo). | | |
