NEW MEXICO
ENVIRONMENT DEPARTMENT
Surface Water Quality Bureau

RE: Construction Storm Water, SIC 1521, NPDES Compliance Evaluation Inspection, Mike Smith and/or Double B & S LLC / Flora Vista Hillside Estates #2, NMR12A237, May 16, 2013

NPDES Compliance Inspection Report

Industrial Storm Water Worksheet (Construction) – State of New Mexico

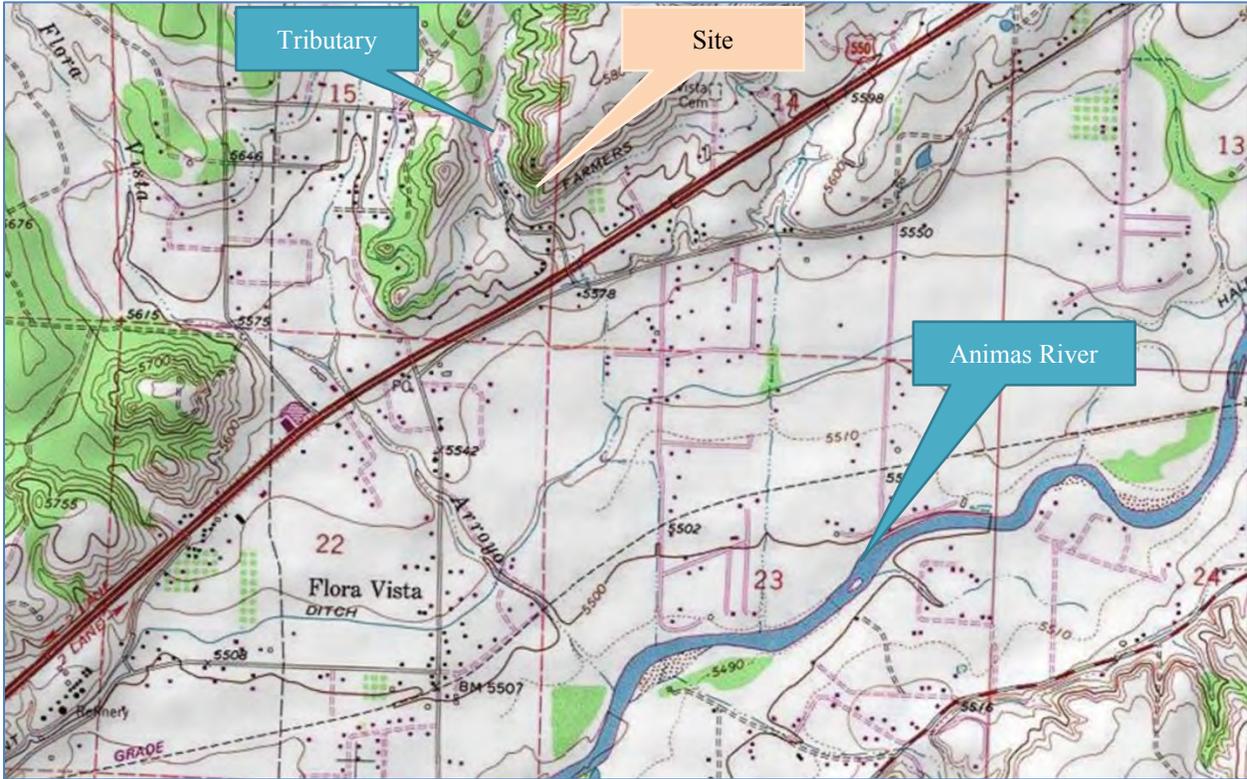
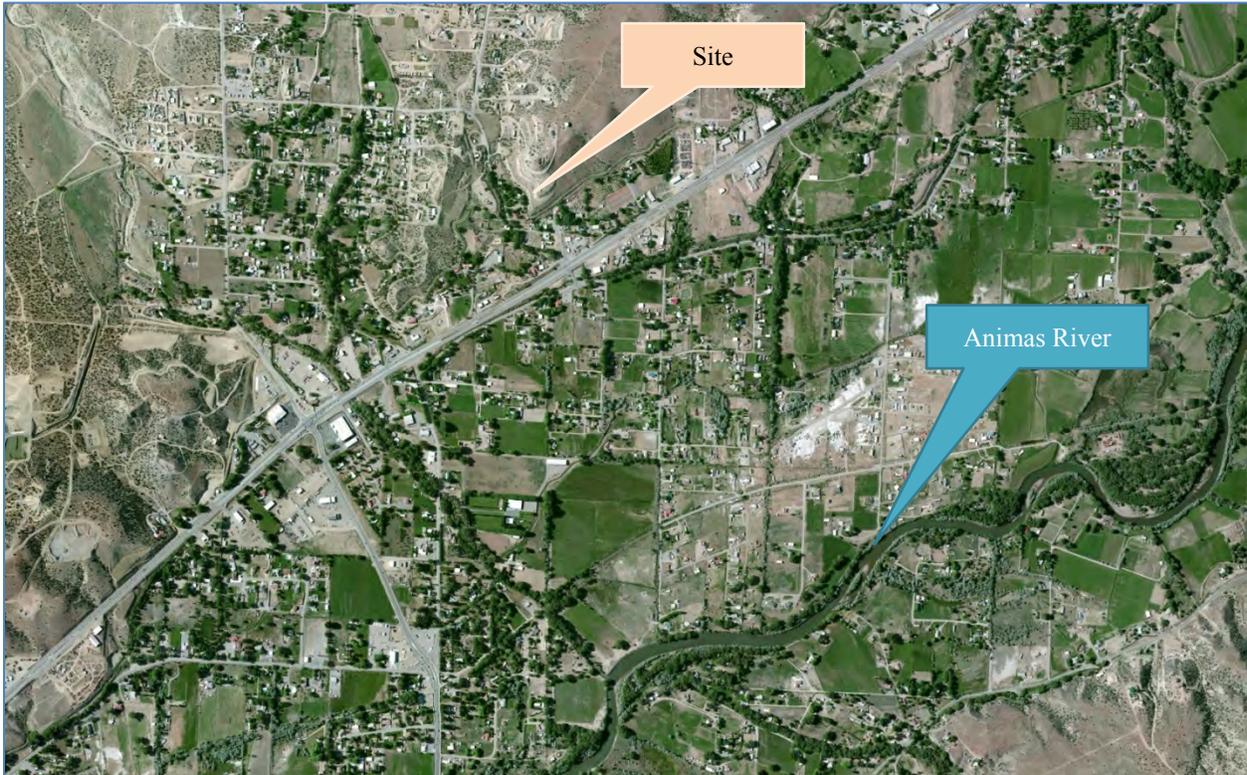
Figures 1 and 2: General Site and Imagery Maps

Subject: Readily available topographic map shows an unnamed tributary along the adjacent county road. On the day of this inspection, evidence of a remaining watercourse (definite bed and bank) was not observed in the area described as a sediment containment pond and shared access road.

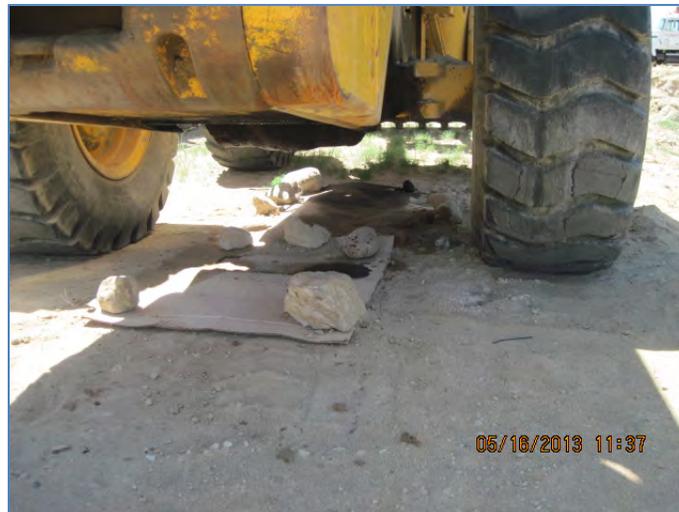
NMED/SWQB Official Photograph Log Photo # 1		
Photographer: Erin Trujillo	Date: 05/16/2013	Time: 1137 hours
City/County: Flora Vista / San Juan County		State: New Mexico
Location: Double B & S LLC / Flora Vista Hillside Estates #2, NMR12A237		
Subject: Example of stains and oil on cardboard and below on site heavy equipment.

Pollution Prevention Measures Part 2.3	
Fueling and maintenance of vehicles:	<p><i>(e.g., locating activities away from surface waters and stormwater inlets or conveyances, providing secondary containment (e.g., spill berms, decks, spill containment pallets) and cover where appropriate, and/or having spill kits readily available)</i></p> <p>No fueling or maintenance of vehicles observed on the day of this inspection. Two above-ground fuel storage tanks were stored on site. The permittee on-site representative stated that the fuel storage tanks were empty (not used). A lined pit, described by on-site permittee representative as the former location of fuel storage, was observed. A spill kit was located on site. Heavy equipment on the lower terrace leaked oil. Corrective action reports indicated repeated activities to clean up leaks by grader, and replace card board under equipment. Stains and oil was limited to the area around the equipment, but the leaked oil needed to be cleaned up.</p>

Pollution Prevention Measures - Continued	
	<p><i>Diesel fuel, oil, hydraulic fluids, other petroleum products, and other chemicals:</i></p> <p>Inspection reports indicate removal of cardboard used to collect leaking oil from heavy equipment. Cardboard does not appear to provide containment from runoff. A few stains were observed on the ground surface.</p>
	<p><i>Hazardous or toxic waste (e.g., paints, solvents, petroleum-based products, wood preservatives, additives, curing compounds, acids):</i></p> <p>Not applicable / None observed</p>
	<p><i>Construction and domestic waste (e.g., packaging materials, scrap construction materials, masonry products, timber, pipe and electrical cuttings, plastics, styrofoam, concrete, and other trash or building materials):</i></p> <p>No windblown domestic trash was observed on the day of this inspection. Inspection/corrective action record-keeping indicated repeated activities to pick up trash left by others. Access to the tract, thru the shared access roads, was not controlled. Also, the site contained items (e.g., vacant mobile home, heavy equipment, empty drum, empty above-ground storage tanks, plastic liner, tire) that may attract illegal dumping by others. There was one pile that appeared to be construction trash. The permittee on-site representative indicated that the pile of plastic pipe, containers and other materials may be the property of the adjacent public water company. Additional controls or methods (e.g., recycling, removal, requesting owners to remove property, securing some equipment or materials, and/or proper disposal, etc.) appeared needed to make the tract less attractive to illegal dumping by others.</p>

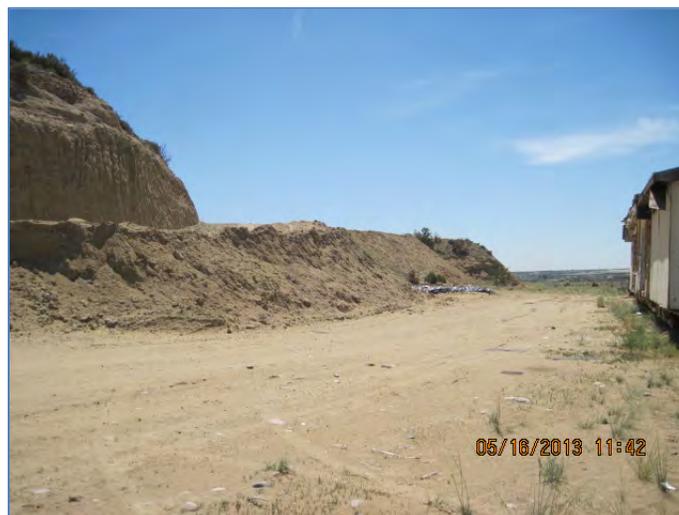
NMED/SWQB Official Photograph Log Photo # 2		
Photographer: Erin Trujillo	Date: 05/16/2013	Time: 1142 hours
City/County: Flora Vista / San Juan County		State: New Mexico
Location: Double B & S LLC / Flora Vista Hillside Estates #2, NMR12A237		
Subject: Example steep slope between lower and middle terraces. Portion of lower terrace is not stabilized. Limits of access (road) is not delineated.

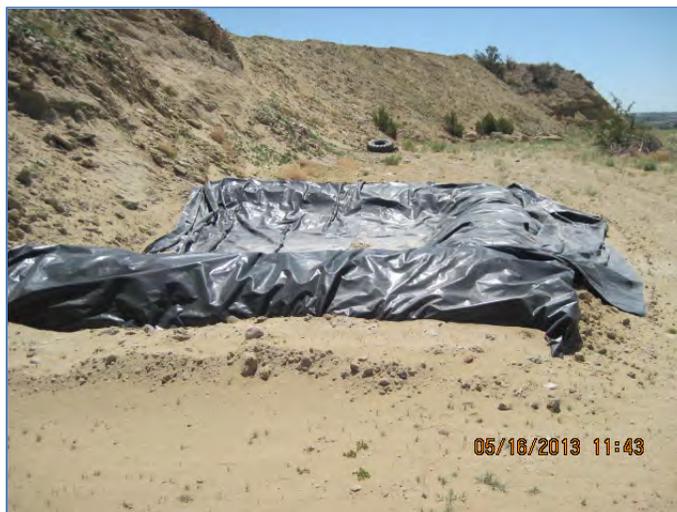
NMED/SWQB Official Photograph Log Photo # 3		
Photographer: Erin Trujillo	Date: 05/16/2013	Time: 1143 hours
City/County: Flora Vista / San Juan County		State: New Mexico
Location: Double B & S LLC / Flora Vista Hillside Estates #2, NMR12A237		
Subject: Remaining plastic liner described as containment by permittee on-site representative. Abandoned tire in background

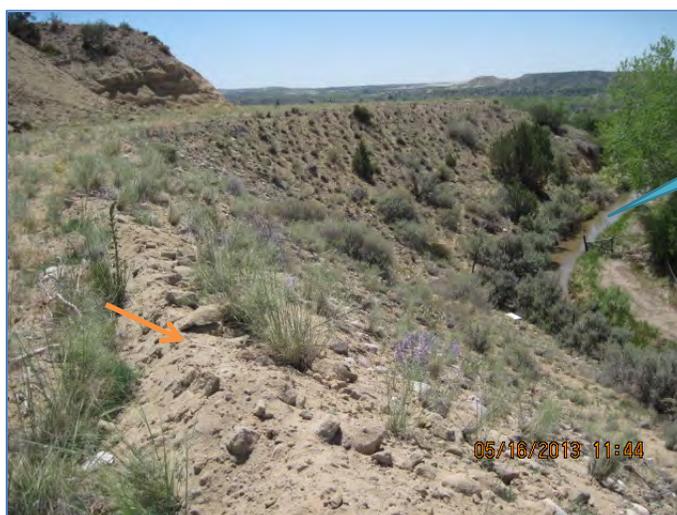
NMED/SWQB Official Photograph Log Photo # 4		
Photographer: Erin Trujillo	Date: 05/16/2013	Time: 1144 hours
City/County: Flora Vista / San Juan County		State: New Mexico
Location: Double B & S LLC / Flora Vista Hillside Estates #2, NMR12A237		
Subject: Vegetation on slope above Farmer's Ditch. Arrow points to low earth berm along edge of slope. Rills on this slope observed from below on CR 3450 did not appear to be active erosional features. Berm appeared to reduce runoff to this slope.

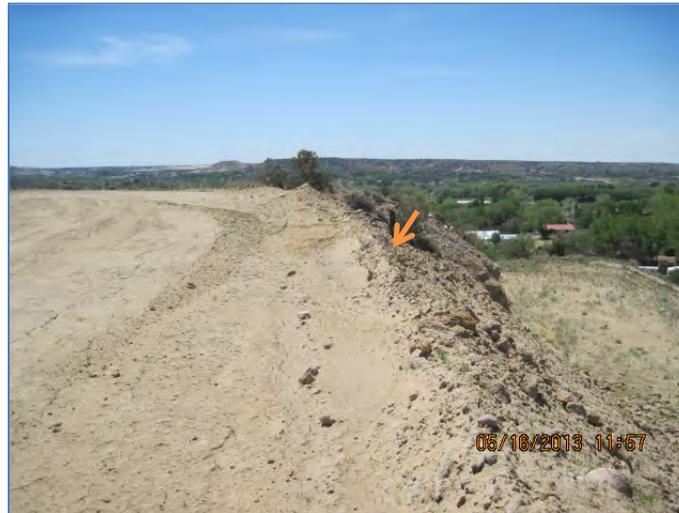
NMED/SWQB Official Photograph Log Photo # 5		
Photographer: Erin Trujillo	Date: 05/16/2013	Time: 1157 hours
City/County: Flora Vista / San Juan County		State: New Mexico
Location: Double B & S LLC / Flora Vista Hillside Estates #2, NMR12A237		
Subject: Arrow points to low earth berm on middle terrace. Photo shows status of vegetation on the lower (right) and middle (left) terrace.

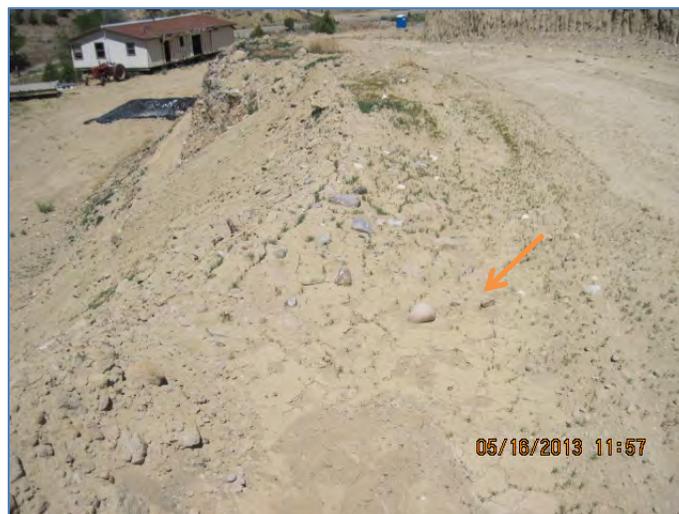
NMED/SWQB Official Photograph Log Photo # 6		
Photographer: Erin Trujillo	Date: 05/16/2013	Time: 1157 hours
City/County: Flora Vista / San Juan County		State: New Mexico
Location: Double B & S LLC / Flora Vista Hillside Estates #2, NMR12A237		
Subject: Earth berm in this area was lower and needed maintenance to reduce erosion onto lower steep slope.

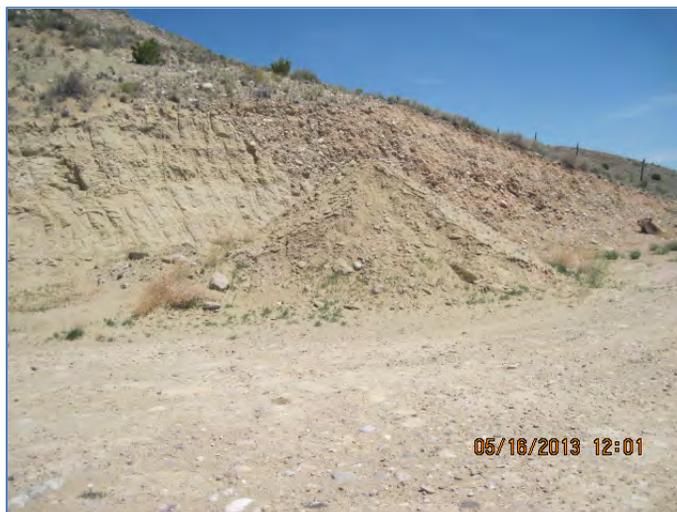
NMED/SWQB Official Photograph Log Photo # 7		
Photographer: Erin Trujillo	Date: 05/16/2013	Time: 1201 hours
City/County: Flora Vista / San Juan County		State: New Mexico
Location: Double B & S LLC / Flora Vista Hillside Estates #2, NMR12A237		
Subject: Stockpile of finer grained/fill material on middle terrace and status of vegetation.

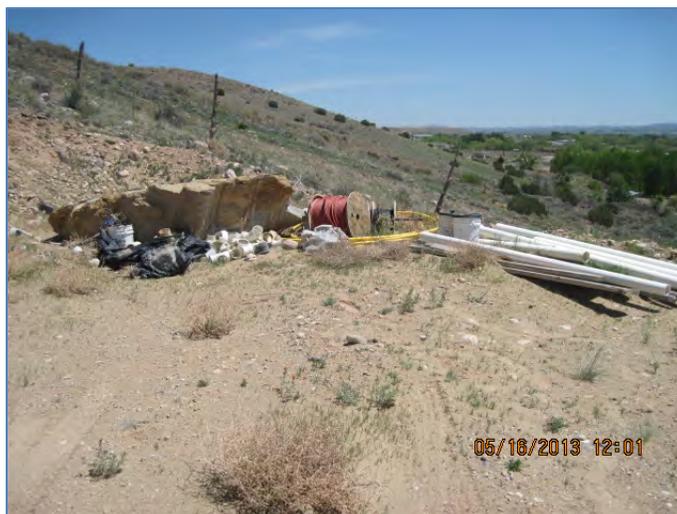
NMED/SWQB Official Photograph Log Photo # 8		
Photographer: Erin Trujillo	Date: 05/16/2013	Time: 1201 hours
City/County: Flora Vista / San Juan County		State: New Mexico
Location: Double B & S LLC / Flora Vista Hillside Estates #2, NMR12A237		
Subject: Pile of construction materials (plastic buckets, PVC pipes, cable, plastic bags on middle terrace.

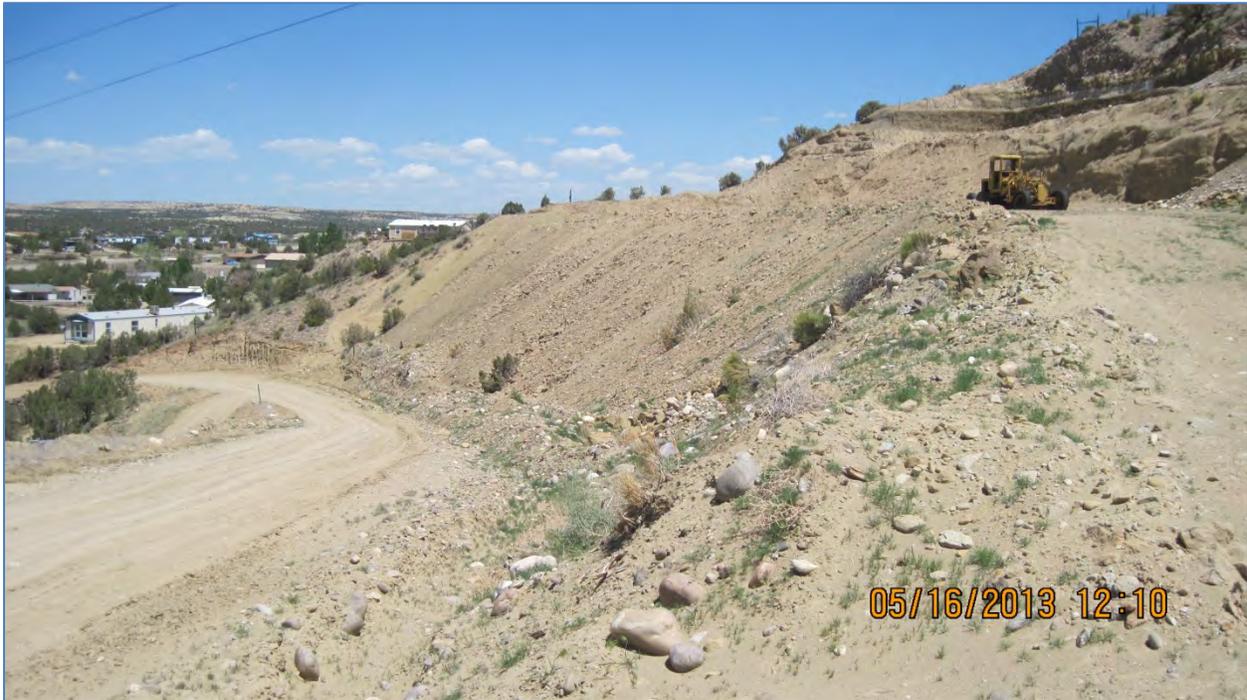
NMED/SWQB
Official Photograph Log
Photo # 9

Photographer: Erin Trujillo	Date: 05/16/2013	Time: 1210 hours
City/County: Flora Vista / San Juan County	State: New Mexico	
Location: Double B & S LLC / Flora Vista Hillside Estates #2, NMR12A237		
Subject: One of two shared access roads to terraces. Steep slopes between road and terrace. Equipment storage on upper terrace.

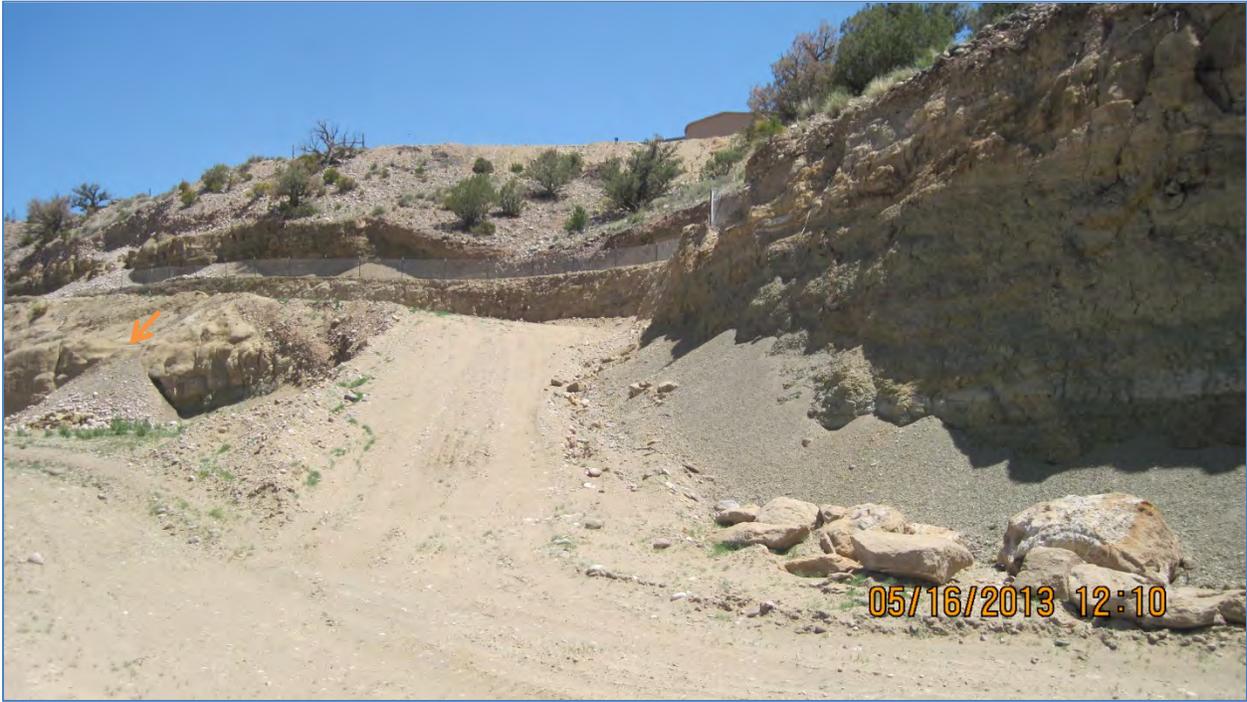
NMED/SWQB Official Photograph Log Photo # 10		
Photographer: Erin Trujillo	Date: 05/16/2013	Time: 1210 hours
City/County: Flora Vista / San Juan County		State: New Mexico
Location: Double B & S LLC / Flora Vista Hillside Estates #2, NMR12A237		
Subject: Arrow points to unconsolidated material between upper terraces. Fence at background is near tract property boundary.

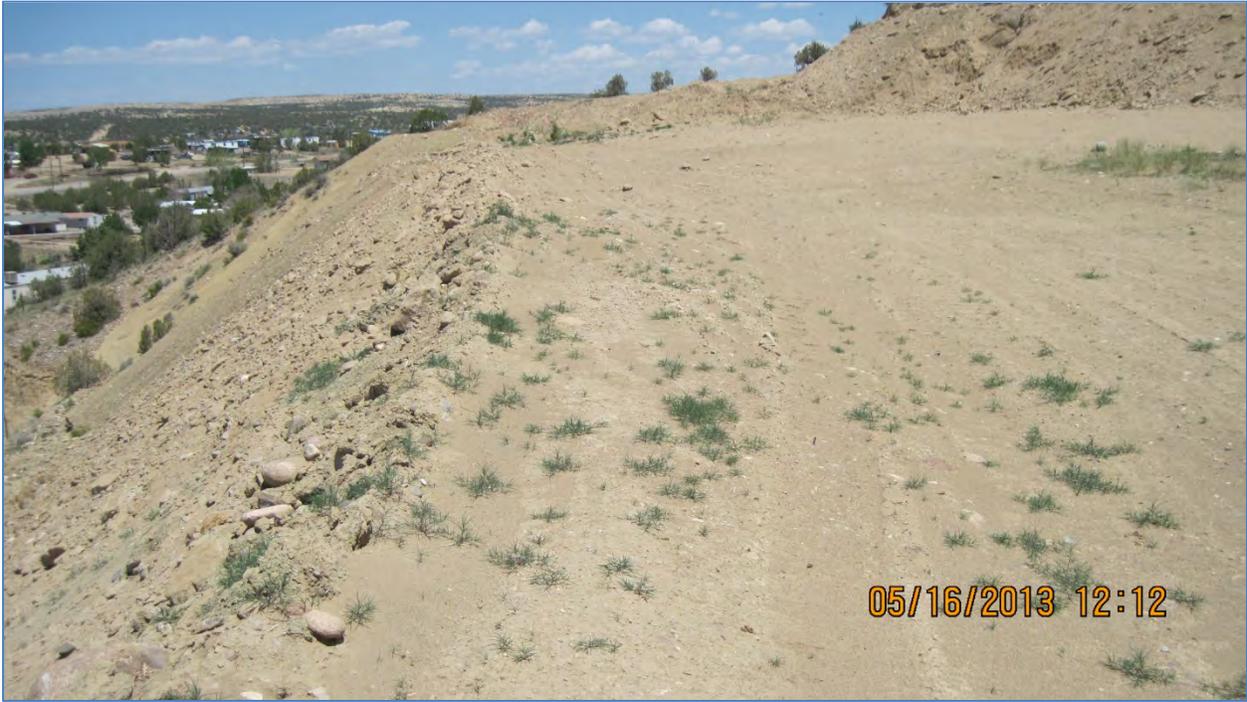
NMED/SWQB Official Photograph Log Photo # 11		
Photographer: Erin Trujillo	Date: 05/16/2013	Time: 1212 hours
City/County: Flora Vista / San Juan County		State: New Mexico
Location: Double B & S LLC / Flora Vista Hillside Estates #2, NMR12A237		
Subject: Status of vegetation on top terrace.

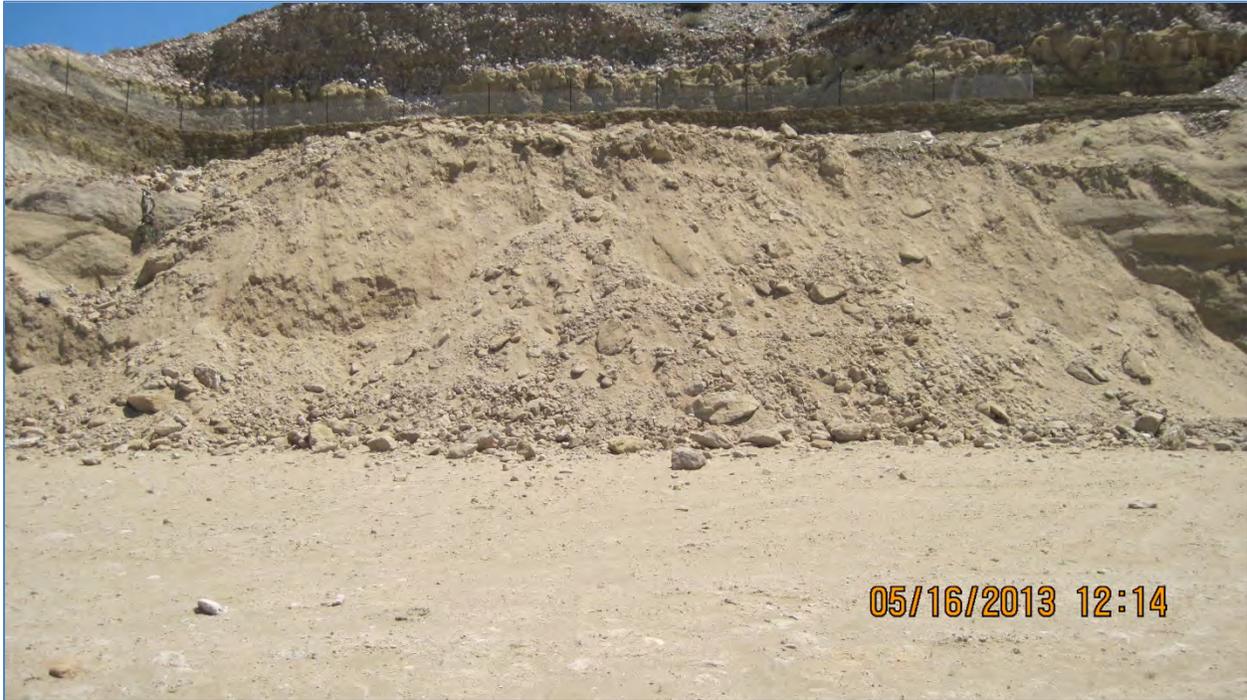
NMED/SWQB
Official Photograph Log
Photo # 12

Subject: Example of unconsolidated material above upper terrace shown in previous photo. Fence at top of photo is at property boundary.
