RE: Construction Storm Water, SIC 1521, NPDES Compliance Evaluation Inspection, Homewise Inc. /
Piñon Ridge, NMR12A571, September 17 and 18, 2012

Industrial Storm Water Worksheet (Construction) – State of New Mexico

On August 17, 2012, a Compliance Evaluation Inspection (CEI) was conducted by Erin Trujillo, of the New Mexico Environment Department (NMED) Surface Water Quality Bureau (SWQB) at the approximately 33-acre (39 lot) Piñon Ridge single-family residential subdivision construction site in Santa Fe, New Mexico. This inspection followed an anonymous complaint concerning the condition of control measures at the site. A reconnaissance from public roadways was conducted by this inspector on 09/17/2012. The purpose of this inspection was to document the facility's status regarding the National Pollutant Discharge Elimination System (NPDES) storm water permit program and storm water regulations at 40 Code of Federal Regulations Part 122.26.

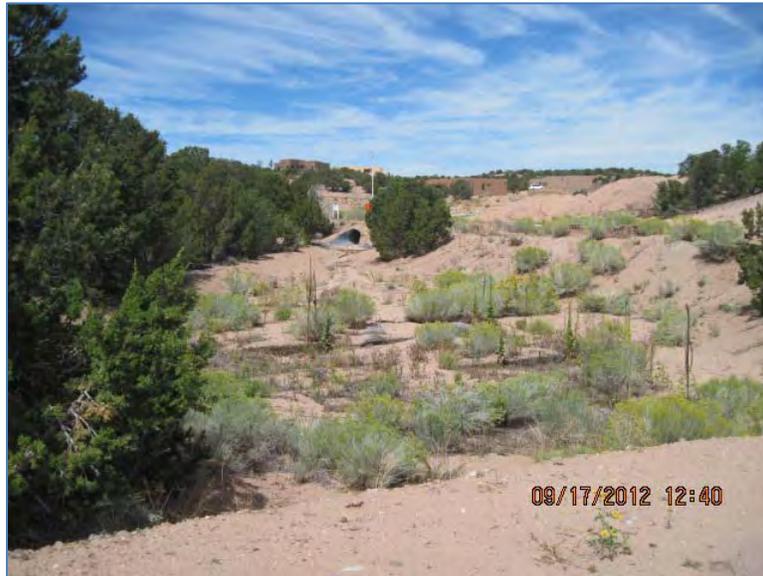
NMED/SWQB Official Photograph Log Photo # 1		
Photographer: Erin Trujillo	Date: 09/17/2012	Time: 1240 hours
City/County: Santa Fe / Santa Fe		State: New Mexico
Location: Piñon Ridge		
Subject: Detention pond (labeled 5D-1) in subdivision constructed before owner/operator acquired site. Bare spots on side slopes not stabilized.

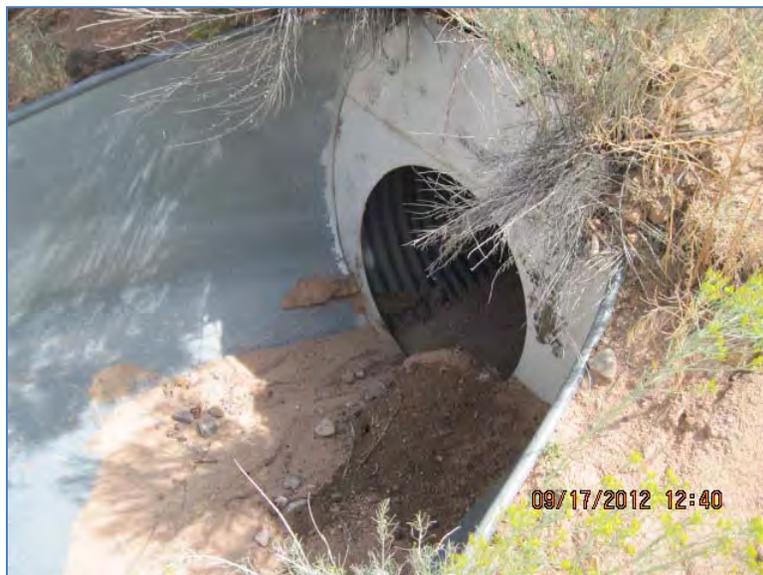
NMED/SWQB Official Photograph Log Photo # 2		
Photographer: Erin Trujillo	Date: 09/17/2012	Time: 1240 hours
City/County: Santa Fe / Santa Fe		State: New Mexico
Location: Piñon Ridge		
Subject: Accumulated sediment in culvert outlet of detention pond shown in previous photo. Flow from outlet of this pond is to unnamed tributary thence to Cañada Rincon.

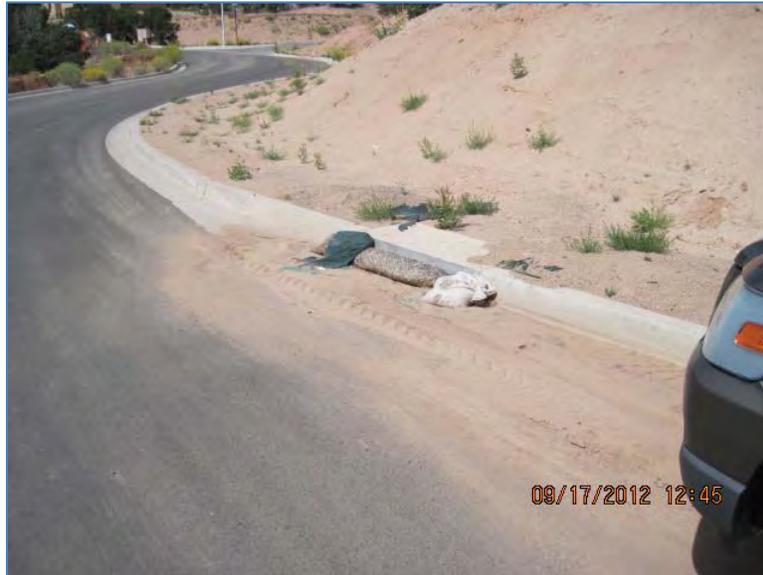
NMED/SWQB Official Photograph Log Photo # 3		
Photographer: Erin Trujillo	Date: 09/17/2012	Time: 1245 hours
City/County: Santa Fe / Santa Fe		State: New Mexico
Location: Piñon Ridge		
Subject: Example of accumulated sediment on Luna Vista at drop inlet control. Filter bags littered area. Disturbed slope not stabilized.

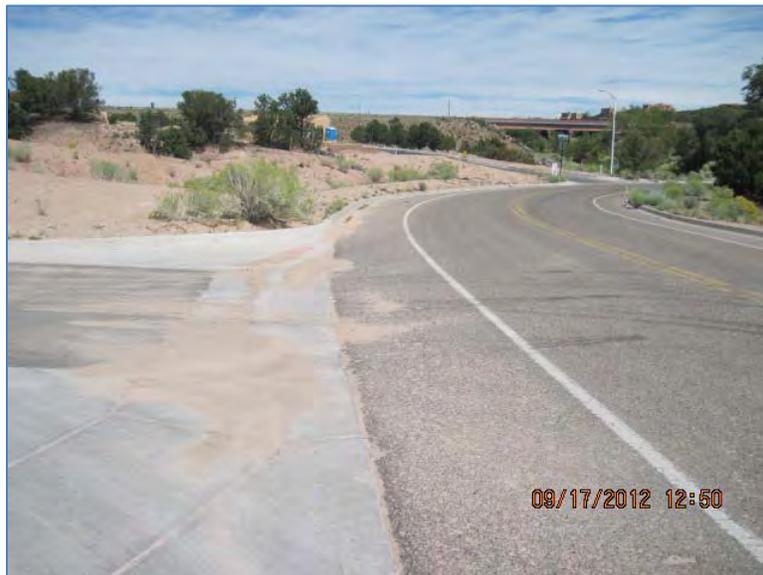
NMED/SWQB Official Photograph Log Photo # 4		
Photographer: Erin Trujillo	Date: 09/17/2012	Time: 1250 hours
City/County: Santa Fe / Santa Fe		State: New Mexico
Location: Piñon Ridge		
Subject: Example of accumulated sediment at Placita de Luna and Camino Francisca.

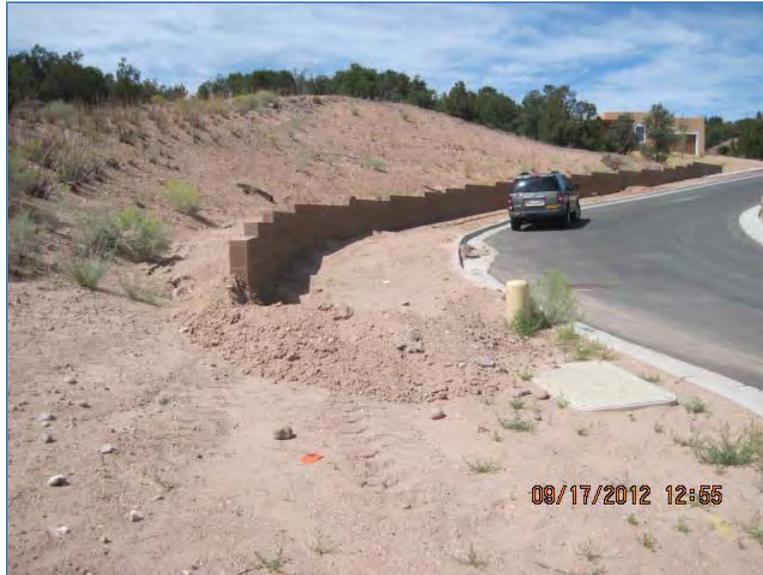
NMED/SWQB Official Photograph Log Photo # 5		
Photographer: Erin Trujillo	Date: 09/17/2012	Time: 1255 hours
City/County: Santa Fe / Santa Fe		State: New Mexico
Location: Piñon Ridge		
Subject: Example of disturbed area on slope above retaining wall along Placita de Luna that was not stabilized.

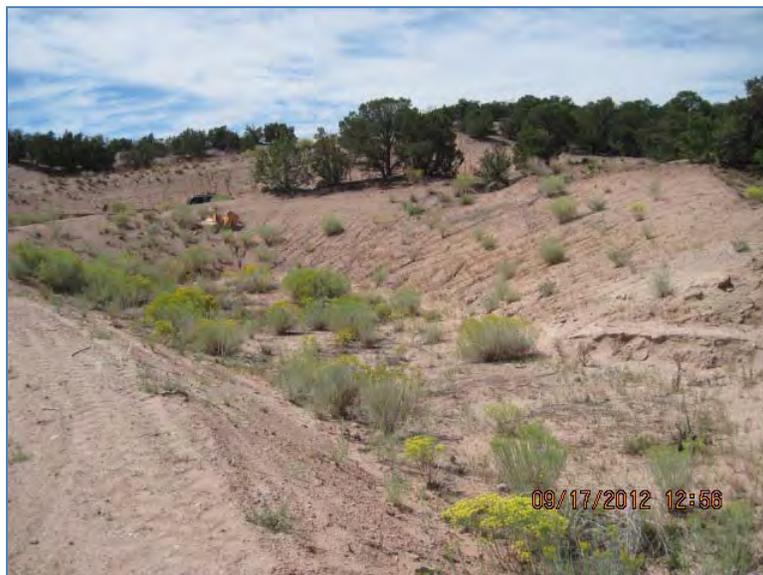
NMED/SWQB Official Photograph Log Photo # 6		
Photographer: Erin Trujillo	Date: 09/17/2012	Time: 1256 hours
City/County: Santa Fe / Santa Fe		State: New Mexico
Location: Piñon Ridge		
Subject: Detention pond (labeled 5D-2) between Placita De Luna loop entrances. Erosion rills observed and bare spots on side slopes not stabilized. Flow from outlet of this pond would be to natural buffer of Cañada Rincon.

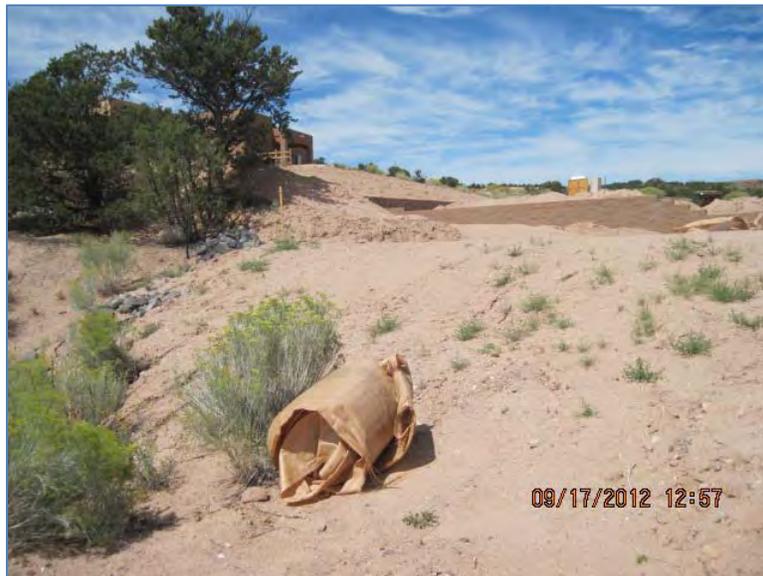
NMED/SWQB Official Photograph Log Photo # 7		
Photographer: Erin Trujillo	Date: 09/17/2012	Time: 1257 hours
City/County: Santa Fe / Santa Fe		State: New Mexico
Location: Piñon Ridge		
Subject: Example of rolled up silt fence, in this case, along perimeter of subdivision and Camino Francisca.

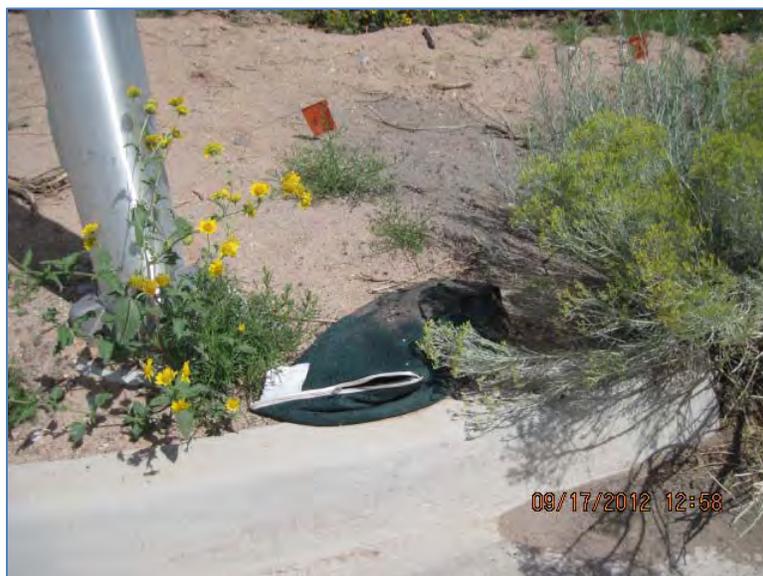
NMED/SWQB Official Photograph Log Photo # 8		
Photographer: Erin Trujillo	Date: 09/17/2012	Time: 1258 hours
City/County: Santa Fe / Santa Fe		State: New Mexico
Location: Piñon Ridge		
Subject: Filter bag did not appear to be used/installed littered site. Some sediment in gutter along Placita de Luna.

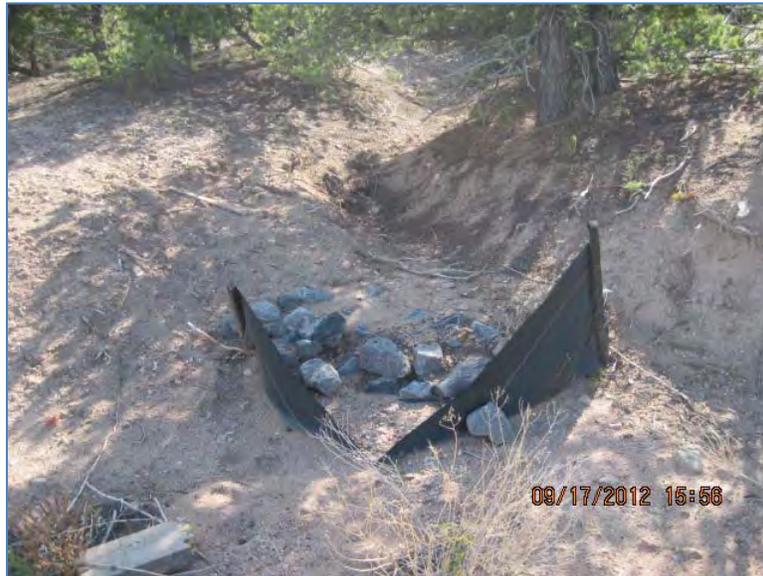
NMED/SWQB Official Photograph Log Photo # 9		
Photographer: Erin Trujillo	Date: 09/17/2012	Time: 1556 hours
City/County: Santa Fe / Santa Fe		State: New Mexico
Location: Piñon Ridge		
Subject: Unmaintained rock and damaged silt fence check dam at end of natural drainage channel near Avenida de Luna Cul de Sac near Lot 19.

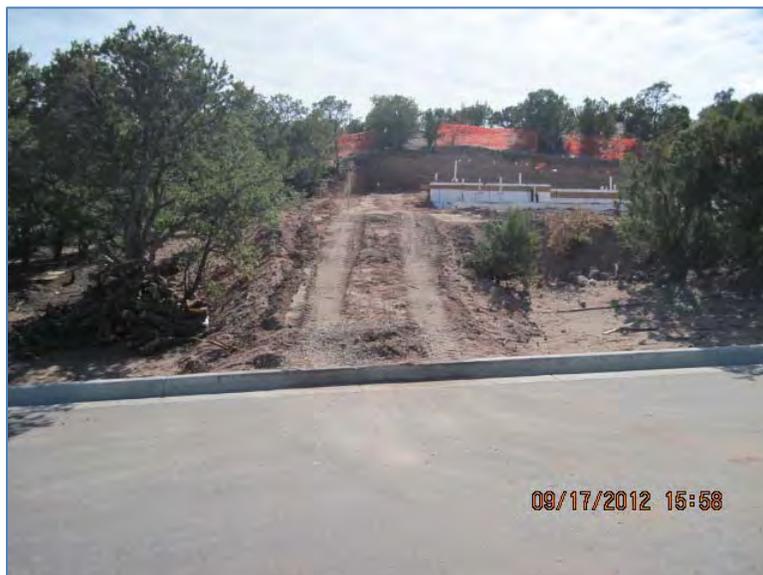
NMED/SWQB Official Photograph Log Photo # 10		
Photographer: Erin Trujillo	Date: 09/17/2012	Time: 1558 hours
City/County: Santa Fe / Santa Fe		State: New Mexico
Location: Piñon Ridge		
Subject: Small diameter rock at location where vehicles access lot under construction did not appear sufficient in size or quantity to prevent/minimize vehicle track out onto Luna Vista. Some sediment was observed on paved street.

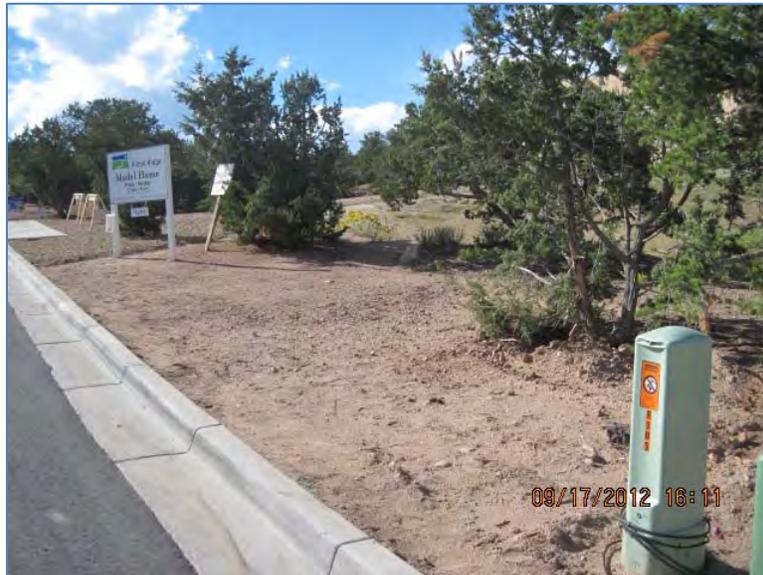
NMED/SWQB Official Photograph Log Photo # 11		
Photographer: Erin Trujillo	Date: 09/17/2012	Time: 1611 hours
City/County: Santa Fe / Santa Fe		State: New Mexico
Location: Piñon Ridge		
Subject: Example of bare un-stabilized area in drainage easement of completed Lot 11 (Model Home).

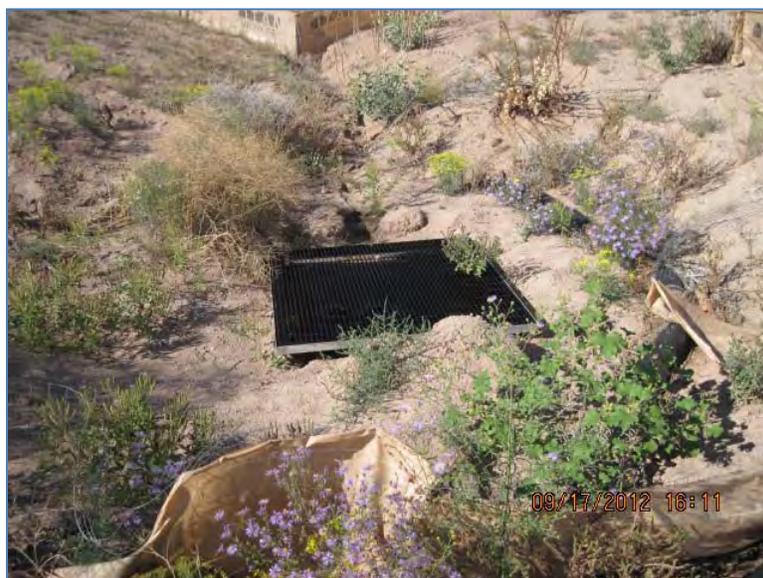
NMED/SWQB Official Photograph Log Photo # 12		
Photographer: Erin Trujillo	Date: 09/17/2012	Time: 1611 hours
City/County: Santa Fe / Santa Fe		State: New Mexico
Location: Piñon Ridge		
Subject: No inlet control measures at grate as described/shown in SWPPP documentation. Wattle and silt fence were damaged and did not protect inlet. Rills observed on side slopes.

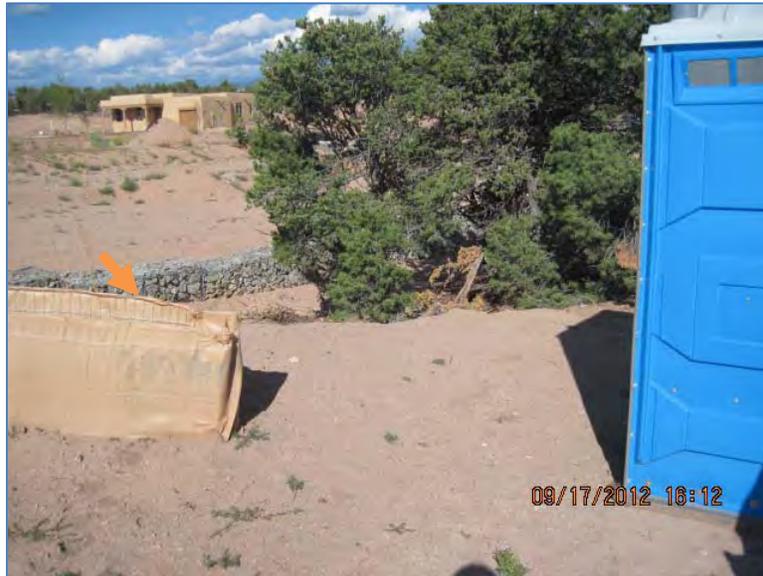
NMED/SWQB Official Photograph Log Photo # 13		
Photographer: Erin Trujillo	Date: 09/17/2012	Time: 1612 hours
City/County: Santa Fe / Santa Fe	State: New Mexico	
Location: Piñon Ridge		
Subject: Gap of control measures in disturbed area above unnamed tributary. Arrow points to silt fence that is folded back at gap. No containment or anchor controls described in SWPPP documentation observed for portable toilet.

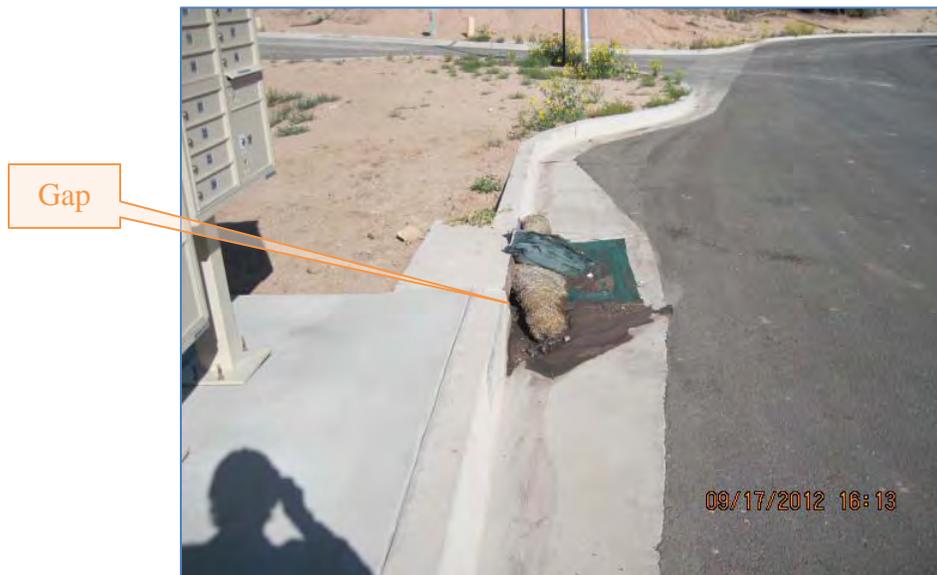
NMED/SWQB Official Photograph Log Photo # 14		
Photographer: Erin Trujillo	Date: 09/17/2012	Time: 1613 hours
City/County: Santa Fe / Santa Fe	State: New Mexico	
Location: Piñon Ridge		
Subject: Example of gap at wattle and drop inlet. Filter bag on top of wattle did not appear sufficient to keep wattle in place and minimize sediment from entering inlet. Sediment is wet from allowable non-stormwater discharge.

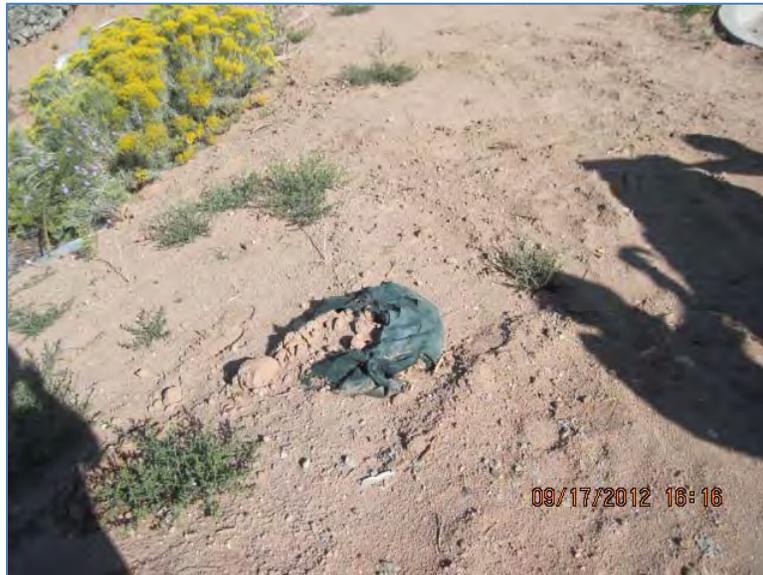
NMED/SWQB Official Photograph Log Photo # 15		
Photographer: Erin Trujillo	Date: 09/17/2012	Time: 1616 hours
City/County: Santa Fe / Santa Fe	State: New Mexico	
Location: Piñon Ridge		
Subject: Example of damaged filter bag/wattle littering site.

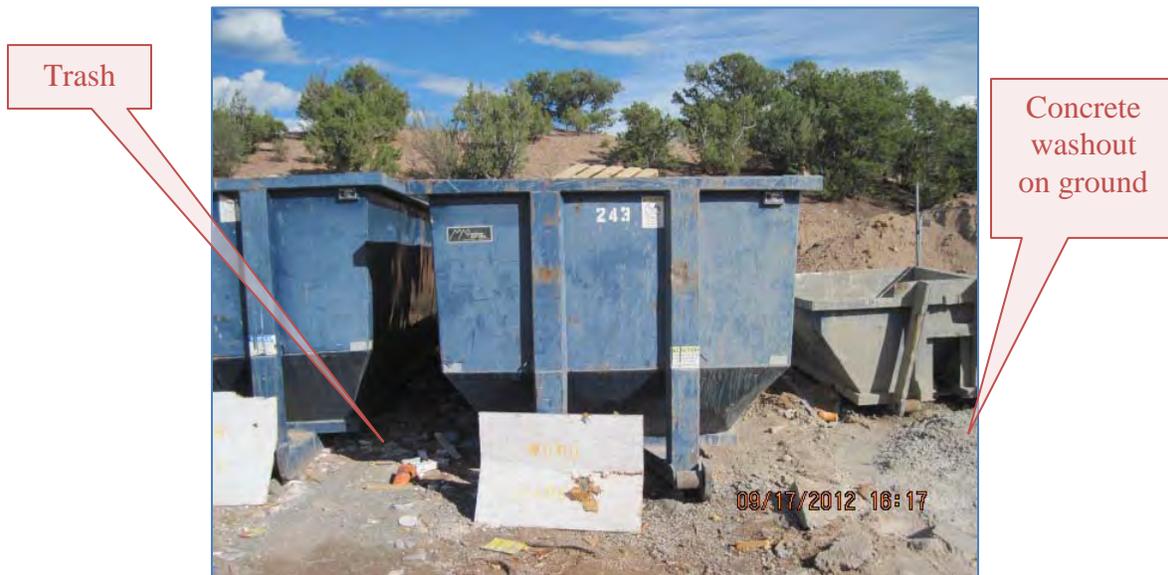
NMED/SWQB Official Photograph Log Photo # 16		
Photographer: Erin Trujillo	Date: 09/17/2012	Time: 1617 hours
City/County: Santa Fe / Santa Fe	State: New Mexico	
Location: Piñon Ridge		
Subject: Concrete washout on ground in front of washout container. Litter and debris around uncovered trash and recycle roll offs. Signs for recycling difficult to read, especially from distance. No sign for washout observed.

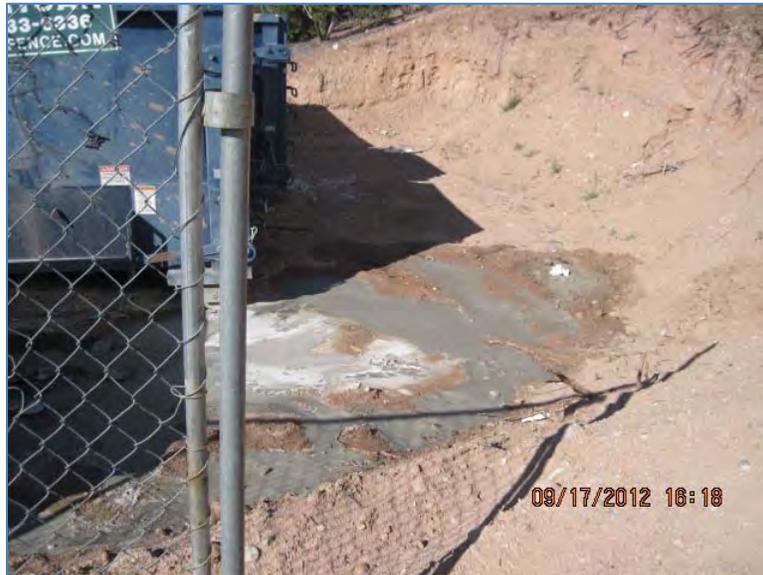
NMED/SWQB Official Photograph Log Photo # 17		
Photographer: Erin Trujillo	Date: 09/17/2012	Time: 1618 hours
City/County: Santa Fe / Santa Fe		State: New Mexico
Location: Piñon Ridge		
Subject: Concrete washout on ground behind washout container.

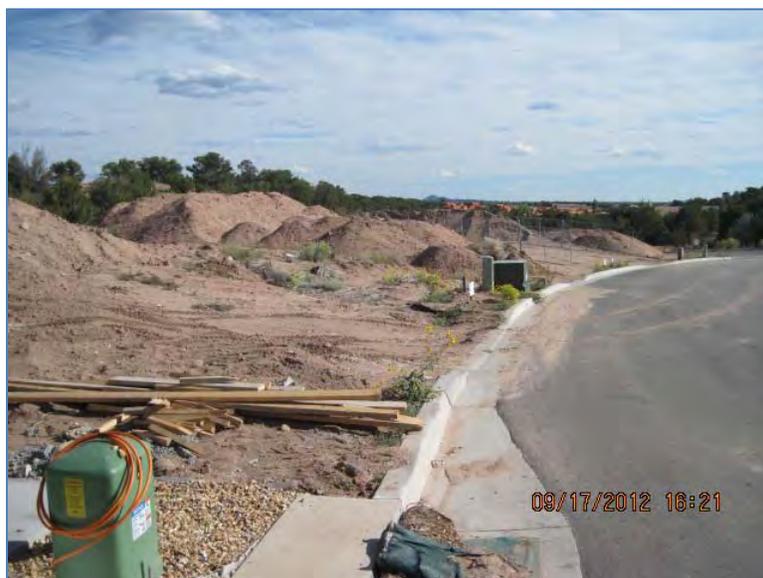
NMED/SWQB Official Photograph Log Photo # 18		
Photographer: Erin Trujillo	Date: 09/17/2012	Time: 1621 hours
City/County: Santa Fe / Santa Fe		State: New Mexico
Location: Piñon Ridge		
Subject: Temporary fill stockpiles and accumulated sediment along Avenida de Luna. No track out controls from un-stabilized areas at driveway curb cuts to paved street observed.

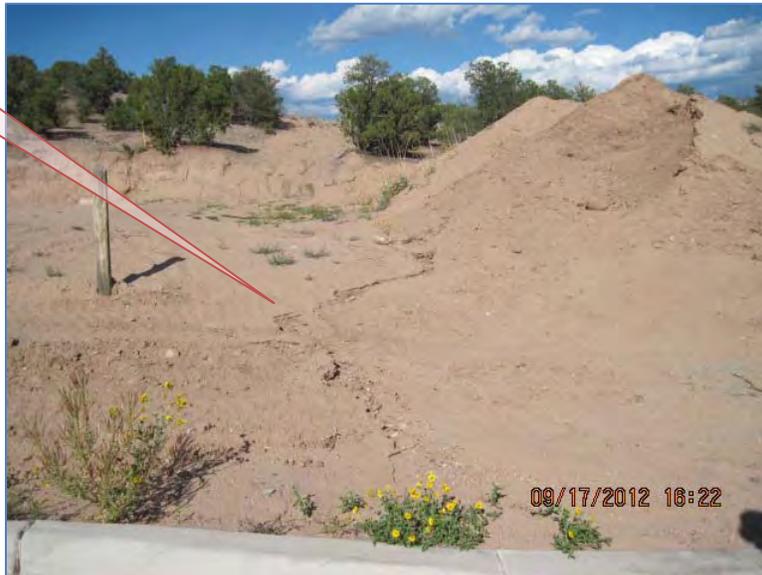
NMED/SWQB Official Photograph Log Photo # 19		
Photographer: Erin Trujillo	Date: 09/17/2012	Time: 1622 hours
City/County: Santa Fe / Santa Fe		State: New Mexico
Location: Piñon Ridge		
Subject: Fill stockpile and erosion rill toward driveway curb cut at paved street. No track out controls observed.

Erosion rill

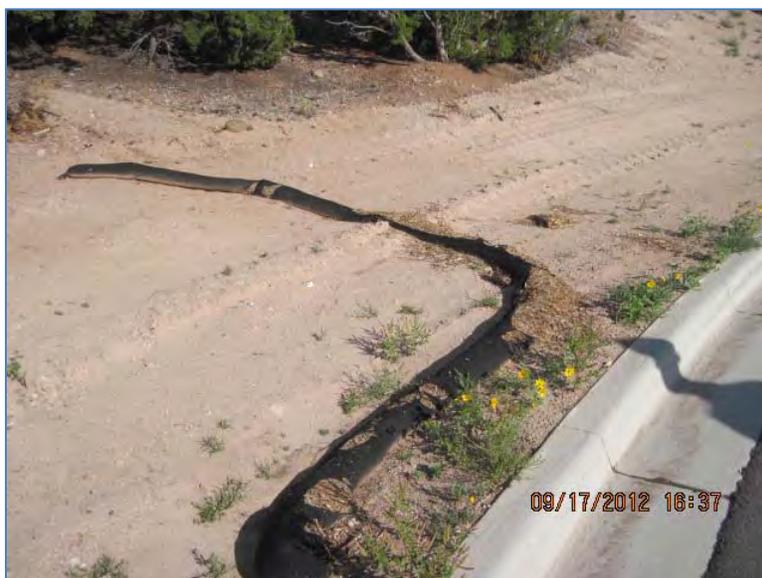
NMED/SWQB Official Photograph Log Photo # 20		
Photographer: Erin Trujillo	Date: 09/17/2012	Time: 1637 hours
City/County: Santa Fe / Santa Fe		State: New Mexico
Location: Piñon Ridge		
Subject: Example of un-stabilized bare area and damaged un-staked straw wattle below soil stockpiles on Lot 29. Other control measures in this area (not shown in photo) appeared undamaged and functioning.

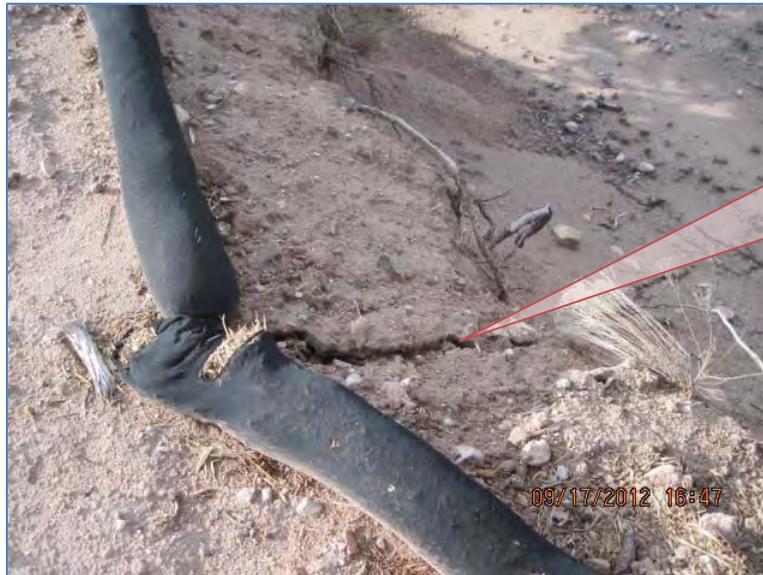
NMED/SWQB Official Photograph Log Photo # 21		
Photographer: Erin Trujillo	Date: 09/17/2012	Time: 1647 hours
City/County: Santa Fe / Santa Fe		State: New Mexico
Location: Piñon Ridge		
Subject: Example of damaged un-staked straw wattle above unnamed tributary in drainage easement.

Erosion rill above unnamed tributary in drainage easement

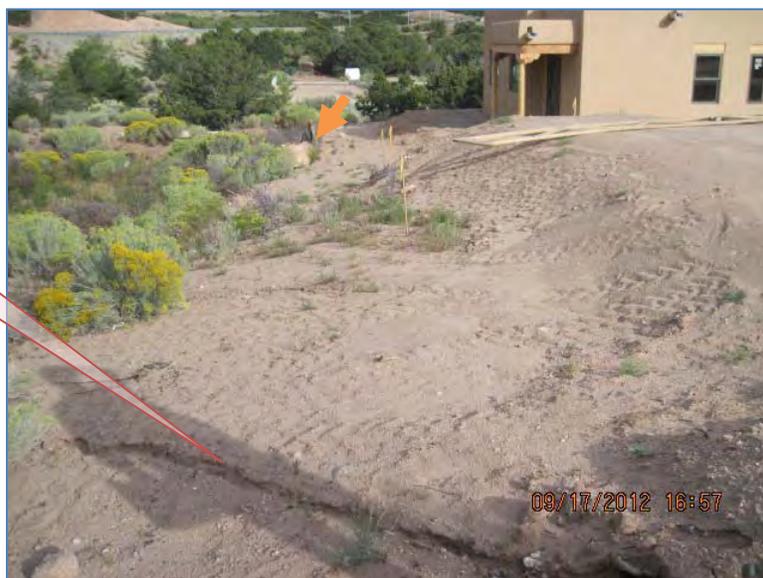
NMED/SWQB Official Photograph Log Photo # 22		
Photographer: Erin Trujillo	Date: 09/17/2012	Time: 1657 hours
City/County: Santa Fe / Santa Fe		State: New Mexico
Location: Piñon Ridge		
Subject: Example of un-stabilized fill and slope, in this case on north side of Lot 35 and 36 adjacent to open space and northeast detention pond (not shown in photo). Arrow points to rolled up silt fence.

Erosion rill

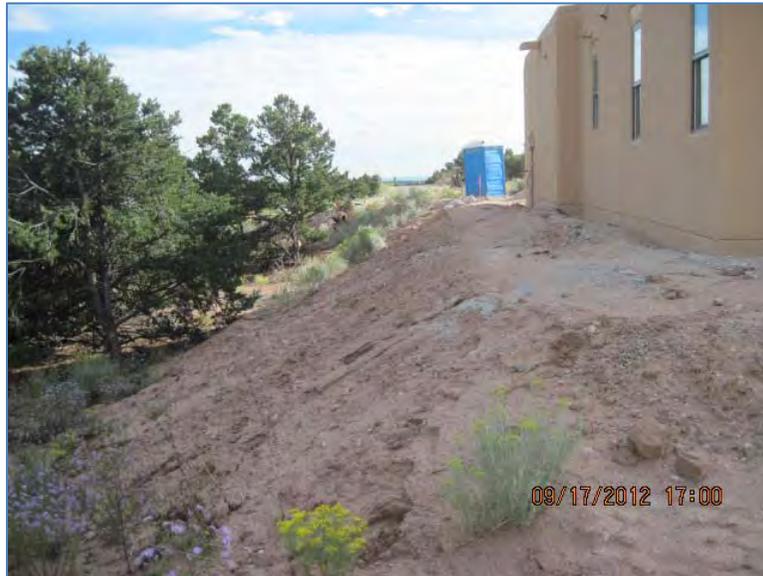
NMED/SWQB Official Photograph Log Photo # 23		
Photographer: Erin Trujillo	Date: 09/17/2012	Time: 1700 hours
City/County: Santa Fe / Santa Fe	State: New Mexico	
Location: Piñon Ridge		
Subject: Un-stabilized fill slope on Lot 36 adjacent to open space and natural buffer along Cañada Rincon. No installed perimeter controls existed below slope.

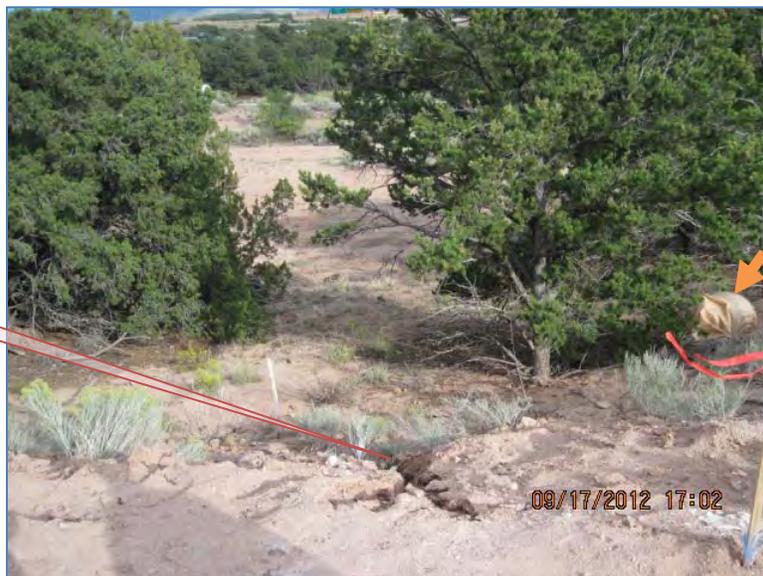
NMED/SWQB Official Photograph Log Photo # 24		
Photographer: Erin Trujillo	Date: 09/17/2012	Time: 1702 hours
City/County: Santa Fe / Santa Fe	State: New Mexico	
Location: Piñon Ridge		
Subject: Arrow points to rolled up silt fence adjacent to open space and natural buffer along Cañada Rincon

Erosion Rill

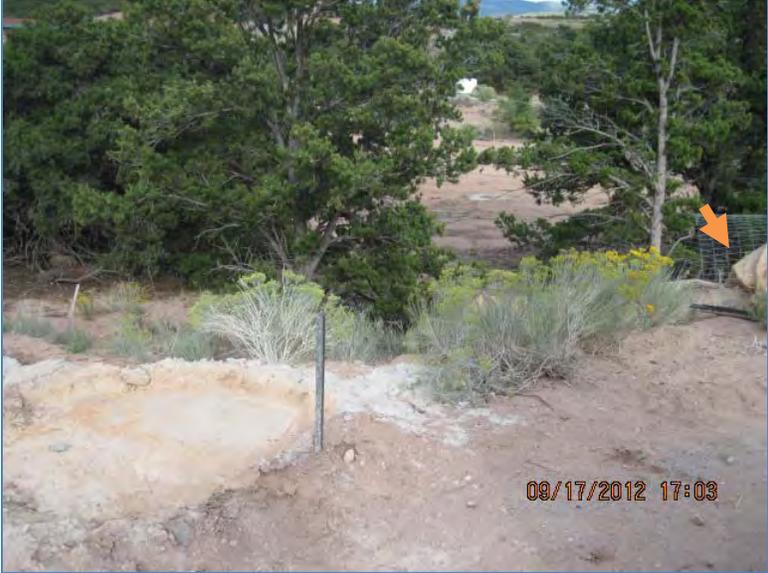
NMED/SWQB Official Photograph Log Photo # 25		
Photographer: Erin Trujillo	Date: 09/17/2012	Time: 1703 hours
City/County: Santa Fe / Santa Fe	State: New Mexico	
Location: Piñon Ridge		
Subject: Concrete and/or other chemical product cleanout in southeast corner of Lot 36 adjacent to open space and natural buffer along Cañada Rincon. Arrow points to example rolled up silt fence.
