RE: Construction Stormwater, SIC 1521, NPDES Compliance Evaluation Inspection, Kitts Development, Inc., Puerto del Sol Construction Site, NPDES Permit NMR15FE53, August 23, 2010

NPDES Compliance Inspection Report

Official Photograph Log

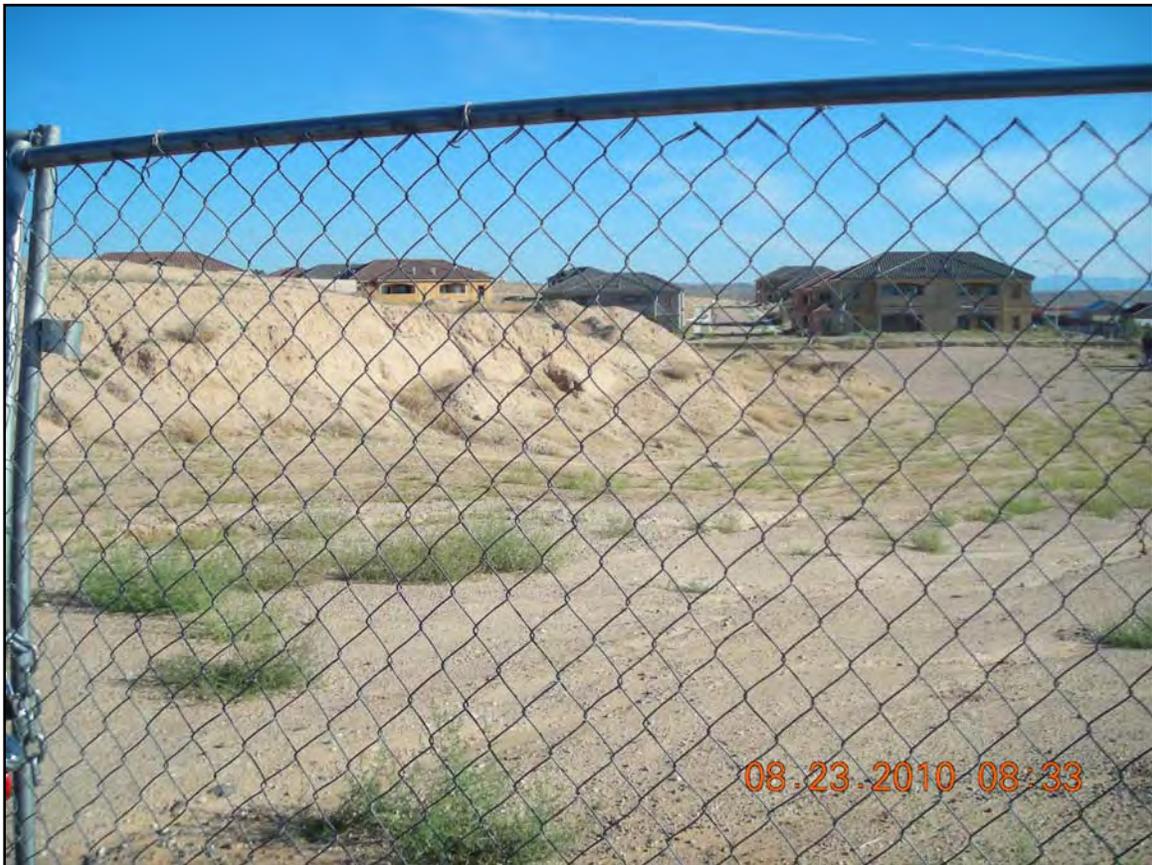
Photo # 1

Photographer: Sarah Holcomb	Date: 8-23-2010	Time: 0833 hours
City/County: Rio Rancho/Sandoval		
Location: Puerto del Sol Development		
Subject: Standing at the entrance to the site. Large dirt stockpile to the left. Unfinished fourplexes can be seen in the background.

Approximately 14 structures were started, but they currently sit vacant on the property. The cleared areas were never stabilized and there is a large dirt stockpile that sits on the property close to the entrance. The inspector did not note any construction materials being stored on site and there were no chemicals or trash left on site.

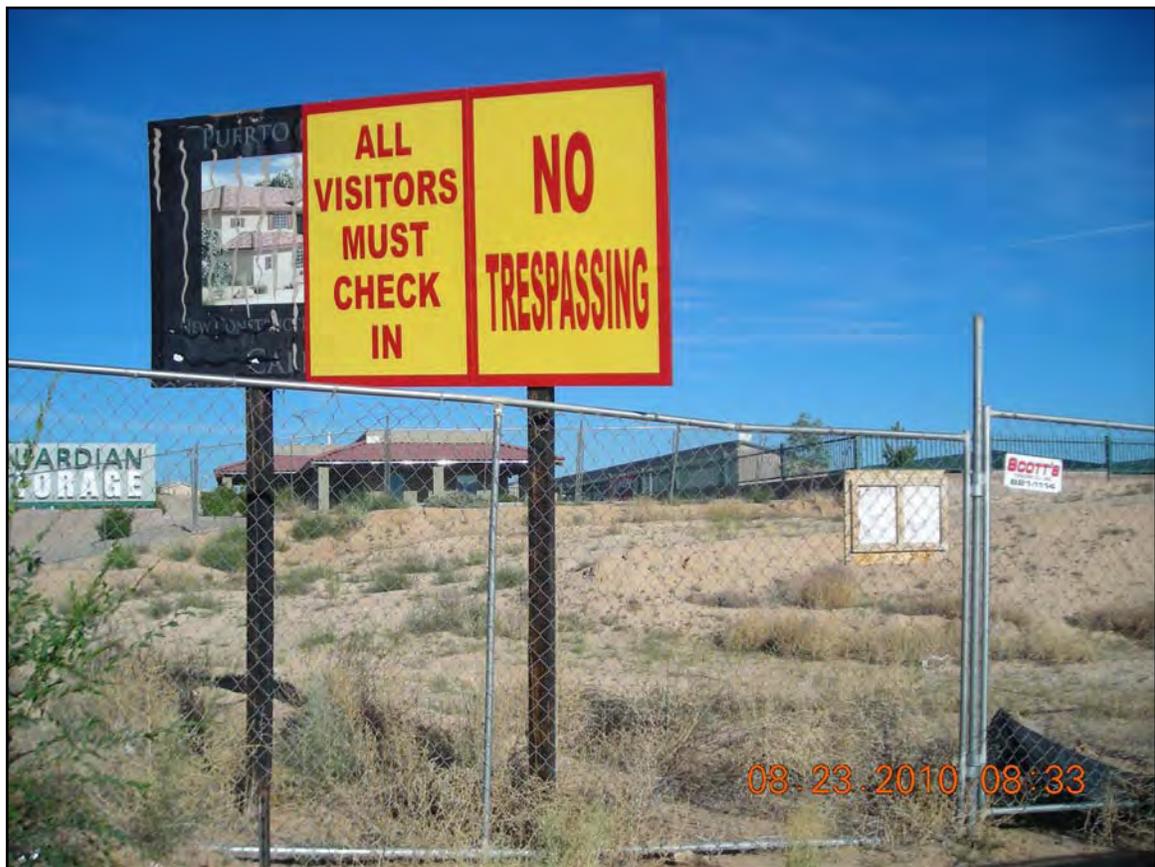
Photo # 2

Photographer: Sarah Holcomb	Date: 8-23-2010	Time: 0833 hours
City/County: Rio Rancho/Sandoval		
Location: Puerto del Sol Development		
Subject: Signage at entry. Small wooden sign attached to fence is the facility NOI.

The inspector arrived at the site at 0815 hours on August 23, 2010. There was an NOI posted at the site, but the contact information was outdated. The inspector made some observations and took some photographs from publicly accessible areas and returned to the office to research owners and operators at the subdivision.

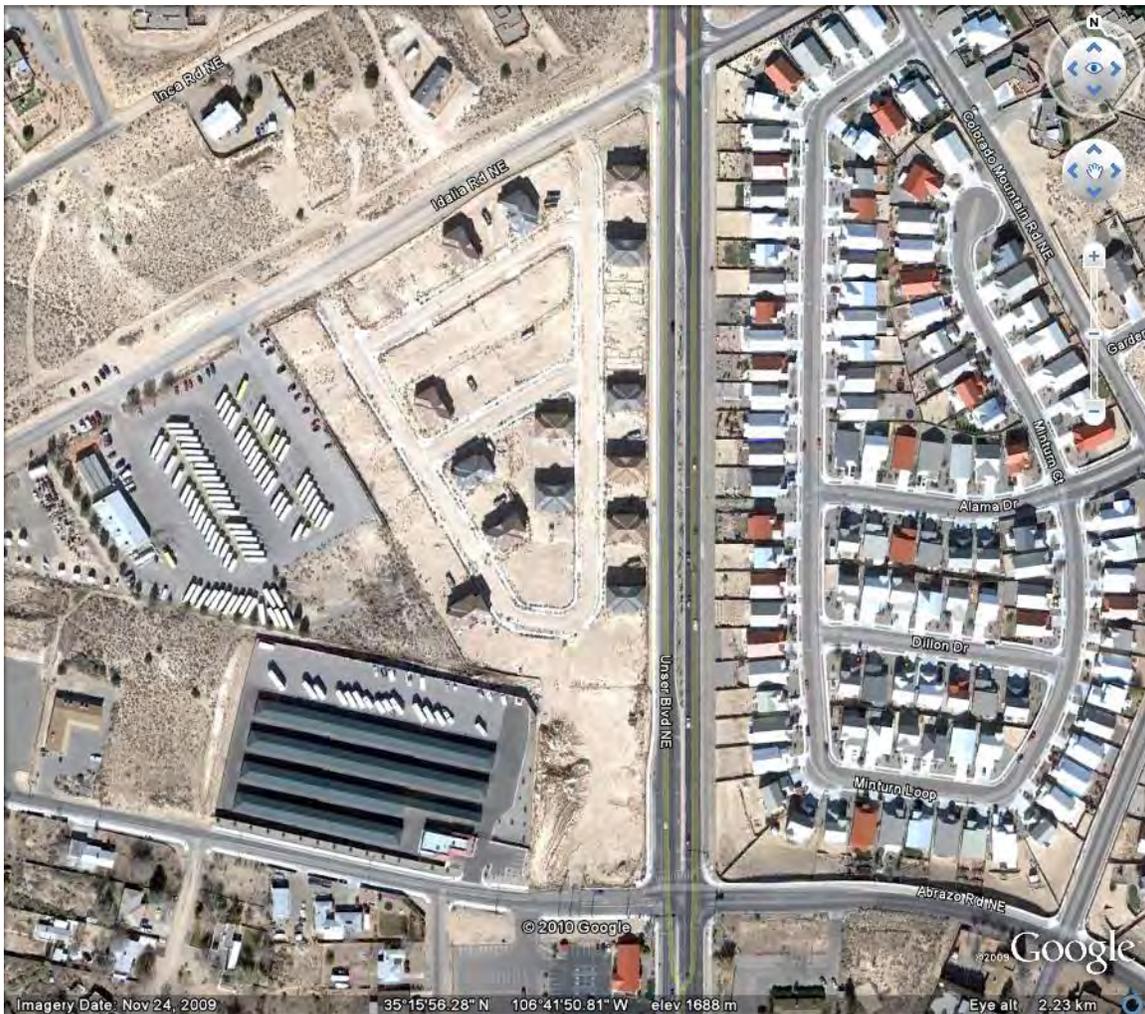
Photo # 3

Photographer: Google Earth	Date: N/A	Time: N/A
City/County: Rio Rancho/Sandoval		
Location: Puerto del Sol Development		
Subject: Current state of the development. Note no stabilization has taken place.

There was not a pollution prevention plan prepared in written form available at the site for the inspection and adequate stabilization measures were not being implemented at the site. A SWPPP should include the following:
