RE: Construction Storm Water, SIC 1521, NPDES Compliance Evaluation Inspection, Smith and Aguirre Construction Co, Inc., Dos Lados Estates Subdivision, NMR15FM67, Las Cruces, New Mexico, July 8, 2010

NPDES Compliance Inspection Report

Compliance Evaluation Inspection
Dos Lados Estates Subdivision, Las Cruces, New Mexico
NPDES Tracking No. NMR15FM67
July 8, 2010

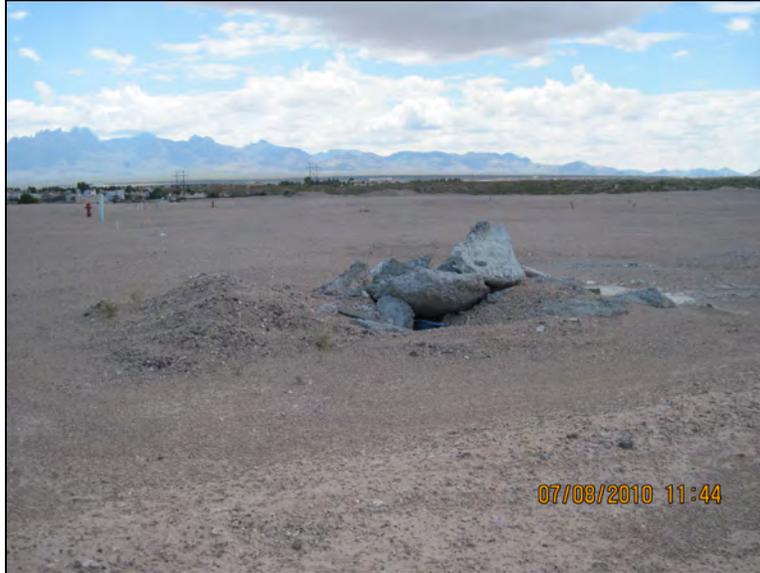
NMED/SWQB Official Photograph Log Photo # 1		
Photographer: Erin S. Trujillo	Date: 07/08/2010	Time: 1144 hours
City/County: Las Cruces / Doña Ana County		State: New Mexico
Location: Dos Lados Estates Subdivision		
Subject: Overview of site from western property boundary. Since access to site is not secured, it is unknown if concrete and concrete washout in center of photo is from previous construction activities of this site or unauthorized dumping.

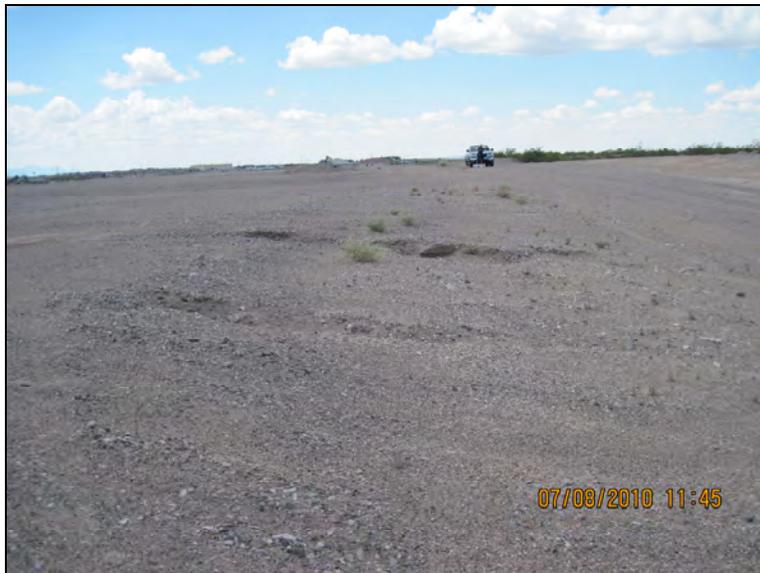
NMED/SWQB Official Photograph Log Photo # 2		
Photographer: Erin S. Trujillo	Date: 07/08/2010	Time: 1145 hours
City/County: Las Cruces / Doña Ana County		State: New Mexico
Location: Dos Lados Estates Subdivision		
Subject: Overview of site from northwestern property corner. A few erosion rills had formed toward the unpaved Settlers Pass Road (left side of photo).

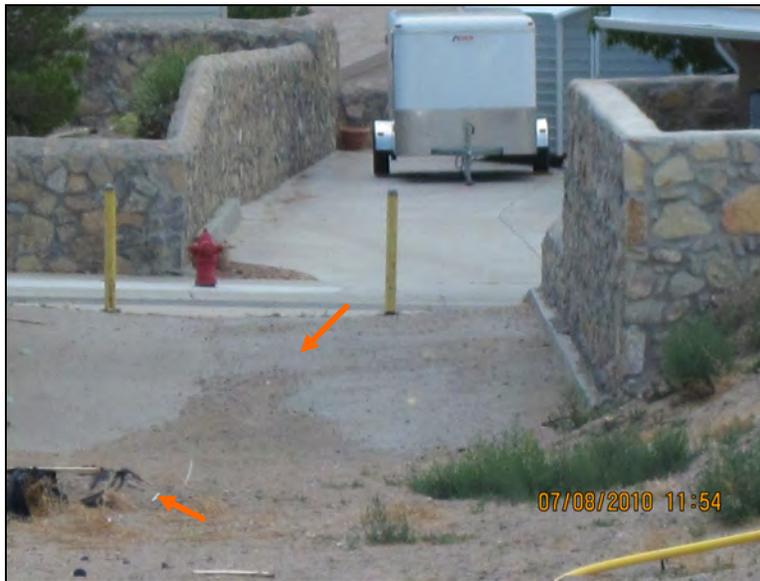
**NMED/SWQB
Official Photograph Log
Photo # 3**

Photographer: Erin S. Trujillo	Date: 07/08/2010	Time: 1154 hours
City/County: Las Cruces / Doña Ana County	State: New Mexico	
Location: Dos Lados Estates Subdivision		
Subject: Arrows point to remnants of unmaintained silt fence along eastern property boundary and sediment that has accumulated in the off-site drainage outlet leading to Galina Drive.

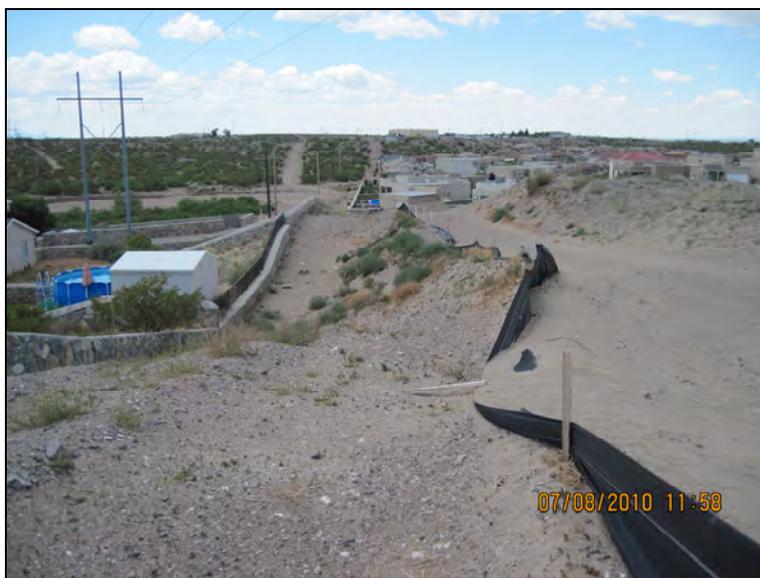
**NMED/SWQB
Official Photograph Log
Photo # 4**

Photographer: Erin S. Trujillo	Date: 07/08/2010	Time: 1158 hours
City/County: Las Cruces / Doña Ana County	State: New Mexico	
Location: Dos Lados Estates Subdivision		
Subject: Example of unmaintained silt fence and accumulated sediment along eastern property boundary.

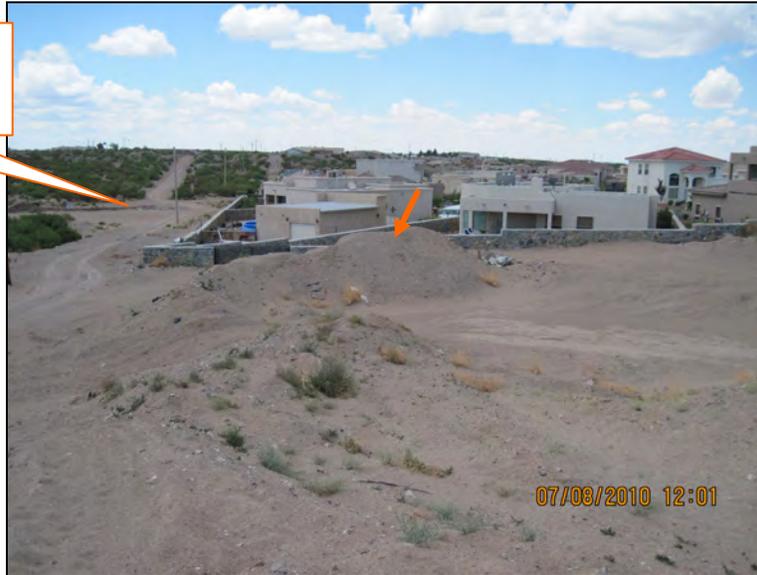
NMED/SWQB Official Photograph Log Photo # 5		
Photographer: Erin S. Trujillo	Date: 07/08/2010	Time: 1201 hours
City/County: Las Cruces / Doña Ana County		State: New Mexico
Location: Dos Lados Estates Subdivision		
Subject: Arrow points to unstabilized earth berm in southeast corner of the site. Drainage in this area is to the southeast-south towards Sand Hill Arroyo

Approximate off-site location
of Sand Hill Arroyo

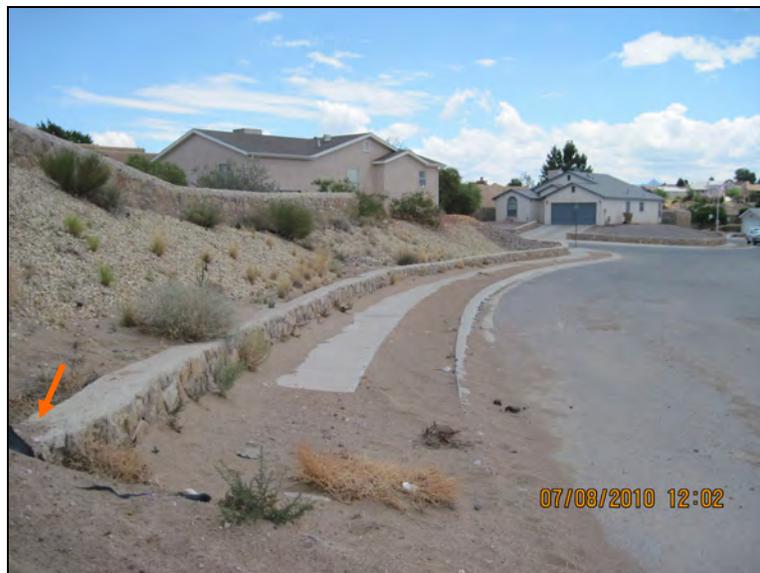
<u>Non-Structural Practices</u>	
Street Cleaning <small>ESO Element 43</small>	<small>(e.g., describe measures taken to remove offsite accumulation of sediment)</small> No current measures. Accumulated sediment off-site (see Photos #6, #8 and #9).
Good Housekeeping & Waste Disposal Practices <small>ESO Element 44</small>	<small>(e.g., describe measures taken to prevent litter and debris from becoming a pollutant source)</small> SWPPP discussed storage of all waste materials at a fenced yard, removal from the site and disposal at a licensed landfill. Abandoned pipe and other construction materials were observed on-site, primarily in and near the off-site fenced yard. Because access is not controlled, there was some evidence of dumping (e.g. bottles and concrete—see Photo #1) on site.
Equipment Wash/Maintenance Area <small>ESO Elements 42</small>	<small>(provide brief description)</small> No active or remaining equipment wash/maintenance areas observed on the day of the inspection.

NMED/SWQB Official Photograph Log Photo # 6		
Photographer: Erin S. Trujillo	Date: 07/08/2010	Time: 1202 hours
City/County: Las Cruces / Doña Ana County		State: New Mexico
Location: Dos Lados Estates Subdivision		
Subject: Accumulated sediment offsite on associated sidewalks and paved Arena Drive. Arrow points to remnant of silt fence along eastern property boundary of the site.

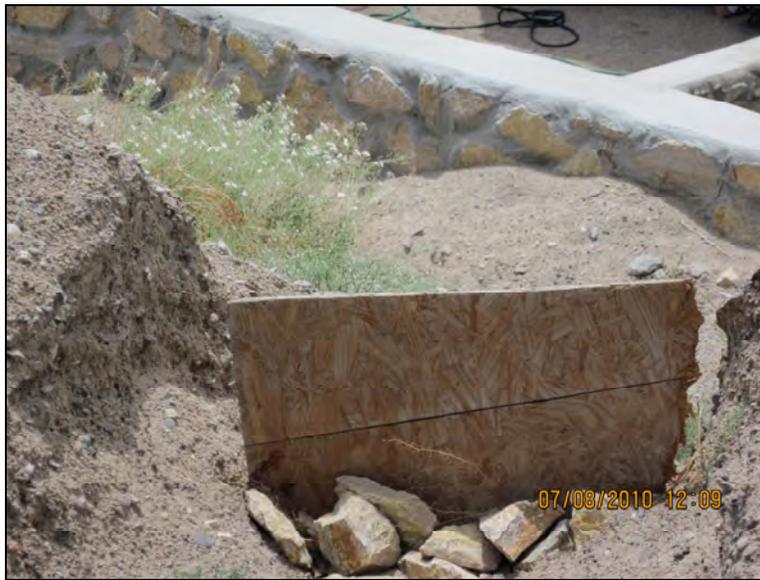
NMED/SWQB Official Photograph Log Photo # 7		
Photographer: Erin S. Trujillo	Date: 07/08/2010	Time: 1209 hours
City/County: Las Cruces / Doña Ana County		State: New Mexico
Location: Dos Lados Estates Subdivision		
Subject: Example of boards and rocks placed in erosion gullies on-site. This measure was not installed by staff of the “The Phillipou Group” according the on-site operator representative. These boards/rocks, likely placed by adjacent property owner(s), can cause additional erosion of the gully sides during a rain event.

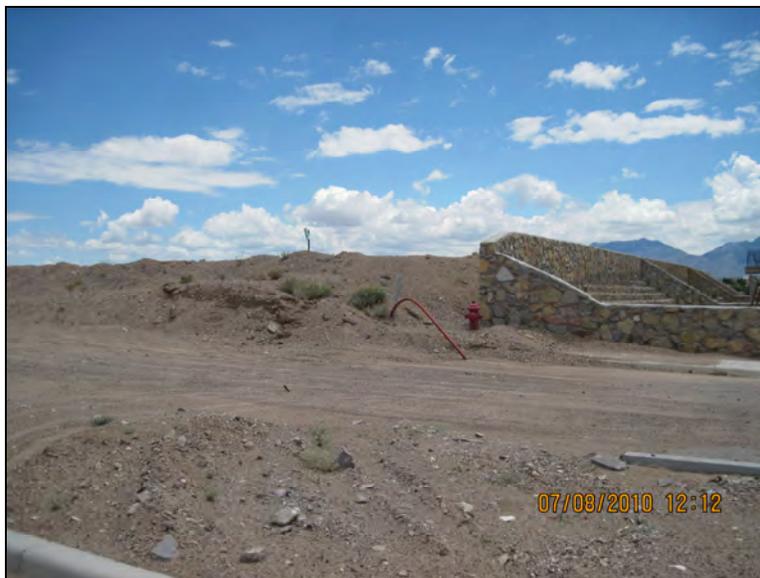
NMED/SWQB Official Photograph Log Photo # 8		
Photographer: Erin S. Trujillo	Date: 07/08/2010	Time: 1212 hours
City/County: Las Cruces / Doña Ana County		State: New Mexico
Location: Dos Lados Estates Subdivision		
Subject: Southwest corner of site at Settlers Pass Road. No erosion control measures were placed in this corner of the site and accumulated sediment was observed the paved street.

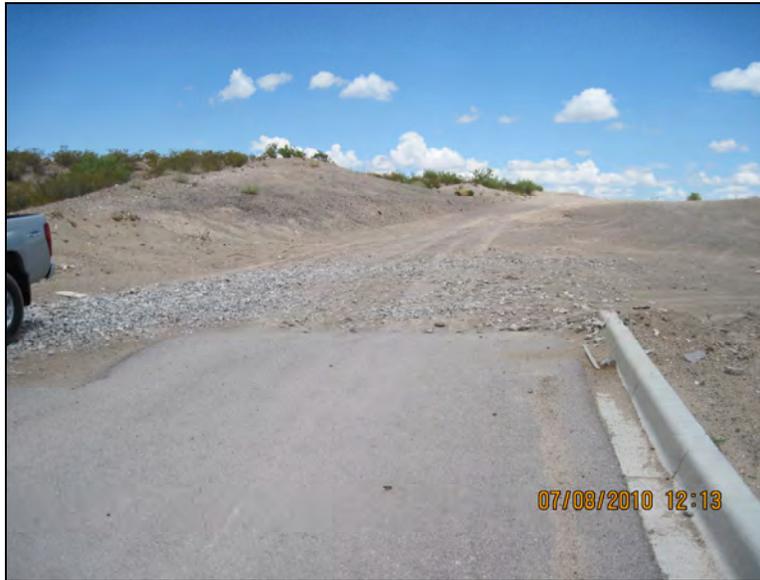
NMED/SWQB Official Photograph Log Photo # 9		
Photographer: Erin S. Trujillo	Date: 07/08/2010	Time: 1213 hours
City/County: Las Cruces / Doña Ana County		State: New Mexico
Location: Dos Lados Estates Subdivision		
Subject: Settlers Pass Road. Vehicle track out had been moved from site's southeast corner to this location according to the site map. The vehicle track out appears to have reduced the amount of accumulated sediment from the unpaved road and subdivision. But, the pad has accumulated sediment and needs maintenance.
