Re: Samantha Lane Residence, Construction Storm Water, SIC 1542, NPDES Compliance Evaluation Inspection, NPDES Permit NMU000000*, September 26, 2013

NPDES Compliance Inspection Report

NPDES Compliance Evaluation Inspection
Samantha Lane Residence, Enviro Co.
Permit No. NMU000000
September 26, 2013

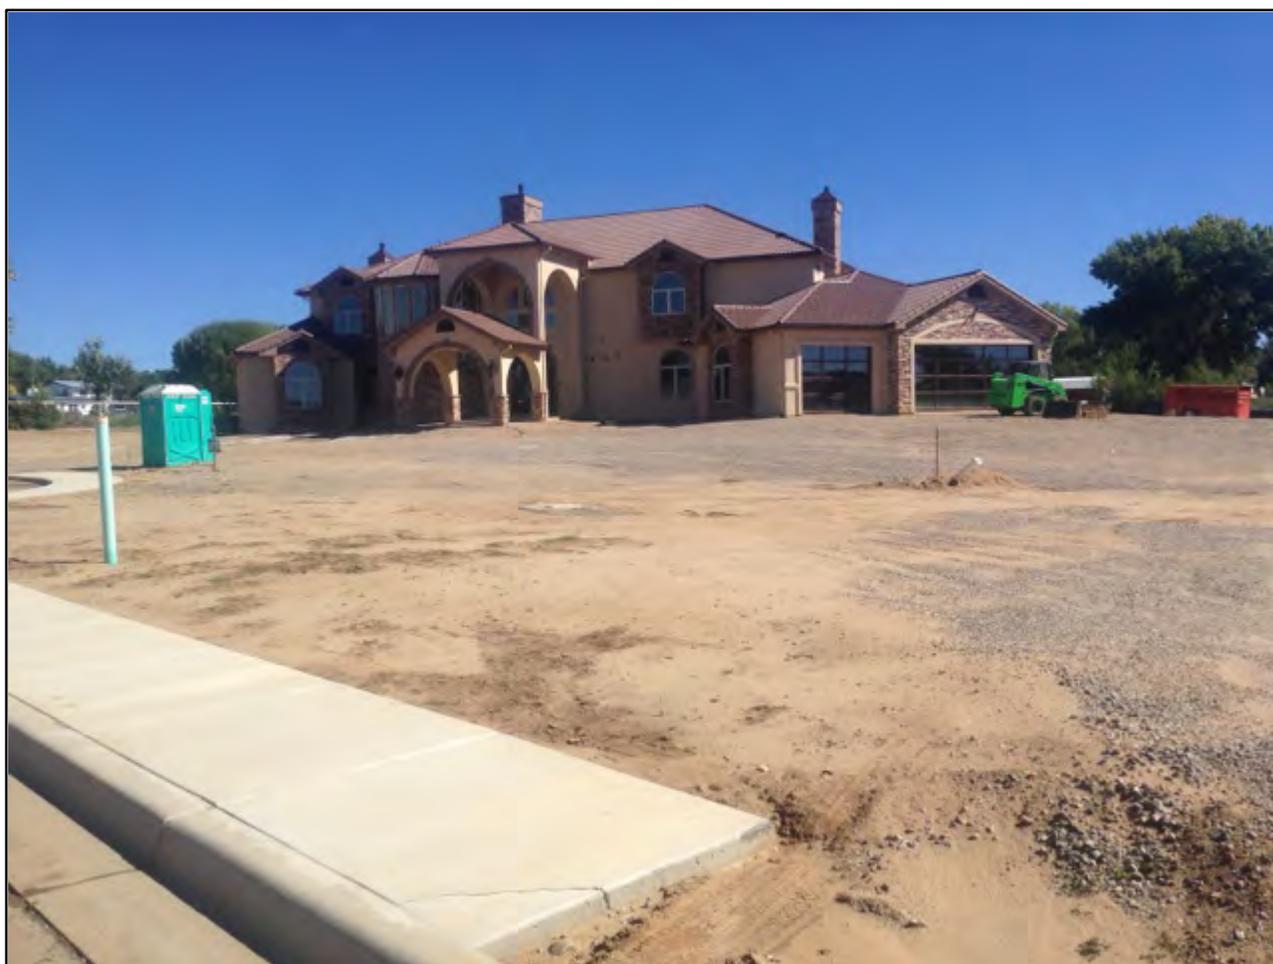
Photo # 1

Photographer: Sarah Holcomb	Date: 9-30-2013	Time: 1100 hours
City/County: Flora Vista, Dona Ana County		
Location: Samantha Lane Residence		
Subject: The exterior of the home had been finalized but no stabilization measures were applied to the property surrounding the home.

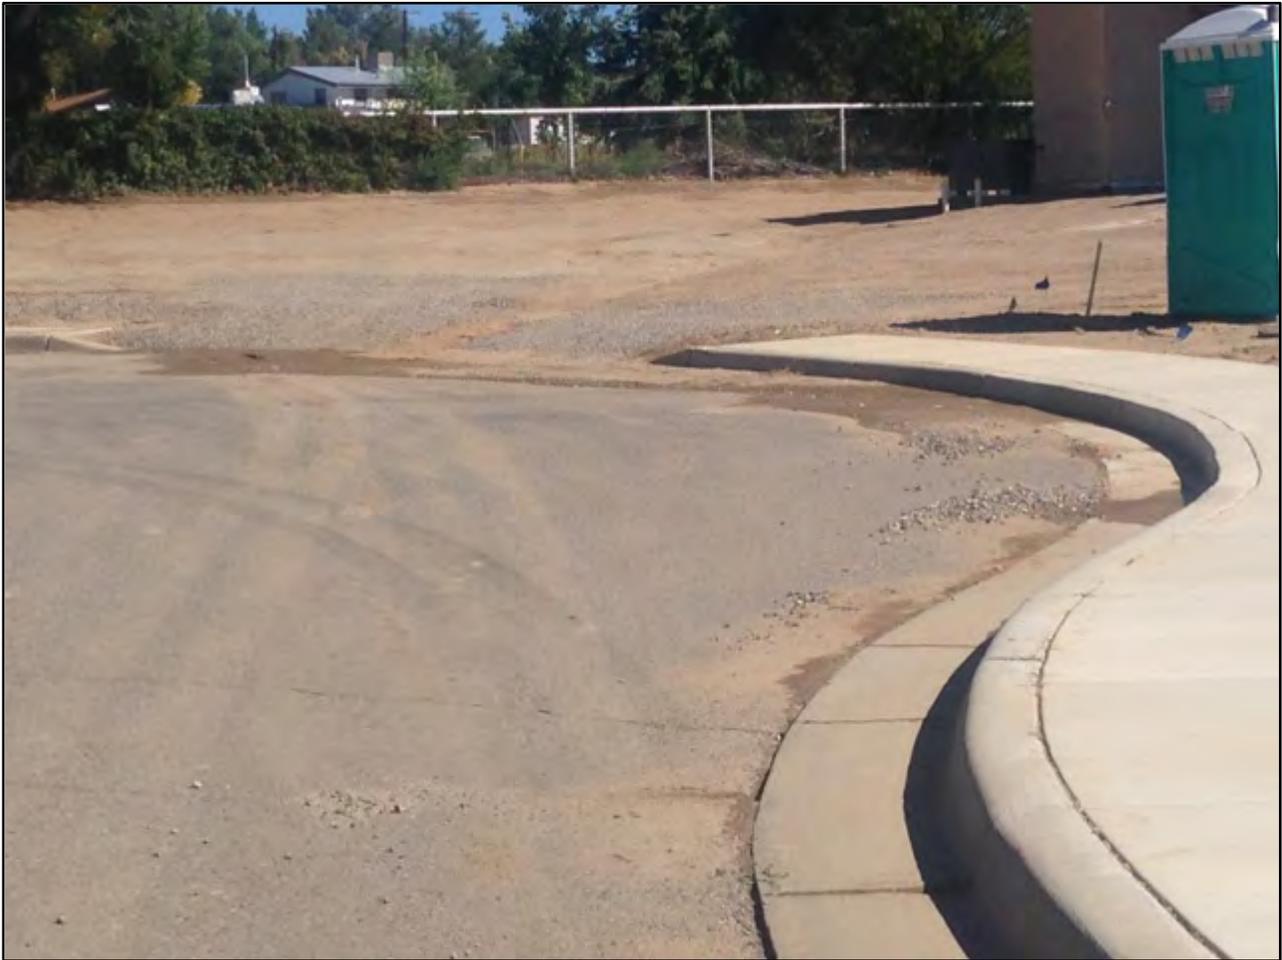
Photo # 2

Photographer: Sarah Holcomb	Date: 9-30-2013	Time: 1100 hours
City/County: Flora Vista, San Juan County		
Location: Samantha Lane Residence		
Subject: Evidence of sediment leaving the site.
