**RE: Concentrated Animal Feeding Operation, SIC 7948, NPDES Compliance Evaluation Inspection, Ruidoso Downs Racetrack and Casino, NMU000638, July 31, 2012**

**NPDES Compliance Inspection Report**

**NPDES Compliance Inspection  
Ruidoso Downs Racetrack and Casino  
Further Explanations**

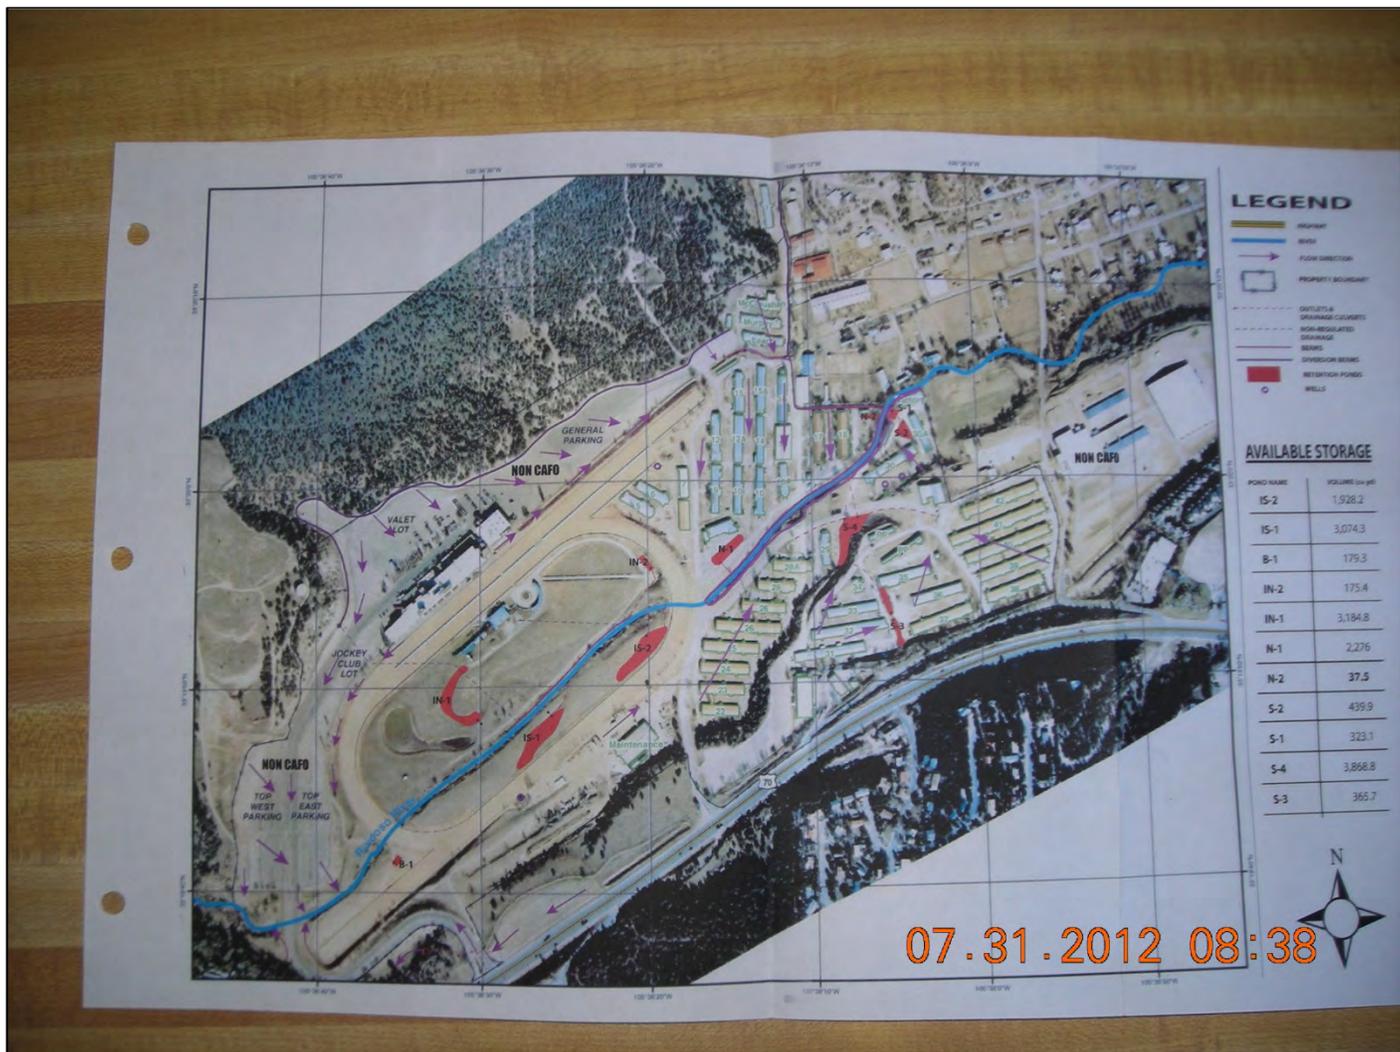
Photo # 1

Runoff from the barn area (including runoff from the wash racks located around the barn area) drains to various earthen ditches that flow to various retention ponds (there are ten total ponds – please see Photo #1). The PPP available onsite did not specify the total drainage acreage of the facility and only gave very basic details about the function of the facility.

Photographer: Sarah Holcomb	Date: July 31, 2012	Time: 0838 hours
City/County: Ruidoso Downs/Lincoln	State: New Mexico	
Location: Ruidoso Downs Racetrack and Casino		
Subject: Map of the facility contained in the onsite PPP.

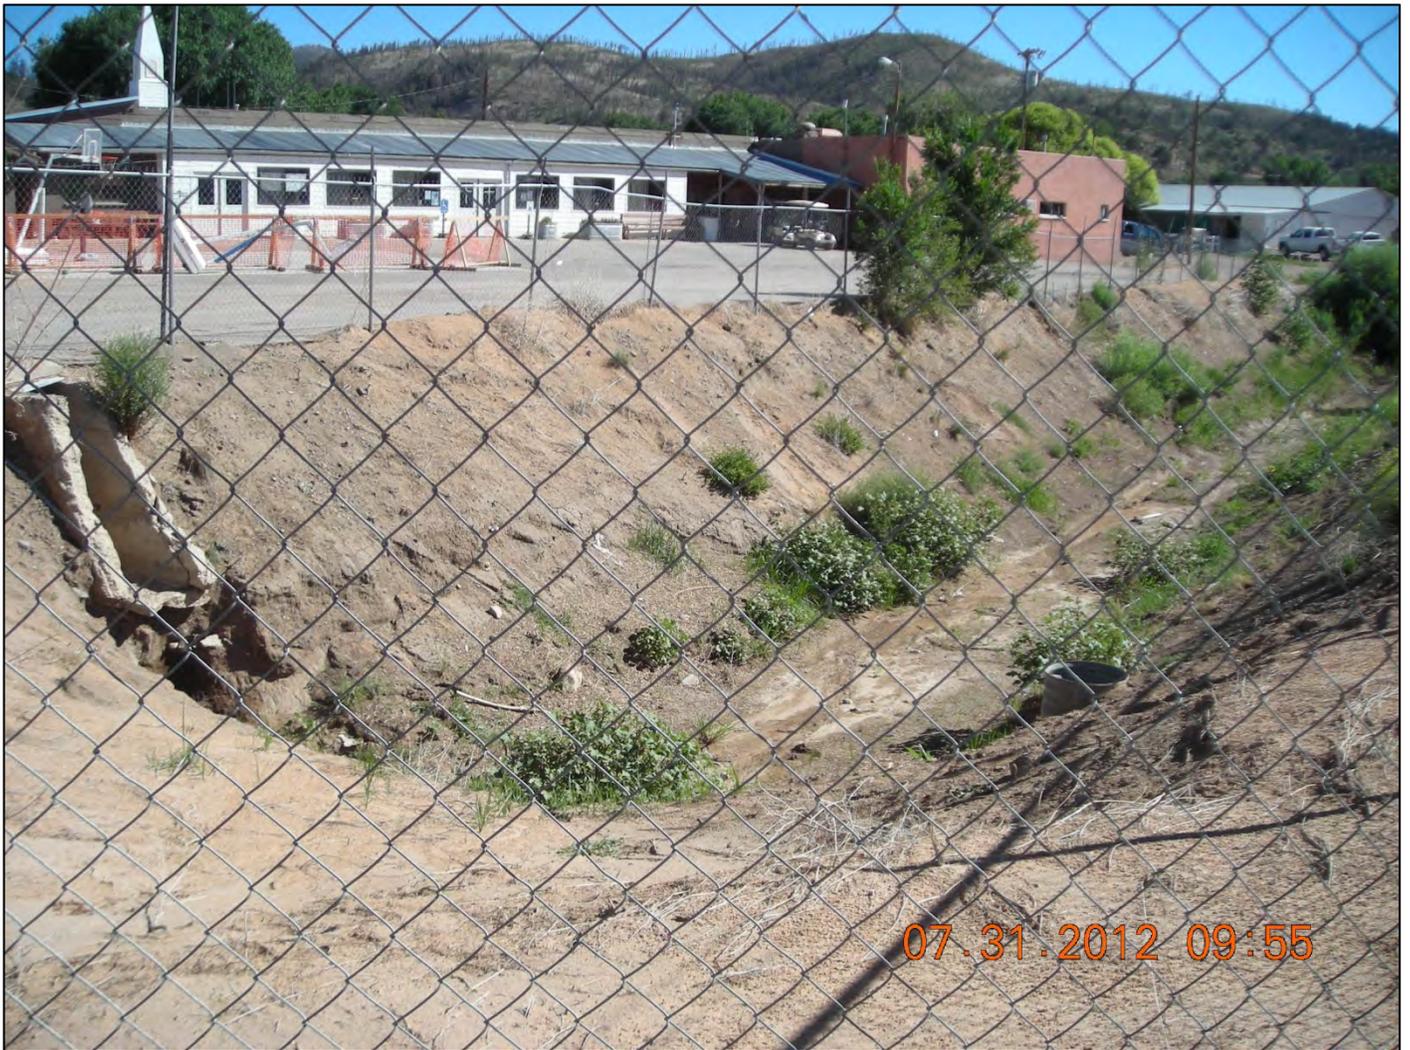
Photo # 2

Photographer: Sarah Holcomb	Date: July 31, 2012	Time: 0955 hours
City/County: Ruidoso Downs/Lincoln	State: New Mexico	
Location: Ruidoso Downs Racetrack and Casino		
Subject: N-1 pond, as indicated on the map shown in Photo #1. The Rio Ruidoso is about 150 feet to the right of the subject in this photograph.

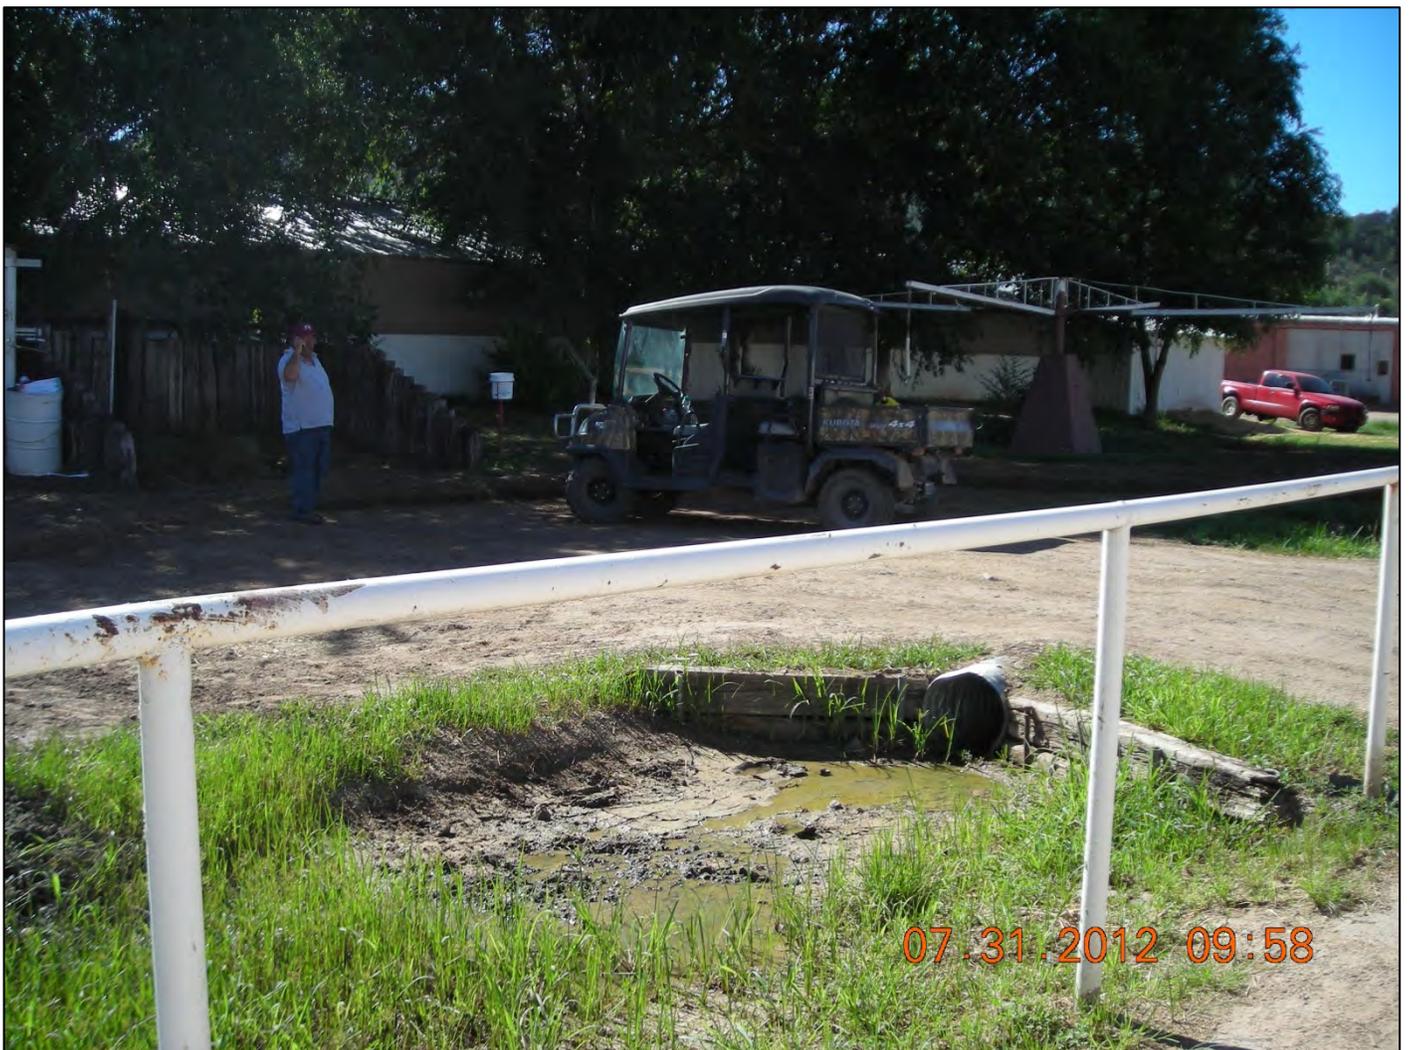
Photo # 3

The Ruidoso Downs Racetrack does not land apply manure or wastewater, but instead hauls the manure offsite daily to the landfill via a contract hauler. The manure is contained in muck bins just outside the barn areas. Wash racks are also located outside of the barns, and the flow from the wash racks travels to the same earthen channels, which are directed to one of the runoff control structure (RCS) onsite.

Photographer: Sarah Holcomb	Date: July 31, 2012	Time: 0958 hours
City/County: Ruidoso Downs/Lincoln	State: New Mexico	
Location: Ruidoso Downs Racetrack and Casino		
Subject: One of the areas outside the barns. The muck bin is located behind the gentleman on the telephone. Any runoff is conveyed toward the drain/culvert shown here. This particular barn would drain to the holding pond shown in Photo #2.

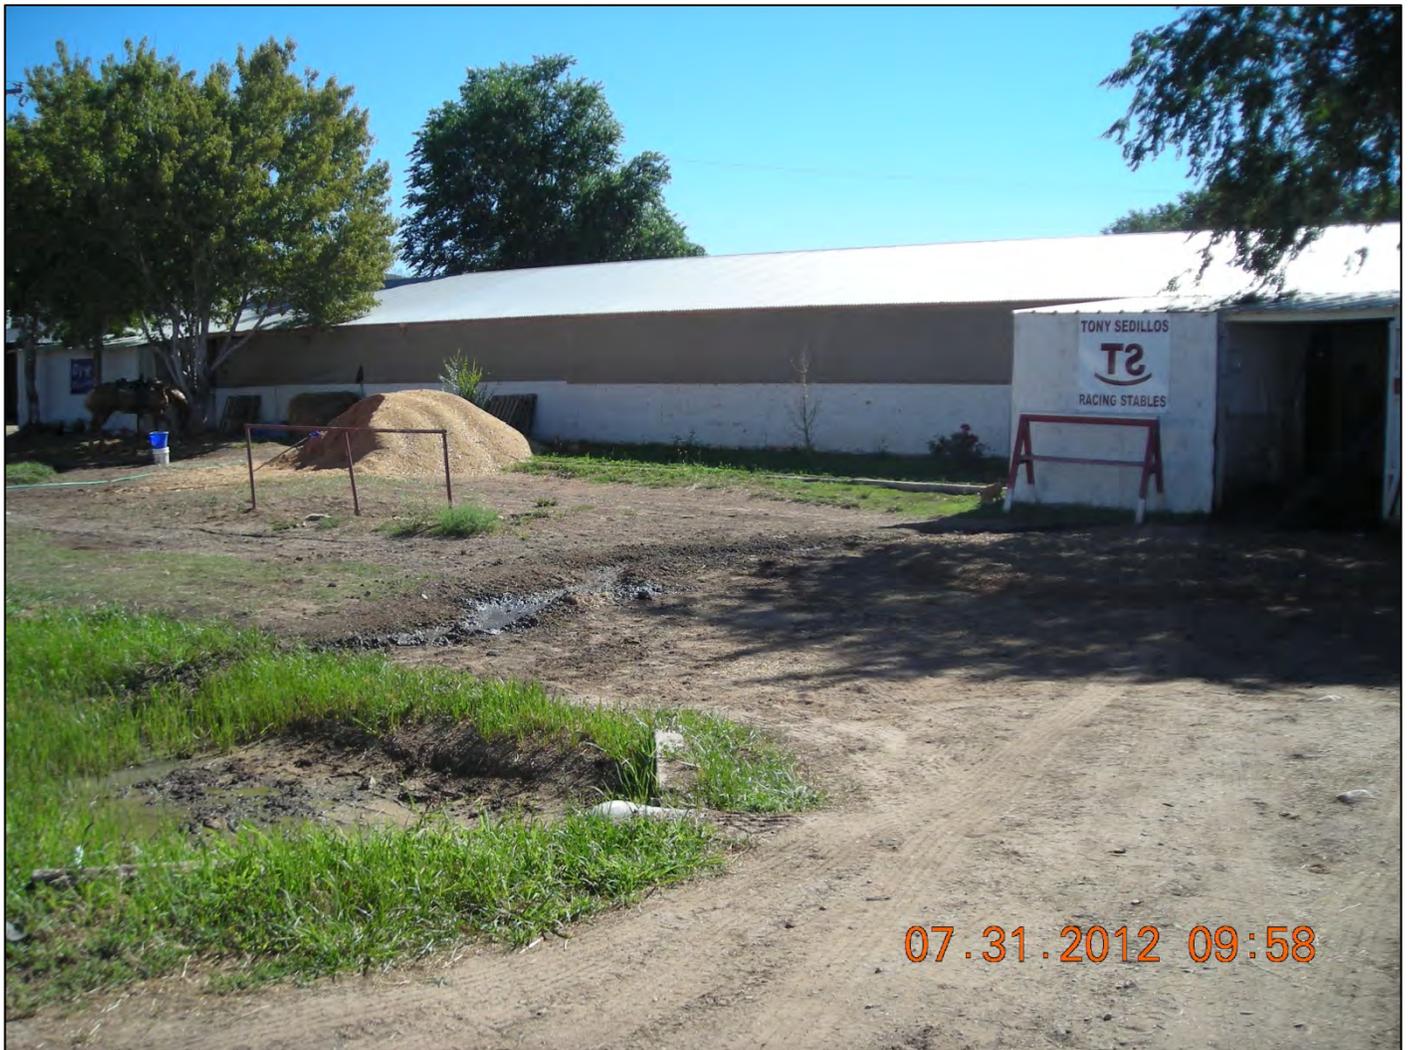
Photo # 4

Photographer: Sarah Holcomb	Date: July 31, 2012	Time: 0958 hours
City/County: Ruidoso Downs/Lincoln	State: New Mexico	
Location: Ruidoso Downs Racetrack and Casino		
Subject: One of the areas outside the barns. Discharge from the wash rack is shown leaving the barn and traveling to the ditch alongside the barn.
