RE: Construction Storm Water, SIC 1521, NPDES Compliance Evaluation Inspection, Logos Development, Inc., Dos Lados Estates Subdivision, NMU001665, Las Cruces, New Mexico, July 8, 2010

Compliance Evaluation Inspection
Dos Lados Estates Subdivision, Las Cruces, New Mexico
NPDES Tracking No. NMU001665
July 8, 2010

NPDES Industrial Storm Water Worksheet (Construction)

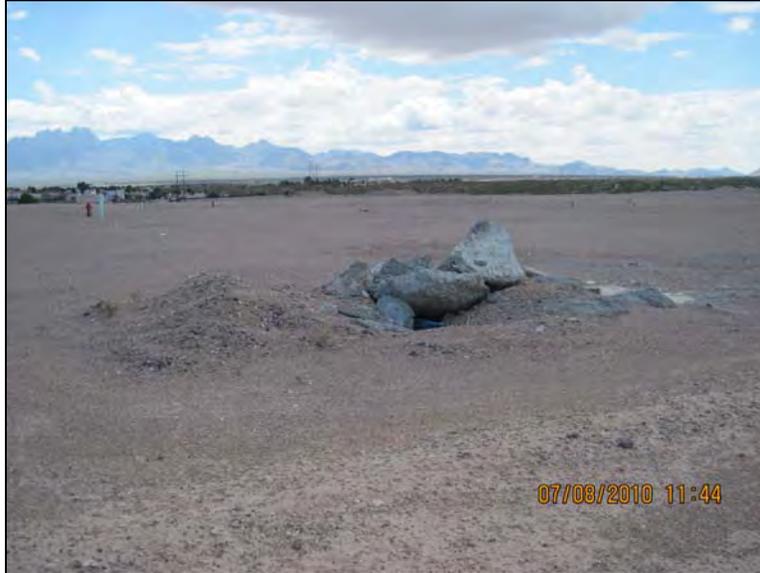
NMED/SWQB Official Photograph Log Photo # 1		
Photographer: Erin S. Trujillo	Date: 07/08/2010	Time: 1144 hours
City/County: Las Cruces / Doña Ana County		State: New Mexico
Location: Dos Lados Estates Subdivision		
Subject: Overview of site from western property boundary. Since access to site is not secured, it is unknown if concrete and concrete washout in center of photo is from previous construction activities of this site or unauthorized dumping.

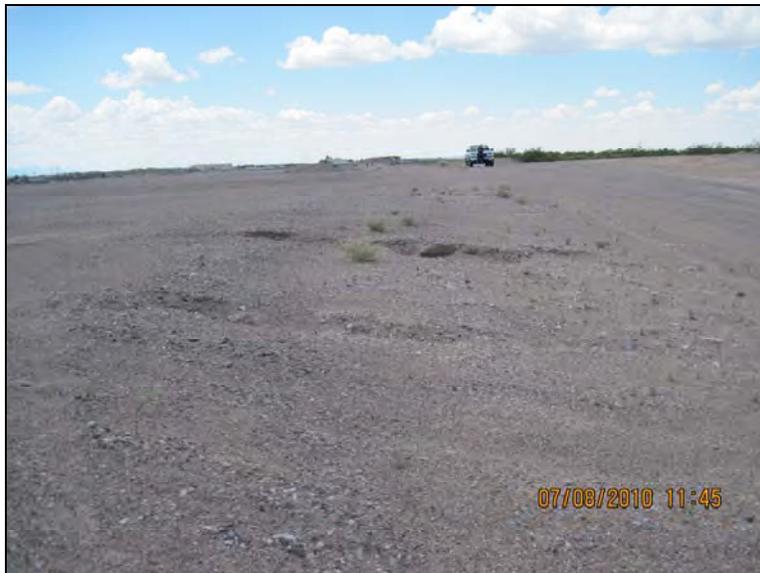
NMED/SWQB Official Photograph Log Photo # 2		
Photographer: Erin S. Trujillo	Date: 07/08/2010	Time: 1145 hours
City/County: Las Cruces / Doña Ana County		State: New Mexico
Location: Dos Lados Estates Subdivision		
Subject: Overview of site from northwestern property corner. A few erosion rills had formed toward the unpaved Settlers Pass Road (left side of photo).

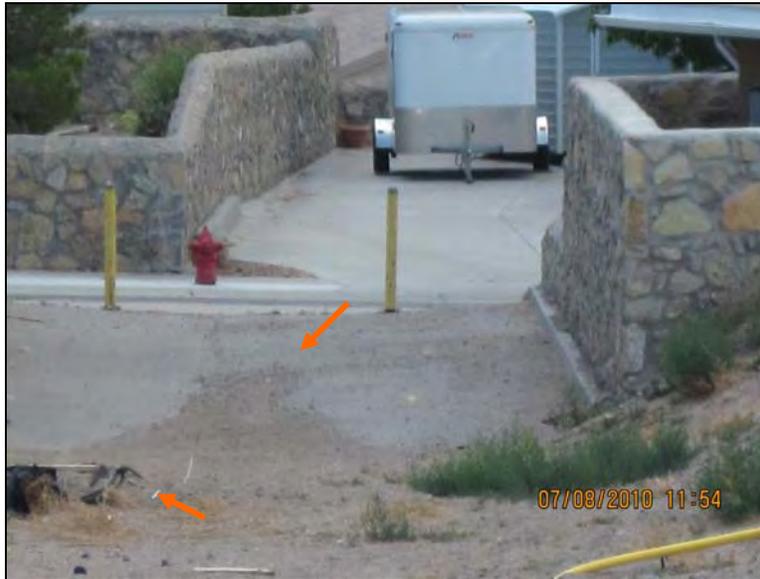
**NMED/SWQB
Official Photograph Log
Photo # 3**

Photographer: Erin S. Trujillo	Date: 07/08/2010	Time: 1154 hours
City/County: Las Cruces / Doña Ana County	State: New Mexico	
Location: Dos Lados Estates Subdivision		
Subject: Arrows point to remnants of unmaintained silt fence along eastern property boundary and sediment that has accumulated in the off-site drainage outlet leading to Galina Drive.

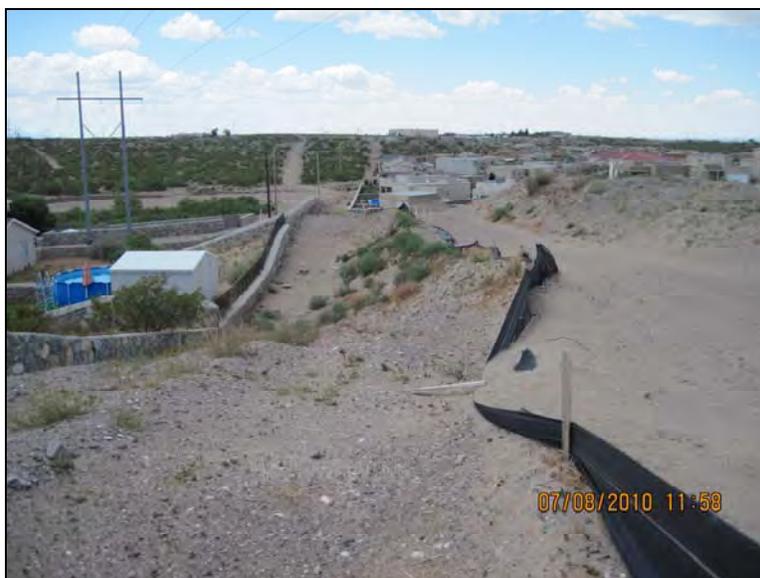
**NMED/SWQB
Official Photograph Log
Photo # 4**

Photographer: Erin S. Trujillo	Date: 07/08/2010	Time: 1158 hours
City/County: Las Cruces / Doña Ana County	State: New Mexico	
Location: Dos Lados Estates Subdivision		
Subject: Example of unmaintained silt fence and accumulated sediment along eastern property boundary.

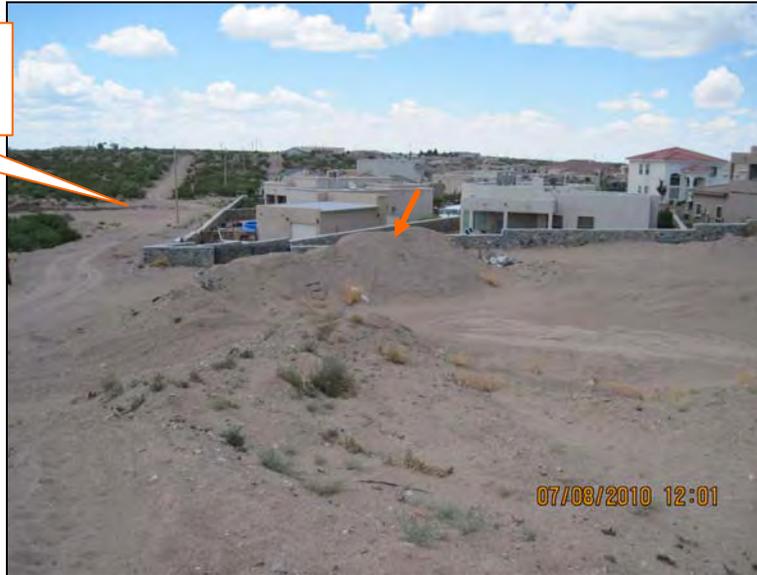
NMED/SWQB Official Photograph Log Photo # 5		
Photographer: Erin S. Trujillo	Date: 07/08/2010	Time: 1201 hours
City/County: Las Cruces / Doña Ana County		State: New Mexico
Location: Dos Lados Estates Subdivision		
Subject: Arrow points to unstabilized earth berm in southeast corner of the site. Drainage in this area is to the southeast-south towards Sand Hill Arroyo

Approximate off-site location
of Sand Hill Arroyo

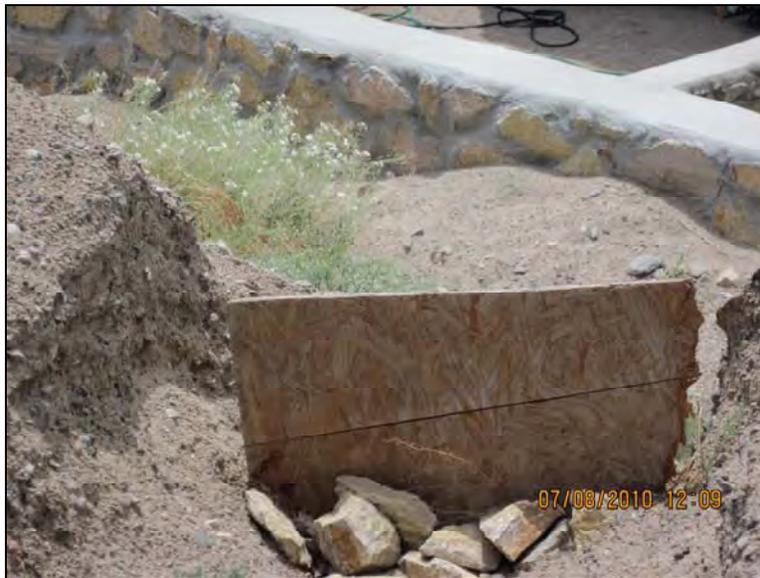
NMED/SWQB Official Photograph Log Photo # 7		
Photographer: Erin S. Trujillo	Date: 07/08/2010	Time: 1209 hours
City/County: Las Cruces / Doña Ana County		State: New Mexico
Location: Dos Lados Estates Subdivision		
Subject: Example of boards and rocks placed in erosion gullies on-site. This measure was not installed by staff of the “The Phillipou Group” according the on-site operator representative. These boards/rocks, likely placed by adjacent property owner(s), can cause additional erosion of the gully sides during a rain event.

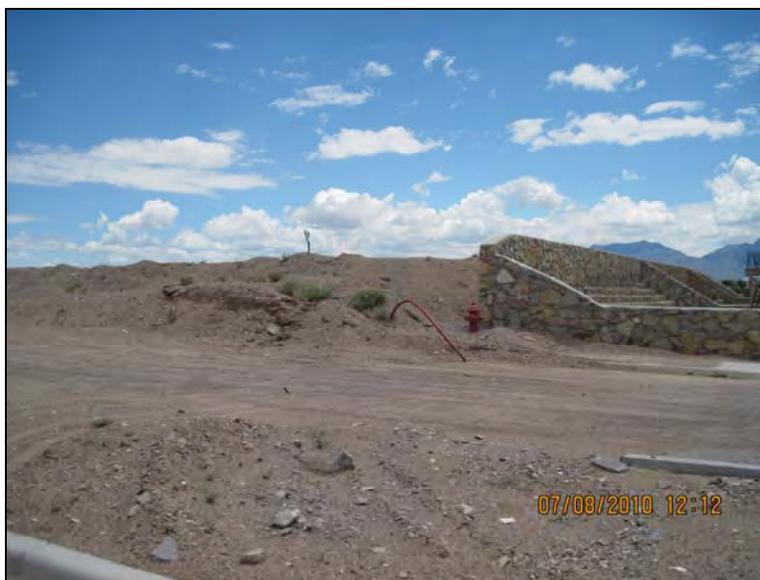
NMED/SWQB Official Photograph Log Photo # 8		
Photographer: Erin S. Trujillo	Date: 07/08/2010	Time: 1212 hours
City/County: Las Cruces / Doña Ana County		State: New Mexico
Location: Dos Lados Estates Subdivision		
Subject: Southwest corner of site at Settlers Pass Road. No erosion control measures were placed in this corner of the site and accumulated sediment was observed the paved street.

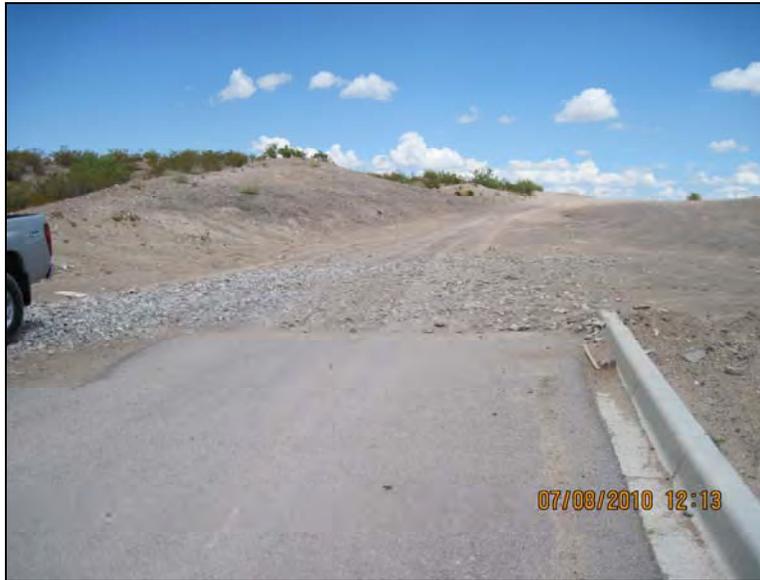
NMED/SWQB Official Photograph Log Photo # 9		
Photographer: Erin S. Trujillo	Date: 07/08/2010	Time: 1213 hours
City/County: Las Cruces / Doña Ana County		State: New Mexico
Location: Dos Lados Estates Subdivision		
Subject: Settlers Pass Road. Vehicle track out had been moved from site's southeast corner to this location according to the site map. The vehicle track out appears to have reduced the amount of accumulated sediment from the unpaved road and subdivision. But, the pad has accumulated sediment and needs maintenance.
