RE: Construction Storm Water, SIC 1521, NPDES Compliance Evaluation Inspection, First Community Bank, Dos Lados Estates Subdivision, NMU001666, Las Cruces, New Mexico, July 8, 2010

Compliance Evaluation Inspection
Dos Lados Estates Subdivision, Las Cruces, New Mexico,
NPDES Tracking No. NMU001666
July 8, 2010

A Compliance Evaluation Inspection (CEI) was conducted by Erin S. Trujillo, accompanied by Sandra Gabaldón, both of the NMED SWQB at the above-referenced 40+ acre disturbed Dos Lados Estates proposed 215+ residential lot subdivision in Las Cruces, New Mexico on July 8, 2010.

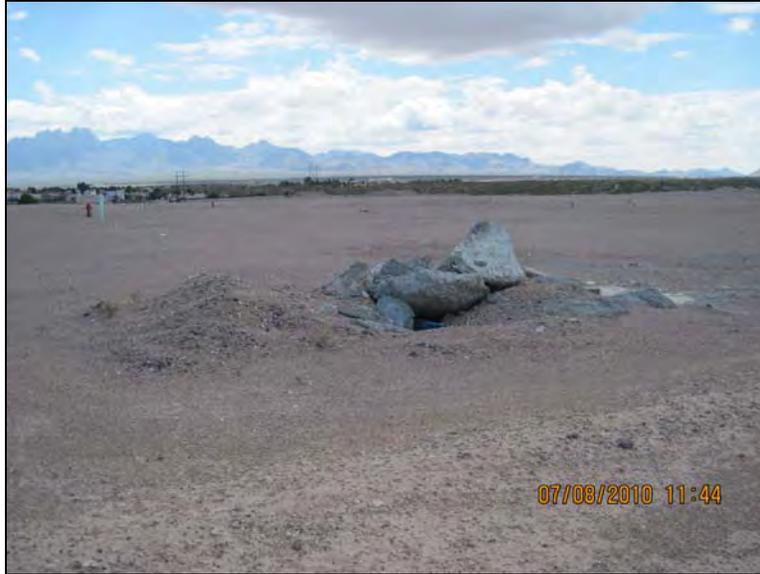
**NMED/SWQB
Official Photograph Log
Photo # 1**

Photographer: Erin S. Trujillo	Date: 07/08/2010	Time: 1144 hours
City/County: Las Cruces / Doña Ana County		State: New Mexico
Location: Dos Lados Estates Subdivision		
Subject: Overview of site from western property boundary. Since access to site is not secured, it is unknown if concrete and concrete washout in center of photo is from previous construction activities of this site or unauthorized dumping.

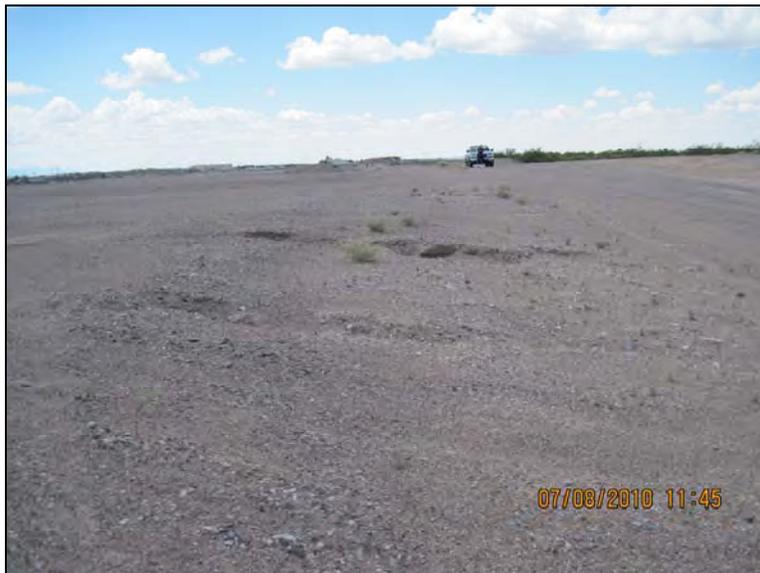
**NMED/SWQB
Official Photograph Log
Photo # 2**

Photographer: Erin S. Trujillo	Date: 07/08/2010	Time: 1145 hours
City/County: Las Cruces / Doña Ana County		State: New Mexico
Location: Dos Lados Estates Subdivision		
Subject: Overview of site from northwestern property corner. A few erosion rills had formed toward the unpaved Settlers Pass Road (left side of photo).

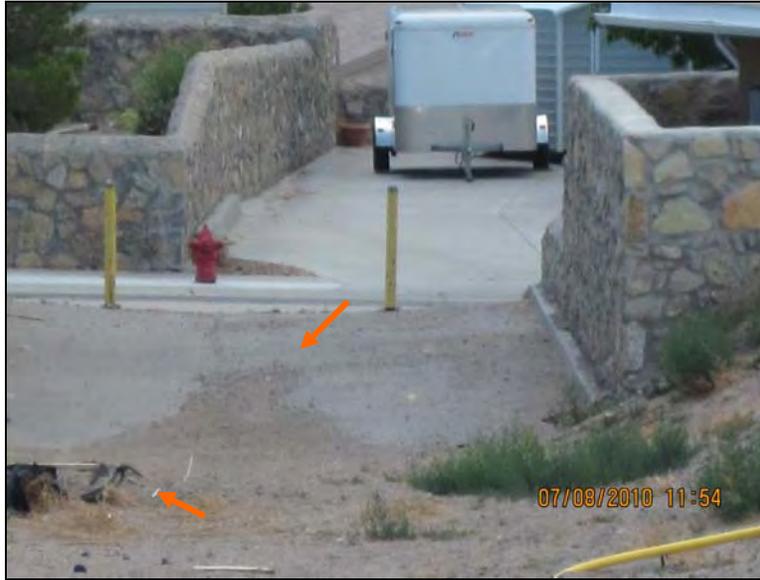
**NMED/SWQB
Official Photograph Log
Photo # 3**

Photographer: Erin S. Trujillo	Date: 07/08/2010	Time: 1154 hours
City/County: Las Cruces / Doña Ana County	State: New Mexico	
Location: Dos Lados Estates Subdivision		
Subject: Arrows point to remnants of unmaintained silt fence along eastern property boundary and sediment that has accumulated in the off-site drainage outlet to leading to Galina Drive.

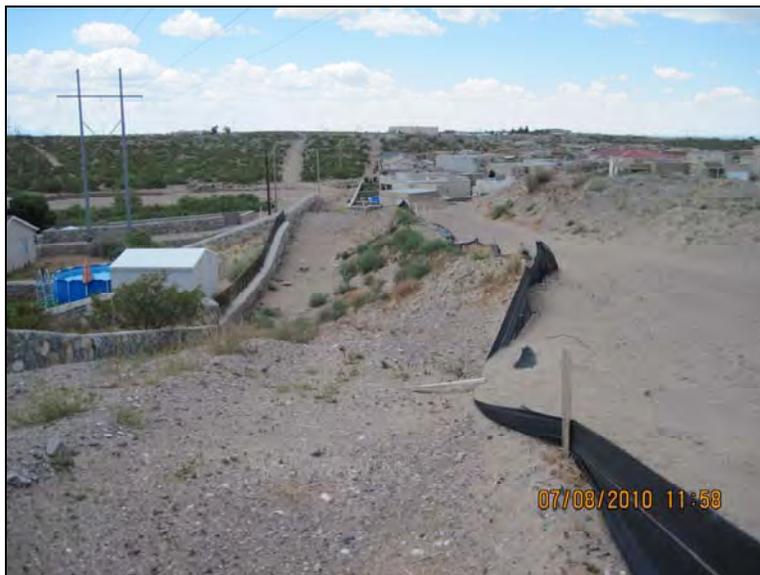
**NMED/SWQB
Official Photograph Log
Photo # 4**

Photographer: Erin S. Trujillo	Date: 07/08/2010	Time: 1158 hours
City/County: Las Cruces / Doña Ana County	State: New Mexico	
Location: Dos Lados Estates Subdivision		
Subject: Example of unmaintained silt fence and accumulated sediment along eastern property boundary.

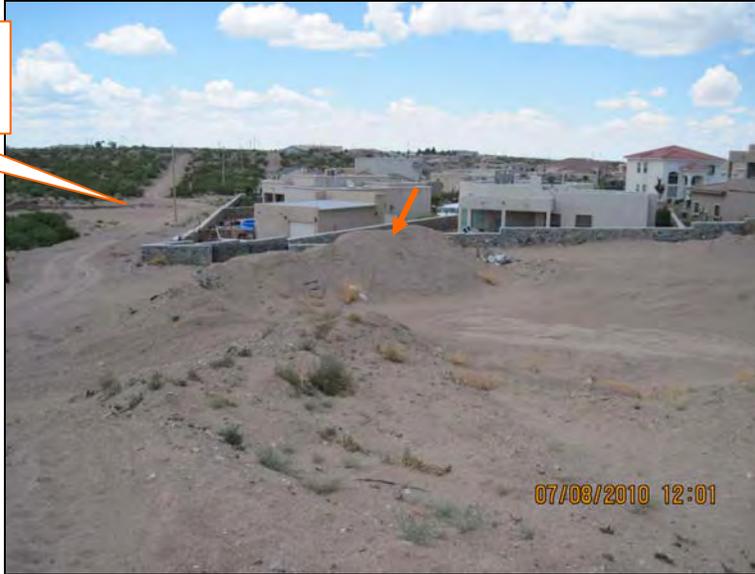
**NMED/SWQB
Official Photograph Log
Photo # 5**

Photographer: Erin S. Trujillo	Date: 07/08/2010	Time: 1201 hours
City/County: Las Cruces / Doña Ana County		State: New Mexico
Location: Dos Lados Estates Subdivision		
Subject: Arrow points to unstabilized earth berm in southeast corner of the site. Drainage in this area is to the southeast-south towards Sand Hill Arroyo

Approximate off-site location
of Sand Hill Arroyo

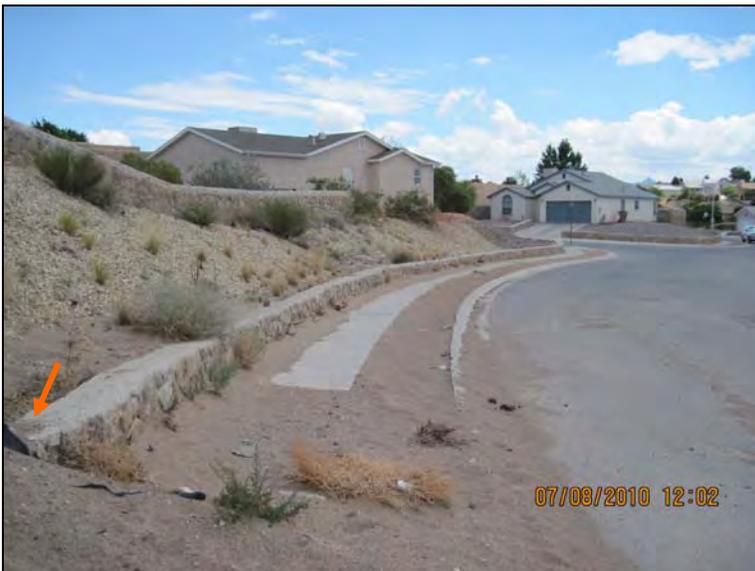
**NMED/SWQB
Official Photograph Log
Photo # 6**

Photographer: Erin S. Trujillo	Date: 07/08/2010	Time: 1202 hours
City/County: Las Cruces / Doña Ana County		State: New Mexico
Location: Dos Lados Estates Subdivision		
Subject: Accumulated sediment offsite on associated sidewalks and paved Arena Drive. Arrow points to remnant of silt fence along eastern property boundary of the site.

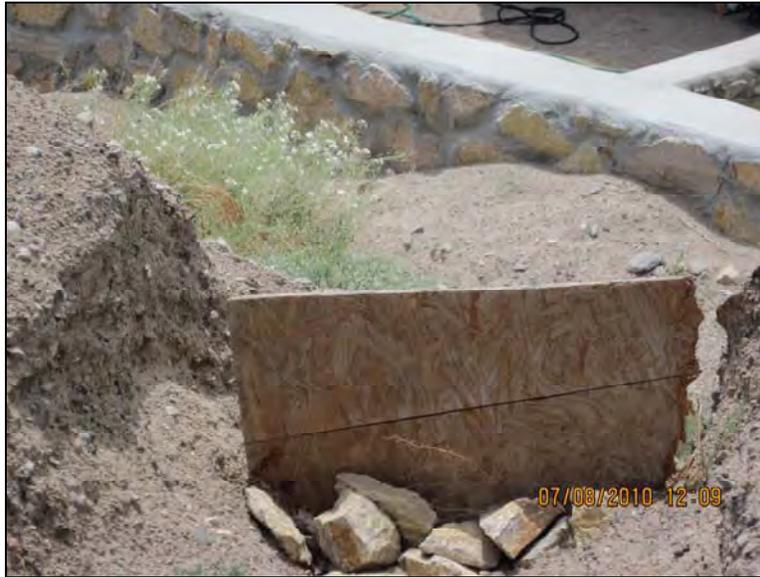
**NMED/SWQB
Official Photograph Log
Photo # 7**

Subject: Example of boards and rocks placed in erosion gullies on-site. This measure was not installed by staff of the "The Phillipou Group" according the on-site operator representative. These boards/rocks, likely placed by adjacent property owner(s), can cause additional erosion of the gully sides during a rain event.

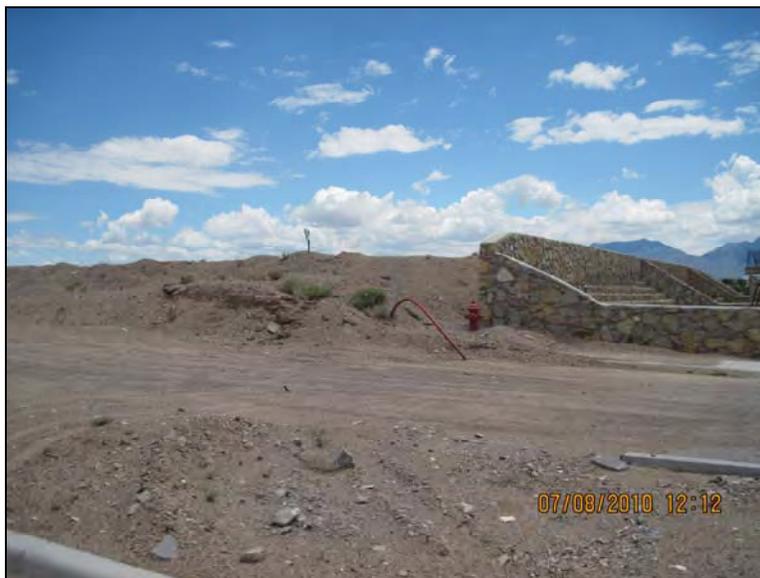
**NMED/SWQB
Official Photograph Log
Photo # 8**

Subject: Southwest corner of site at Settlers Pass Road. No erosion control measures were placed in this corner of the site and accumulated sediment was observed the paved street.

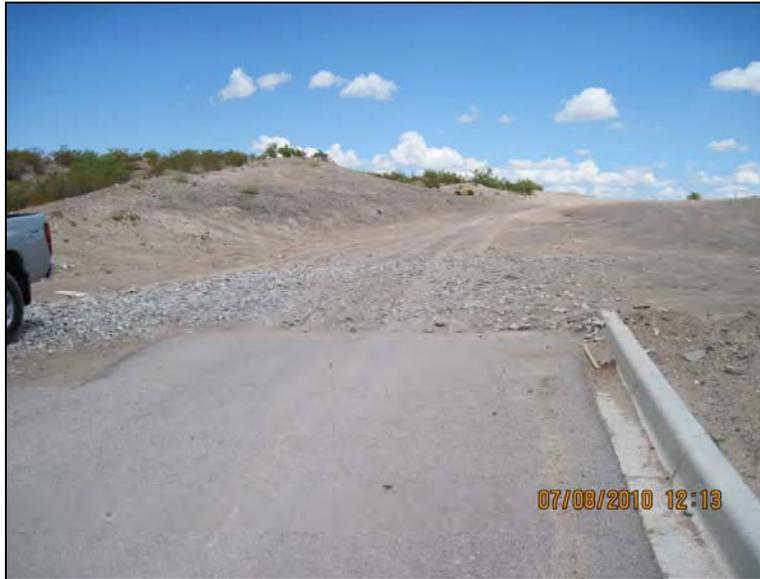
**NMED/SWQB
Official Photograph Log
Photo # 9**

Subject: Settlers Pass Road. Vehicle track out had been moved from site's southeast corner to this location according to the site map. The vehicle track out appears to have reduced the amount of accumulated sediment from the unpaved road and subdivision. But, the pad has accumulated sediment and needs maintenance.
