RE: NPDES Construction Storm Water, Compliance Evaluation Inspection, Town of Taos Alexander Gusdorf Eco-Park, NMU001668, July 13, 2010

NPDES Compliance Inspection Report

NPDES Industrial Storm Water Worksheet (Construction)

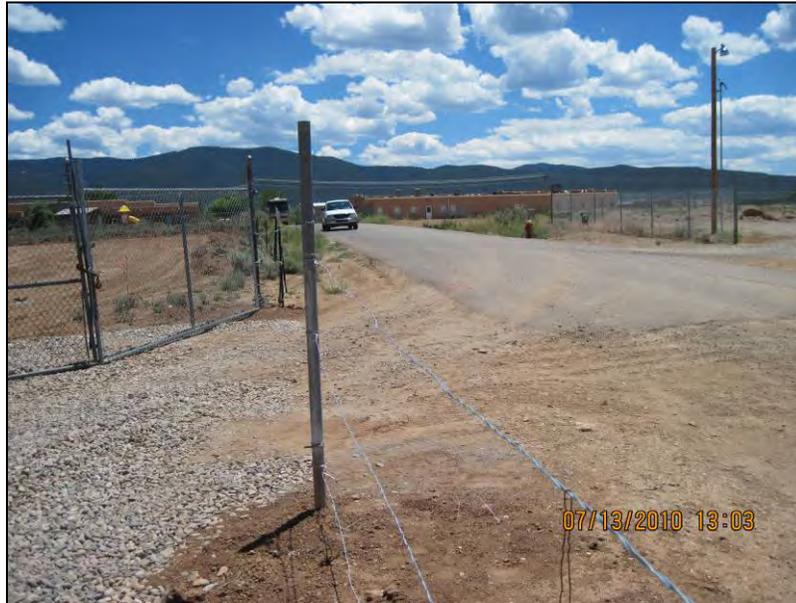
NMED/SWQB Official Photograph Log Photo # 1		
Photographer: Erin Trujillo	Date: 07/14/2010	Time: 1303 hours
City/County: Taos / Taos County	State: New Mexico	
Location: Town of Taos Alexander Gusdorf Eco-Park		
Subject: Construction entrance (correct location was not shown on site map) with accumulated sediment from construction vehicle tracking on paved St Francis Lane.

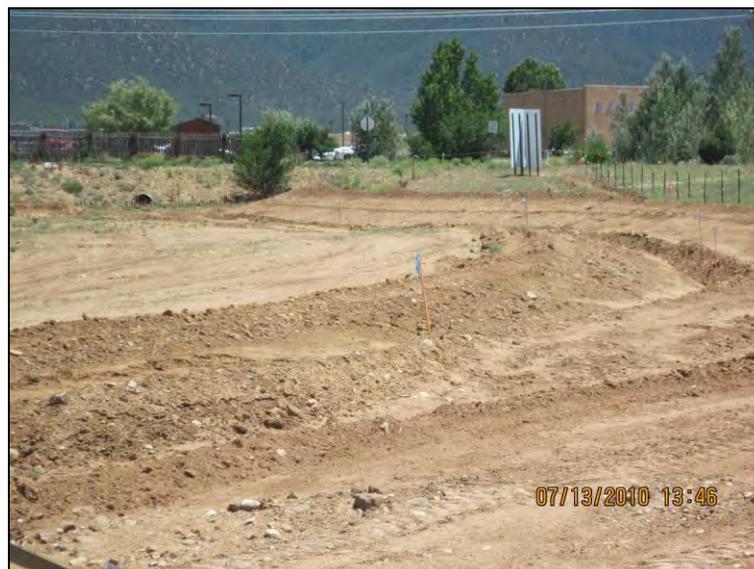
NMED/SWQB Official Photograph Log Photo # 2		
Photographer: Erin Trujillo	Date: 07/14/2010	Time: 1346 hours
City/County: Taos / Taos County	State: New Mexico	
Location: Town of Taos Alexander Gusdorf Eco-Park		
Subject: Overview of drainage channel under construction. See Photo #6 for outfall location.

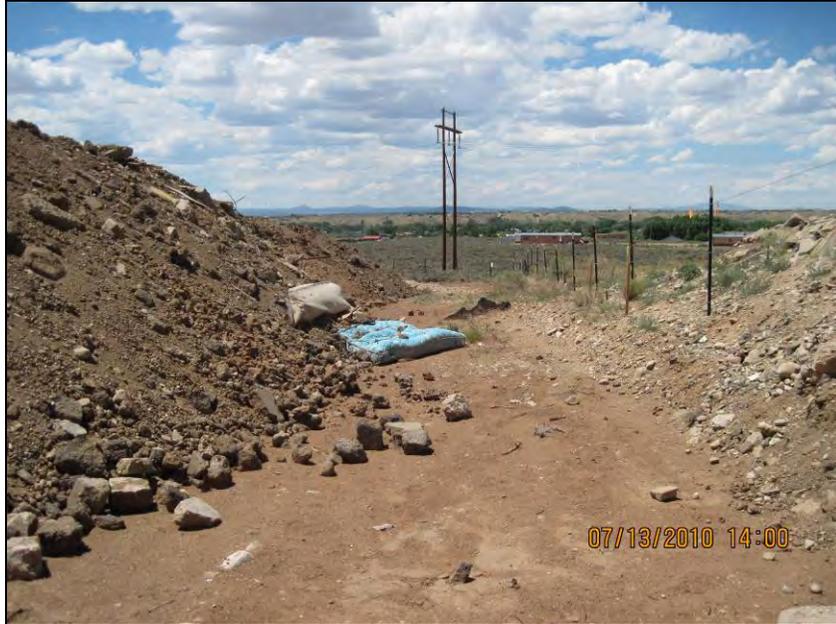
NMED/SWQB Official Photograph Log Photo # 3		
Photographer: Erin Trujillo	Date: 07/14/2010	Time: 1400 hours
City/County: Taos / Taos County	State: New Mexico	
Location: Town of Taos Alexander Gusdorf Eco-Park		
Subject: Stockpile (north side) with mostly dirt fill and concrete visible. No sediment or erosion control measures observed.

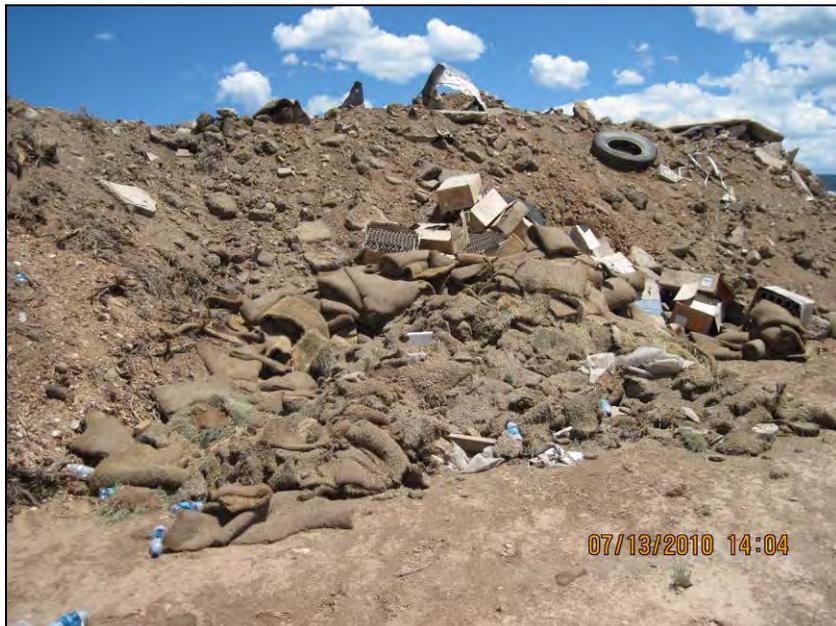
NMED/SWQB Official Photograph Log Photo # 4		
Photographer: Erin Trujillo	Date: 07/14/2010	Time: 1404 hours
City/County: Taos / Taos County	State: New Mexico	
Location: Town of Taos Alexander Gusdorf Eco-Park		
Subject: Same stockpile shown in previous photo (south side) with trash (cardboard boxes and bottles) and tire visible.

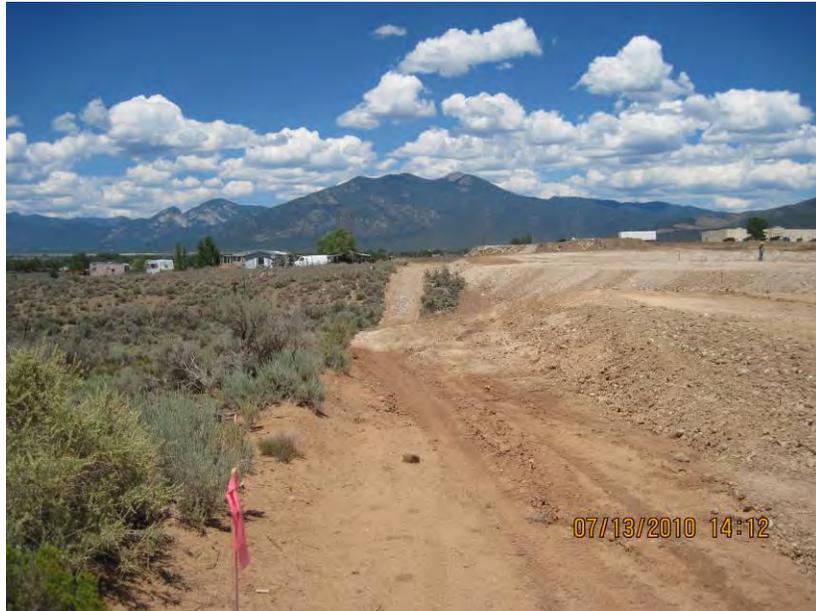
NMED/SWQB Official Photograph Log Photo # 5		
Photographer: Erin Trujillo	Date: 07/14/2010	Time: 1412 hours
City/County: Taos / Taos County		State: New Mexico
Location: Town of Taos Alexander Gusdorf Eco-Park		
Subject: Western boundary. Silt fence shown on site map not installed.

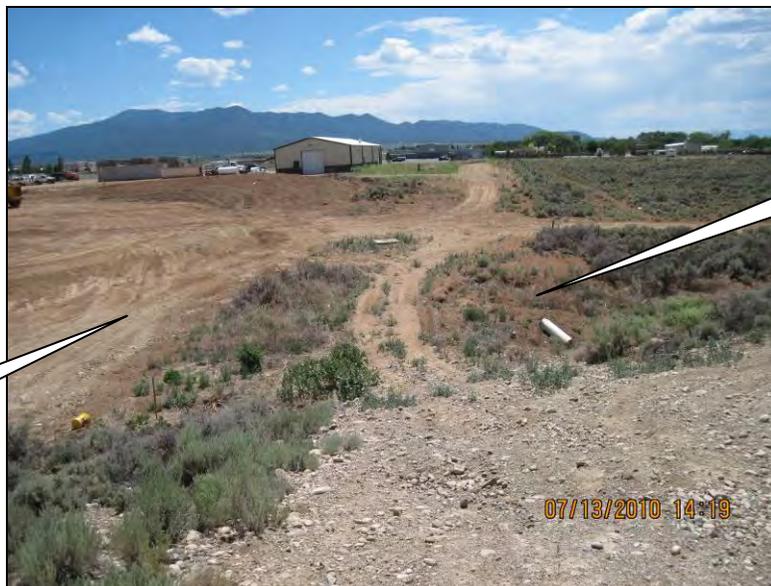
NMED/SWQB Official Photograph Log Photo # 6		
Photographer: Erin Trujillo	Date: 07/14/2010	Time: 1419 hours
City/County: Taos / Taos County		State: New Mexico
Location: Town of Taos Alexander Gusdorf Eco-Park		
Subject: Western boundary at south-southwest corner of site where stormwater in constructed drainage channel would flow off-site. Sediment basin and hale bales for this area described in SWPPP had not been constructed. Off-site erosion appears to have been altered from off-site dirt road shown in center of photo and downstream flood control berm not shown in photo.

On-site Constructed
Drainage Channel

Off-site Erosion Features

<u>Notes on SWPPP Implementation</u>
<p>Control measures were not implemented as described in SWPPP. Part 3 Effluent Limits of the 2008 CGP states, "You must implement the control measures from commencement of construction activity until final stabilization is complete."</p> <p>The constructed drainage channel from culverts crossing under Salazar Road to the western site boundary meandered through the site which may reduce stormwater velocity off-site. However, concentrated or increased flow velocity from the channel and a proposed outfall from a permanent storm drain basin could cause erosion and/or alter off-site water courses. Information on velocity dissipation of the drainage channel and future pond outfall was not described in SWPPP. Part 3.1.D (Erosive Velocity Control) of the 2008 CGP states, "You must place velocity dissipation devices at discharge locations and along the length of any outfall channel to provide a non-erosive flow velocity from the structure to a water course so that the natural physical and biological characteristics and functions are maintained and protected (e.g., no significant changes in the hydrological regime of the receiving water)." Also, Part 10.D.1.b states, "The SWPPP must include site-specific interim and permanent stabilization, managerial, and structural solids, erosion, and sediment control best management practices (BMPs) and/or other controls that are designed to prevent to the maximum extent practicable an increase in the sediment yield and flow velocity from pre-construction, pre-development conditions to assure that applicable standards in 20.6.4 NMAC, including the antidegradation policy, or WLAs are met. This requirement applies to discharges both during construction and after construction operations have been completed."</p> <p>Part 5.10.A Maintaining an Updated Plan of the 2008 CGP states, "The SWPPP must be modified: A. To reflect modifications to stormwater control measures made in response to a change in design, construction, operation, or maintenance at the construction site that has or could have a significant effect on the discharge of pollutants to the waters of the United States that has not been previously addressed in the SWPPP. B. If during inspections or investigations by site staff, or by local, state, tribal or federal officials, it is determined that the existing stormwater controls are ineffective in eliminating or significantly minimizing pollutants in stormwater discharges from the construction site. C. Based on the results of an inspection, as necessary to properly document additional or modified BMPs designed to correct problems identified. Revisions to the SWPPP must be completed within seven (7) calendar days following the inspection."</p>

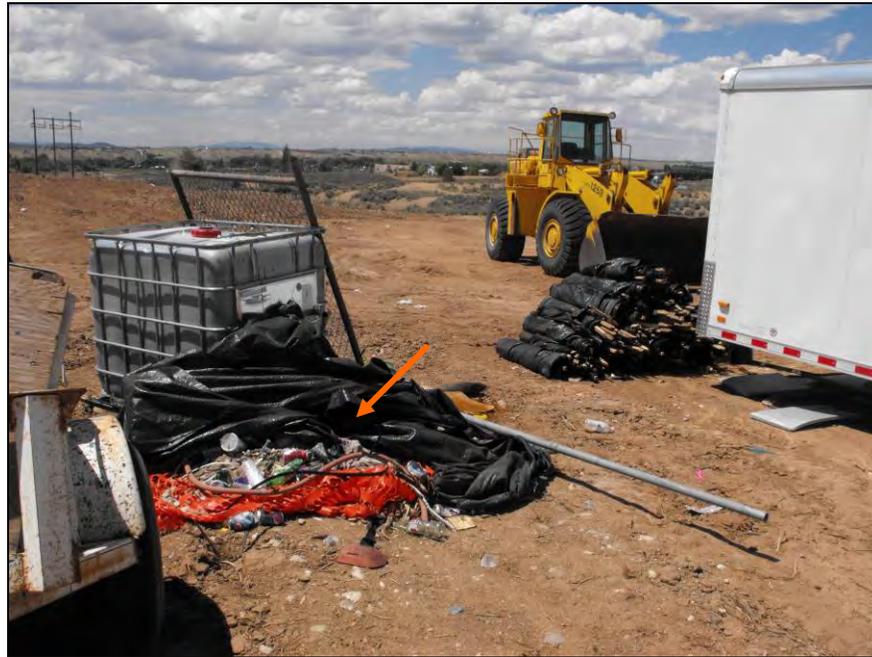
NMED/SWQB Official Photograph Log Photo # 7		
Photographer: Daniel Valenta	Date: 07/14/2010	Time: 1428 hours
City/County: Taos / Taos County	State: New Mexico	
Location: Town of Taos Alexander Gusdorf Eco-Park		
Subject: Arrow points to trash piled on ground, including cans and bottles at equipment and material storage area.
