RE: NPDES Construction Storm Water, Compliance Evaluation Inspection, Town of Taos Alexander GUSDORF Eco-Park, NMU001669, July 13, 2010

NPDES Compliance Inspection Report

NPDES Industrial Storm Water Worksheet (Construction)

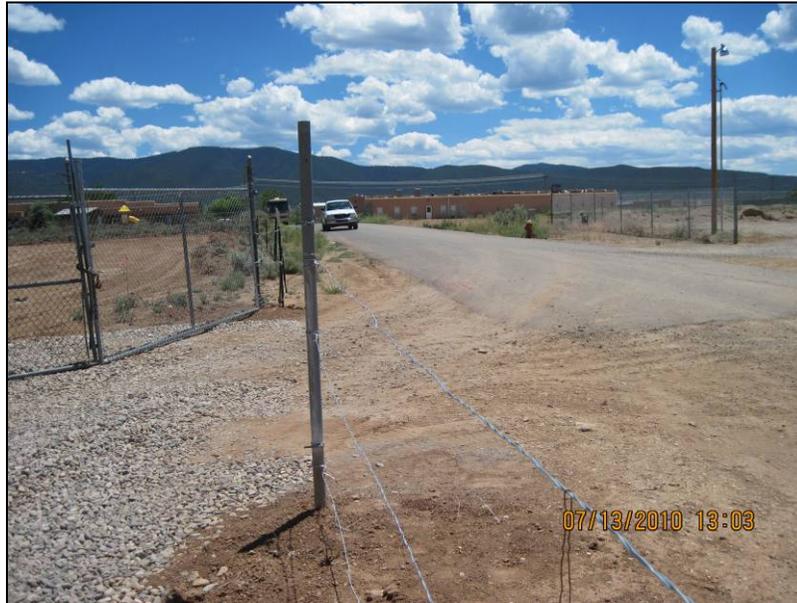
NMED/SWQB Official Photograph Log Photo # 1		
Photographer: Erin Trujillo	Date: 07/14/2010	Time: 1303 hours
City/County: Taos / Taos County		State: New Mexico
Location: Town of Taos Alexander Gusdorf Eco-Park		
Subject: Construction entrance (correct location was not shown on site map) with accumulated sediment from construction vehicle tracking on paved St Francis Lane.

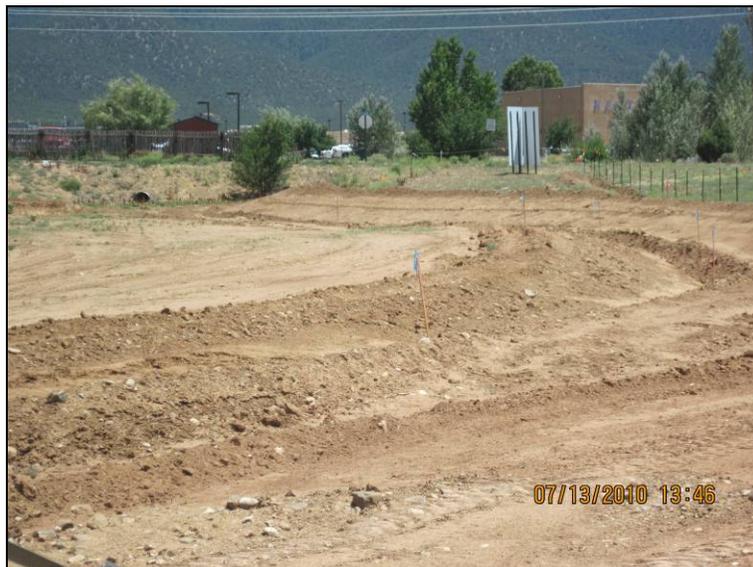
NMED/SWQB Official Photograph Log Photo # 2		
Photographer: Erin Trujillo	Date: 07/14/2010	Time: 1346 hours
City/County: Taos / Taos County		State: New Mexico
Location: Town of Taos Alexander Gusdorf Eco-Park		
Subject: Overview of drainage channel under construction through site. See Photo # 6 for outfall location.

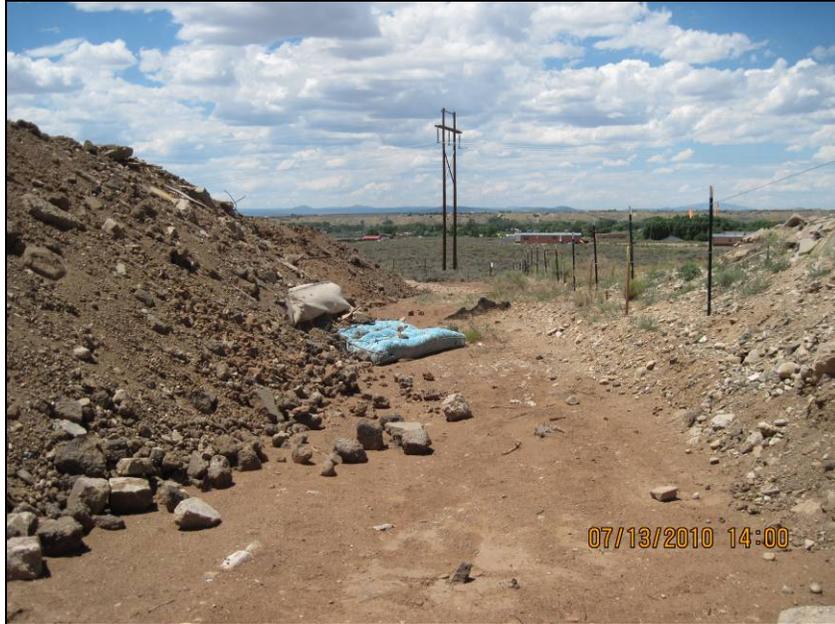
NMED/SWQB Official Photograph Log Photo # 3		
Photographer: Erin Trujillo	Date: 07/14/2010	Time: 1400 hours
City/County: Taos / Taos County	State: New Mexico	
Location: Town of Taos Alexander Gusdorf Eco-Park		
Subject: Stockpile (north side) with mostly dirt fill and concrete visible. No sediment or erosion control measures observed.

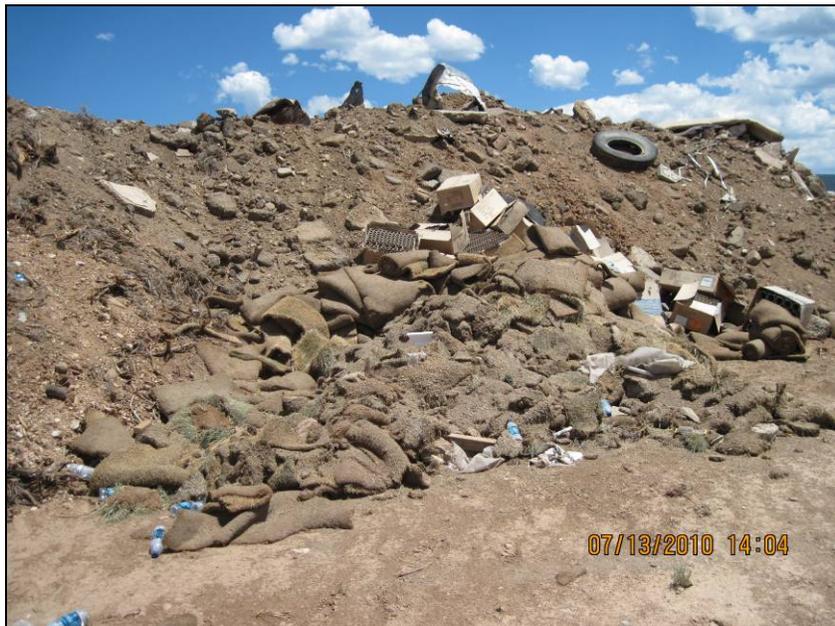
NMED/SWQB Official Photograph Log Photo # 4		
Photographer: Erin Trujillo	Date: 07/14/2010	Time: 1404 hours
City/County: Taos / Taos County	State: New Mexico	
Location: Town of Taos Alexander Gusdorf Eco-Park		
Subject: Same stockpile shown in previous photo (south side) with trash (cardboard boxes and bottles) and tire visible.

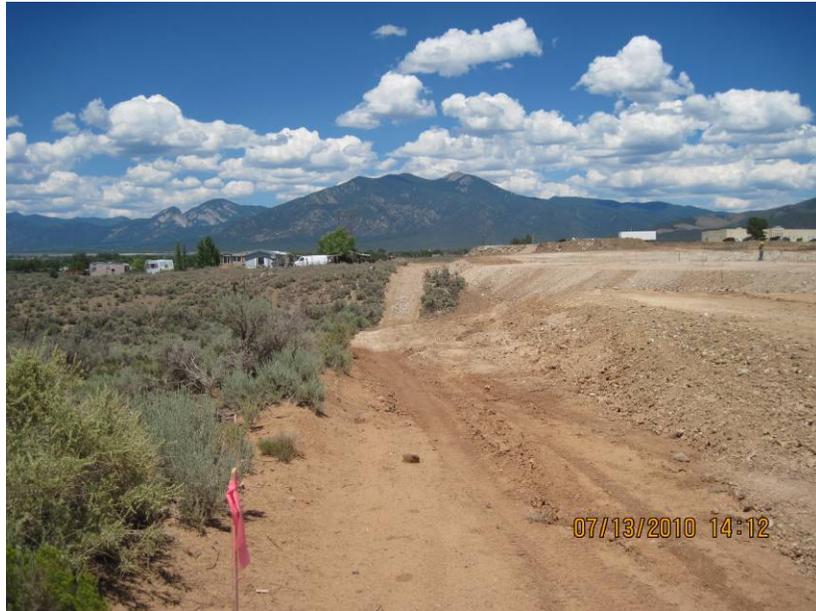
NMED/SWQB Official Photograph Log Photo # 5		
Photographer: Erin Trujillo	Date: 07/14/2010	Time: 1412 hours
City/County: Taos / Taos County		State: New Mexico
Location: Town of Taos Alexander Gusdorf Eco-Park		
Subject: Western boundary. Silt fence shown on site map not installed.

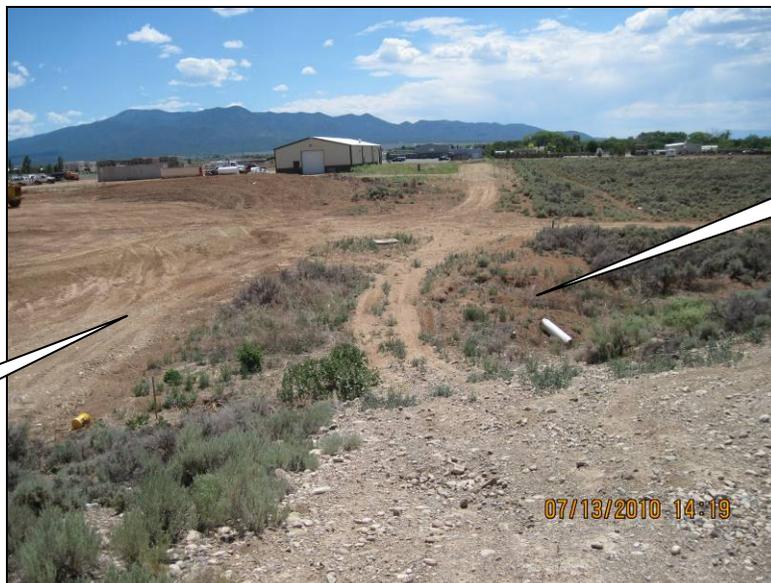
NMED/SWQB Official Photograph Log Photo # 6		
Photographer: Erin Trujillo	Date: 07/14/2010	Time: 1419 hours
City/County: Taos / Taos County		State: New Mexico
Location: Town of Taos Alexander Gusdorf Eco-Park		
Subject: Western boundary at south-southwest corner of site where stormwater in constructed drainage channel would flow off-site. Sediment basin and hale bales for this area described in SWPPP had not been constructed. Off-site erosion appears to have been altered from off-site dirt road shown in center of photo and downstream flood control berm not shown in photo.

On-site Constructed
Drainage Channel

Off-site Erosion Features

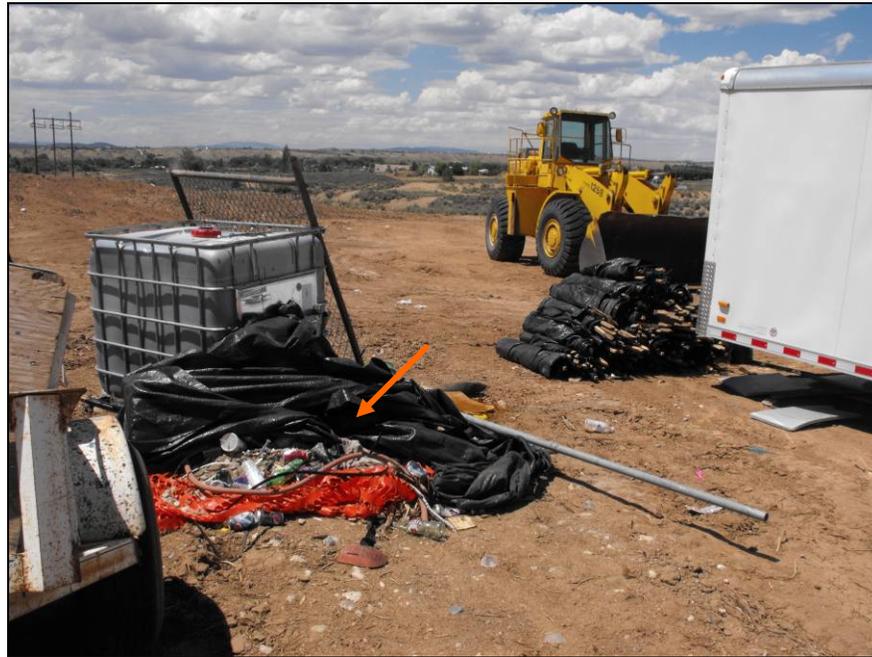
NMED/SWQB Official Photograph Log Photo # 7		
Photographer: Daniel Valenta	Date: 07/14/2010	Time: 1428 hours
City/County: Taos / Taos County	State: New Mexico	
Location: Town of Taos Alexander Gusdorf Eco-Park		
Subject: Arrow points to trash piled on ground, including cans and bottles at equipment and material storage area.
