Re: Industrial Storm Water, SIC 4952, NPDES Compliance Evaluation Inspection, County of Doña Ana, South Central Regional Wastewater Treatment Facility, NMU001675, August 27, 2010

**NPDES Compliance Inspection Report**

**County of Doña Ana, South Central Regional Wastewater Treatment Facility**  
**NPDES Tracking No. NMU001675**  
**Compliance Evaluation Inspection**  
**August 27, 2010**

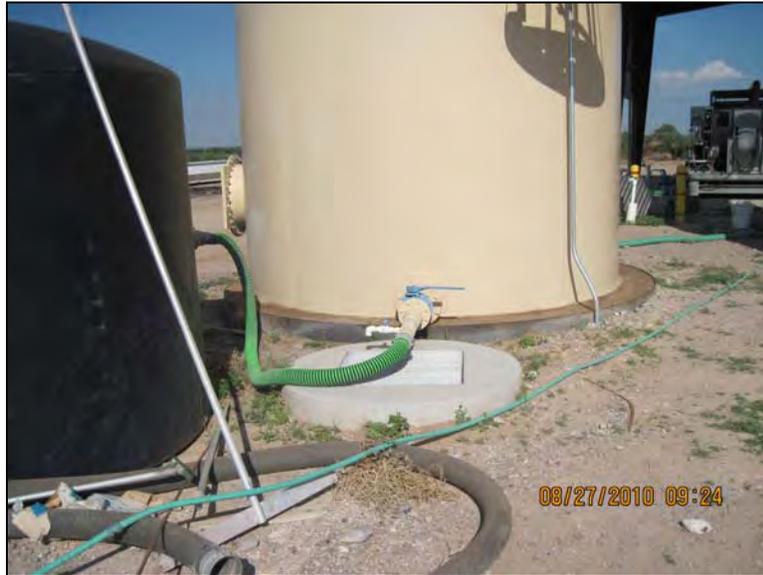
<b>NMED/SWQB Official Photograph Log Photo # 1</b>		
Photographer: Erin S. Trujillo	Date: 08/27/2010	Time: 0924 hours
City/County: Near La Mesa and Vado / Doña Ana		State: New Mexico
Location: South Central Regional Wastewater Treatment Facility		
Subject: Facility waste sludge tank and various associated hoses/valves exposed to precipitation.

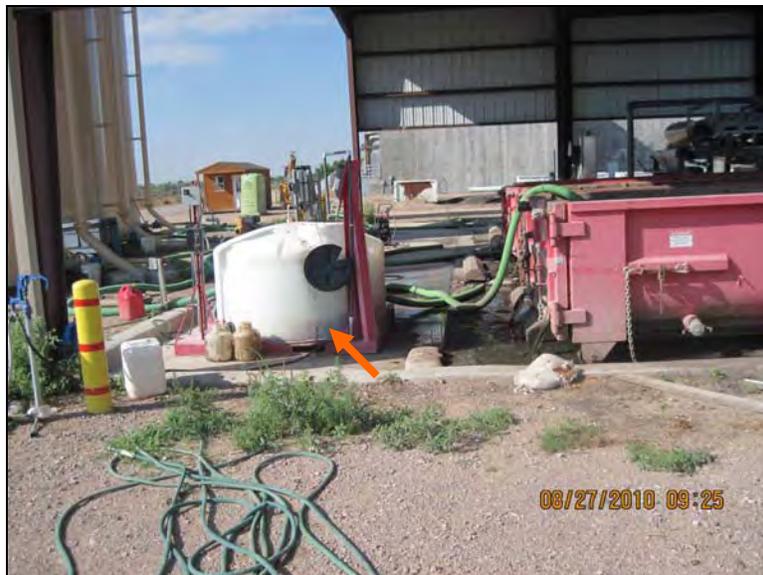
<b>NMED/SWQB Official Photograph Log Photo # 2</b>		
Photographer: Erin S. Trujillo	Date: 08/27/2010	Time: 0925 hours
City/County: Near La Mesa and Vado / Doña Ana		State: New Mexico
Location: South Central Regional Wastewater Treatment Facility		
Subject: Septage (liquid sanitary waste) processing area with various hoses, products and storage containers near the three 25,000 gallon sludge and liquid waste storage tanks. Arrow points to polymer mixing tank exposed to precipitation, but is on curbed concrete pad with a drain to the treatment works.

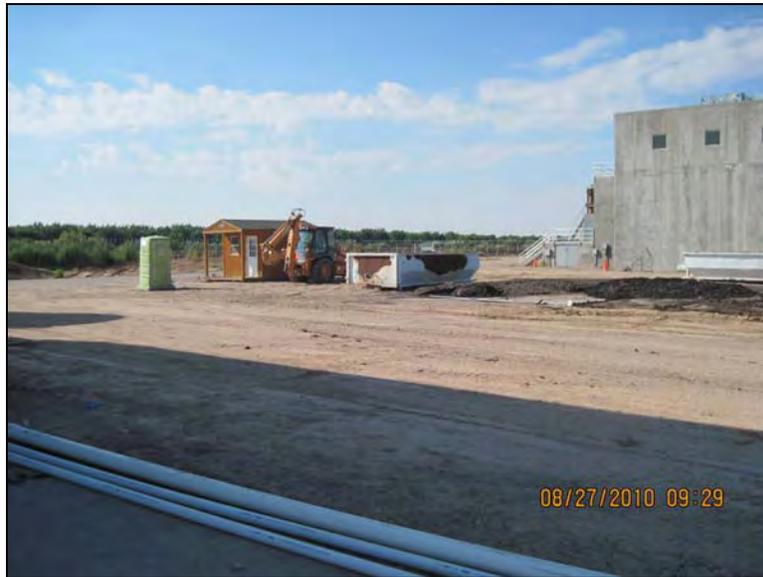
<b>NMED/SWQB Official Photograph Log Photo # 3</b>		
Photographer: Erin S. Trujillo	Date: 08/27/2010	Time: 0929 hours
City/County: Near La Mesa and Vado / Doña Ana		State: New Mexico
Location: South Central Regional Wastewater Treatment Facility		
Subject: Overview of sludge roll off and sludge drying area exposed to precipitation. Portable toilet not protected from vehicle traffic.

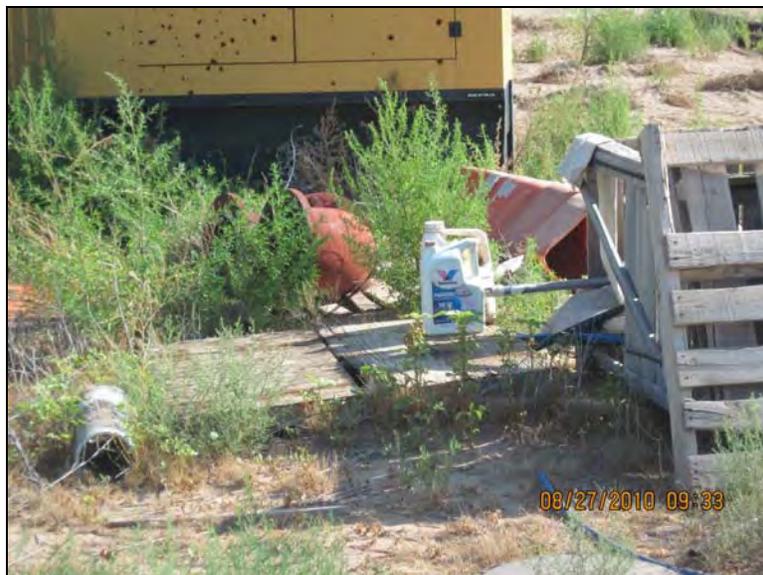
<b>NMED/SWQB Official Photograph Log Photo # 4</b>		
Photographer: Erin S. Trujillo	Date: 08/27/2010	Time: 0933 hours
City/County: Near La Mesa and Vado / Doña Ana		State: New Mexico
Location: South Central Regional Wastewater Treatment Facility		
Subject: Example of trash (in this case empty oil containers) with damaged equipment and other debris at the facility.
