RE: Construction Stormwater; SIC 1611; NPDES Compliance Evaluation; New Mexico State Land Office; NMU001682; September 16, 2010

NPDES Compliance Inspection Report

**Compliance Evaluation Inspection
Road Construction- White Mt. Area
NPDES Permit No. NMU001682
September 16, 2010**

On September 16, 2010 a Compliance Evaluation Inspection was conducted at a ≥ 1 acre road construction site located approximately 3 miles east on Hwy 120 from Ocate, New Mexico. The inspection was conducted by Daniel Valenta accompanied by Sandra Gabaldon of the NMED/SWQB. This unpaved road travels north from Hwy 120 for 0.6 miles; it crosses Ocate Creek and ends at the top of the hill.

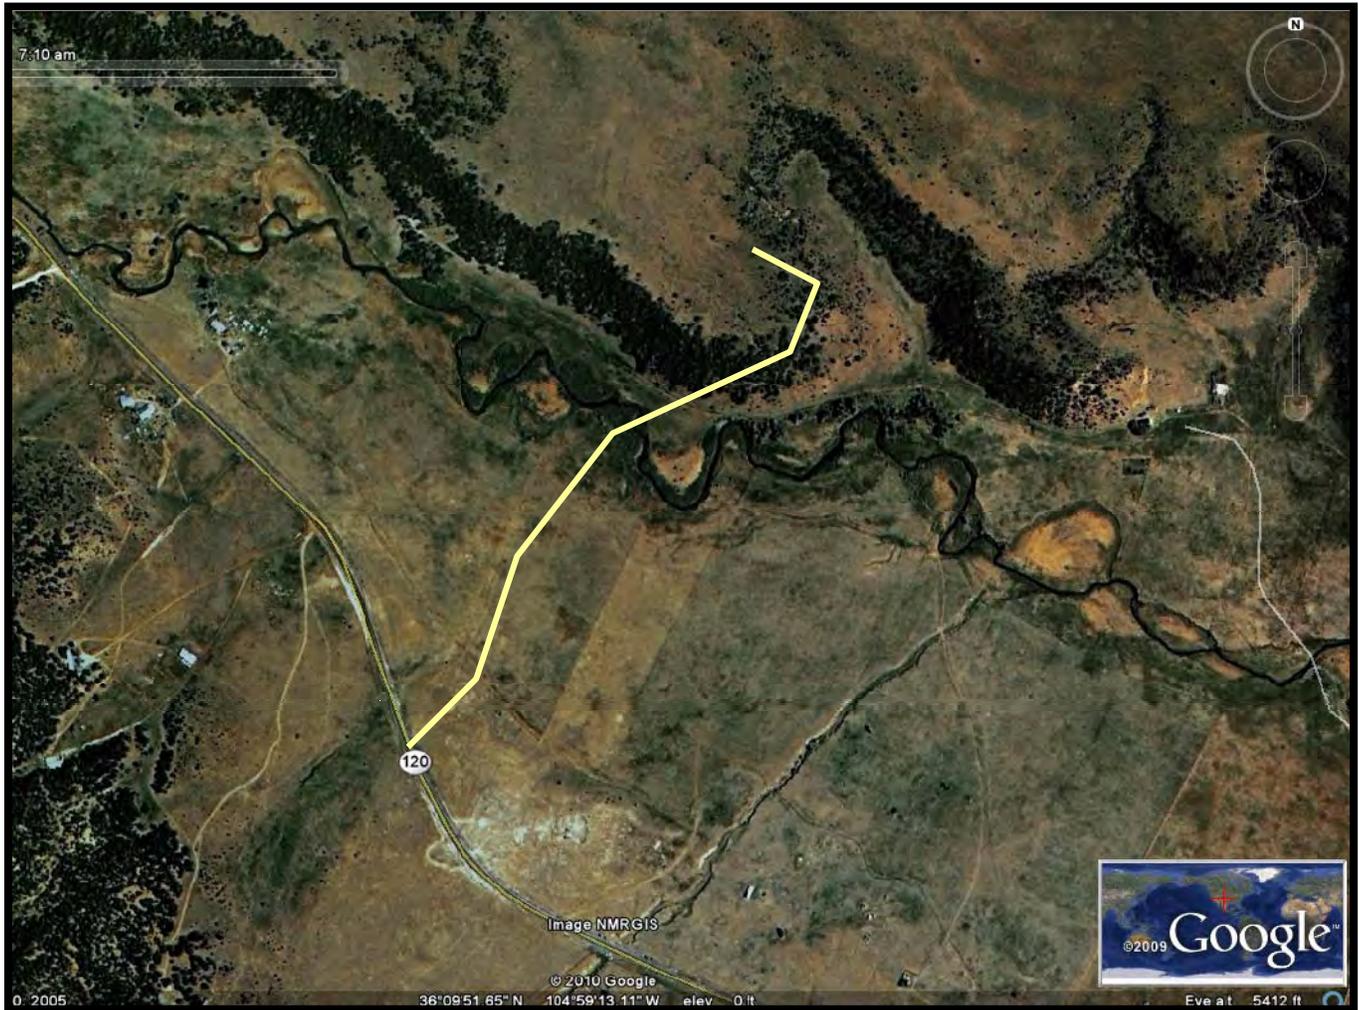
**NMED/SWQB
Site Overview**

Subject: Approximant direction and location of constructed road traveling 0.6 miles from Hwy 120 across Ocate Creek, up the hill to the top and stopping. Photo not taken on day of inspection.

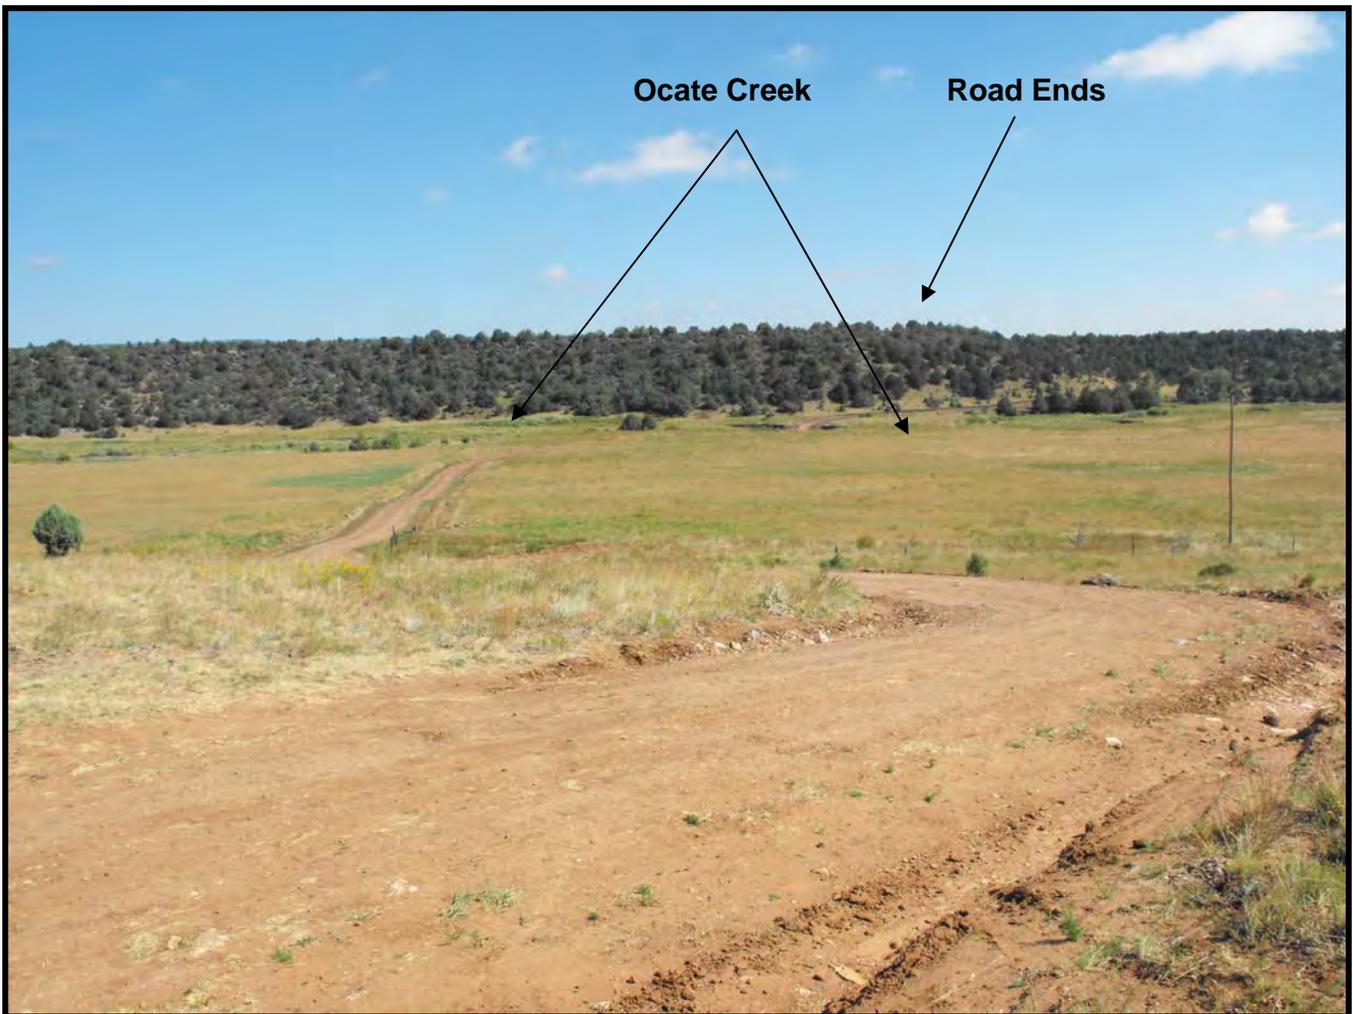
Photo # 1

Photographer: Daniel Valenta	Date: 9/16/2010	Time: 1050 hours
City/County: Outside Ocate, NM/ Mora County		
Location: Approximately 3 miles east of Ocate, off Hwy 120, facing north.		
Subject: Road from Hwy 120 to top of hill.

According to the facility's representatives, and based on a review of the EPA storm water permit database, it has been determined that none of the operators of this construction site had NPDES construction general storm water permit coverage on the date of this inspection. The New Mexico State Land Office appears to be the owner/developer of this construction project and may have operational control over project specifications. Mr. David Stanley is the general contractor who has day-to-day operational control of those activities at the project which are necessary to ensure compliance with the storm water pollution prevention plan (SWPPP) and other permit conditions. On the day of the inspection no construction activity was occurring and the site had not been stabilized. Road construction had begun in early August 2010, (See overview and photos 1-3). Some Best Management Practices (BMPs) were on site to prevent stormwater from carrying sediment from the site into the adjacent Ocate Creek. Lead Off ditches have been installed in several places to divert stormwater away from the road but more stormwater controls are needed along the creek and roadway. A SWPPP should include the following:

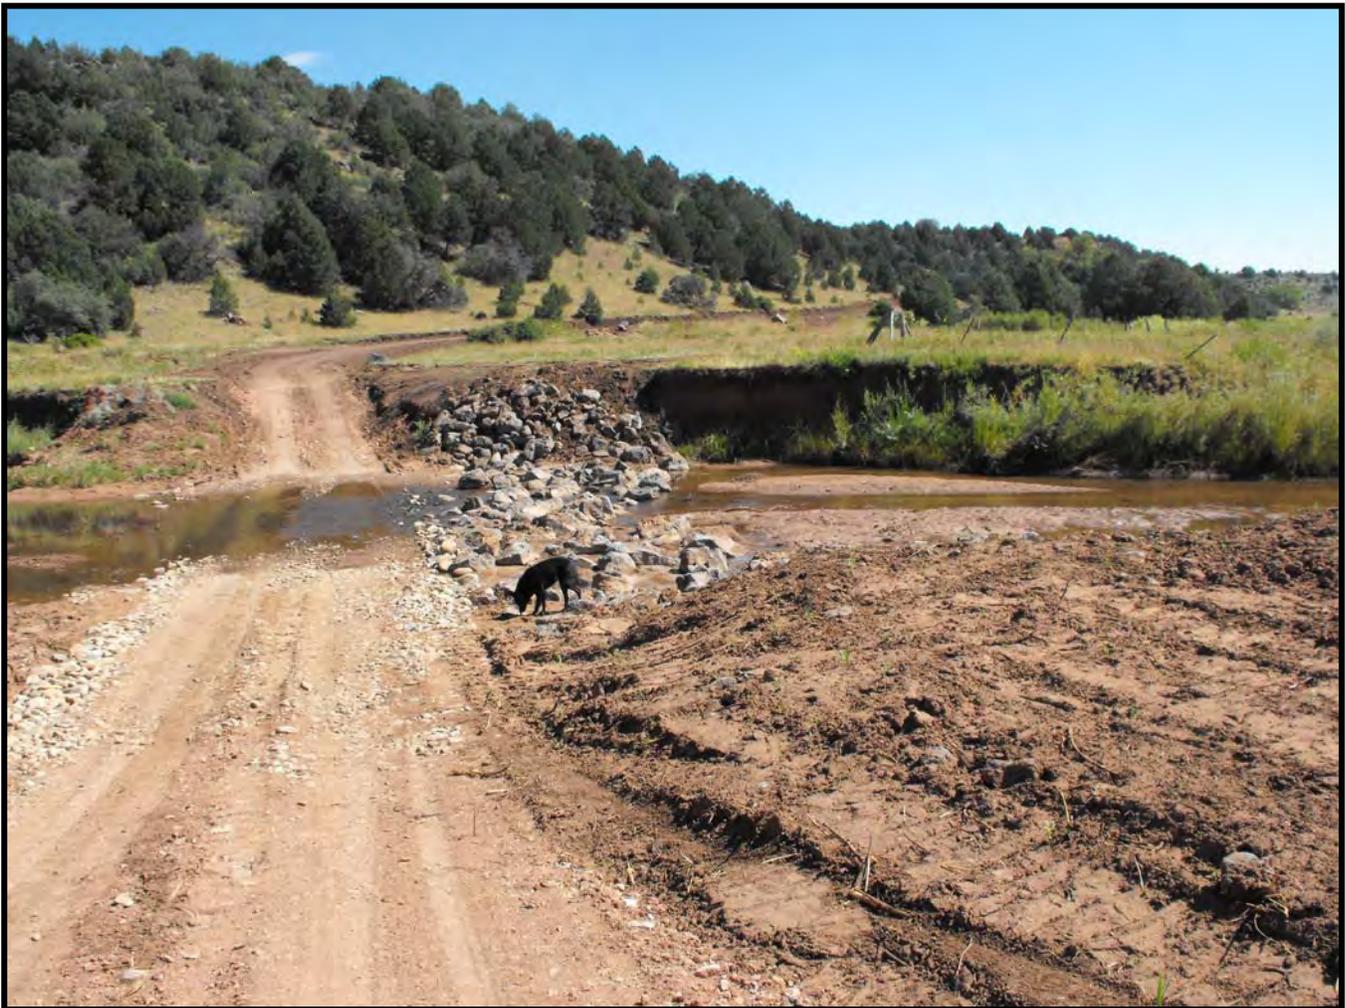
Photo # 2

Photographer: Daniel Valenta	Date: 9/16/2010	Time: 1123 hours
City/County: Outside Ocate NM/ Mora County		
Location: Approximately 3 miles east of Ocate, off Hwy 120, facing north at crossing of Ocate Creek.		
Subject: Unpaved road crossing Ocate Creek and going to top of hill.

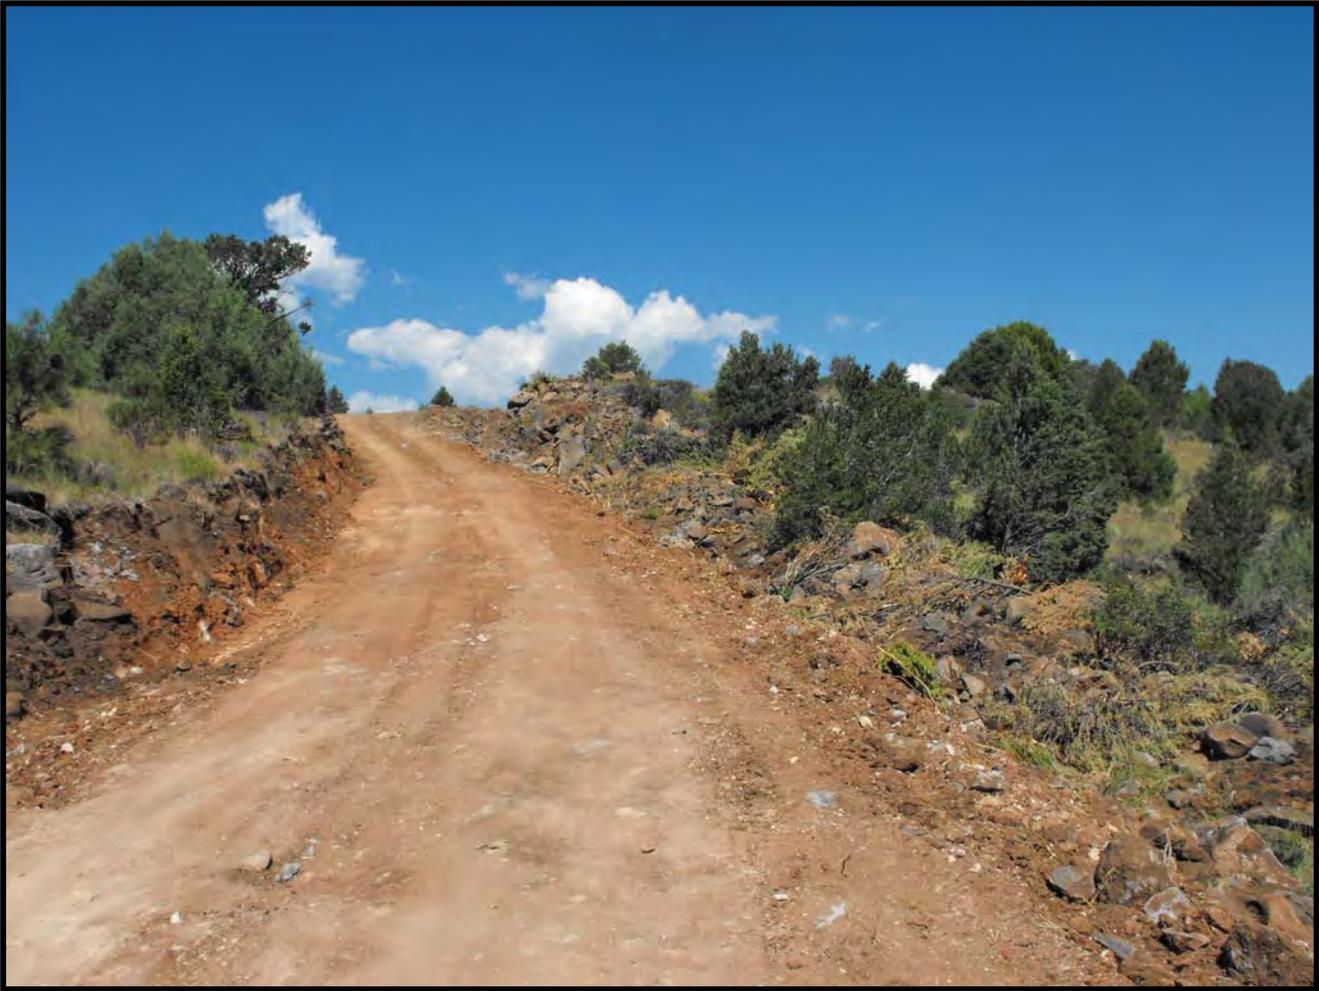
Photo # 3

Photographer: Daniel Valenta	Date: 9/16/2010	Time: 1133 hours
City/County: Outside Ocate NM/ Mora County		
Location: Approximately 3 miles east of Ocate, off Hwy 120, facing west near the top of the hill.		
Subject: Road cut into the side of hill nearing the top, road ends at top.
