RE: Industrial Storm Water, SIC 4581, NPDES Compliance Evaluation Inspection, City of Las Vegas / Las Vegas Municipal Airport, NMU001713, February 15, 2011

NPDES Compliance Inspection Report

**City of Las Vegas Municipal Airport
Compliance Evaluation Inspection – Industrial Stormwater
NPDES Tracking No. NMU001713
February 15, 2011**

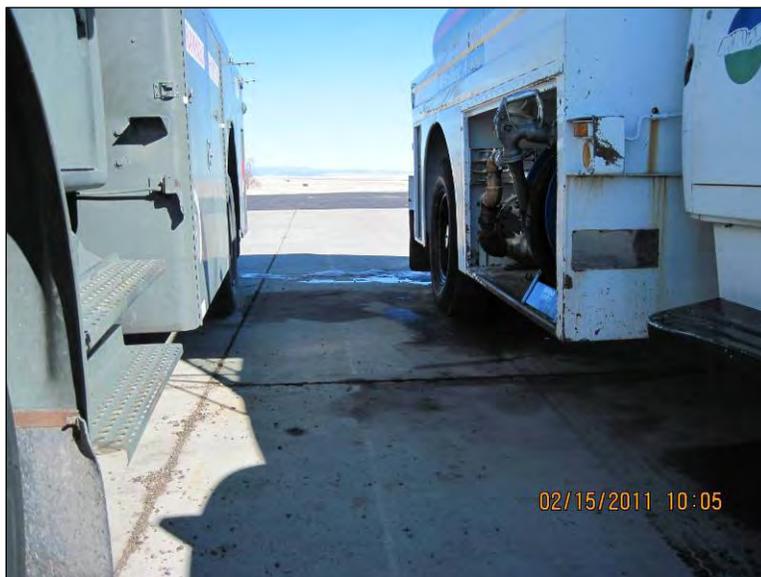
NMED/SWQB Official Photograph Log Photo # 1		
Photographer: Erin Trujillo	Date: 02/15/2011	Time: 1005 hours
City/County: Las Vegas / San Miguel		State: New Mexico
Location: City of Las Vegas Municipal Airport		
Subject: Staining was observed below the ground fueling vehicles in the designated parking area on the concrete apron. Photo brightness was increased for report.

Additional BMPs should be considered (e.g., drip pans under vehicles and equipment for the collection of fluid leaks; vehicle preventative maintenance; clearly label drums and containers; cover and properly dispose of wastes before quantities accumulate; determine if secondary containment for fuel tanks is sufficient or provide secondary containment if missing; shelter drums, barrels and similar containers from exposure from stormwater run on and runoff to prevent deterioration and leaks). Because aircraft fueling occurs throughout the apron areas of the facility, additional spill kits more readily accessible (e.g., inside ground fuel trucks) should be considered.

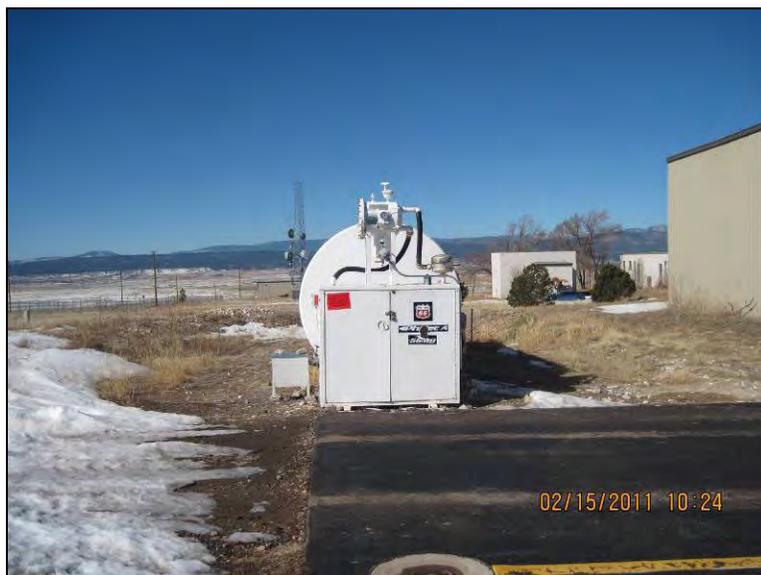
NMED/SWQB Official Photograph Log Photo # 2		
Photographer: Erin Trujillo	Date: 02/15/2011	Time: 1024 hours
City/County: Las Vegas / San Miguel		State: New Mexico
Location: City of Las Vegas Municipal Airport		
Subject: An excavated low area and earthen berm only partially surrounded this fuel tank. The on-site operator representative stated that secondary containment for this tank was being reviewed.

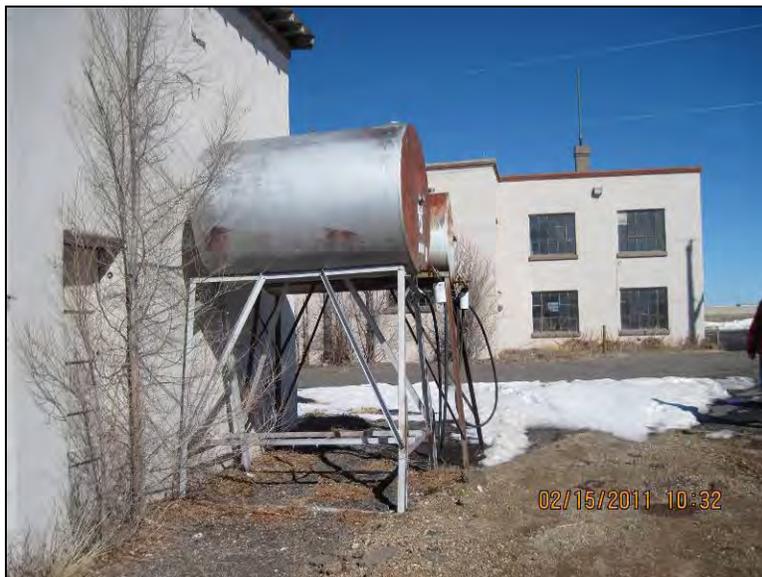
NMED/SWQB Official Photograph Log Photo # 3		
Photographer: Erin Trujillo	Date: 02/15/2011	Time: 1032 hours
City/County: Las Vegas / San Miguel		State: New Mexico
Location: City of Las Vegas Municipal Airport		
Subject: No secondary containment was provided for these above-ground storage tanks. The 2001 SWPPP indicated that these smaller above-ground tanks were being phased out. The on-site operator representative stated that the tanks were still used for fueling ground equipment.

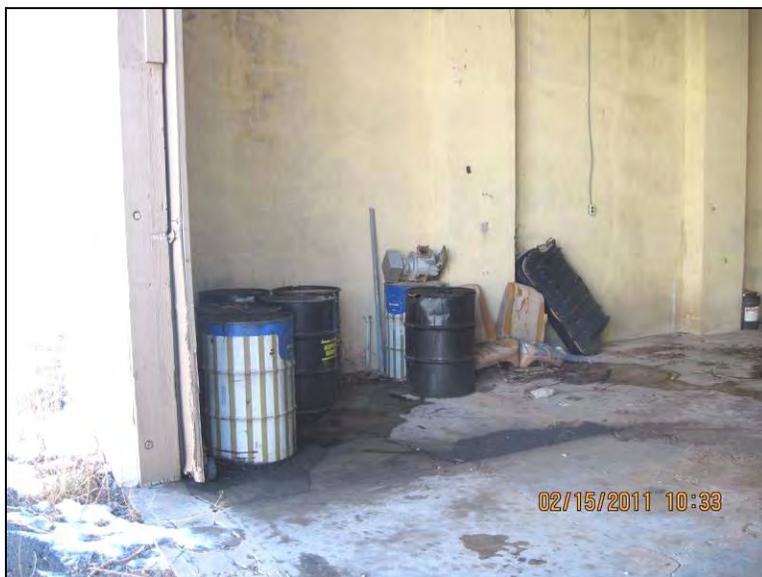
NMED/SWQB Official Photograph Log Photo # 4		
Photographer: Erin Trujillo	Date: 02/15/2011	Time: 1033 hours
City/County: Las Vegas / San Miguel		State: New Mexico
Location: City of Las Vegas Municipal Airport		
Subject: The roof of this building is damaged and not completely storm resistant. Drums and equipment/vehicle parts are exposed to precipitation. Materials and wastes stored in this open bay building was not clean and orderly. Photo brightness increased for report.

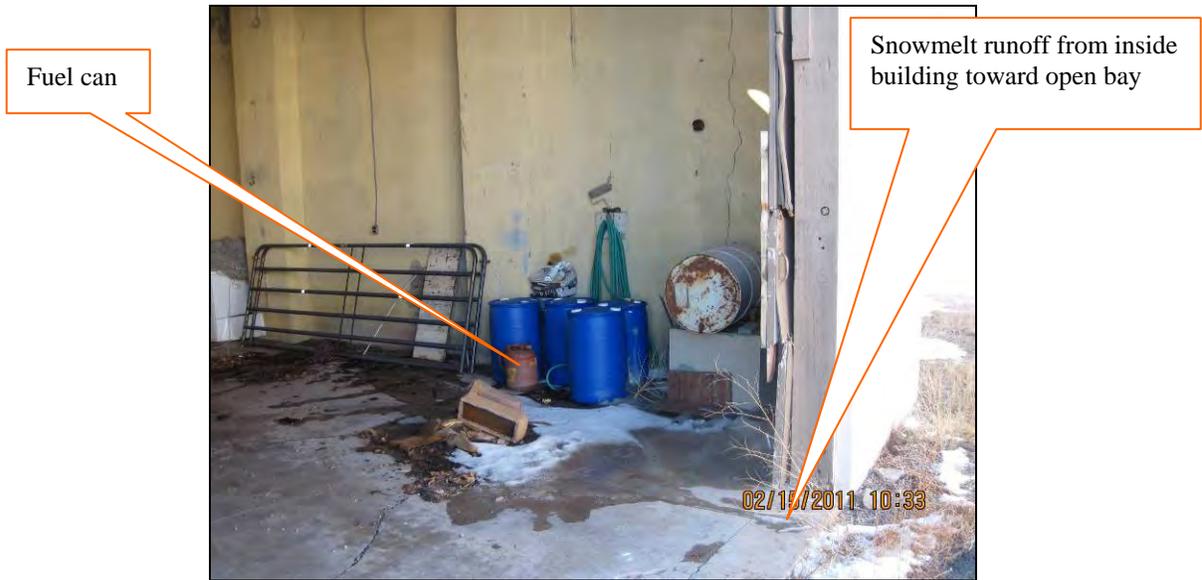
NMED/SWQB Official Photograph Log Photo # 5		
Photographer: Erin Trujillo	Date: 02/15/2011	Time: 1033 hours
City/County: Las Vegas / San Miguel		State: New Mexico
Location: City of Las Vegas Municipal Airport		
Subject: As previously discussed, the roof of this storage building is damaged and not completely storm resistant.

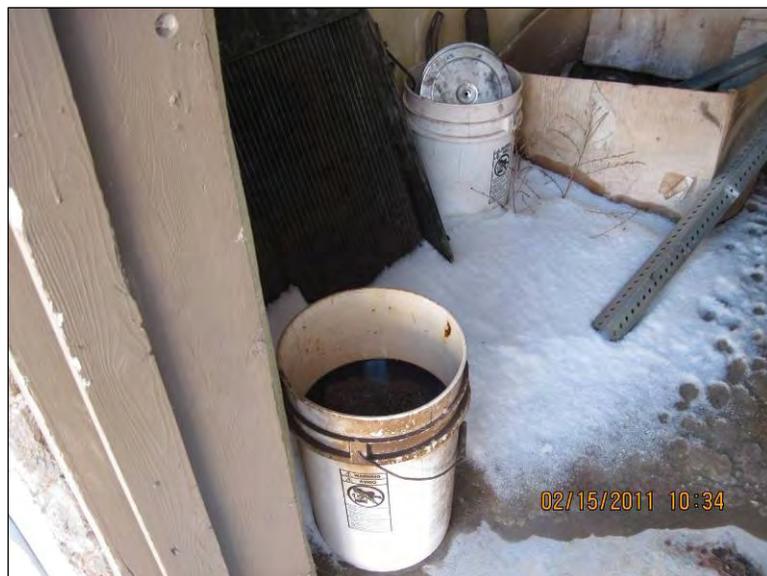
NMED/SWQB Official Photograph Log Photo # 6		
Photographer: Erin Trujillo	Date: 02/15/2011	Time: 1034 hours
City/County: Las Vegas / San Miguel		State: New Mexico
Location: City of Las Vegas Municipal Airport		
Subject: Uncovered unlabeled bucket at open bay of the building shown in Photos #4 & #5 is exposed to precipitation. Contents were not determined.
