RE: Industrial Storm Water, SIC 3273 & 2951, NPDES Compliance Evaluation Inspection, Sangre De Cristo Gravel Products, LLC, NMU001714, February 15, 2011

NPDES Compliance Inspection Report

Sangre De Cristo Gravel Products, LLC
Compliance Evaluation Inspection – Industrial Stormwater
NPDES Tracking No. NMU001714
February 15, 2011

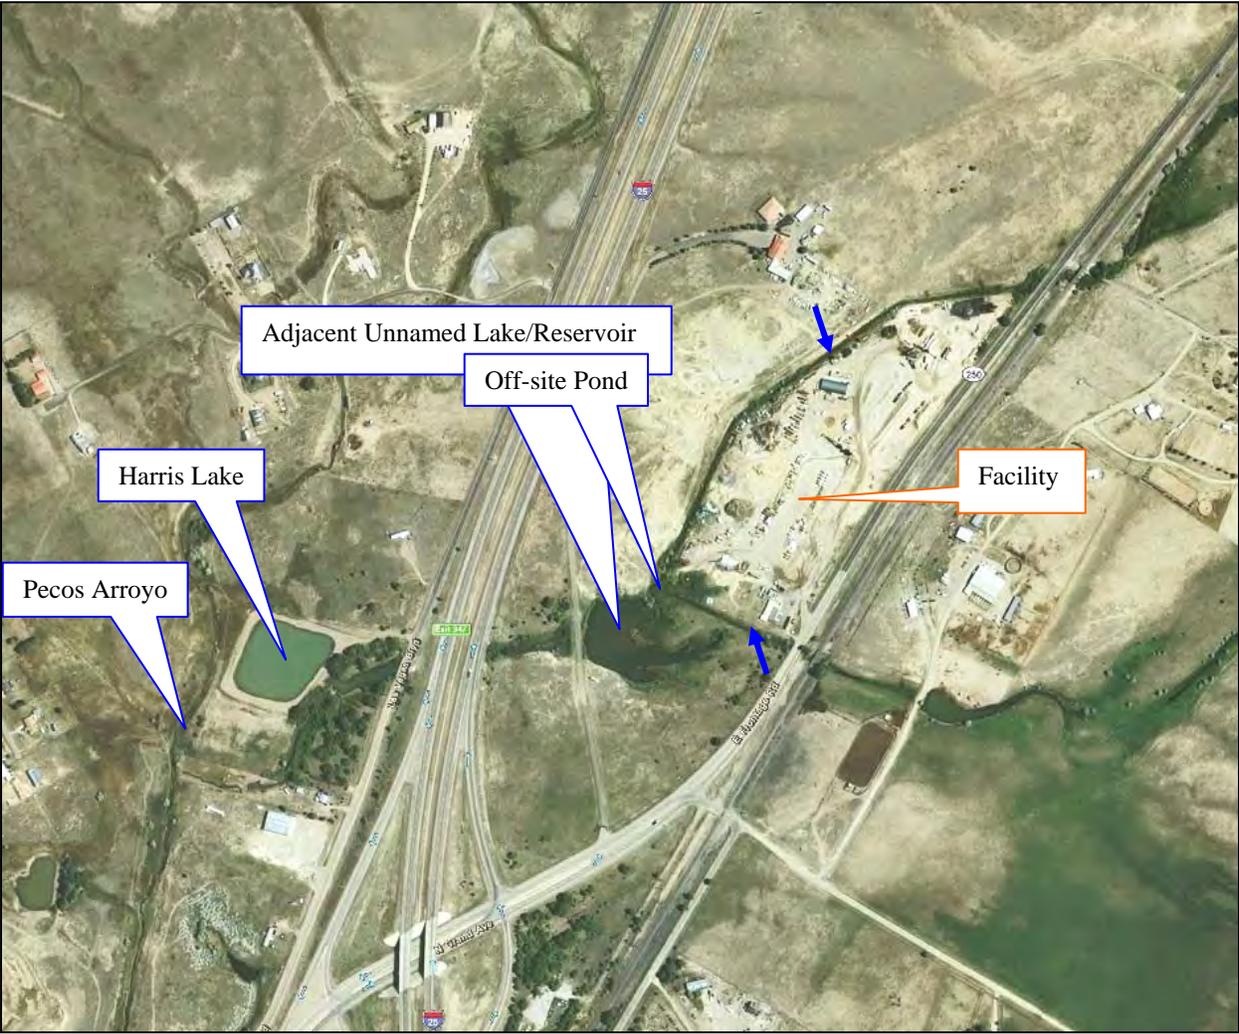
NMED/SWQB General Area Map		
Created by: Erin Trujillo		
City/County: Las Vegas / San Miguel	State: New Mexico	
Location: Sangre de Cristo Gravel Products, LLC		
Subject: Arrows point to off-site unnamed tributaries surrounding the facility that lead to pond. Pond is shown on SWPPP site map to be outside the facility's property boundaries. Overflow from the off-site pond is to an unnamed lake/reservoir that flows to a tributary to Harris Lake and Pecos Arroyo.

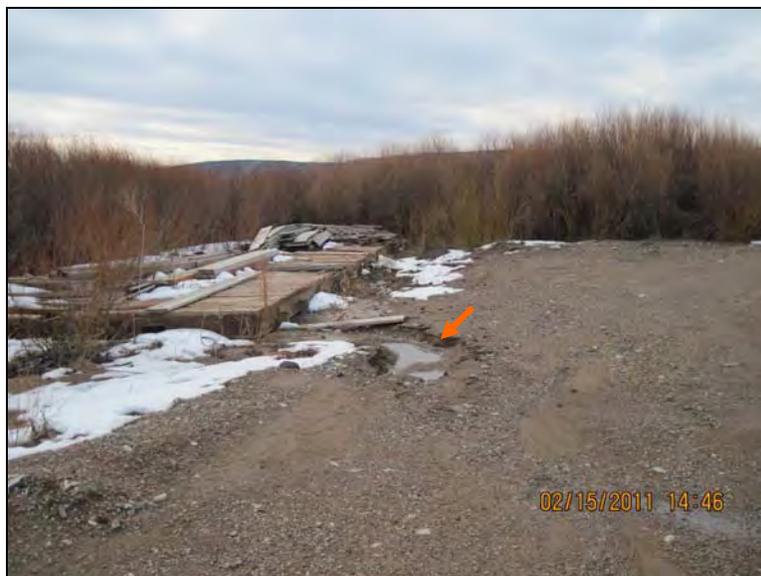
NMED/SWQB Official Photograph Log Photo # 1		
Photographer: Erin Trujillo	Date: 02/15/2011	Time: 1446 hours
City/County: Las Vegas / San Miguel		State: New Mexico
Location: Sangre de Cristo Gravel Products, LLC		
Subject: Arrow points to erosion channel in the south-southwest portion of the site.

SWPPP Implementation	
Spill Prevention and Response	<p><i>(e.g., minimizing the potential for leaks, spills and other releases that may be exposed to storm water and develop plans for effective response to such spills if or when they occur)</i></p> <p>Larger on-site fuel storage had secondary containment, but a smaller tank did not (see photo log). As previously discussed, spills and leaks at the vehicle maintenance building had not been cleaned up.</p>
Erosion and Sediment Controls	<p><i>(e.g., stabilize exposed areas and contain runoff using structural and/or non-structural control measures to minimize onsite erosion and sedimentation, flow velocity dissipation devices at discharge locations and within outfall channels)</i></p> <p>Vegetative filter strips existed along most of the property boundaries. However, earth berms had breaks or gaps along the western property boundary along an unnamed tributary and at the south-southwest portion and corner of the property adjacent to the pond. Earth berm construction techniques (e.g., specifications, dimensions, stabilization) should also be reviewed. Along the south-southwest portion of the site, erosion channels had formed (see photo log).</p>

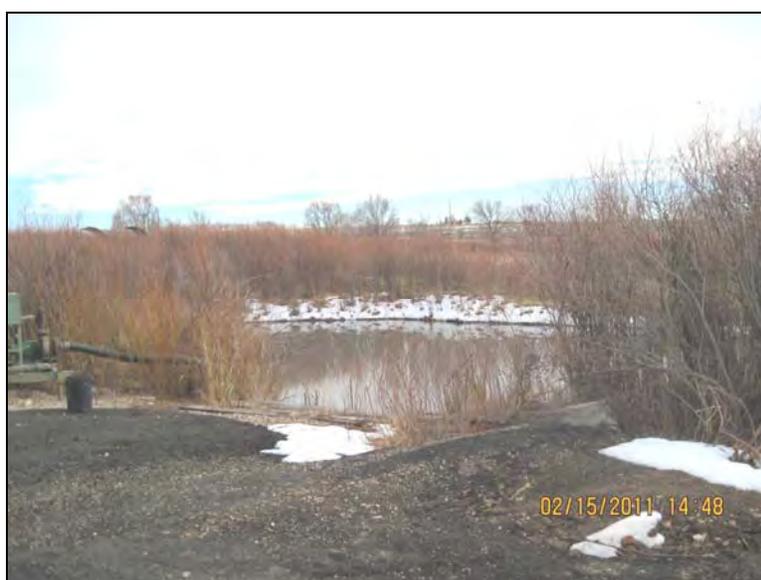
NMED/SWQB Official Photograph Log Photo # 2		
Photographer: Erin Trujillo	Date: 02/15/2011	Time: 1448 hours
City/County: Las Vegas / San Miguel		State: New Mexico
Location: Sangre de Cristo Gravel Products, LLC		
Subject: Paved area without curb at water pump in south-southwest corner of site and off-site pond. Photo brightness increased for report.

Management of Runoff	<p><i>(e.g., divert, infiltrate, reuse, contain, or otherwise reduce storm water runoff, to minimize pollutants in discharges)</i></p> <p>The low area/pond behind the Main Office was at capacity. Additional measures (e.g., additional ponds, cleaning out sediment, increasing capacity, etc.) appeared needed to manage runoff.</p>
Salt Storage Piles	<p><i>(e.g., enclose or cover piles appropriate measures (e.g., good housekeeping, diversions, containment) to minimize exposure resulting from adding to or removing materials from the pile)</i></p> <p>No salt storage.</p>

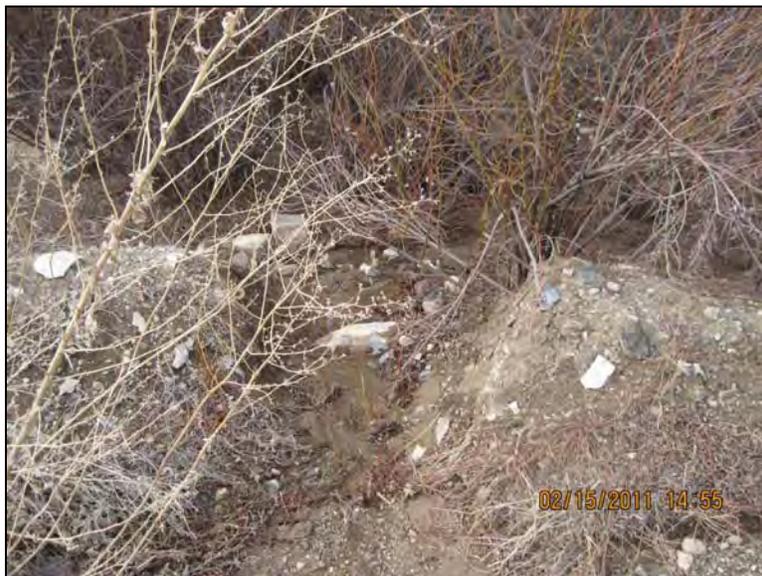
NMED/SWQB Official Photograph Log Photo # 3		
Photographer: Erin Trujillo	Date: 02/15/2011	Time: 1455 hours
City/County: Las Vegas / San Miguel		State: New Mexico
Location: Sangre de Cristo Gravel Products, LLC		
Subject: Erosion channel that has cut through earth berm in south-southwest portion of property.

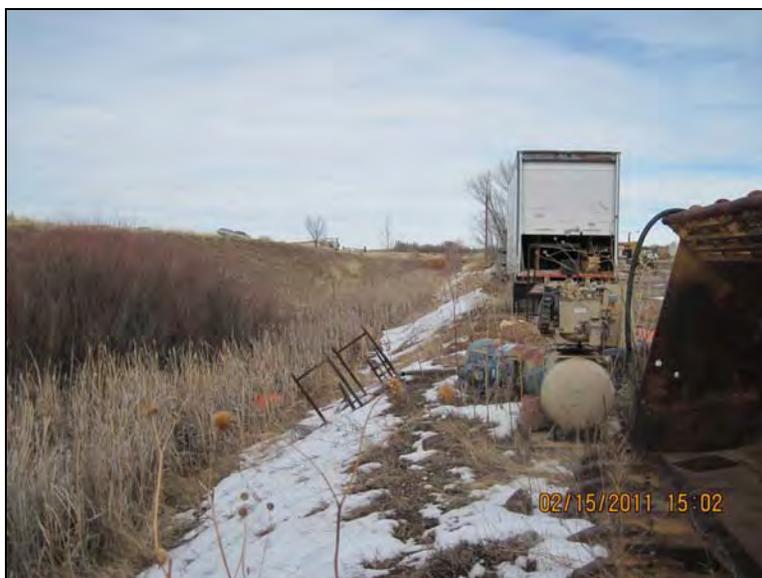
NMED/SWQB Official Photograph Log Photo # 4		
Photographer: Erin Trujillo	Date: 02/15/2011	Time: 1502 hours
City/County: Las Vegas / San Miguel		State: New Mexico
Location: Sangre de Cristo Gravel Products, LLC		
Subject: Portion of west property boundary that does not have earth berm.

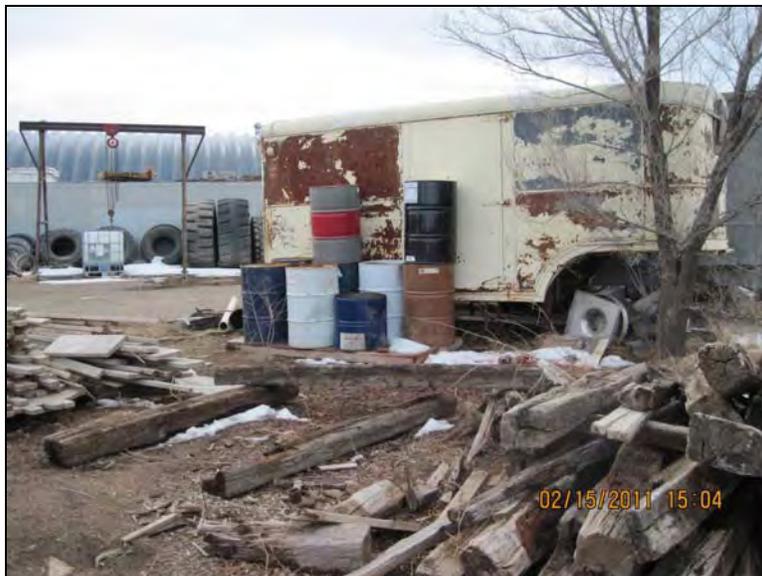
NMED/SWQB Official Photograph Log Photo # 5		
Photographer: Erin Trujillo	Date: 02/15/2011	Time: 1504 hours
City/County: Las Vegas / San Miguel		State: New Mexico
Location: Sangre de Cristo Gravel Products, LLC		
Subject: Example of un-labled drum and other material storage along west property boundary.

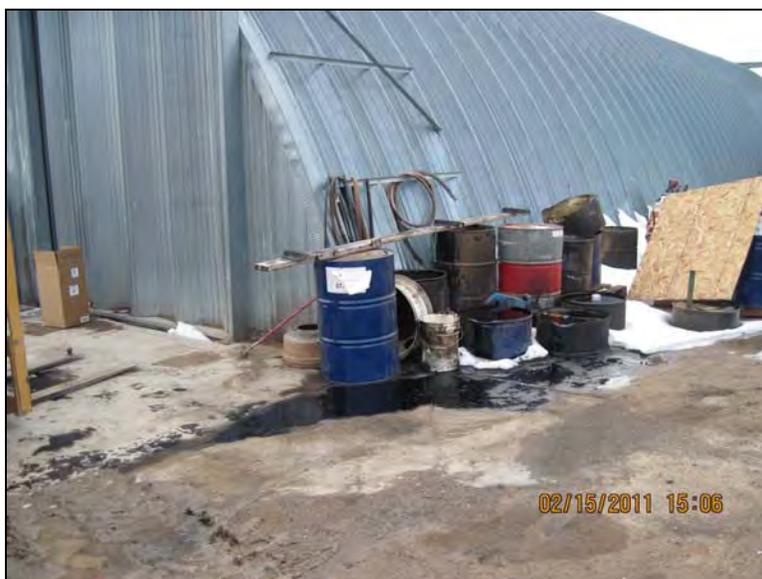
NMED/SWQB Official Photograph Log Photo # 6		
Photographer: Erin Trujillo	Date: 02/15/2011	Time: 1506 hours
City/County: Las Vegas / San Miguel		State: New Mexico
Location: Sangre de Cristo Gravel Products, LLC		
Subject: Spill on ground at vehicle maintenance shop. Open buckets and containers with what appeared to be waste-oil were also exposed to precipitation.

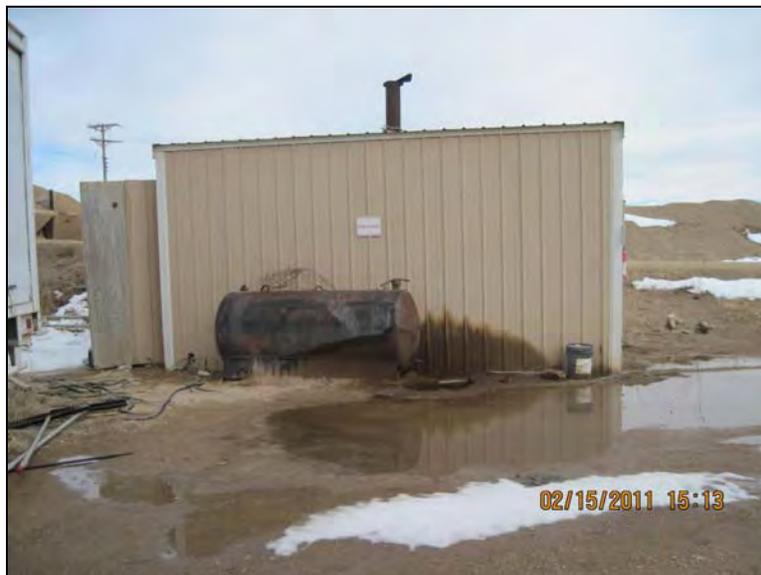
NMED/SWQB Official Photograph Log Photo # 7		
Photographer: Erin Trujillo	Date: 02/15/2011	Time: 1513 hours
City/County: Las Vegas / San Miguel		State: New Mexico
Location: Sangre de Cristo Gravel Products, LLC		
Subject: Unlabeled liquid storage tank with staining on building and no secondary containment.

SWPPP Implementation	
<p>Measures to minimize the exposure of manufacturing, processing, and material storage areas (including loading and unloading, storage, disposal, cleaning, maintenance, and fueling operations) to rain, snow, snowmelt, and runoff</p>	<p><i>(e.g., use grading, berming, or curbing to prevent runoff of contaminated flows and divert run-on away; locate materials, equipment, and activities so that leaks are contained in existing containment and diversion systems; clean up spills and leaks promptly using dry methods (e.g., absorbents) to prevent the discharge of pollutants; use drip pans and absorbents under or around leaky vehicles and equipment or store indoors where feasible; use spill/overflow protection equipment; drain fluids from equipment and vehicles prior to on-site storage or disposal; perform all cleaning operations indoors, under cover, or in bermed areas that prevent runoff and run-on and also that capture any overspray; and ensure that all washwater drains to a proper collection system)</i></p> <p>Spills and leaks at the vehicle maintenance building had not been cleaned up (see photo log).</p>

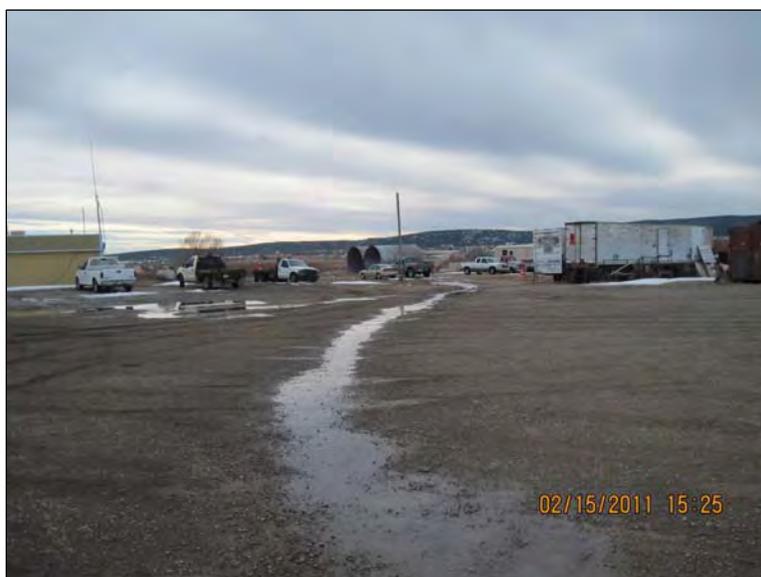
NMED/SWQB Official Photograph Log Photo # 8		
Photographer: Erin Trujillo	Date: 02/15/2011	Time: 1525 hours
City/County: Las Vegas / San Miguel		State: New Mexico
Location: Sangre de Cristo Gravel Products, LLC		
Subject: Snowmelt flowing through central portion of site in swale (swale not shown on site map).
