NEW MEXICO  
ENVIRONMENT DEPARTMENT

*Surface Water Quality Bureau*

**RE: Construction Stormwater, SIC 1521, NPDES Compliance Evaluation Inspection, Galbreth Land Development Co., LLC, 12000 Block San Antonio Blvd. Construction Project, NPDES Permit NMU001721, Albuquerque, New Mexico, September 8, 2011**

**NPDES Compliance Inspection Report**

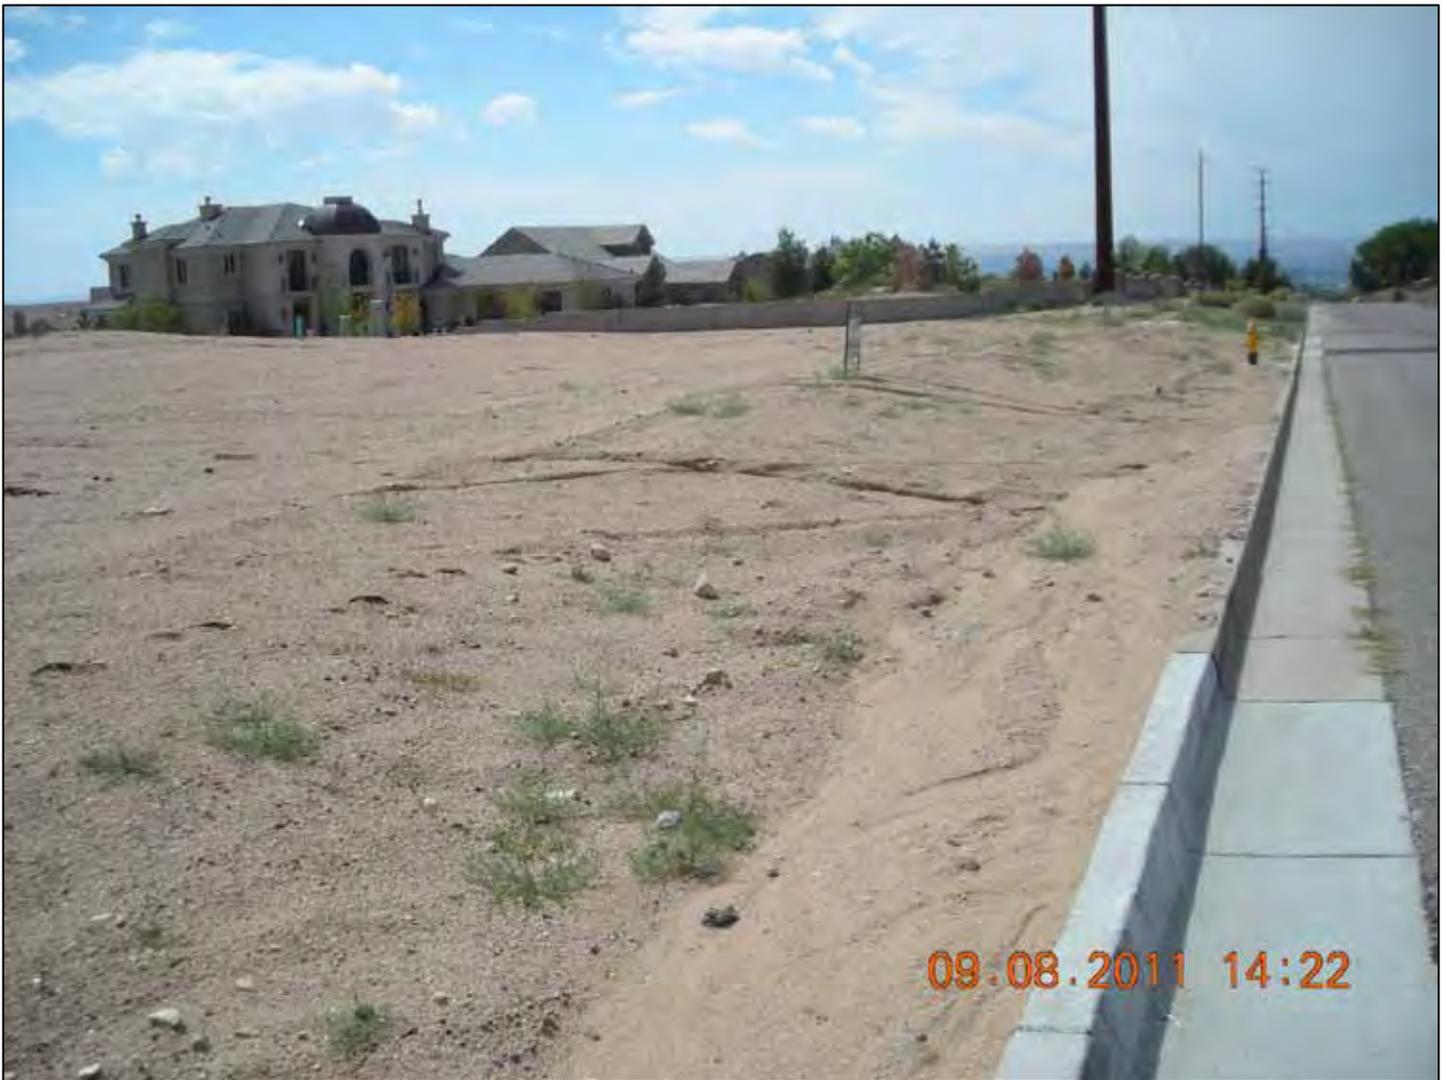
Official Photograph Log  
Photo # 1

| Subject: Lack of BMPs on site allowing silt and sediment to leave and travel down the road during a rainstorm. | | |

There was not a pollution prevention plan prepared in written form available at the site for the inspection and adequate stabilization measures were not being implemented at the site. A SWPPP should include the following:

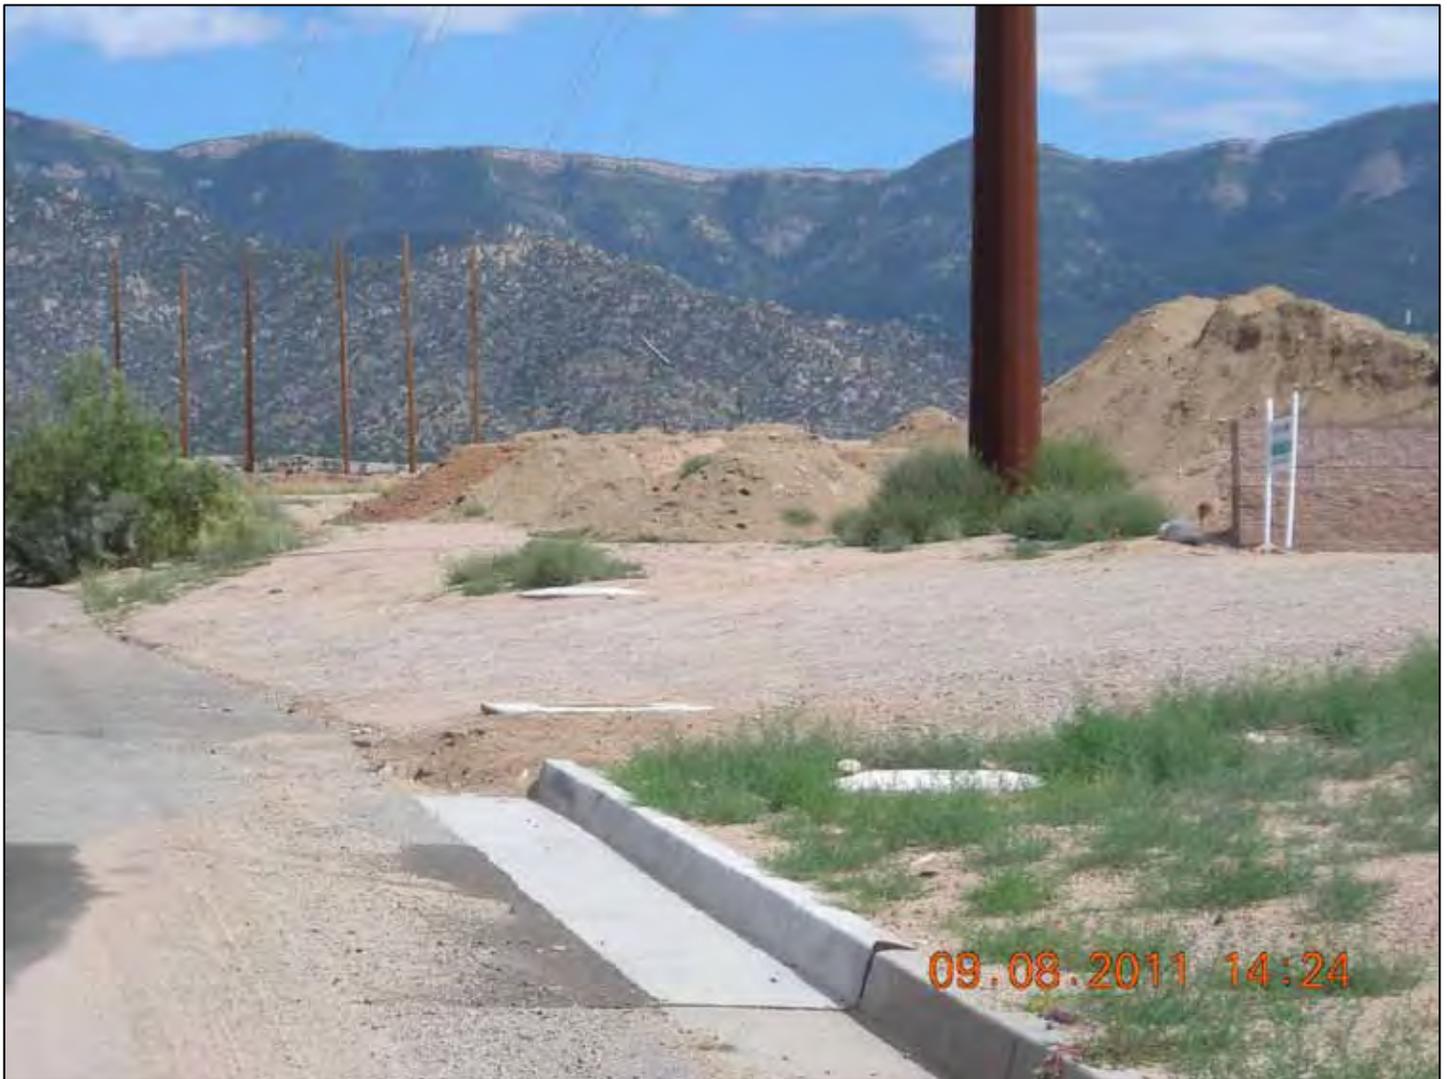
Official Photograph Log  
Photo # 2

| Subject: Dirt piles located on the East side of the project with no BMPs to control runoff from the piles. | | |

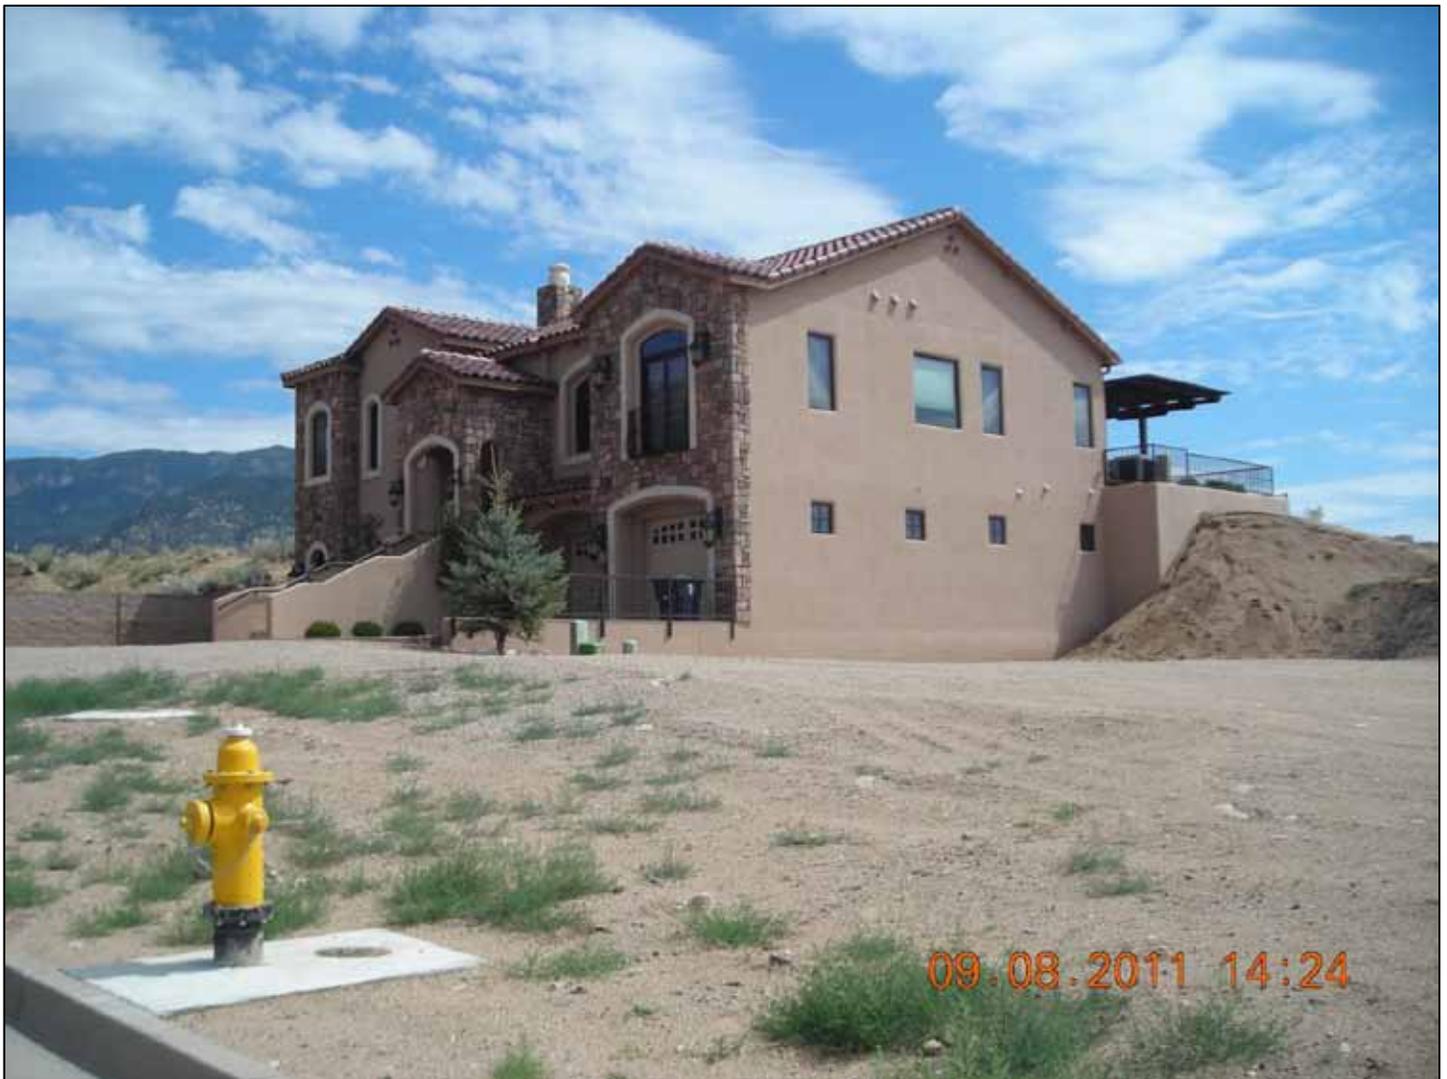
**Official Photograph Log**  
Photo # 3

| Subject: This is the only completed building on the project. | | |
