RE: Industrial Storm Water, SIC 5093, NPDES Compliance Evaluation Inspection, Francisco Chavarria dba Clovis Recycling, NMU001726, March 2, 2011

NPDES Compliance Inspection Report

Francisco Chavarria dba Clovis Recycling
Compliance Evaluation Inspection – Industrial Stormwater
NPDES Tracking No. NMU001726
March 2, 2011

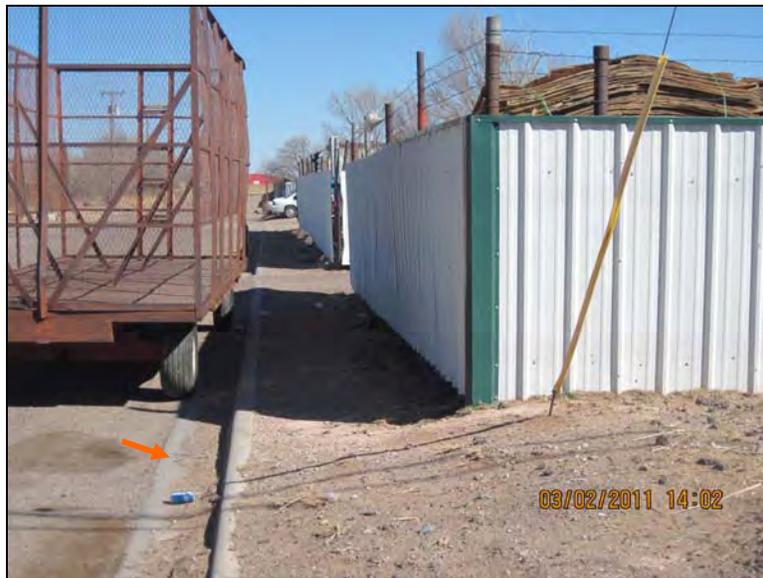
NMED/SWQB Official Photograph Log Photo # 1		
Photographer: Erin Trujillo	Date: 03/02/2011	Time: 1402 Hours
City/County: Clovis / Curry County		State: New Mexico
Location: Clovis Recycling		
Subject: Fence along the northern property boundary provides some protection to minimize windblown trash from getting off site. However, arrow points to off-site sediment accumulation on McDonald Street.

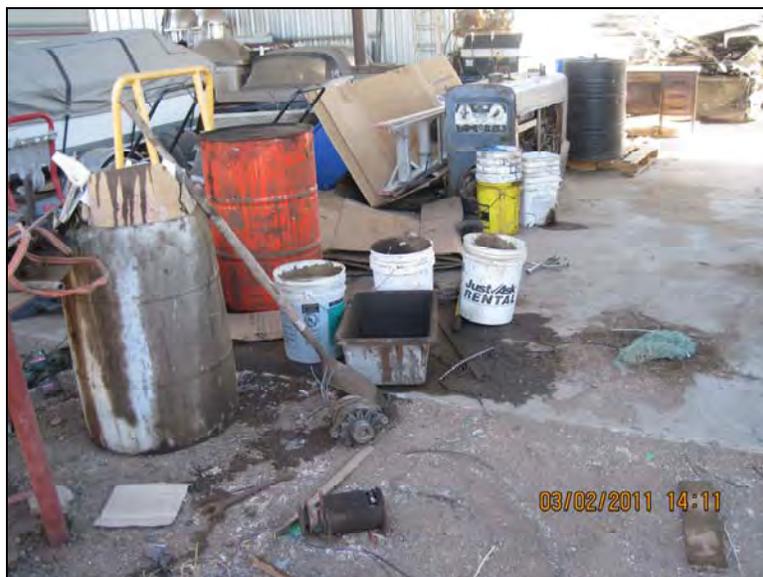
NMED/SWQB Official Photograph Log Photo # 2		
Photographer: Erin Trujillo	Date: 03/02/2011	Time: 1411 Hours
City/County: Clovis / Curry County		State: New Mexico
Location: Clovis Recycling		
Subject: Spills and leaks on concrete and ground associated with on-site vehicle maintenance. Trash can was filled above the top of container. Although this area is covered, it is not protected from stormwater run on or subsequent runoff. During this inspection, it was noted that open containers and buckets containing waste oil had been moved and stored near the drum in background of photo. That drum was stored on pallet.

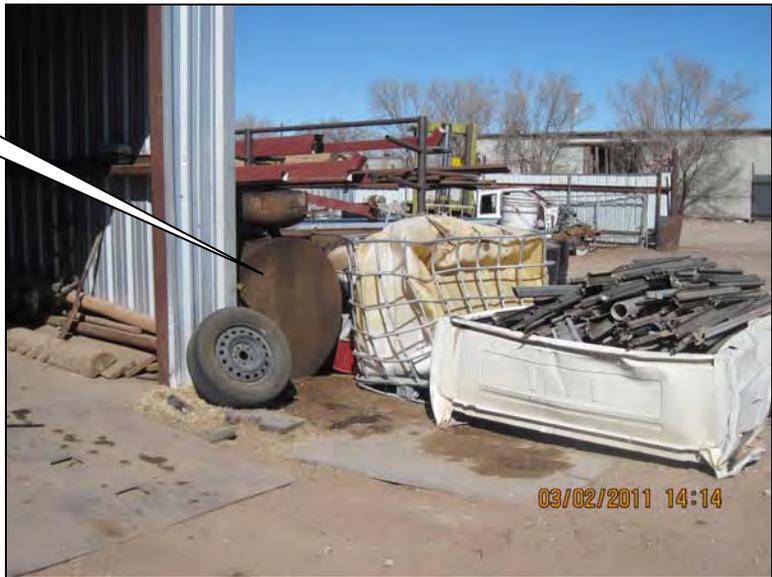
Waste oil tank outside

NMED/SWQB Official Photograph Log Photo # 3		
Photographer: Erin Trujillo	Date: 03/02/2011	Time: 1414 Hours
City/County: Clovis / Curry County		State: New Mexico
Location: Clovis Recycling		
Subject: Spills and leaks on boards and ground near waste oil tank and at shop. Tank did not have secondary containment. Surrounding material storage would make it difficult to inspect tank's integrity (corrosion and leaks).

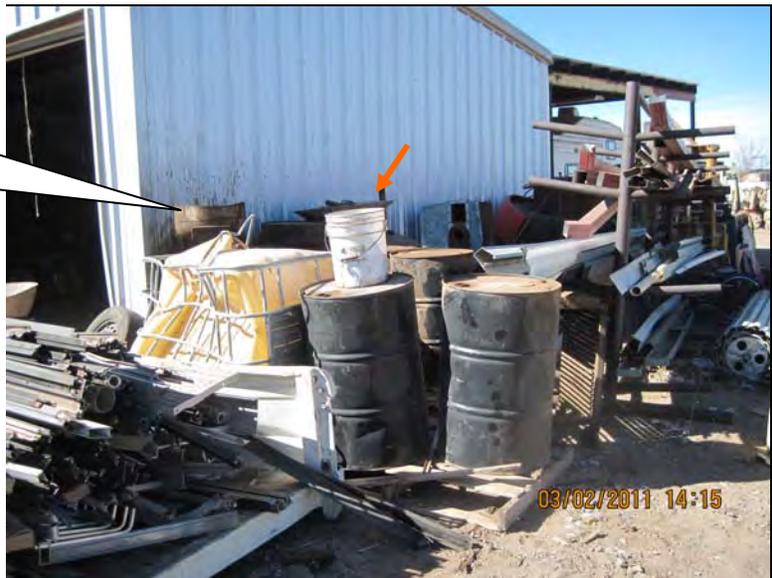
Waste oil tank outside shop and stains on exterior wall

NMED/SWQB Official Photograph Log Photo # 4		
Photographer: Erin Trujillo	Date: 03/02/2011	Time: 1415 Hours
City/County: Clovis / Curry County		State: New Mexico
Location: Clovis Recycling		
Subject: Oil stains existed on wall behind tank shown in previous photo. Waste oil drums were stored on pallets. Arrow points to open bucket that was partially filled with what appeared to be waste oil sitting on top of drum.

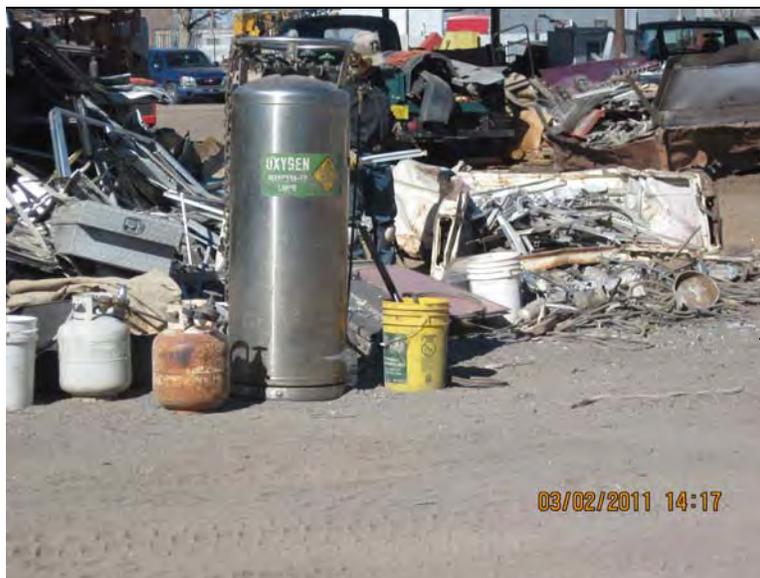
Smaller metal fragments on ground near cutting area

NMED/SWQB Official Photograph Log Photo # 5		
Photographer: Erin Trujillo	Date: 03/02/2011	Time: 1417 hours
City/County: Clovis / Curry County		State: New Mexico
Location: Clovis Recycling		
Subject: Metal cutting was occurring on site during the inspection in this area. Bins or equivalent were not provided in this area to contain smaller metal fragments that were observed on ground.

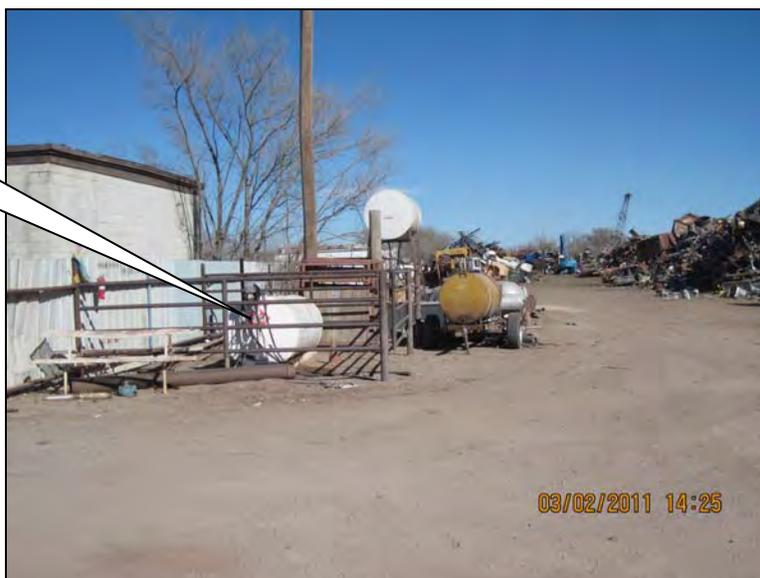
Active fuel storage tank

NMED/SWQB Official Photograph Log Photo # 6		
Photographer: Erin Trujillo	Date: 03/02/2011	Time: 1425 hours
City/County: Clovis / Curry County		State: New Mexico
Location: Clovis Recycling		
Subject: Metal barriers/fencing had been placed around fuel storage tank to protect the tank from vehicle traffic. Tank did not have secondary containment. Other storage tanks shown in photo were not used according to on-site operator representative.

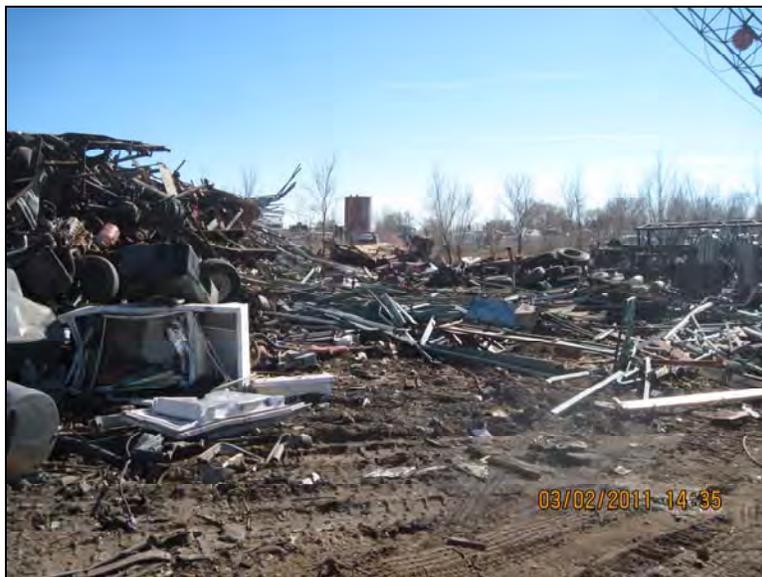
NMED/SWQB Official Photograph Log Photo # 7		
Photographer: Erin Trujillo	Date: 03/02/2011	Time: 1435 hours
City/County: Clovis / Curry County		State: New Mexico
Location: Clovis Recycling		
Subject: Example of scrap and waste storage area in southwest portion of site and high traffic area.

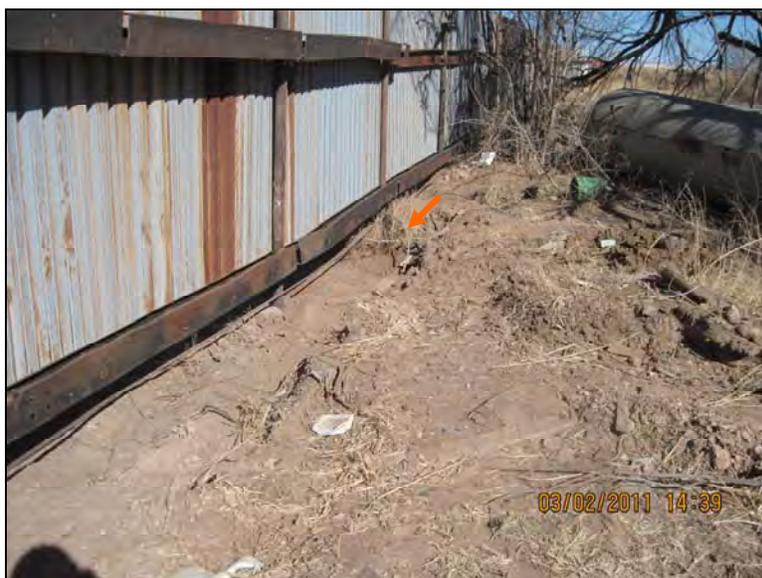
NMED/SWQB Official Photograph Log Photo # 8		
Photographer: Erin Trujillo	Date: 03/02/2011	Time: 1439 hours
City/County: Clovis / Curry County		State: New Mexico
Location: Clovis Recycling		
Subject: Arrow points to example of gap at bottom of fence and erosion in northeast corner of facility. No erosion or sediment control measures were located along the north facility boundary fence.
