**Re: Municipal Industrial; SIC 4941; NPDES Reconnaissance Evaluation Inspection; NMU001727;
March 28, 2011**

NPDES Compliance Inspection Report

Reconnaissance Evaluation Inspection
Rio Pueblo de Taos Well Field
NMU001727
March 28, 2011

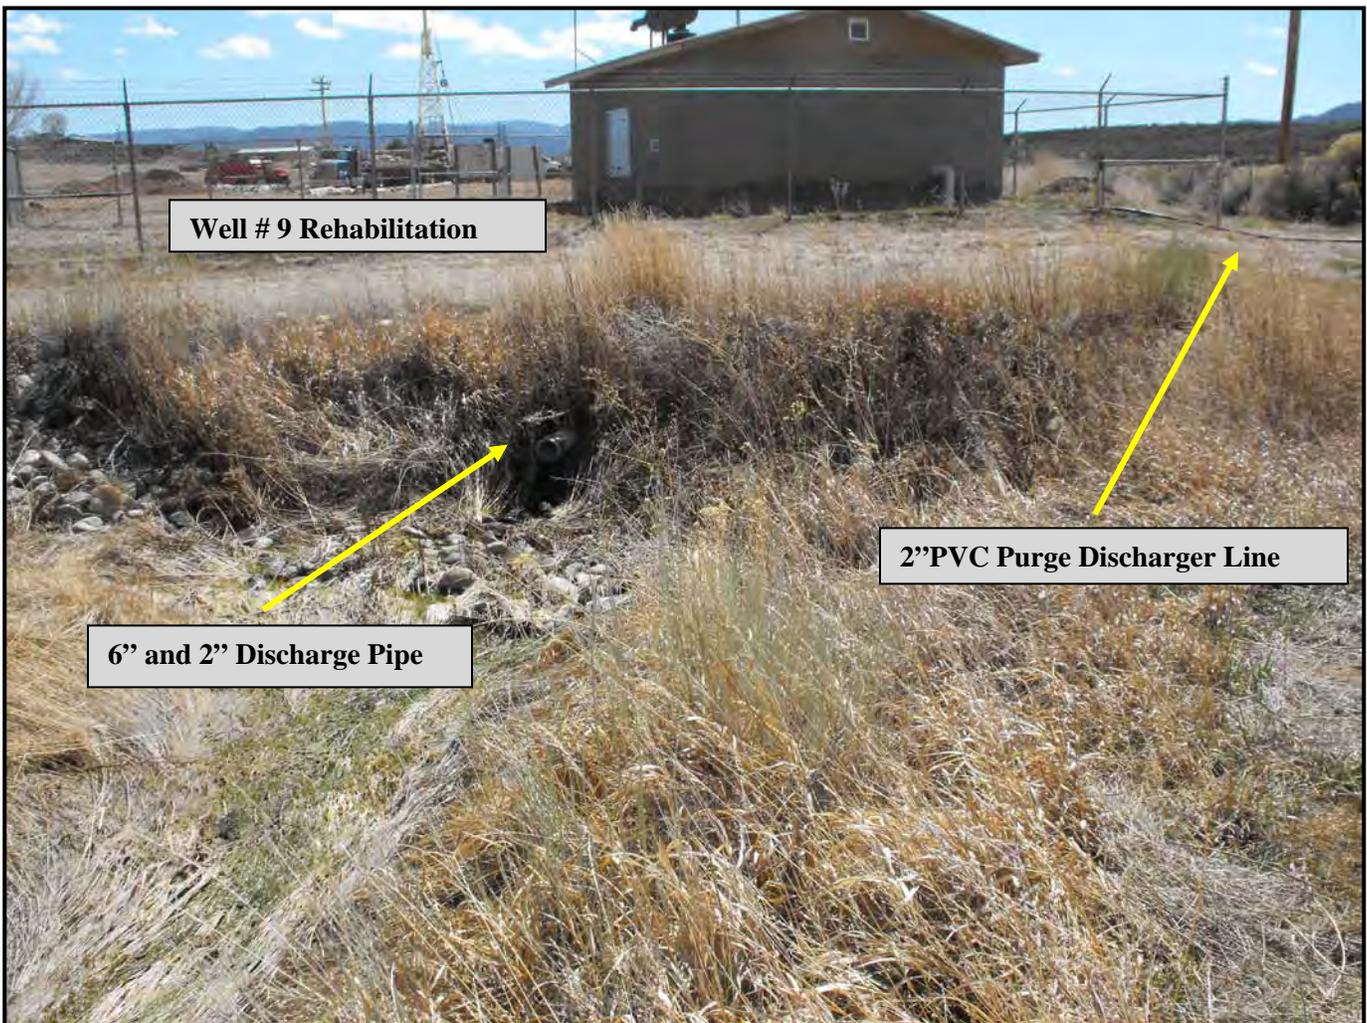
Photo 1

Photographer: Daniel Valenta	Date: 3/28/2011	Time: 1228 hours
City/County: Taos/Taos County		
Location: Rio Pueblo de Taos Well Field, approximately 5 miles southwest of the Town of Taos, facing south.		
Subject: Discharge lines from the pumping well house.

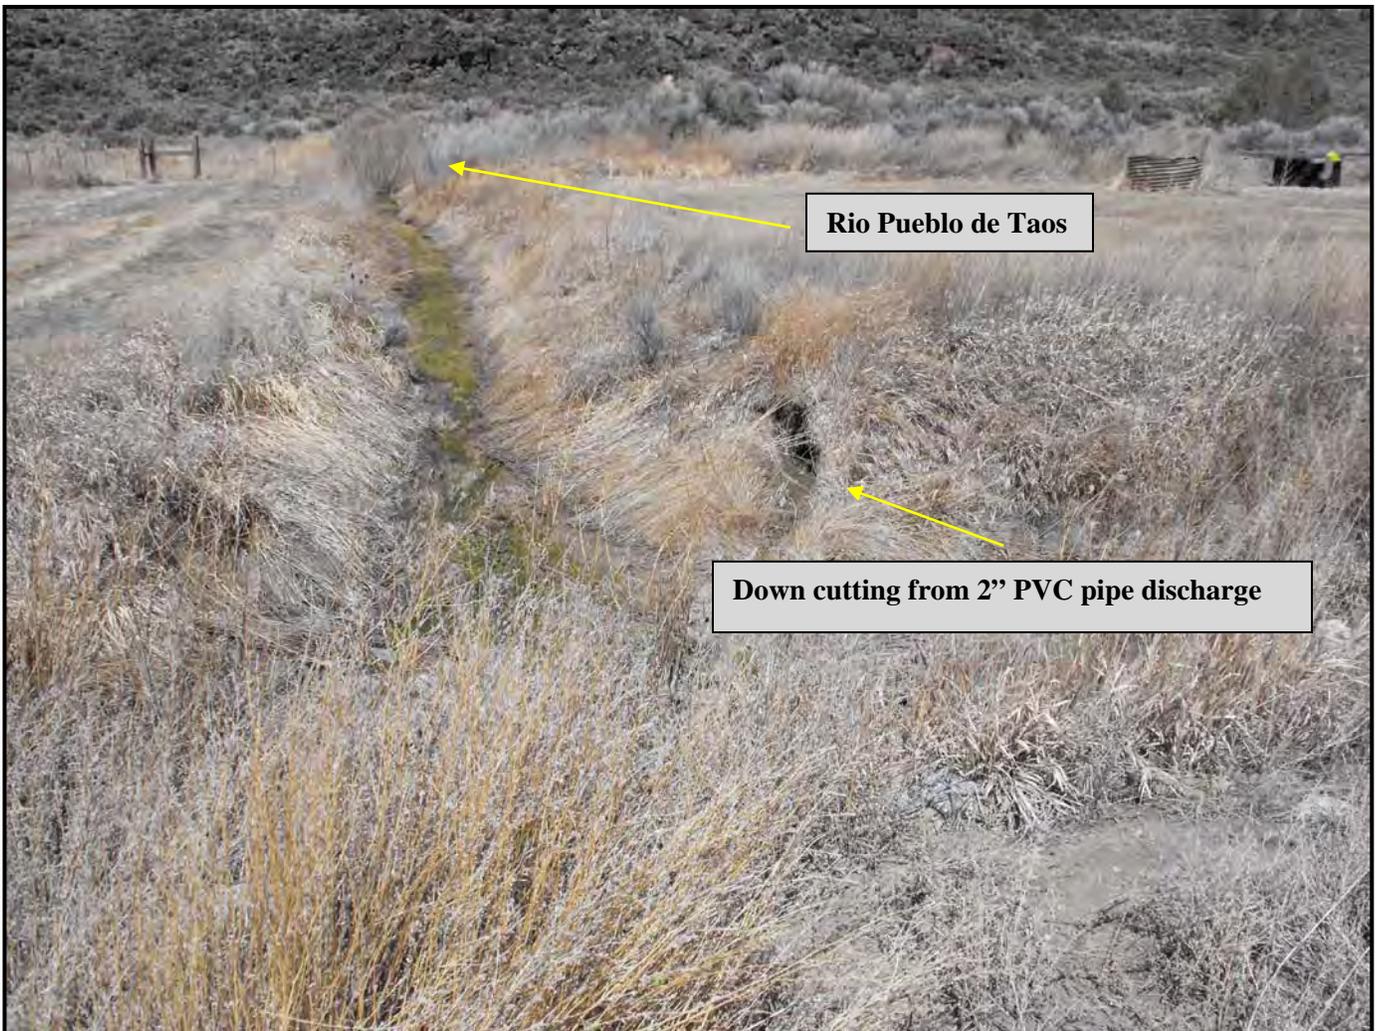
Photo 2

Photographer: Daniel Valenta	Date: 3/28/2011	Time: 1230 hours
City/County: Taos/Taos County		
Location: Rio Pueblo de Taos Well Field, approximately 5 miles southwest of the Town of Taos, facing north.		
Subject: Discharge channel from the pumping well house.

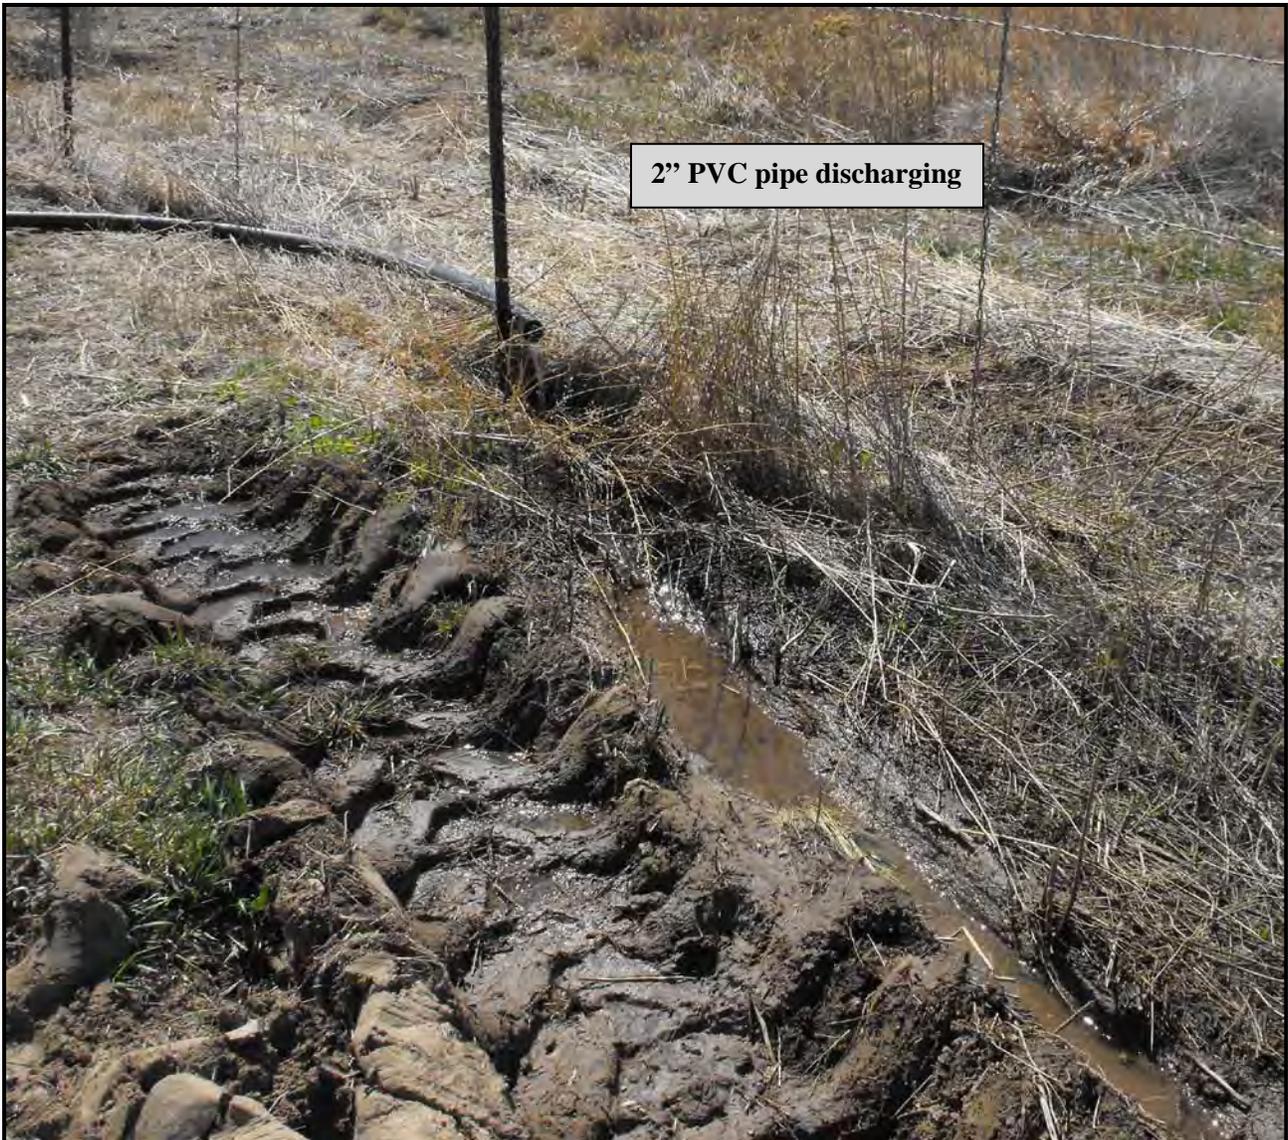
Photo 3

The Town of Taos has an enclosed well house on the north side of the site. From the back side of the building, north side, a 6" PVC pipe emerges and appears to discharge a short distance from the building into a channel that discharges to the Rio Pueblo de Taos, (see photo 1). Alongside the 6" PVC pipe discharge is a 2" PVC pipe. The 2" black PVC pipe discharges with such velocity it has down cut into the ground (see photo 2). A second 2" black PVC pipe coming from the side of the building was discharging but did not appear to flow into the channel or to the stream. The second 2" pipe discharged for the two hours the inspectors were at the site, inspectors were told this was purge water, (see photo 3).

Photographer: Daniel Valenta	Date: 3/28/2011	Time: 1227 hours
City/County: Taos/Taos County		
Location: Rio Pueblo de Taos Well Field, approximately 5 miles southwest of the Town of Taos, facing southwest.		
Subject: 2" PVC pipe discharging to field, discharge flows toward the Rio Pueblo de Taos.

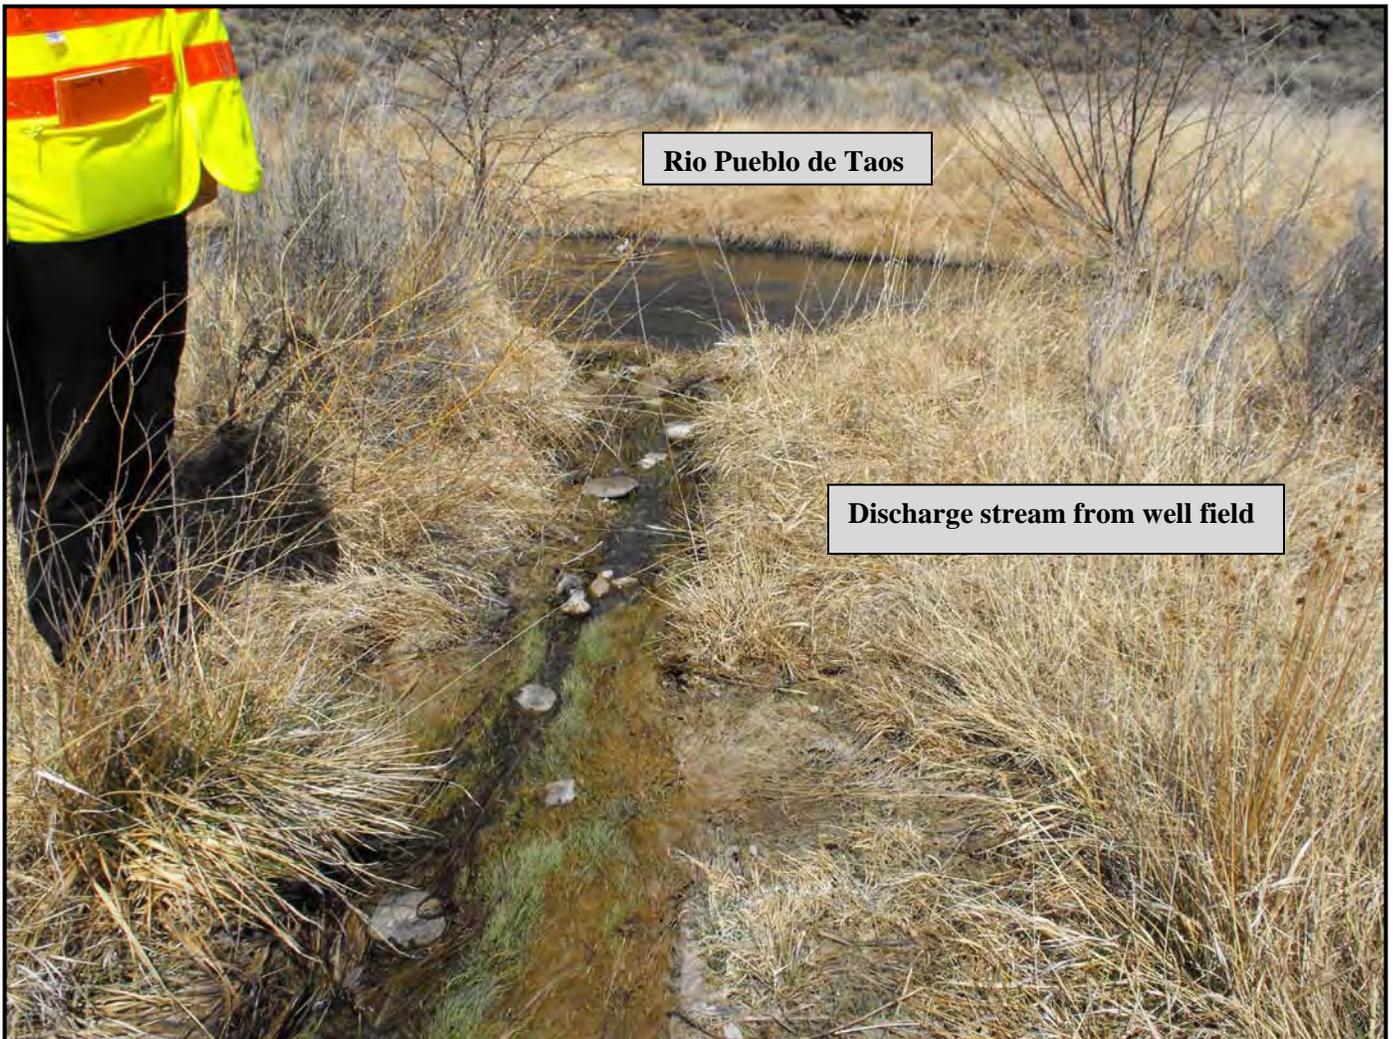
Photo 4

Photographer: Daniel Valenta	Date: 3/28/2011	Time: 1208 hours
City/County: Taos/Taos County		
Location: Rio Pueblo de Taos Well Field, approximately 5 miles southwest of the Town of Taos, facing north.		
Subject: Stream of water discharging from the well field.
