Re: Minor Industrial, SIC 4941, NPDES Compliance Evaluation Inspection, Rio Rancho Well #17 Purge Operations, NMU001733,
May 24, 2011

NPDES Compliance Inspection Report

**Compliance Evaluation Inspection
Rio Rancho Well #17 Purge Discharge
May 24, 2011**

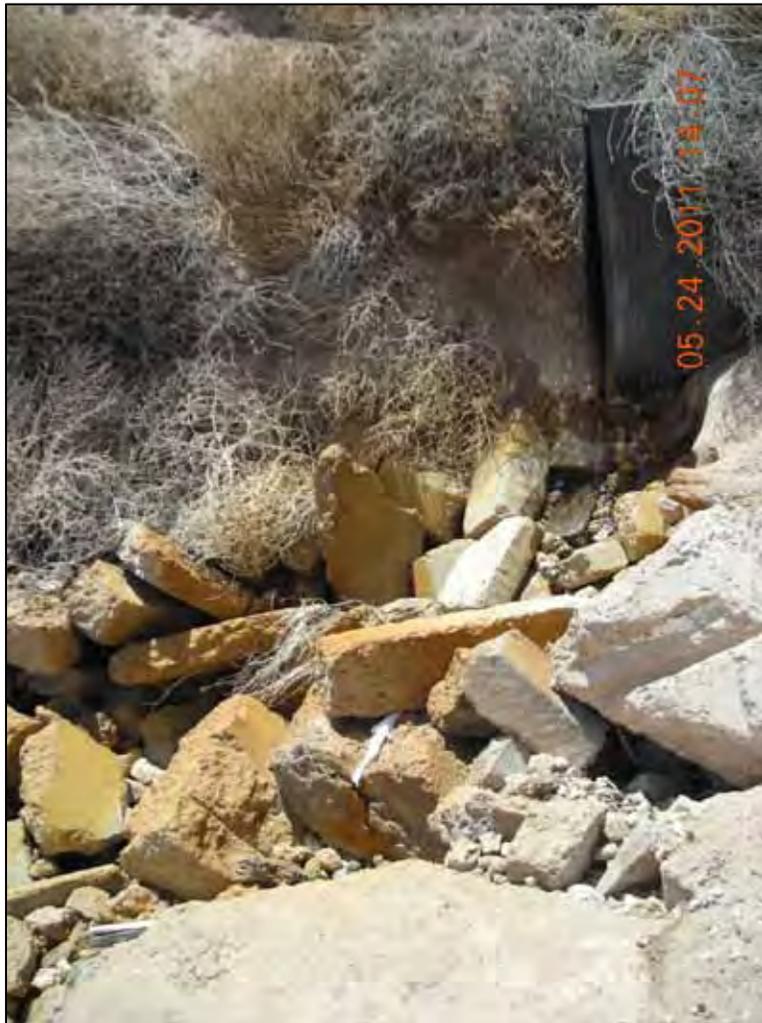
NMED/SWQB
Official Photograph Log
Photo # 1

During the inspection, it was noted that the arsenic treatment facility was started up in March of 2010. During that process, the contract engineer was fine tuning the arsenic treatment system and accidentally discharged ferric chloride to the arroyo. According to the facility representatives, this was an isolated incident and the staining observed in the arroyo was due to this incident. The city did not report the spill to NMED or EPA.

Photographer: Sarah Holcomb	Date: 5-24-2011	Time: 1407 hours
City/County: Rio Rancho/Sandoval County		
Location: Well #17 Outfall		
Subject: Outfall pipe from Well #17 into the arroyo. Rocks are discolored from a discharge of ferric chloride in March 2010.

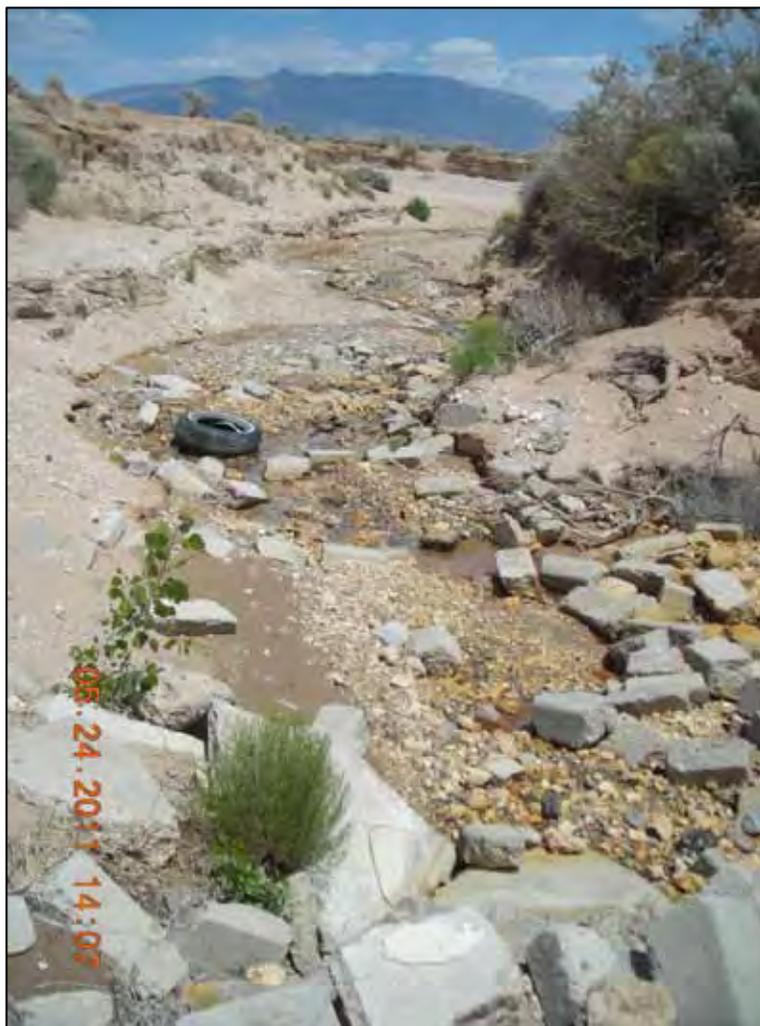
NMED/SWQB
Official Photograph Log
Photo # 2

Photographer: Sarah Holcomb	Date: 5-24-2011	Time: 1407 hours
City/County: Rio Rancho/Sandoval County		
Location: Well #17 Outfall

Subject: Arroyo being discharged to (outfall is behind the photographer). Some discoloration of the rocks is due to the fact that it is old concrete once used as curbing (now being used as rip rap to prevent erosion), which was once painted yellow.

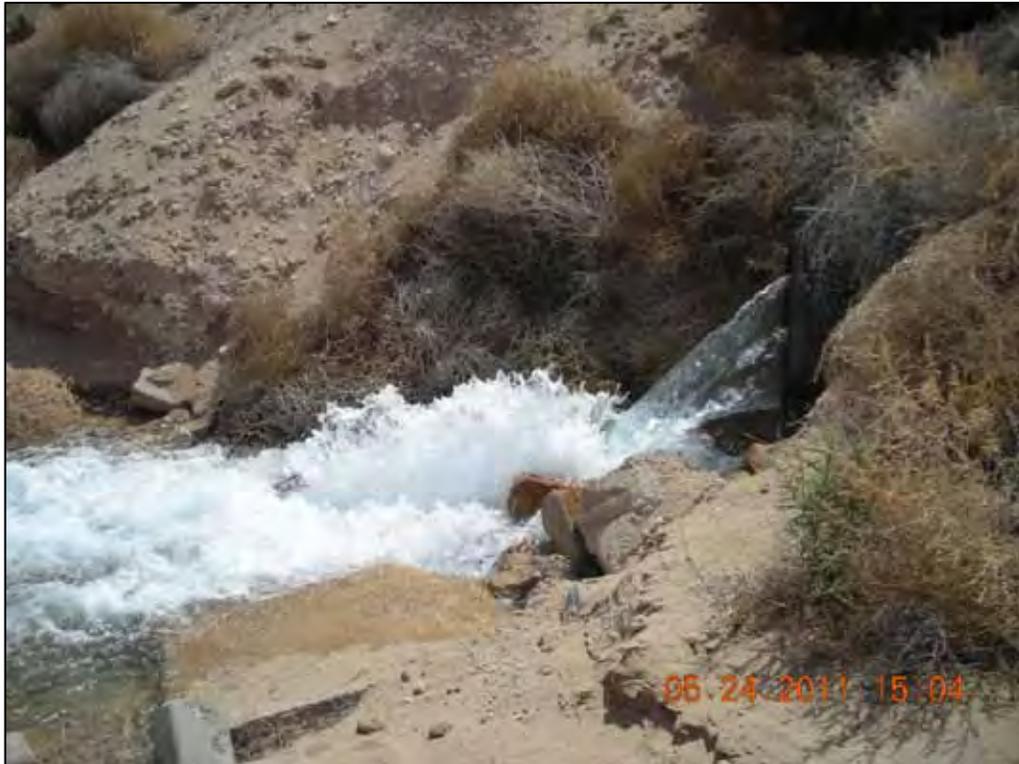
NMED/SWQB
Official Photograph Log
Photo # 3

The inspector asked the facility representatives to run through a typical purge cycle during the inspection. When they did so, it was evident that the check valve was in place, and that the water being discharged was not being treated with any sort of the chemical prior to its exit from the facility. Please see attached photos.

Photographer: Sarah Holcomb	Date: 5-24-2011	Time: 1504 hours
City/County: Rio Rancho/Sandoval County		
Location: Well #17 Outfall		
Subject: Active discharge from the purge cycle.

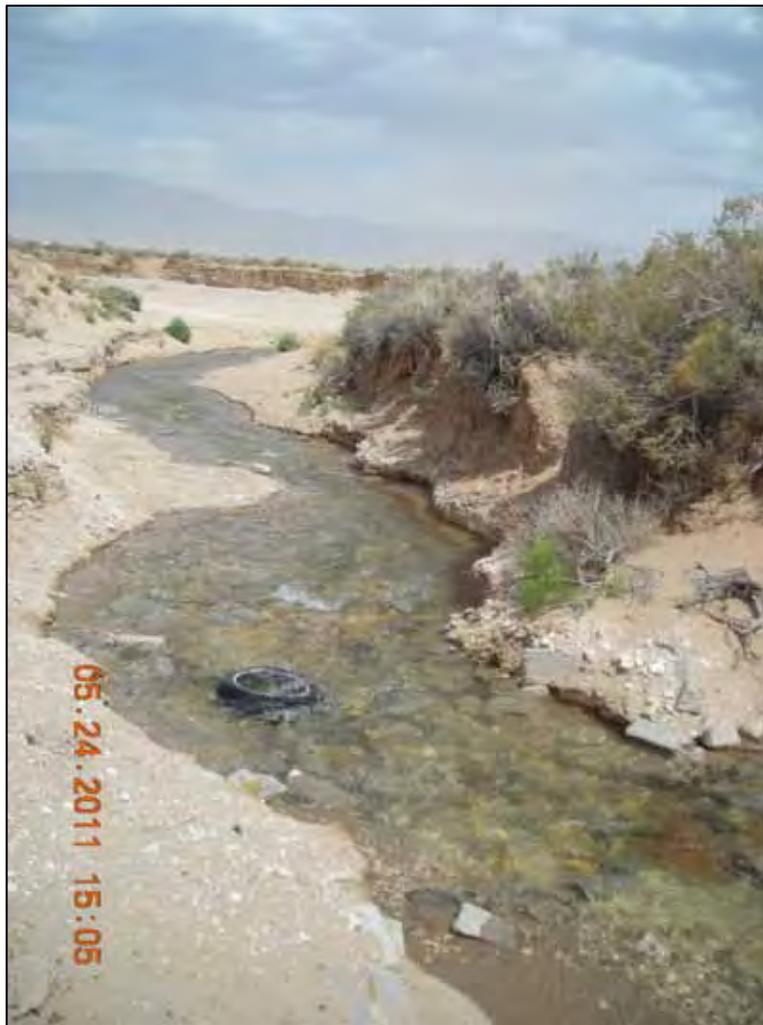
NMED/SWQB
Official Photograph Log
Photo # 4

This facility did not have NPDES permit coverage for the discharge of purge water from Well #17 on the date of this inspection. This well has a regular discharge resulting in approximately 33,600 gallons of ground water per day being discharged to the arroyo. The water makes it into the Black Arroyo (part of the Southern Sandoval County Arroyo Flood Control Authority conveyance system), but on the day of this inspection, did not appear to make it past a retention pond a few miles east of the discharge. However, the discharge could have the potential to make it to the Rio Grande during storm events.

Photographer: Sarah Holcomb	Date: 5-24-2011	Time: 1504 hours
City/County: Rio Rancho/Sandoval County		
Location: Well #17 Outfall		
Subject: Arroyo during active discharge.
