RE: Construction Storm Water; SIC 1611; NPDES Compliance Evaluation; Dollar General Retail Store; NMU001734; May 12, 2011

NPDES Compliance Inspection Report

NMED/SWQB
Site Overview

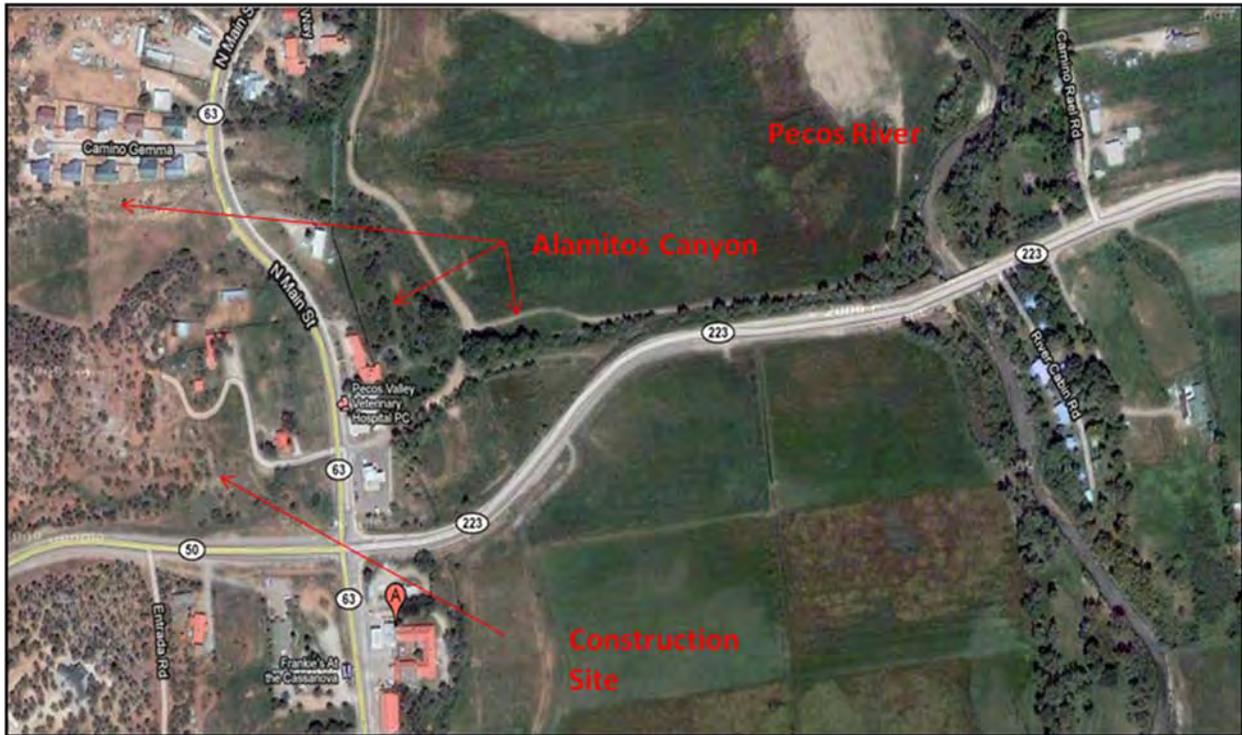
City/County: Pecos/San Miguel County	
Location: NM State Hwy 50/223 & NM State Hwy 63	
Subject: Overview of construction site and surface waters.

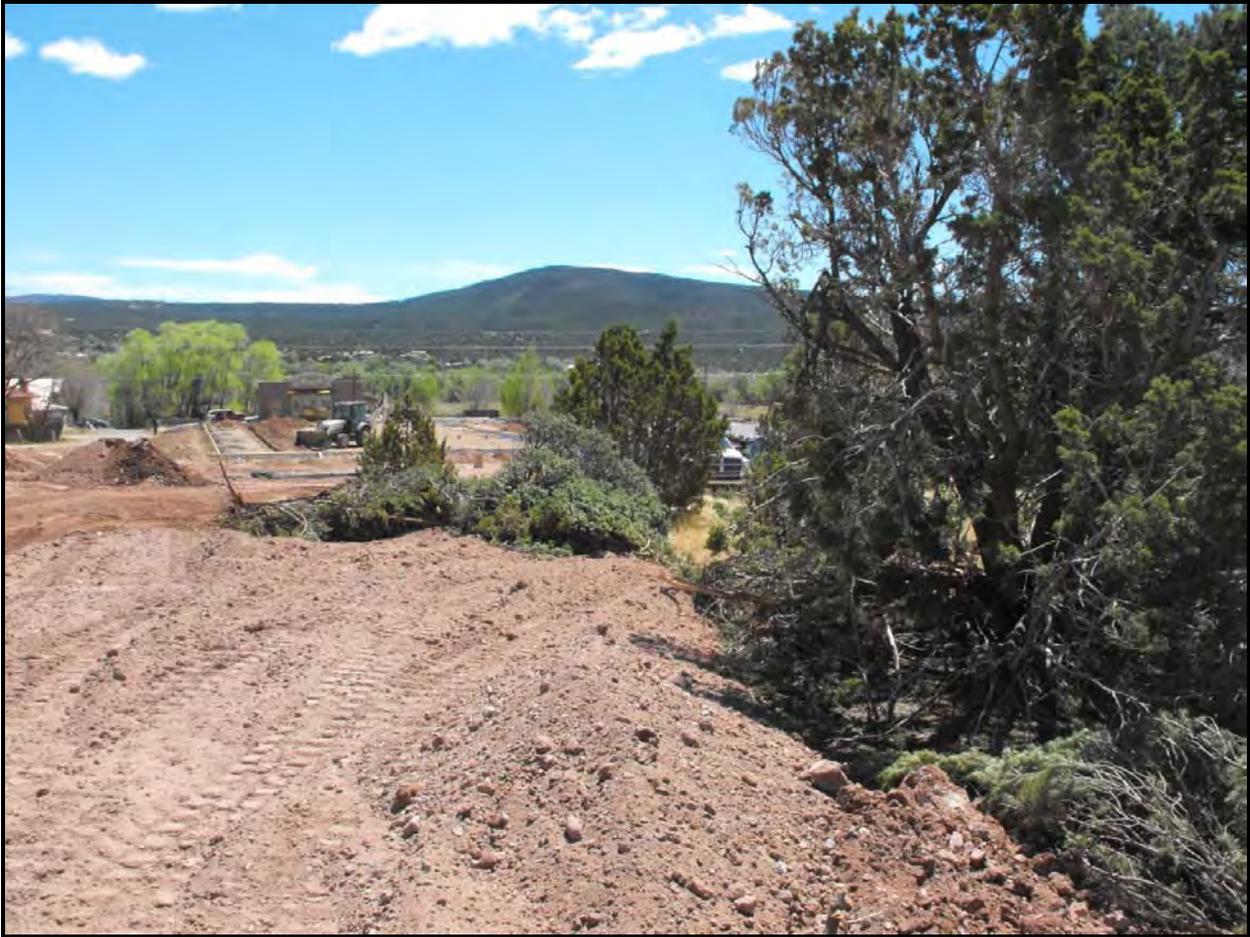
Photo # 1

Photographer: Daniel Valenta	Date: 5/12/11	Time: 1135 hours
City/County: Pecos/San Miguel County		
Location: Northwest corner of NM State Hwy 50/223 & NM State Hwy 63, Pecos, New Mexico		
Subject: Site of Dollar General store, preparing site for pouring foundation, picture taken facing east.

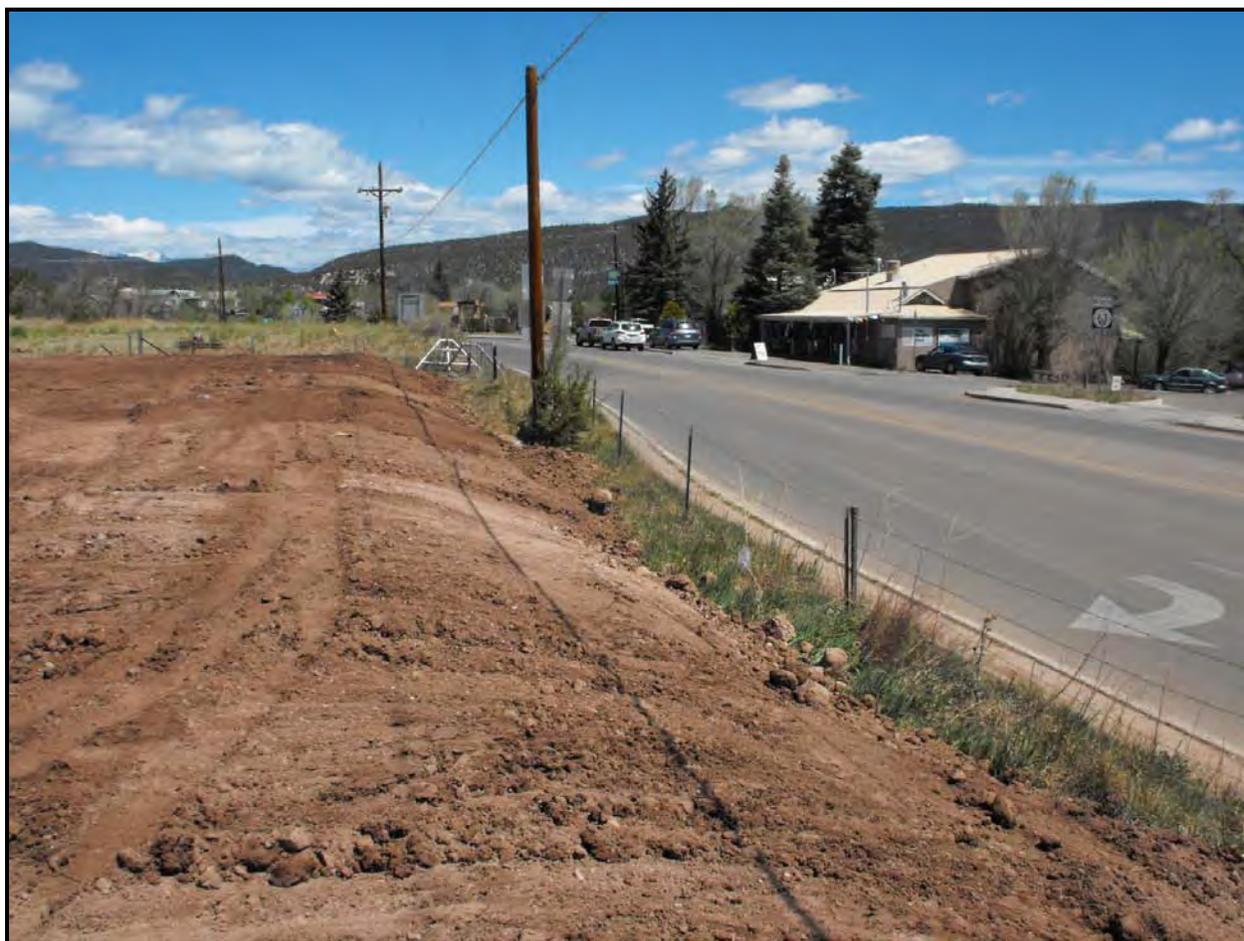
Photo # 2

None of these BMP's was on site the day of the inspection, (see photos).

Photographer: Daniel Valenta	Date: 5/12/11	Time: 1127 hours
City/County: Pecos/San Miguel County		
Location: Northwest corner of NM State Hwy 50/223 & NM State Hwy 63, Pecos, New Mexico. Picture taken facing north.		
Subject: East side of the property facing State Hwy 63, no BMP's as described in SWPPP to contain sediment from leaving the construction site.

Problems noted during this inspection are discussed in the attached further explanations. You are encouraged to review the inspection report; and required to correct any problems noted during the inspection and to modify your operational and/or administrative procedures, as appropriate. Further, you are encouraged to notify in writing, both USEPA (Marcia Adams, 6EN-AS, USEPA, 1445 Ross Avenue, Dallas, Texas 75202-2733) and NMED Surface Water Quality Bureau Program Manager (address above) regarding modifications and compliance schedules.

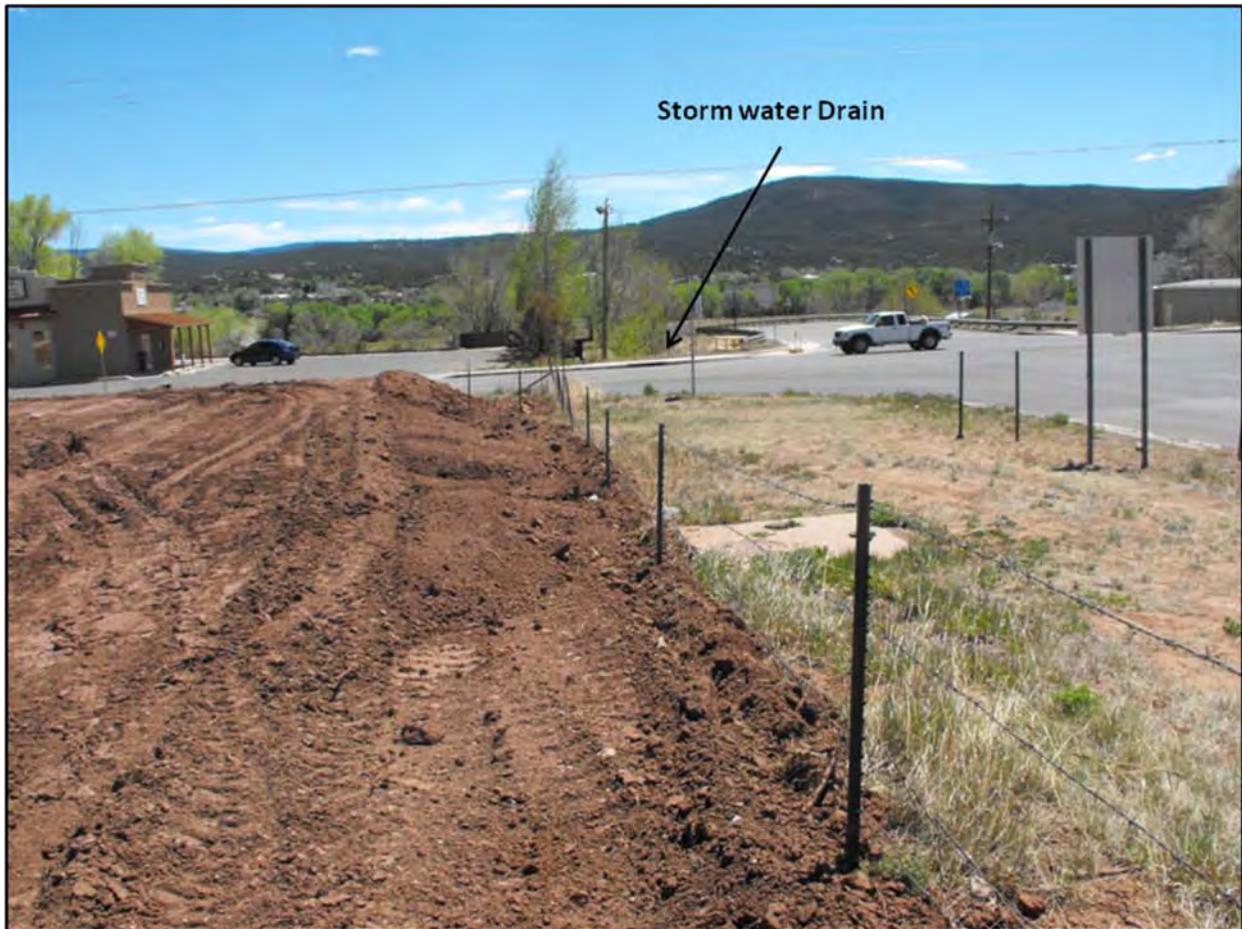
Photo # 3

Photographer: Daniel Valenta	Date: 5/12/11	Time: 1126 hours
City/County: Pecos/San Miguel County		
Location: Northwest corner of NM State Hwy 50/223 & NM State Hwy 63, Pecos, New Mexico. Picture taken facing east.		
Subject: South side of the property facing State Hwy 63, no BMP's as described in SWPPP to contain sediment from leaving the construction site.

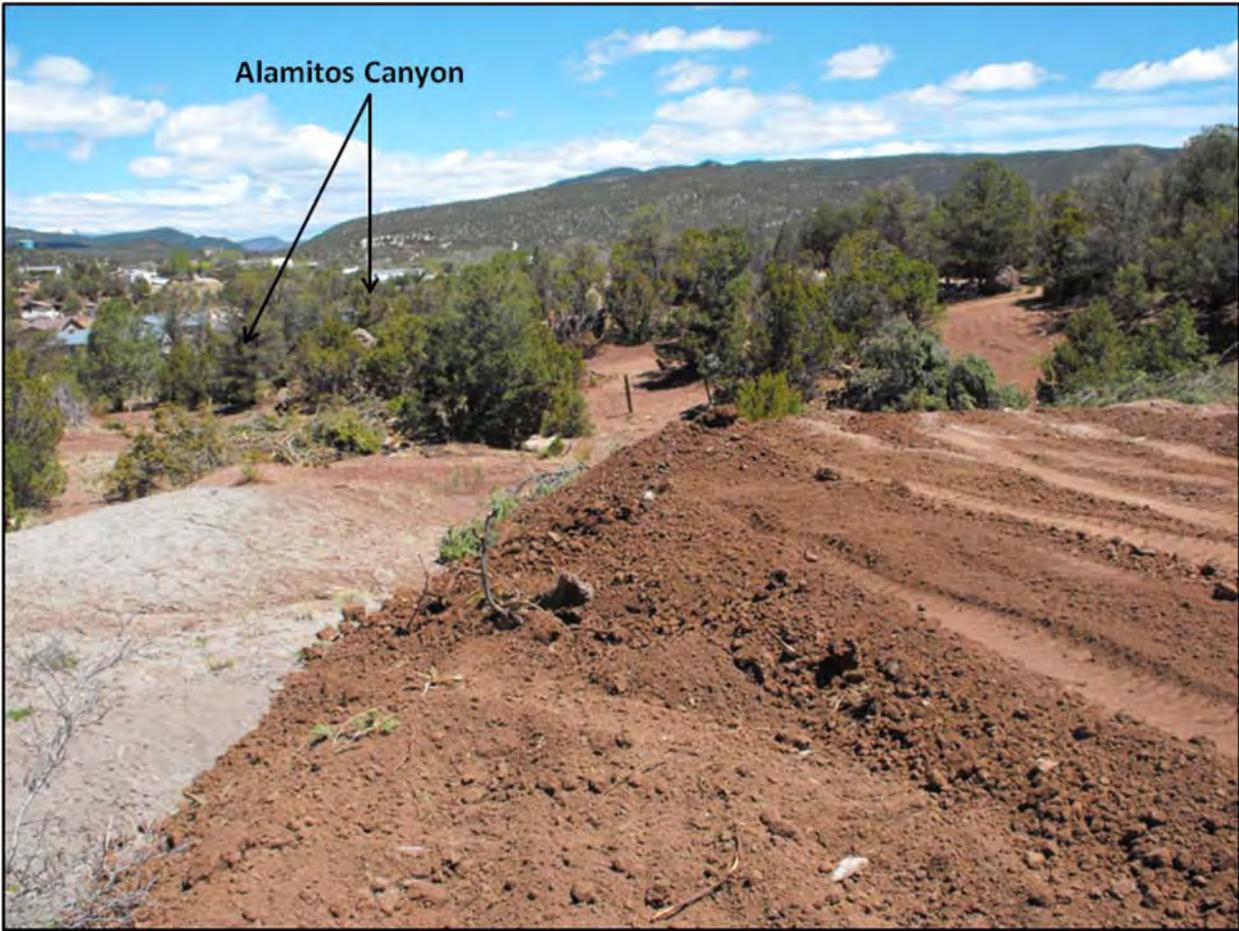
Photo # 4

Photographer: Daniel Valenta	Date: 5/12/11	Time: 1126 hours
City/County: Pecos/San Miguel County		
Location: Northwest corner of NM State Hwy 50/223 & NM State Hwy 63, Pecos, New Mexico. Picture taken facing east.		
Subject: North side of the property facing Alamitos Canyon, no BMP's as described in SWPPP to contain sediment from leaving the construction site.
