RE: Construction Storm Water, SIC 1542, NPDES Compliance Evaluation Inspection, New Mexico Highlands University Student Union, NMU001738, June 9, 2011

NPDES Industrial Storm Water Worksheet (Construction)

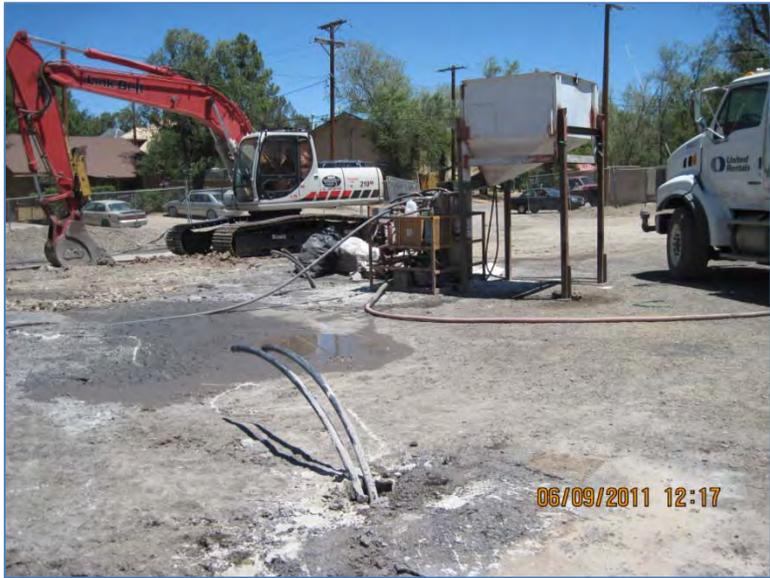
NMED/SWQB Official Photograph Log Photo #1		
Photographer: Erin S. Trujillo	Date: 06/09/2011	Time: 1217 hours
City/County: Las Vegas / San Miguel County		State: New Mexico
Location: New Mexico Highlands University, Student Union, Geothermal Well Drilling Area		
Subject: Pulvarized cuttings, grout and sand at surface.

SWPPP Implementation <i>(complete in field)</i>	
Stabilization Practices	
<p>List and describe stabilization practices <i>ESO Element 42, 48</i></p>	<p><i>(e.g., seeding, mulching, geotextiles, sod stabilization)</i></p> <p><u>Student Union</u>: Stabilization had occurred in the areas with vertical construction. Some artificial grass where runoff was anticipated had not been disturbed.</p> <p><u>Off-Site Support Area (Equipment Staging/Material Storage)</u>: Most existing vegetation in the off-site equipment staging and material storage area at the corner of Reynolds Avenue and 9th Street had been preserved which provided stabilization. Mulching that existed at this off-site support activity area prior to construction also remained. However, an excavated material stockpile in the off-site support activity area had not been stabilized.</p> <p><u>Geothermal Well Drilling Area</u>: Gravel of the former parking lot provided stabilization. The portion of the area where drilling had occurred was disturbed and pulverized cuttings were at the surface.</p>

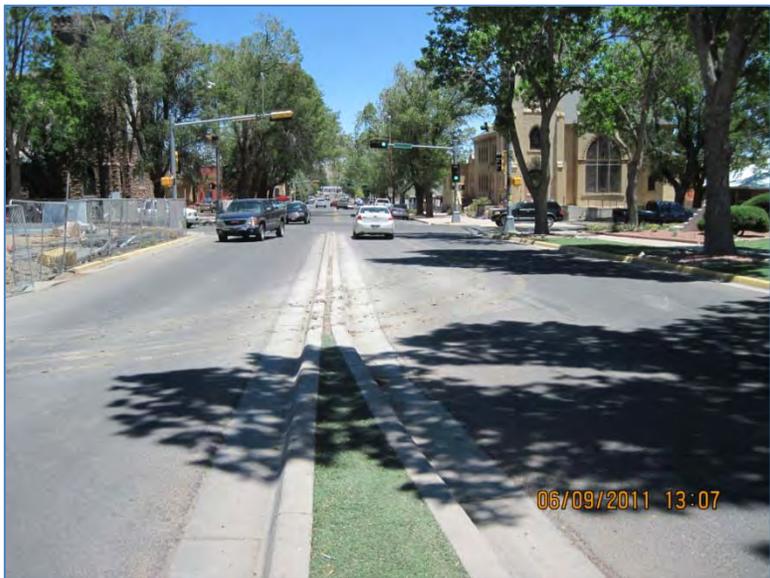
NMED/SWQB Official Photograph Log Photo #2		
Photographer: Erin S. Trujillo	Date: 06/09/2011	Time: 1307 hours
City/County: Las Vegas / San Miguel County		State: New Mexico
Location: New Mexico Highlands University, Student Union, Building Construction Area		
Subject: Vehicle tracking at exit/entrance shown in next photo.

<u>Non-Structural Practices</u>	
<p>Street Cleaning ESO Element 43</p>	<p><i>(e.g., describe measures taken to remove offsite accumulation of sediment)</i></p> <p>Inspection logs refer to sweeping drive. Off-site accumulation of sediment/mud needed to be removed at a temporary exit at the Student Union construction area. The temporary exit was not noted on the site map.</p>
<p>Good Housekeeping & Waste Disposal Practices ESO Element 44</p>	<p><i>(e.g., describe measures taken to prevent litter and debris from becoming a pollutant source)</i></p> <p>No windblown litter or trash was observed. Most materials were protected from precipitation or stormwater (stored on pallets or stored in covered shipping containers). Trash and recycled materials were disposed and stored in roll offs. Off-site disposal and removal of recycled materials conducted routinely according to on-site owner/operators' representatives.</p>

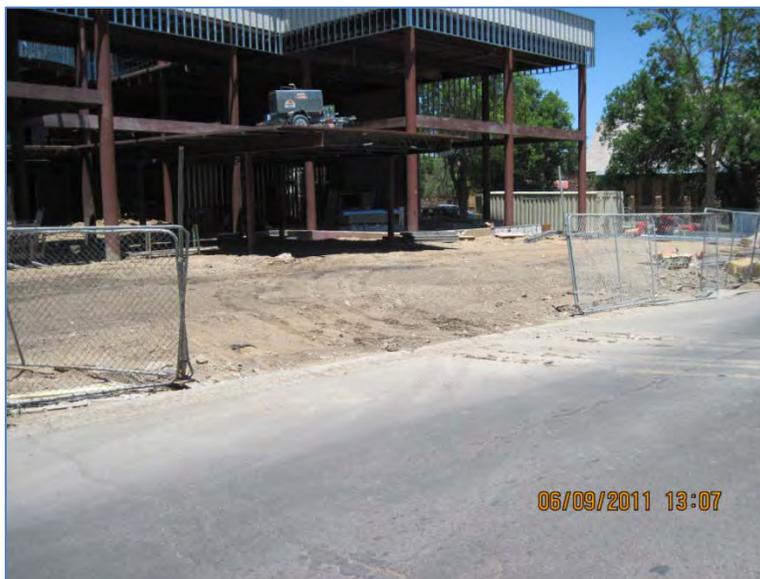
NMED/SWQB Official Photograph Log Photo # 3		
Photographer: Erin S. Trujillo	Date: 06/09/2011	Time: 1307 hours
City/County: Las Vegas / San Miguel County		State: New Mexico
Location: New Mexico Highlands University, Student Union, Building Construction Area		
Subject: No vehicle tracking control measures observed at exit/entrance. On-site mud is from watering for dust control according to owner/operators' on-site representatives.

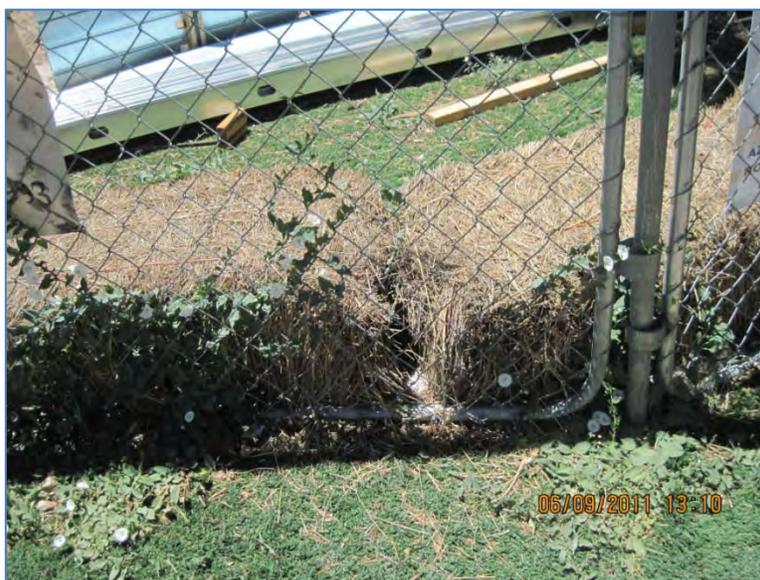
NMED/SWQB Official Photograph Log Photo # 4		
Photographer: Erin S. Trujillo	Date: 06/09/2011	Time: 1310 hours
City/County: Las Vegas / San Miguel County		State: New Mexico
Location: New Mexico Highlands University, Student Union, Building Construction Area		
Subject: Gap in bale. Artificial grass and vegetation was preserved in this area.

<u>Structural Practices</u>	
<p>List and describe structural controls ESO Element 41, 42, 46</p>	<p><i>(e.g., silt fences, hay bales, storm drain inlet protection, sedimentation pond, rip rap, check dam, diversion structure, off-site vehicle track-out)</i></p> <p>Student Union: Details on how hay or straw bales would be linked and anchored to the ground was not provided in the SWPPP. Hay bales and straw wattles were placed where runoff was anticipated, but these control measures had small gaps and were not overlapped.</p> <p>Geothermal Well Drilling Area: Coarse gravel berm, hale bales and wattle at this area were not sufficient to contain discharges of process waters and pulverized drilling cuttings on site. Therefore, additional measures may also be needed for stormwater discharges in the disturbed areas and material storage in this area.</p> <p>Off-Site Support Area (Equipment Staging/Material Storage Area): Except for the excavated material stockpile, the preservation of vegetation appeared to be sufficient to control erosion. However, additional pollution prevention measures including track-out control may be needed if access or disturbance is anticipated when removing the equipment, materials and perimeter fencing.</p>
