RE: Industrial Stormwater; SIC 2951, NPDES Compliance Evaluation Inspection; FNF New Mexico, Airport Hot Plant; NPDES Permit No. NMU001740; June 22, 2011

NPDES Multi-Sector General Permit Compliance Evaluation Inspection
FNF New Mexico, Inc. – Airport Hot Plant
NPDES Tracking #NMU001740

Further Explanations

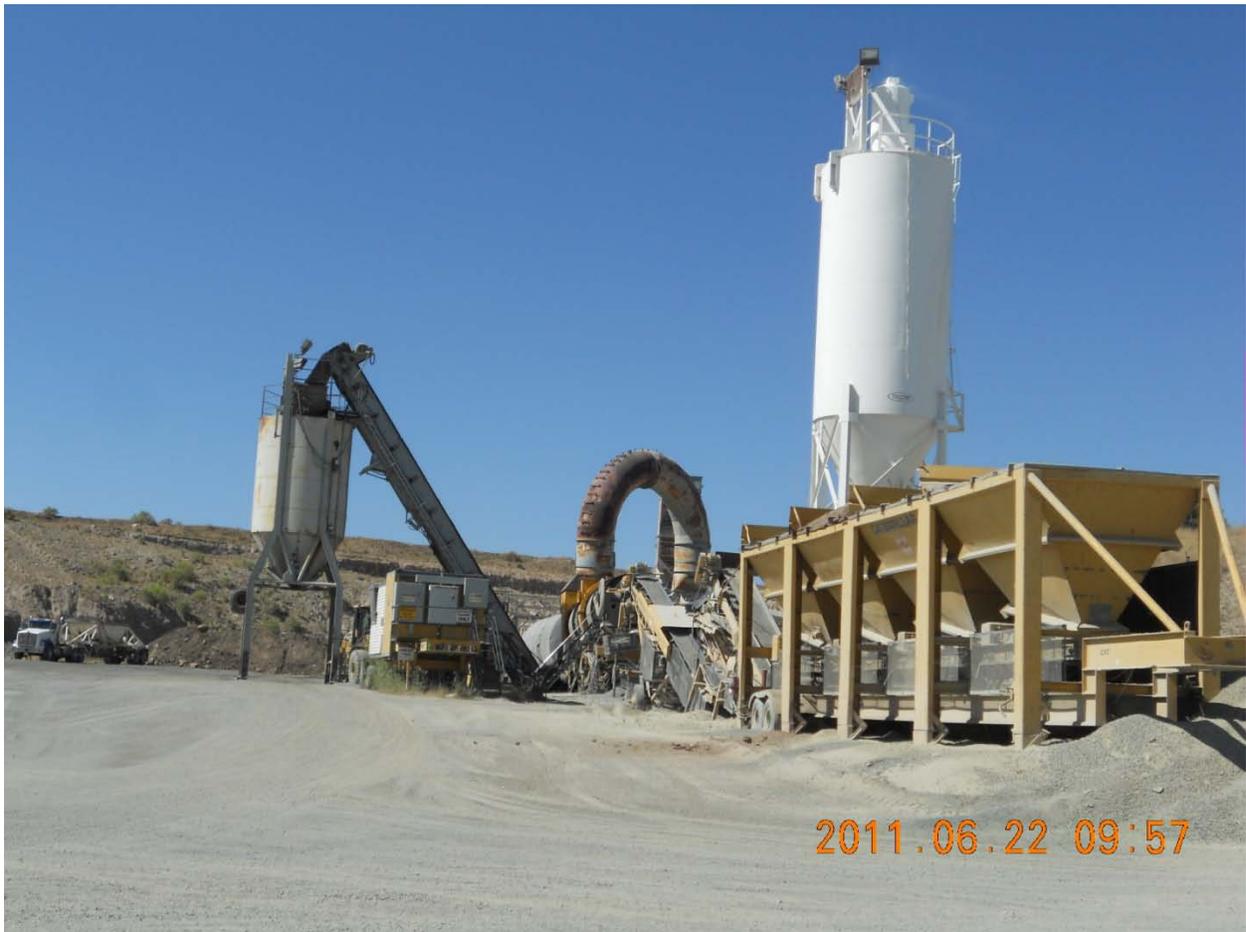
NMED/SWQB
Official Photograph Log
Photo # 1

Photographer: Sandra Gabaldón	Date: June 22, 2011	Time: 0957
City/County: Ruidoso / Lincoln County		State: New Mexico
Location: Airport Hot Plant		
Subject: Airport Hot Plant Process Equipment

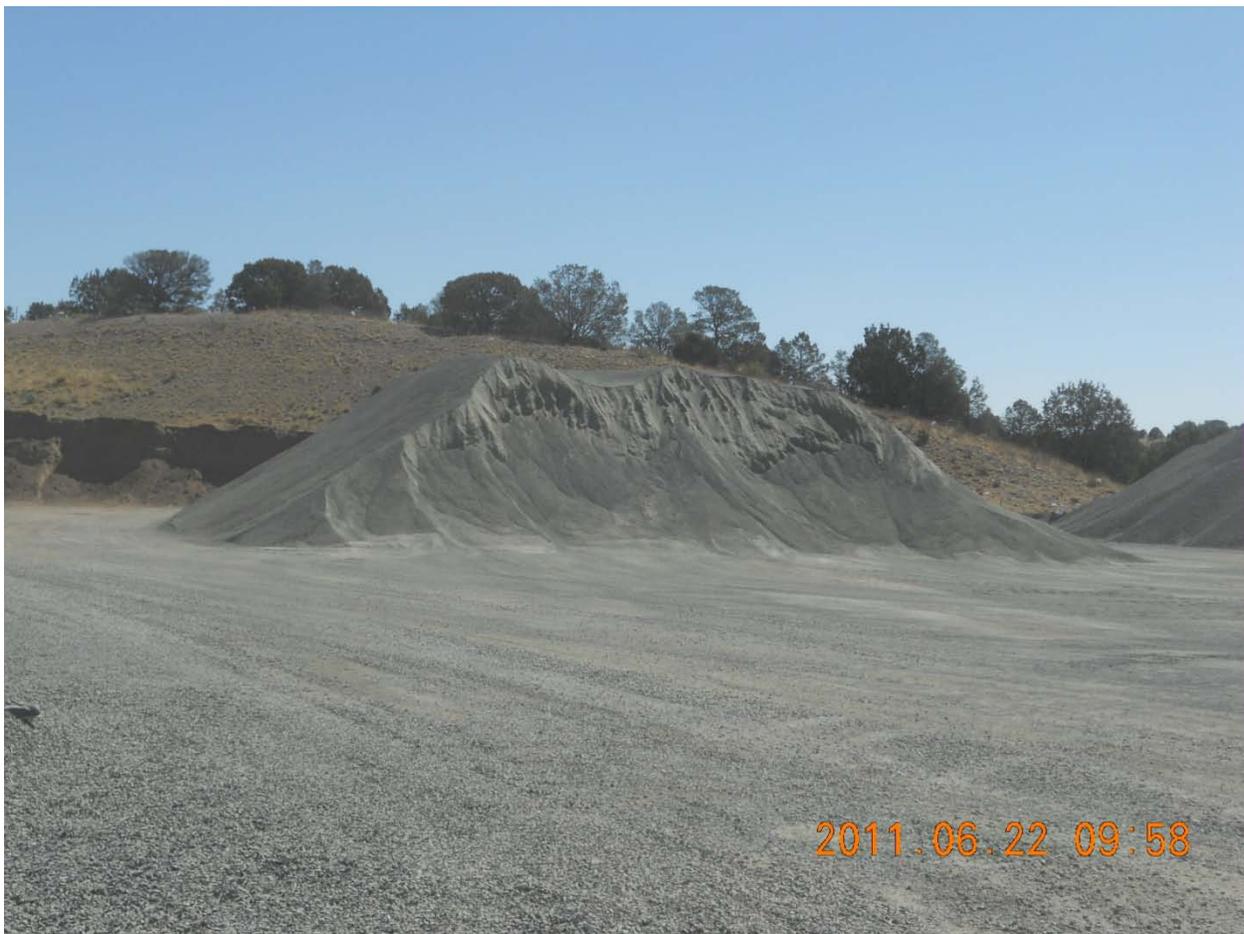
NMED/SWQB
Official Photograph Log
Photo # 2

Photographer: Sandra Gabaldón	Date: June 22, 2011	Time: 0958
City/County: Ruidoso / Lincoln County		State: New Mexico
Location: Airport Hot Plant		
Subject: Northeast corner of property – Stockpile of raw material

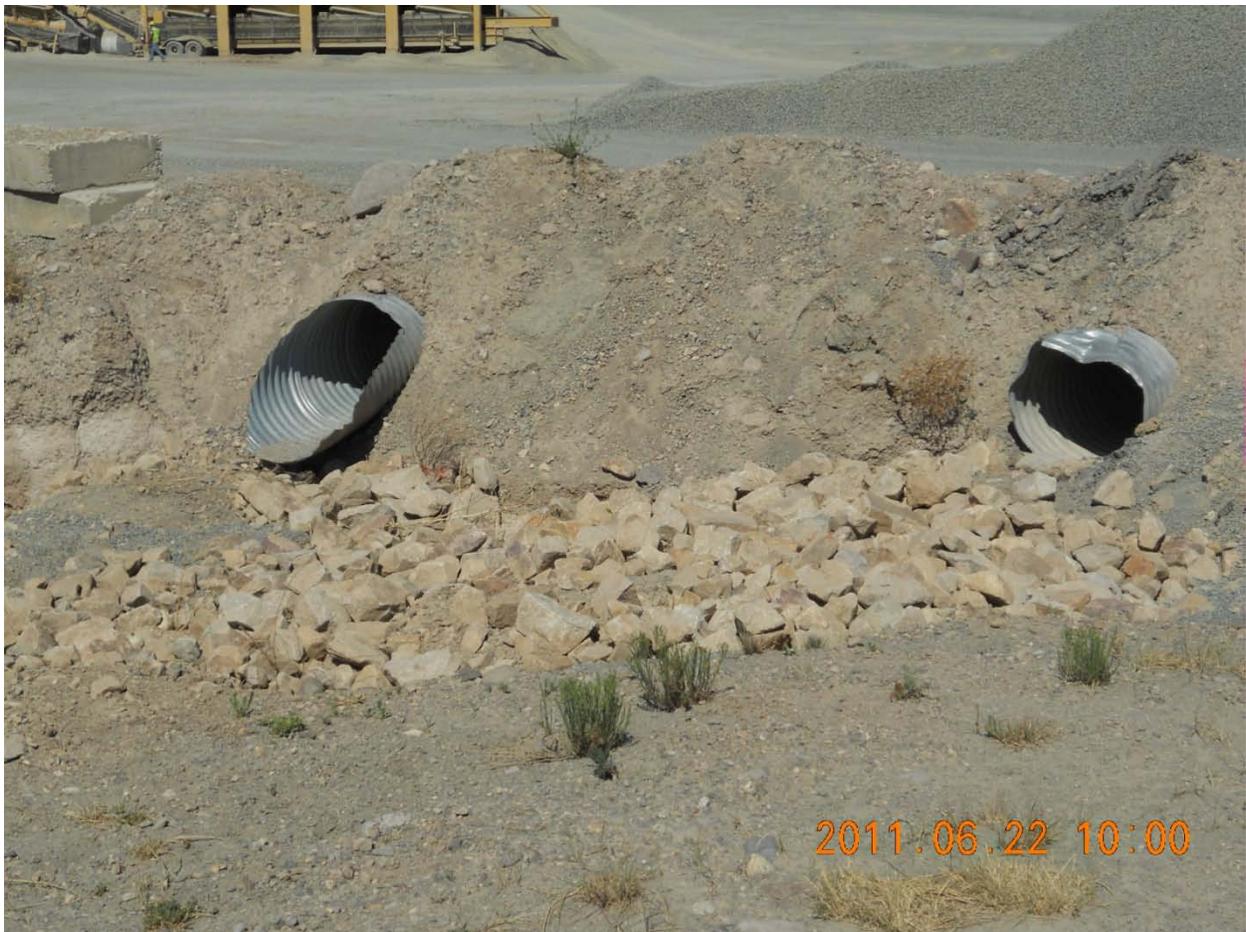
**NMED/SWQB
Official Photograph Log
Photo # 3**

Photographer: Sandra Gabaldón	Date: June 22, 2011	Time: 1000
City/County: Ruidoso / Lincoln County		State: New Mexico
Location: Airport Hot Plant		
Subject: Culverts leading to unnamed arroyo in the east corner of the property.

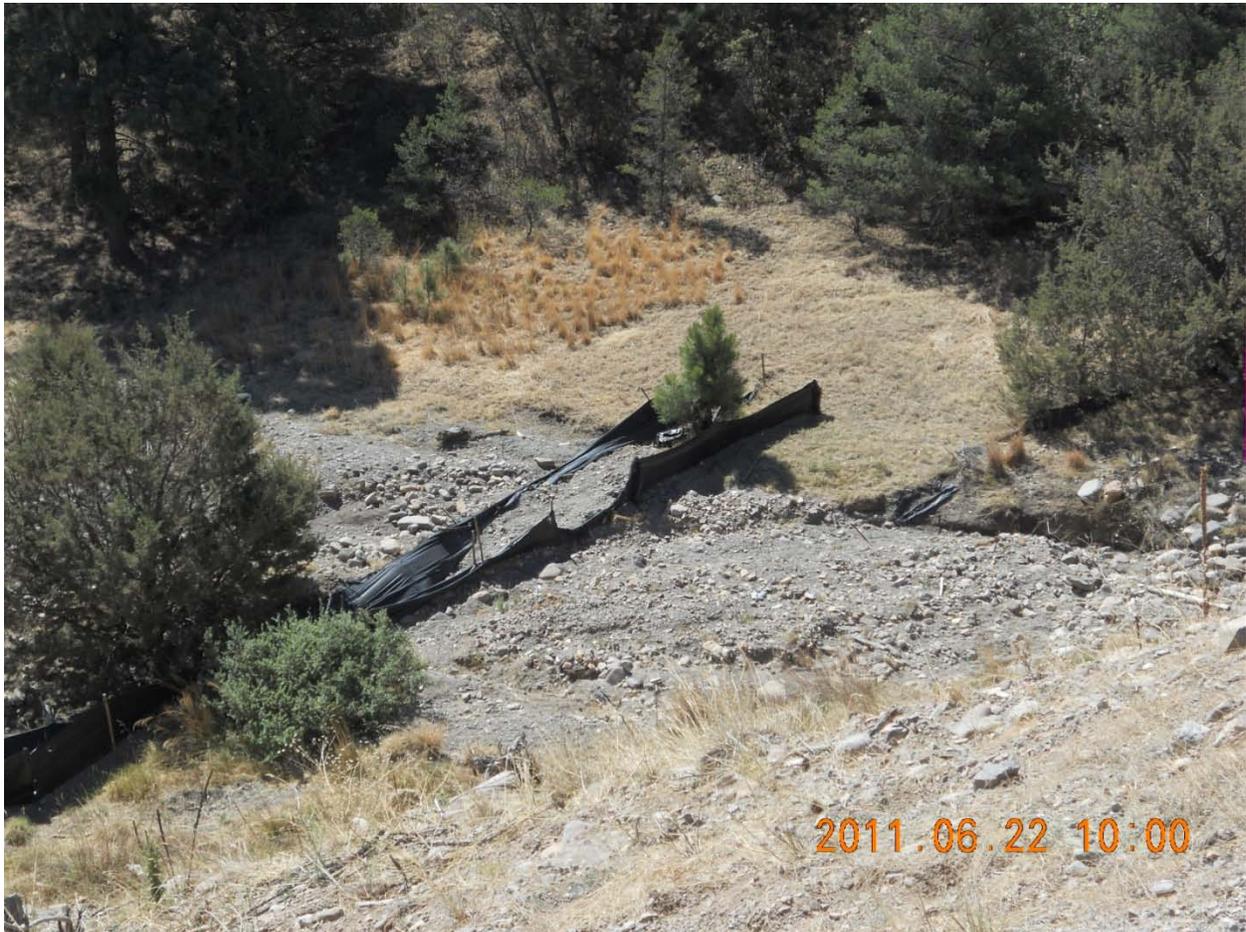
**NMED/SWQB
Official Photograph Log
Photo #4**

Photographer: Sandra Gabaldón	Date: June 22, 2011	Time: 1000
City/County: Ruidoso / Lincoln County		State: New Mexico
Location: Airport Hot Plant		
Subject: Silt fencing below the culverts in the previous picture.
