**RE:** Industrial Storm Water, SIC 1499, NPDES Compliance Evaluation Inspection Morningstar Minerals Corporation / Humate Mill and Manufacturing Facility, Farmington, NMU001745, June 28, 2011

### NPDES Compliance Inspection Report

**Morningstar Minerals Corporation - Humate Mill and Manufacturing Facility**  
**NMU001745**  
**Compliance Evaluation Inspection – Industrial Stormwater**  
**June 28, 2011**

**NMED/SWQB  
Official Photograph Log  
Photo # 1**

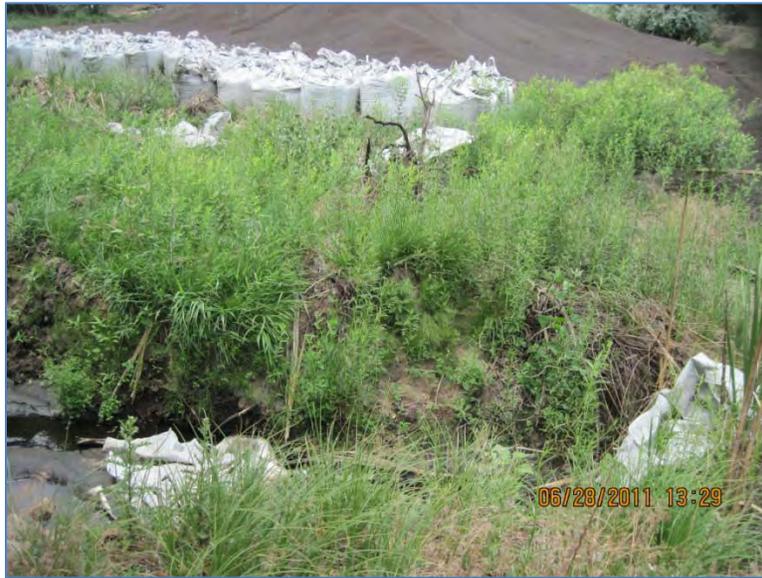
Photographer: Erin S. Trujillo	Date: 06/28/2011	Time: 1329 hours
City/County: Farmington / San Juan County	State: New Mexico	
Location: Morningstar Minerals Corporation Mill and Manufacturing Facility		
Subject: Mill's agricultural soil conditioner storage area shown in background. Vegetative buffer was not sufficient to prevent humate from entering trench from dust/runoff. Humate storage bags also observed in trench.

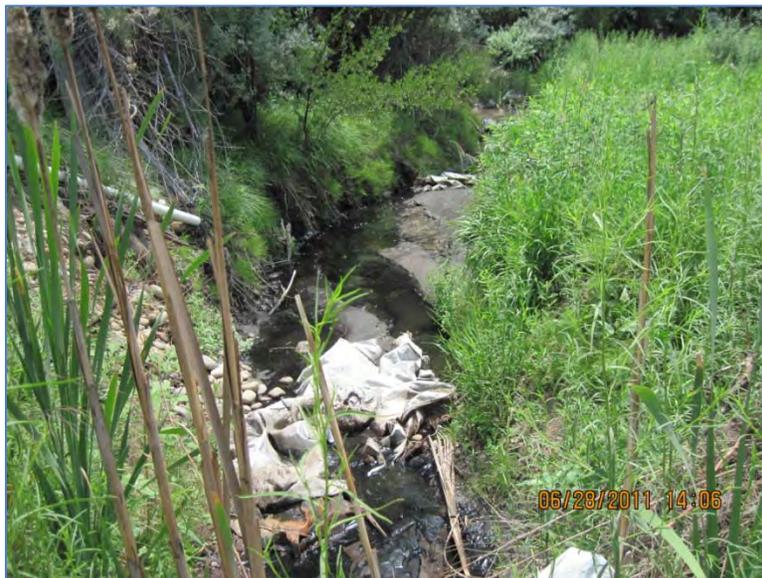
**NMED/SWQB  
Official Photograph Log  
Photo # 2**

Photographer: Erin S. Trujillo	Date: 06/28/2011	Time: 1406 hours
City/County: Farmington / San Juan County	State: New Mexico	
Location: Morningstar Minerals Corporation Mill and Manufacturing Facility		
Subject: Trench along mill's storage area boundary. Black solids in trench is humate from dust/runoff. Humate storage bags also observed in trench.

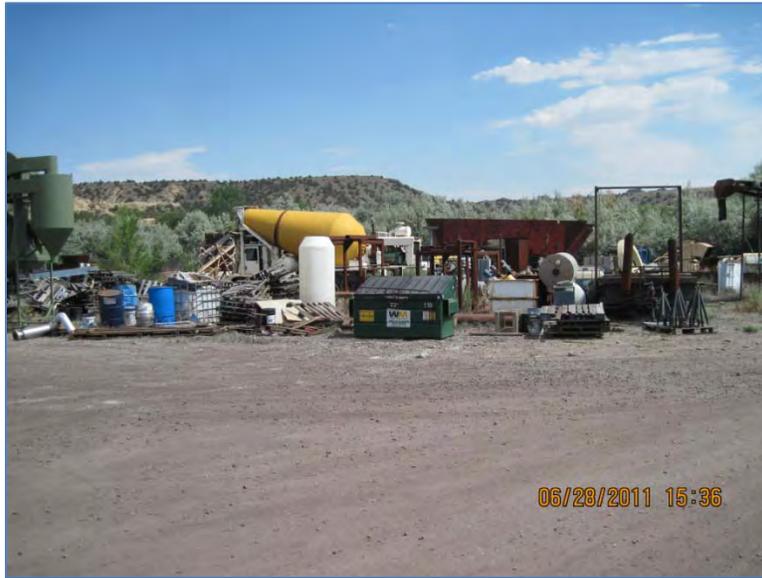
**NMED/SWQB  
Official Photograph Log  
Photo # 3**

Photographer: Erin S. Trujillo	Date: 06/28/2011	Time: 1536 hours
City/County: Farmington / San Juan County	State: New Mexico	
Location: Morningstar Minerals Corporation Mill and Manufacturing Facility		
Subject: Example of equipment and material storage area. Waste dumpster was on site. Drums and containers in this photo were stored on pallet.

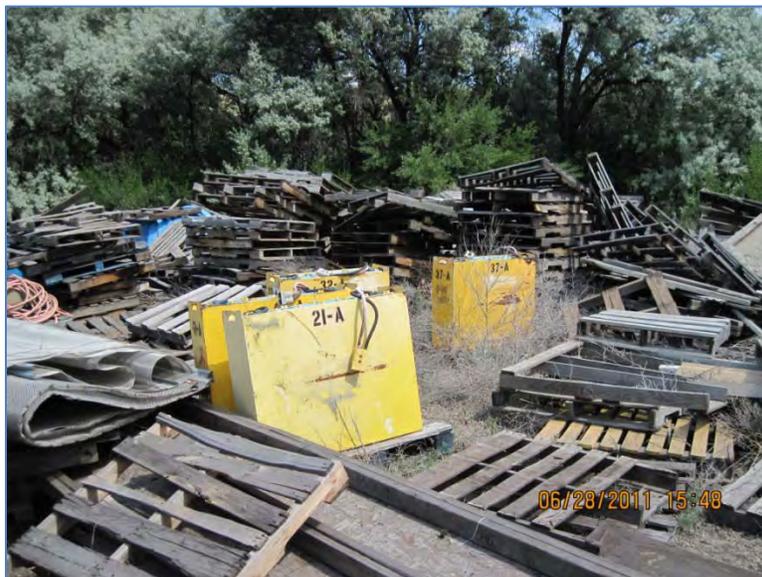
**NMED/SWQB  
Official Photograph Log  
Photo # 4**

Photographer: Erin S. Trujillo	Date: 06/28/2011	Time: 1548 hours
City/County: Farmington / San Juan County	State: New Mexico	
Location: Morningstar Minerals Corporation Mill and Manufacturing Facility		
Subject: Lead batteries stored on pallets, but not in storm resistant shelter.

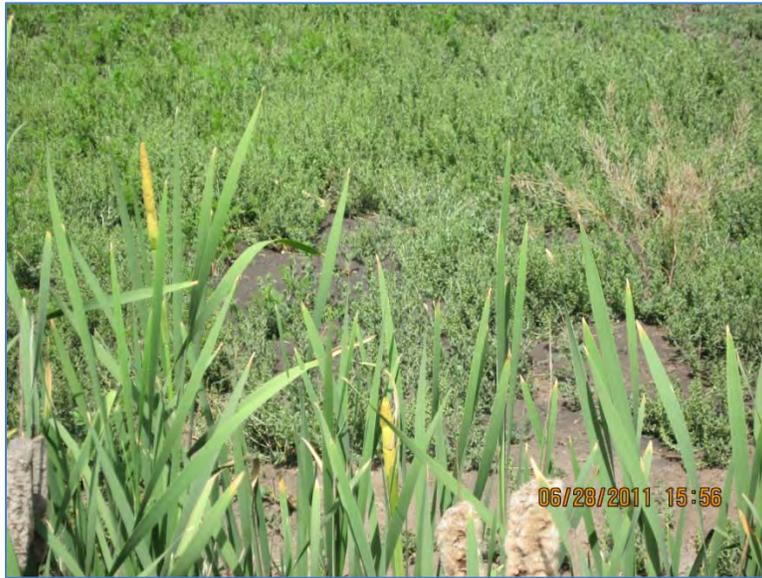
NMED/SWQB  
Official Photograph Log  
Photo # 5

Photographer: Erin S. Trujillo	Date: 06/28/2011	Time: 1556 hours
City/County: Farmington / San Juan County	State: New Mexico	
Location: Morningstar Minerals Corporation Mill and Manufacturing Facility		
Subject: Dark solids observed on adjacent property. Cattails in foreground of photo are along an irrigation lateral that runs along the south-southeast property boundary.

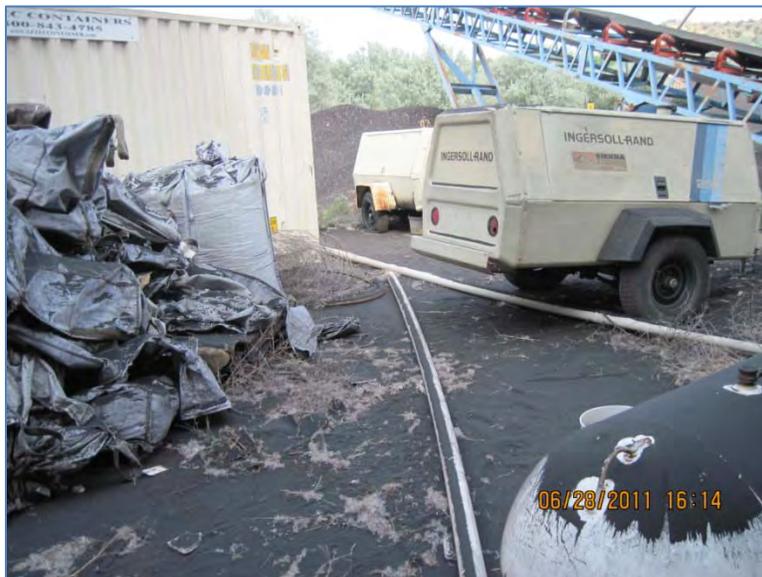
NMED/SWQB  
Official Photograph Log  
Photo # 6

Photographer: Erin S. Trujillo	Date: 06/28/2011	Time: 1614 hours
City/County: Farmington / San Juan County	State: New Mexico	
Location: Morningstar Minerals Corporation Mill and Manufacturing Facility		
Subject: Example of humate on ground and coating surfaces.

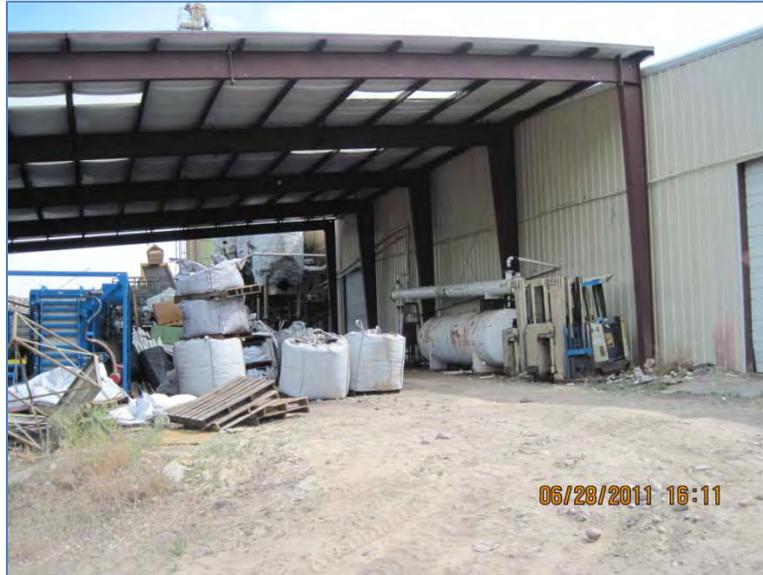
**NMED/SWQB  
Official Photograph Log  
Photo # 7**

Photographer: Erin S. Trujillo	Date: 06/28/2011	Time: 1611 hours
City/County: Farmington / San Juan County		State: New Mexico
Location: Morningstar Minerals Corporation Mill and Manufacturing Facility		
Subject: Material storage in this processing area is only partially covered/protected.

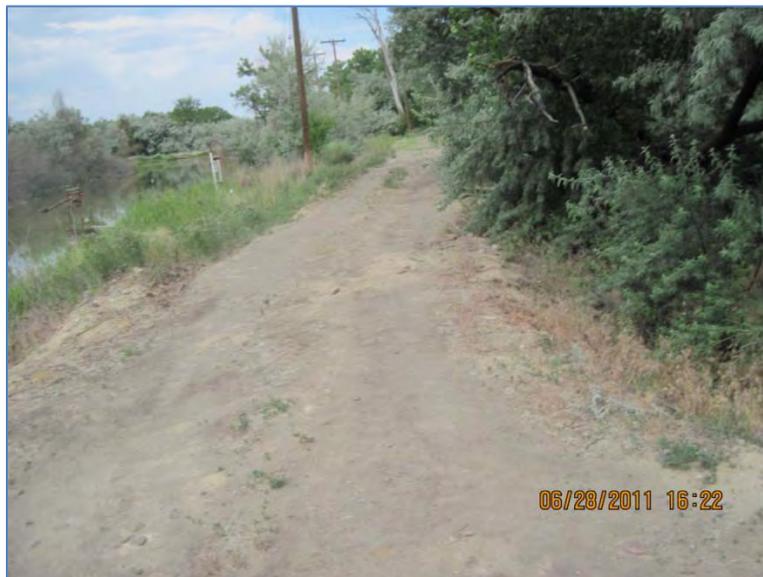
**NMED/SWQB  
Official Photograph Log  
Photo # 8**

Photographer: Erin S. Trujillo	Date: 06/28/2011	Time: 1622 hours
City/County: Farmington / San Juan County		State: New Mexico
Location: Morningstar Minerals Corporation Mill and Manufacturing Facility		
Subject: Berm between facility and Animas Valley intake/gallery pond along Animas River.

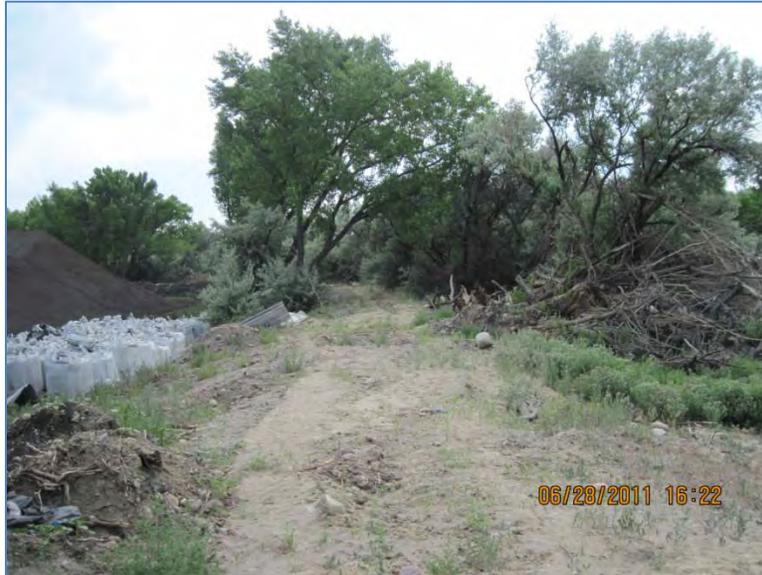
NMED/SWQB  
Official Photograph Log  
Photo # 8

Photographer: Erin S. Trujillo	Date: 06/28/2011	Time: 1622 hours
City/County: Farmington / San Juan County	State: New Mexico	
Location: Morningstar Minerals Corporation Mill and Manufacturing Facility		
Subject: Berm between agricultural soil conditioner storage area (left side of photo) and Animas River (not shown).

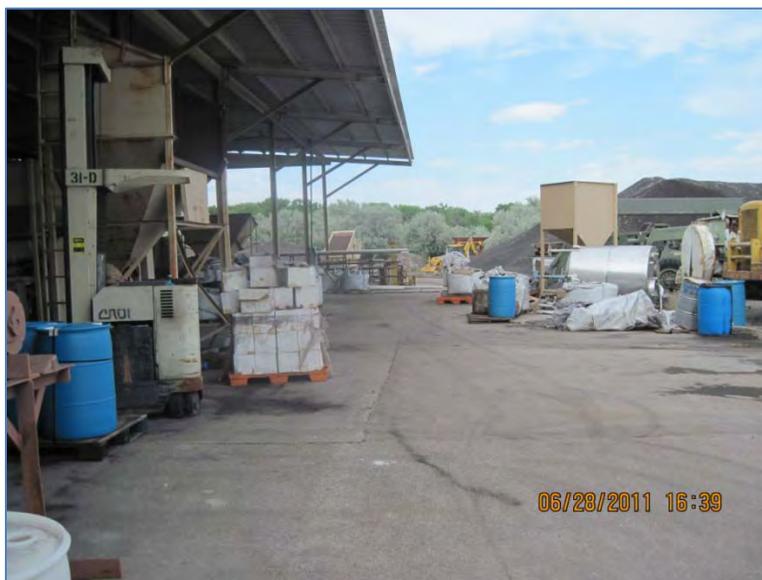
NMED/SWQB  
Official Photograph Log  
Photo # 9

Photographer: Erin S. Trujillo	Date: 06/28/2011	Time: 1639 hours
City/County: Farmington / San Juan County	State: New Mexico	
Location: Morningstar Minerals Corporation Mill and Manufacturing Facility		
Subject: Outside storage of materials and equipment both under covered and not. Spilled humate observed on paved surface.

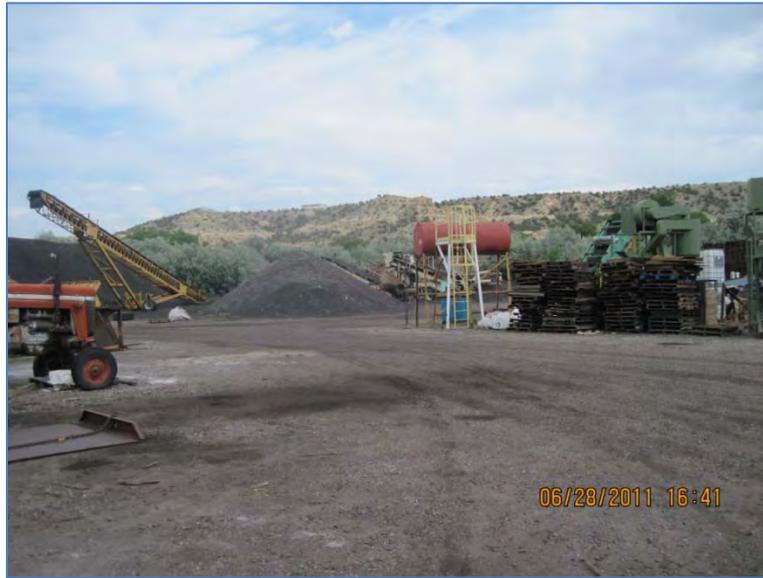
**NMED/SWQB  
Official Photograph Log  
Photo # 10**

Photographer: Erin S. Trujillo	Date: 06/28/2011	Time: 1641 hours
City/County: Farmington / San Juan County		State: New Mexico
Location: Morningstar Minerals Corporation Mill and Manufacturing Facility		
Subject: Tracking shown in this photo was not observed on access road off site. No barriers between fuel storage and traffic area. No secondary containment for fuel tank in the event of spill or leaks.

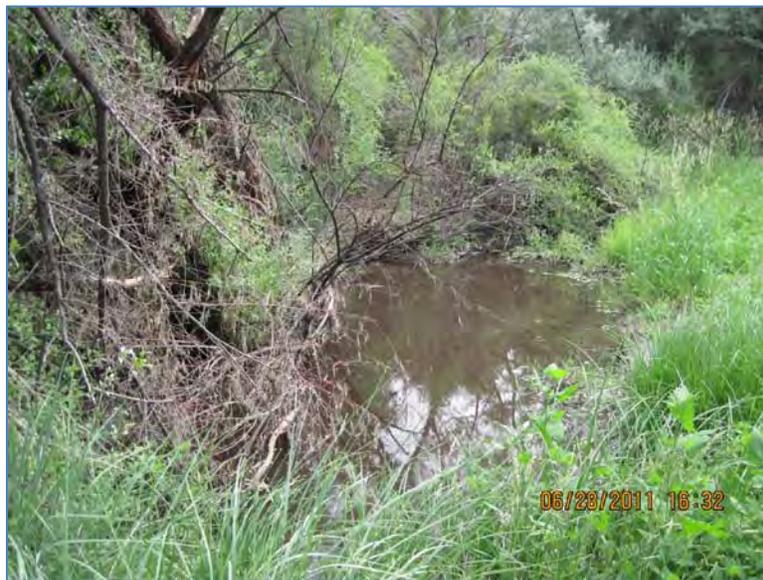
**NMED/SWQB  
Official Photograph Log  
Photo # 11**

Photographer: Erin S. Trujillo	Date: 06/28/2011	Time: 1632 hours
City/County: Farmington / San Juan County		State: New Mexico
Location: Morningstar Minerals Corporation Mill and Manufacturing Facility		
Subject: Looking west/southwest at standing water in trench shown in Photo 1 at property boundary.
